# Arboricultural Appraisal Report

## Subsidence Damage Investigation at:

31 Copse Wood Way  
Northwood  
Harrow  
HA6 2TZ

| REPORT DATE: | 03/08/2023 |

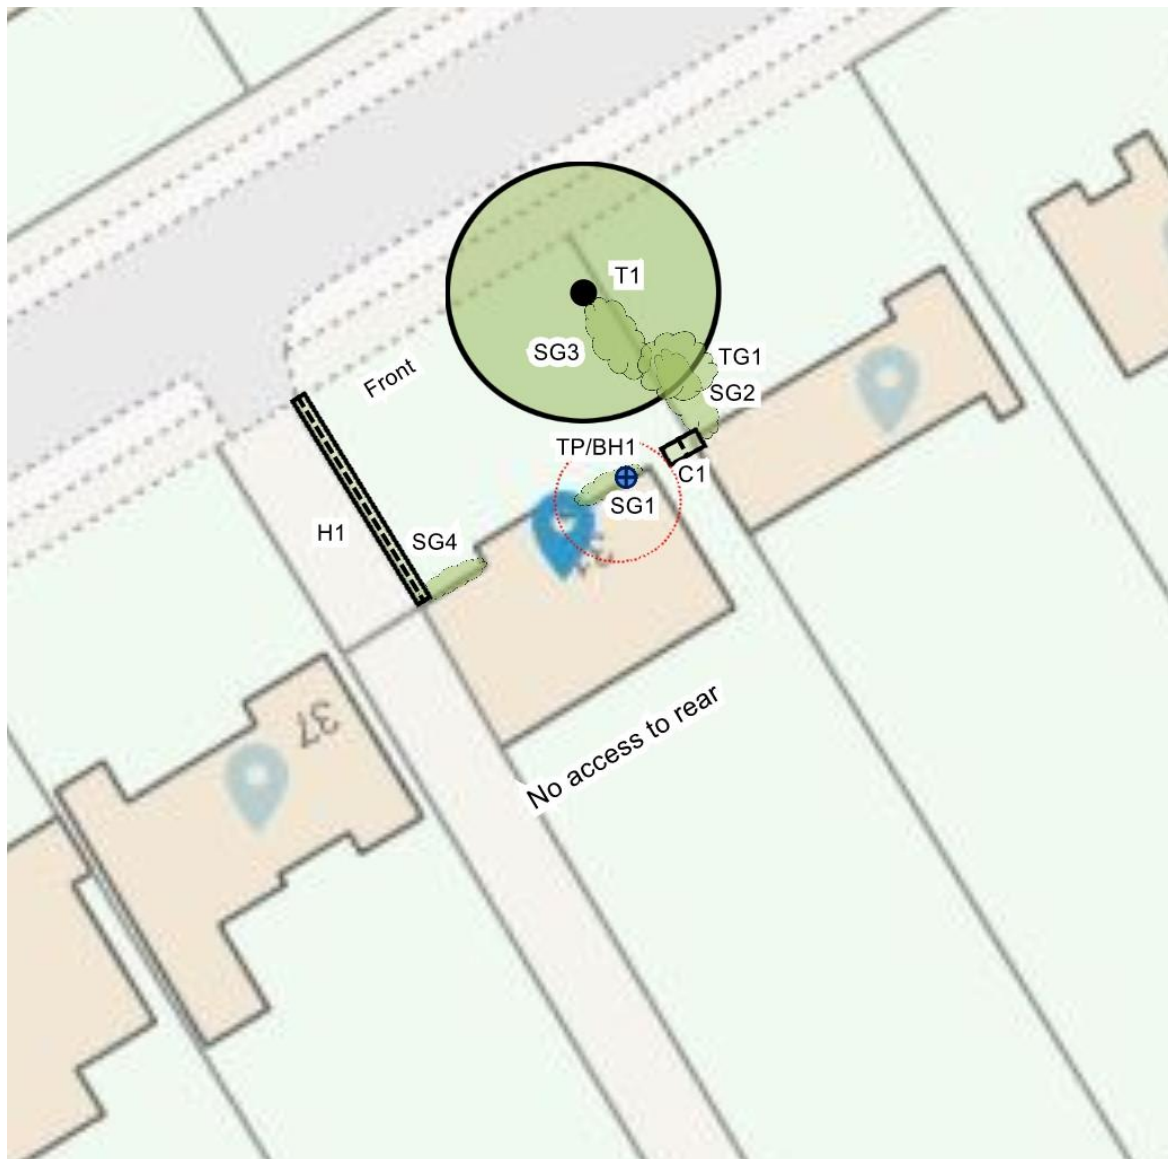
## Site Plan

Damage relates to the front left-hand corner of the insured dwelling.

Approximate areas of damage

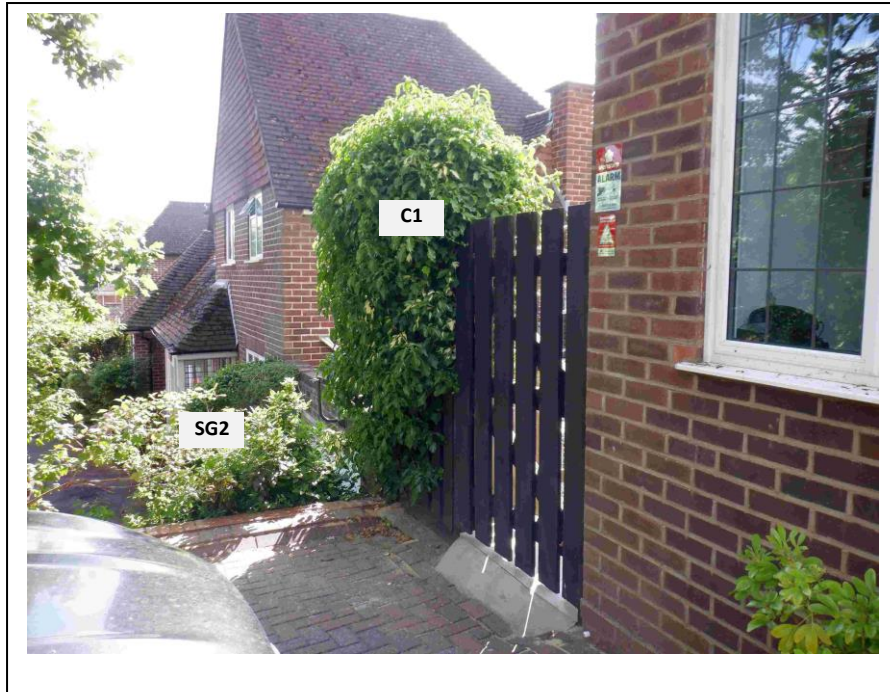
View of C1 & SG2

By virtue of their size and species profiles the mixed species shrub groups SG1 and SG2 are not considered to be a material influence in the current subsidence event.

| Tree No. | Species | Ht (m) | Dia (mm) | Crown Spread (m) | Dist. to building (m) | Age Classification | Ownership |
|---|---|---|---|---|---|---|---|
| C1 | Ivy | 3 | 10 Ms * | 1.2 | 2.4 * | Younger than Property | Policy Holder |

| Tree No. | Species | Ht (m) | Dia (mm) | Crown Spread (m) | Dist. to building (m) | Age Classification | Ownership |
|---|---|---|---|---|---|---|---|
| Recommendation | | Maintain broadly at no more than current dimensions by periodic pruning. | | | | | |

| Tree No. | Species | Ht (m) | Dia (mm) | Crown Spread (m) | Dist. to building (m) | Age Classification | Ownership |
|---|---|---|---|---|---|---|---|
| Recommendation | | Do not allow to exceed current dimensions. | | | | | |

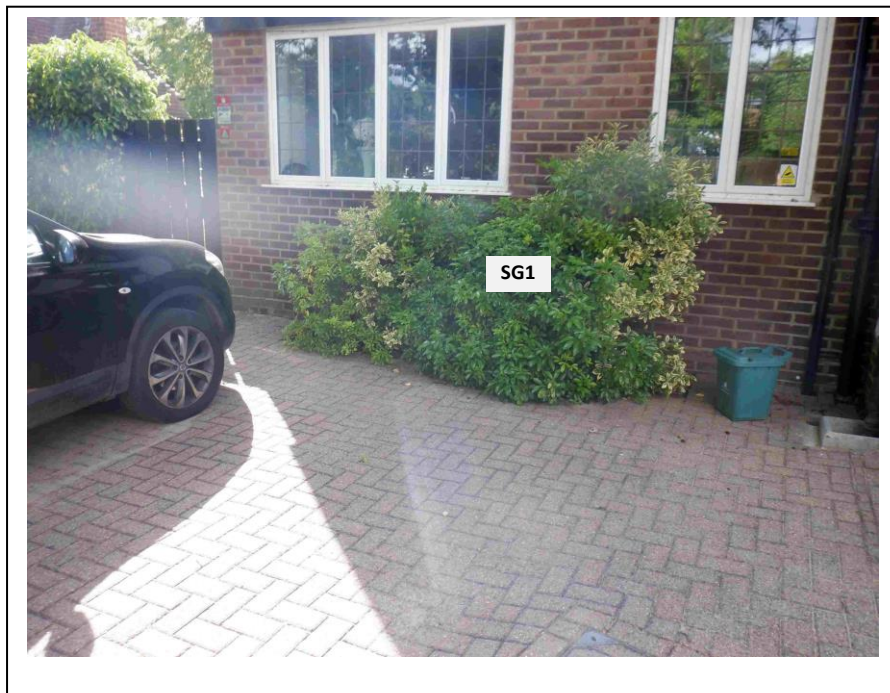
View of SG1

Roots were observed to a depth of 1.3m bgl in TP/BH1 and recovered samples have been tentatively identified as a shrub similar to Cistaceae, Lavender or the Caprifoliaceae family, the origin of which will be shrub groups SG1 and/or SG2.

| Tree No. | Species | Ht (m) | Dia (mm) | Crown Spread (m) | Dist. to building (m) | Age Classification | Ownership |
|---|---|---|---|---|---|---|---|
| Recommendation | | Maintain broadly at no more than current dimensions by periodic pruning. | | | | | |

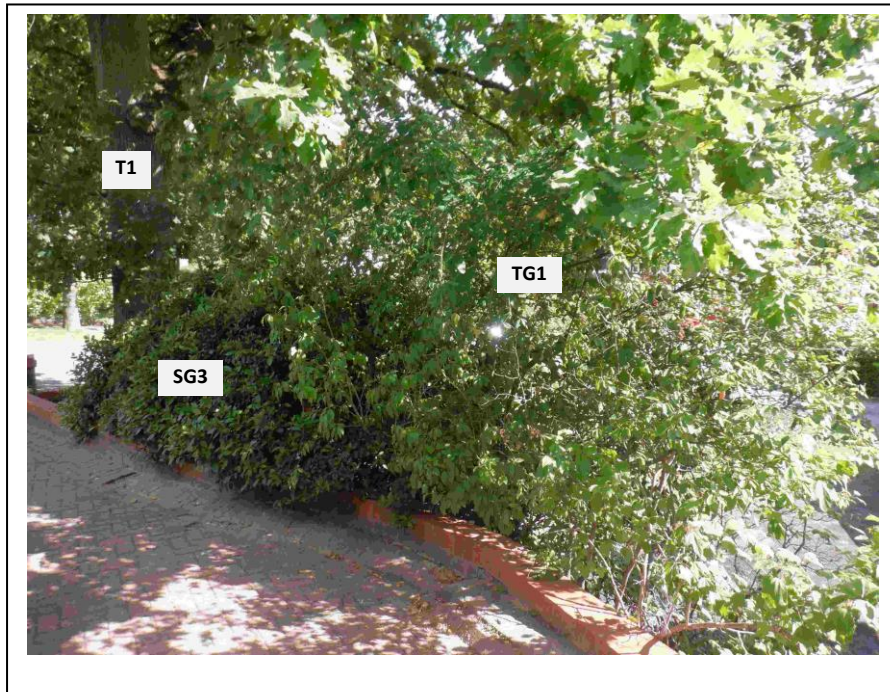
View of SG3 & TG1

| Tree No. | Species | Ht (m) | Dia (mm) | Crown Spread (m) | Dist. to building (m) | Age Classification | Ownership |
|---|---|---|---|---|---|---|---|
| TG1 | Laburnum and amelanchier | 4 * | 35 Ms * | 4 * | 5.5 * | Younger than Property | Third Party<br>29 Copse Wood Way<br>HA6 2TZ |
| SG3 | Viburnum | 3.8 * | 15 Ms * | 2 * | 6.5 * | Younger than Property | Policy Holder |

| Tree No. | Species | Ht (m) | Dia (mm) | Crown Spread (m) | Dist. to building (m) | Age Classification | Ownership |
|---|---|---|---|---|---|---|---|
| Recommendation | | Maintain broadly at no more than current dimensions by periodic pruning. | | | | | |

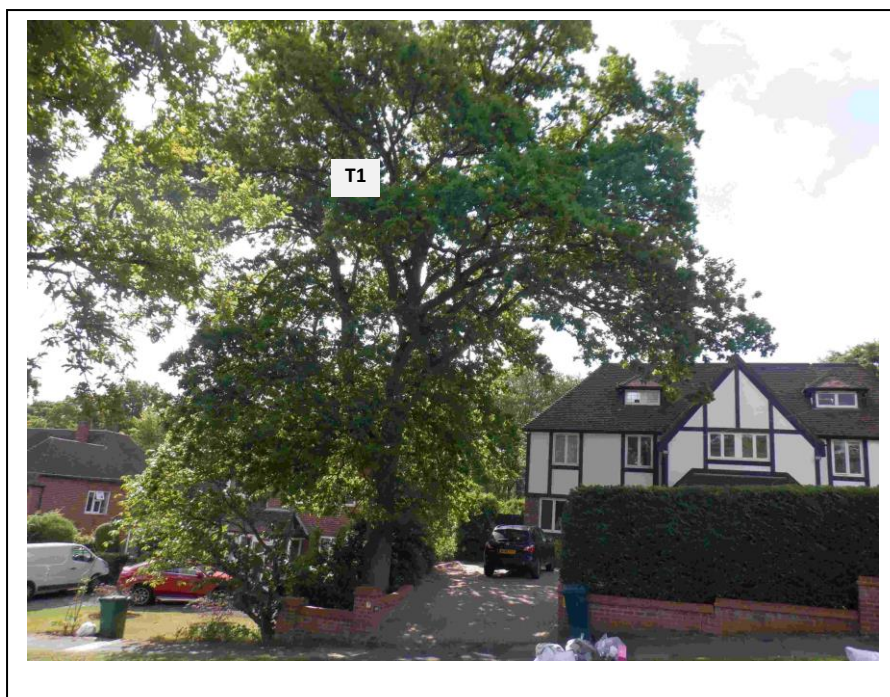
View of T1

Irrespective of the identification of recovered root samples, the roots of the Oak (T1) are likely to be present below foundation level in proximity to the area of movement/damage and influencing soil moisture and volumes.

Based on the technical reports currently available, engineering opinion and our own site assessment we conclude the damage is consistent with shrinkage of the clay subsoil related to moisture abstraction by vegetation. Having considered the information currently available, it is our opinion that the Oak (T1) is the principal cause of the current subsidence damage.

| Tree No. | Species | Ht (m) | Dia (mm) | Crown Spread (m) | Dist. to building (m) | Age Classification | Ownership |
|---|---|---|---|---|---|---|---|
| T1 | Oak | 19.9 | 675 * | 20.2 | 9.4 | Older than Property | Policy Holder |

If an arboricultural solution is to be implemented to mitigate the influence of the implicated trees/vegetation we recommend that the Oak (T1) is removed. Other vegetation recorded presents a potential future risk to building stability and management is therefore recommended.

| Tree No. | Species | Ht (m) | Dia (mm) | Crown Spread (m) | Dist. to building (m) | Age Classification | Ownership |
|---|---|---|---|---|---|---|---|
| Recommendation | | Remove (fell) to near ground level and treat stump to inhibit regrowth. | | | | | |
