Site Investigation Report

145212.1.USI

Auger were commissioned by - to undertake a site investigation and CCTV inspection of the underground drainage within the area of concern (AOC) at the property.

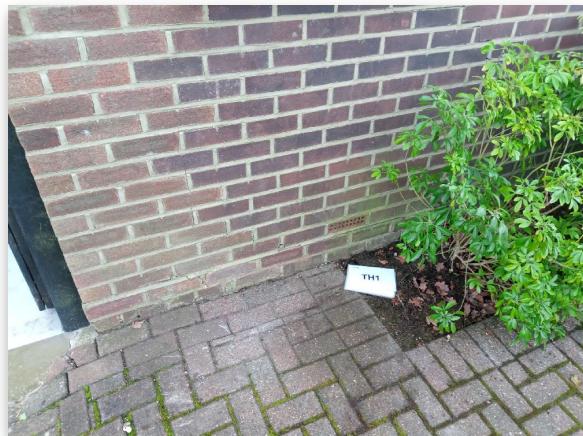
TH1 was completed in the proposed location and the footing was determined, soil and root samples were taken. Please note the footing was determined by probing to a depth below 1m therefore exact depth cannot be guaranteed.

Fig 1.1: Trial Hole 1 Location

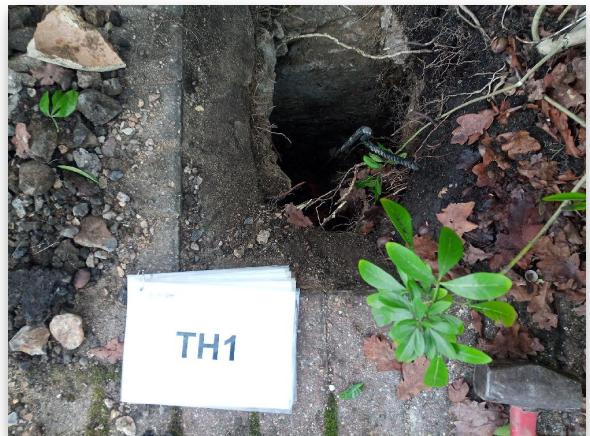
Fig 1.2: Trial Hole 1 Footing

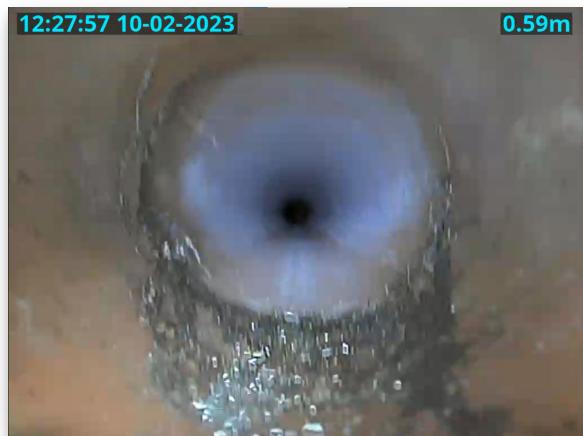
Our survey of line 1 revealed root ingress at 0.6m and cracking at 4.1m.

The above mentioned defects to the below ground drainage system have been caused by ground movement.

Fig 2.1: Line 1 Roots

Refer Back to Client	<p>It is recommended that the following repairs are carried out to prevent an escape of water from the system:</p> <p>Line 1 Install 4.5m of 100mm liner directly upstream of MH1.</p> <p>Line 2 Excavate and replace SVP2 restbend and 1m 100mm pipework at a depth no greater than 1m through block paving. Install 2m 100mm liner directly downstream of the excavation.</p> <p>Line 3 Excavate and replace WG1 and 1m of 100mm pipework at a depth no greater than 1.0m through block paving. Install 1m of 100mm liner directly downstream of excavation.</p> <p>Line 4 Excavate and replace the RWP1 restbend and 3m of 100mm pipework at a depth no greater than 1.0m through block paving.</p> <p>Auger have not allowed or will not be held responsible for any alteration or modification to the above ground drainage following the removal of the existing gully and reinstatement of a new gully. The customer must ensure that the above ground drainage correctly expels into the gully pot and avoids overcrowding the gully with numerous downpipes which could lead to the gully overflowing.</p> <p>During the clean-up/reinstatement process we will endeavour to leave the area we are working in clean and tidy and as close to how we found it as possible. There will always be an element of general debris/mud/waste that will build up in the area which cannot be prevented. There may however be elements of this process that are outside our remit i.e., Repainting or cleaning. If this is the case, then we will need to speak to the customer's insurer to help in this regard.</p> <p>We will now refer the claim back to the client in order to progress the claim.</p>

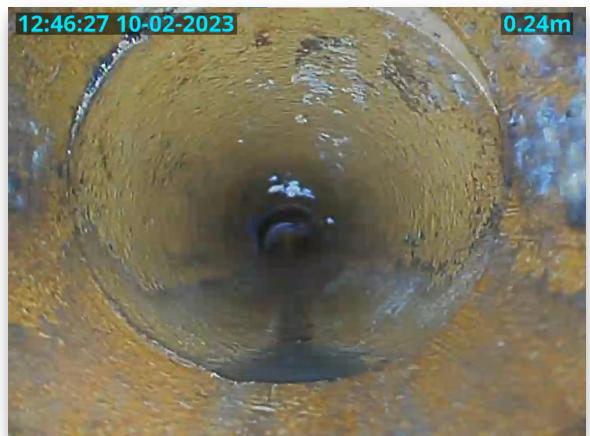
Our survey of line 2 revealed root ingress at 1m and 3.8m and joint displacements at 1.5m, 2m 2.5m and 3m.

Fig 2.2: Line 2 Displacement

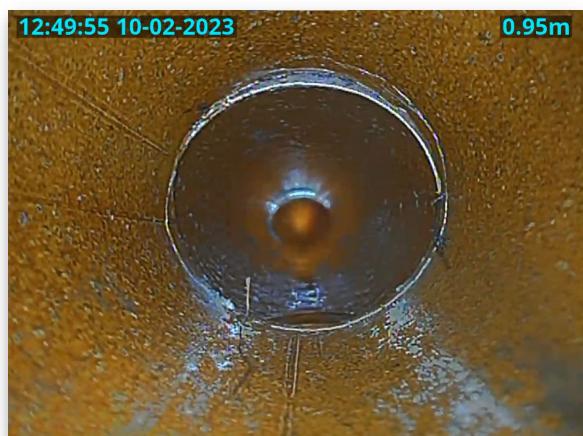
Our survey of line 3 revealed joint displacements at 2m and cracking at 1m.

Fig 2.3: Line 3 Cracking

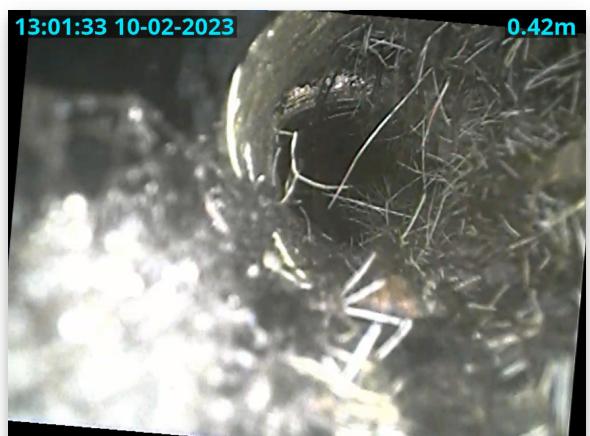
Our survey of line 4 revealed root ingress through the pipe.

Fig 2.4: Line 4 Roots
