**Phase 1 Land Contamination  
Risk Assessment**

**Proposed Conversion of  
Commercial Floorspace  
(Charitable Service Units  
to Residential Use)**

**Units No.2-6, 8-12, 15-20, 22-30,  
Hawthorne Court, Ryefield Crescent,  
Northwood  
HA6 1LJ**

**Date: December 2022**

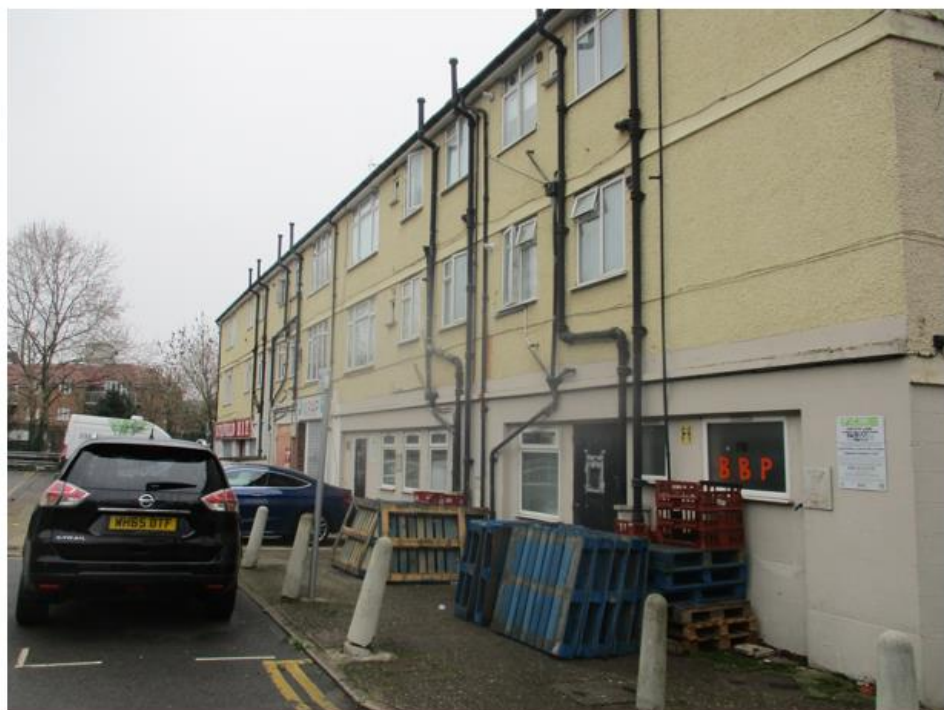
**Photo No.1: Facing slightly NE from outside the SW corner of site showing the western face of Hawthorne Court**

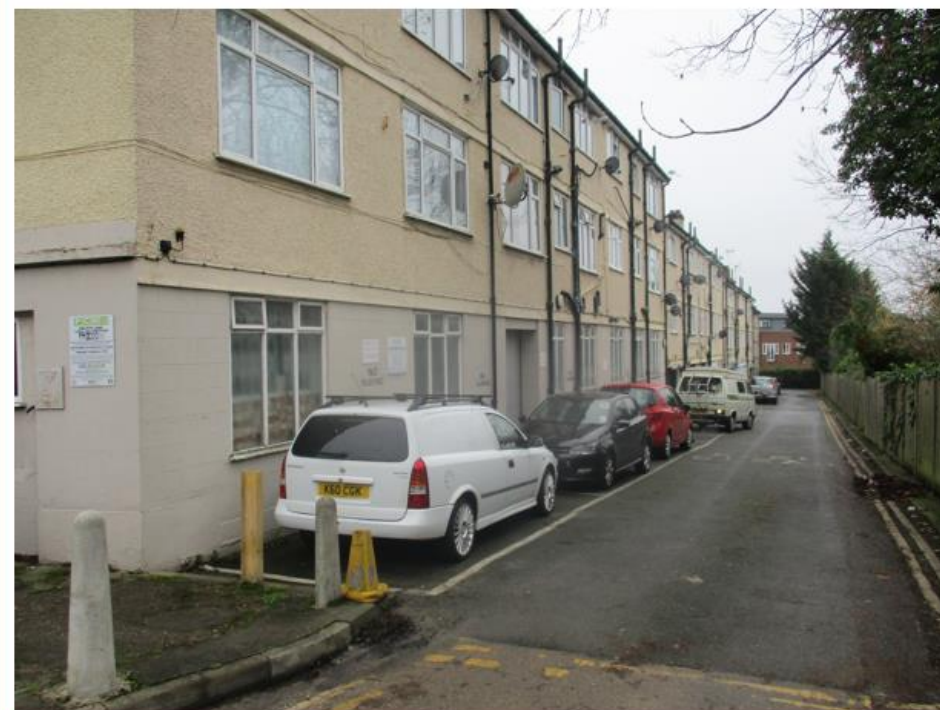
**Photo No.2: Facing east from the same location showing the southern face of the building and access road to eastern extent**

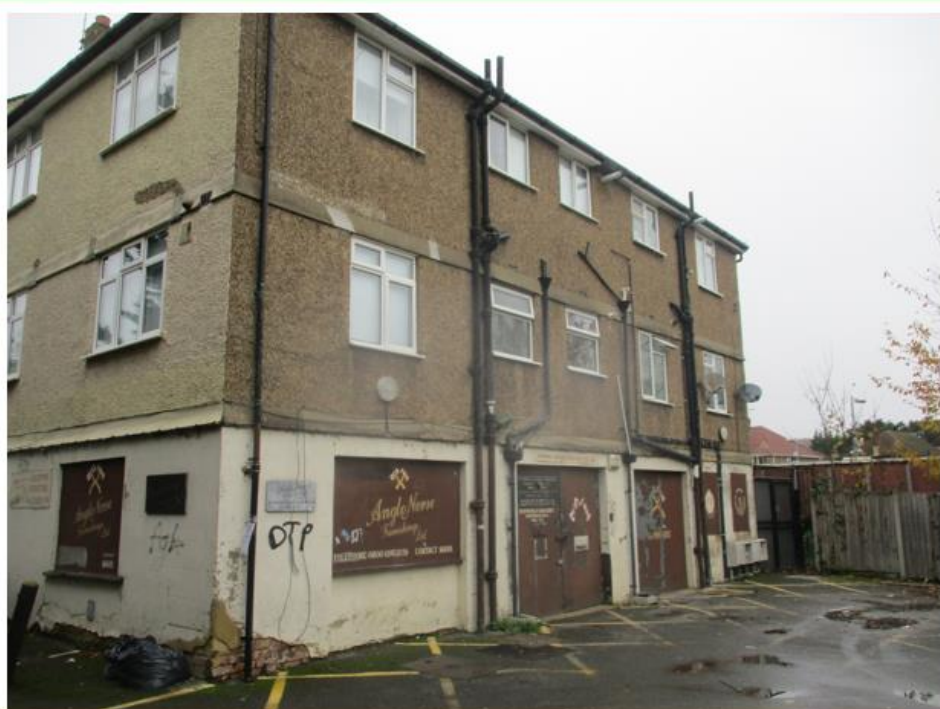
**Photo No.3: Facing NW from outside the SE corner of site showing the eastern face of Hawthorne Court**

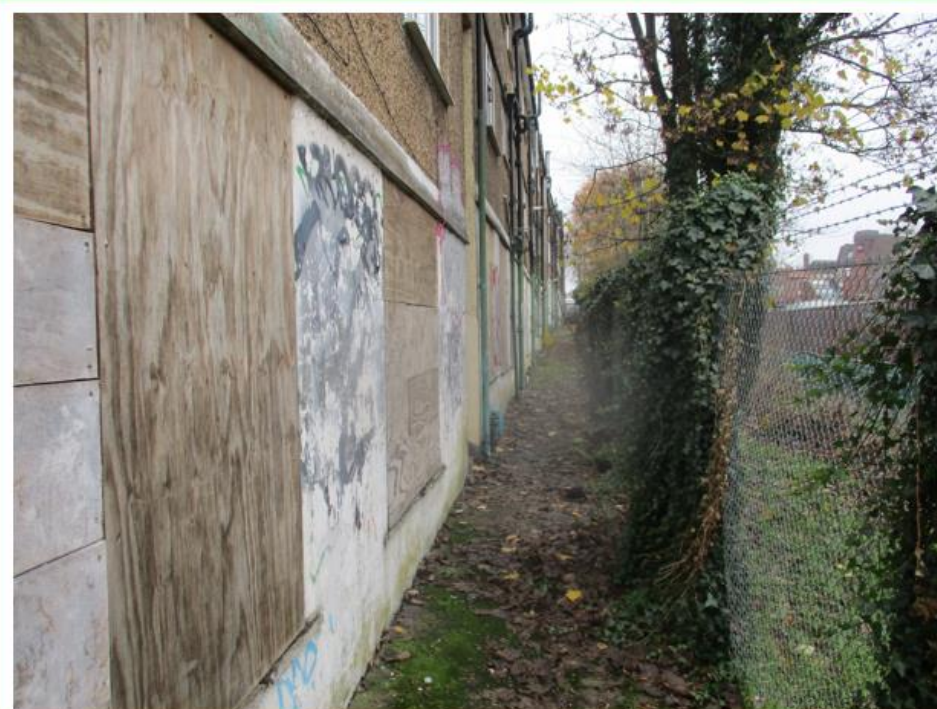
**Photo No.4: Facing NW from the NE corner of site showing the northern face of the building and adj. railway (right)**

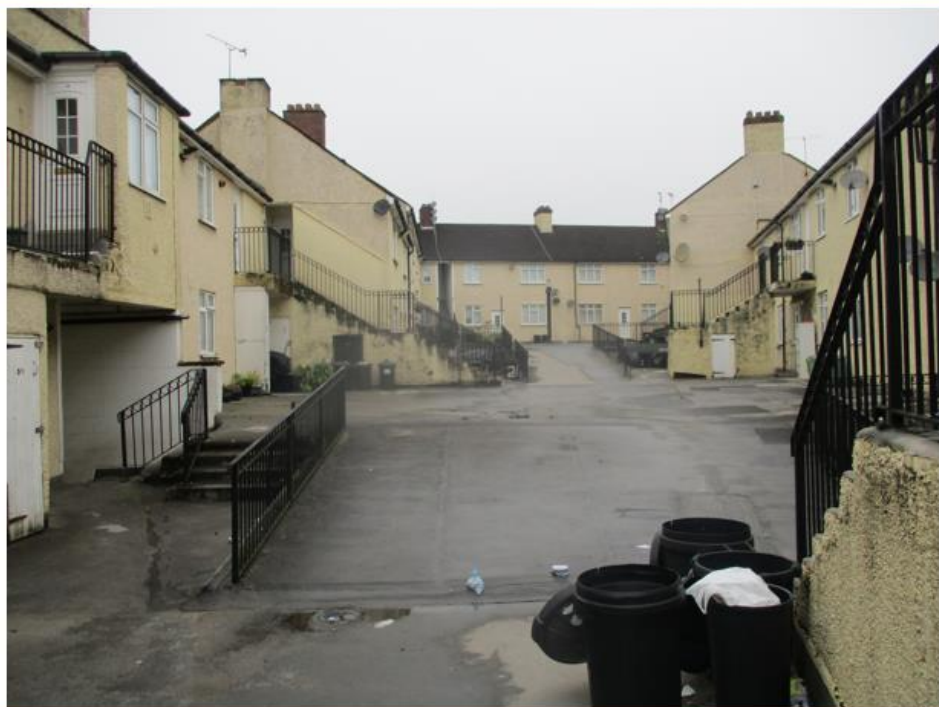
**Photo No.5: Facing NW from the SE extent of the first-floor inner courtyard on site showing residential usage here**

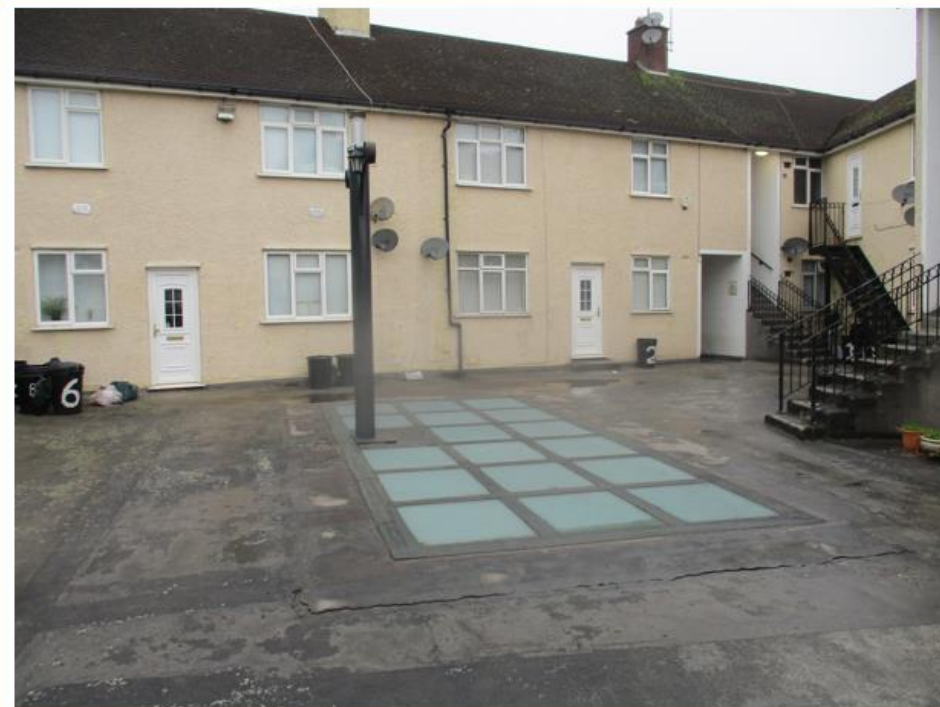
**Photo No.6: Skylight and stack of units No.2-6 noted in the NW extent of the inner, first-floor courtyard of the building**

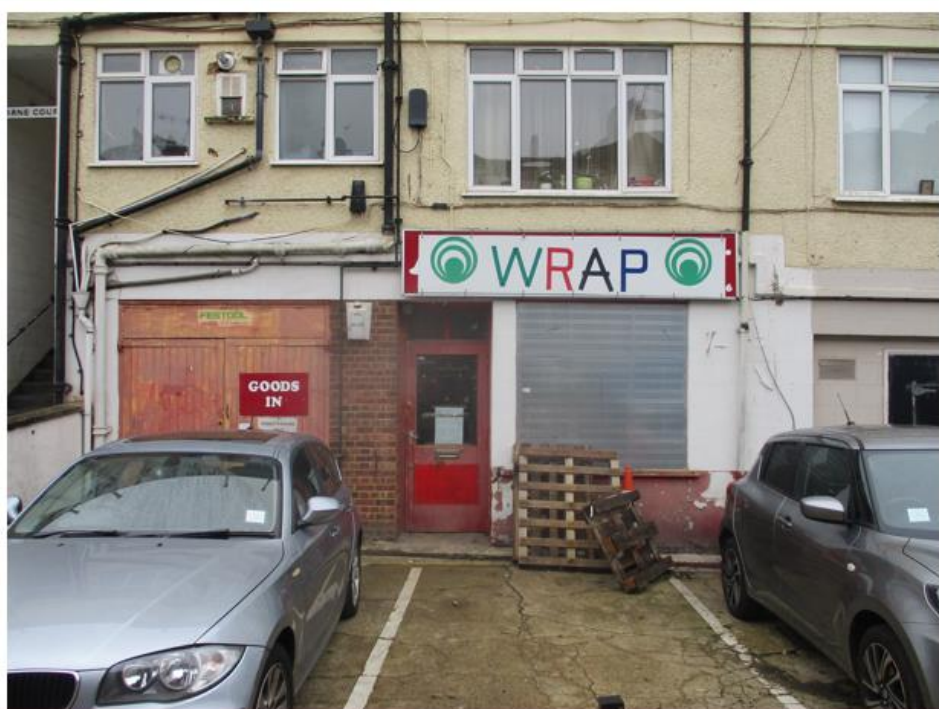
**Photo No.7: Facing east from outside the western face of Hawthorne Court showing access to units No.2-6**

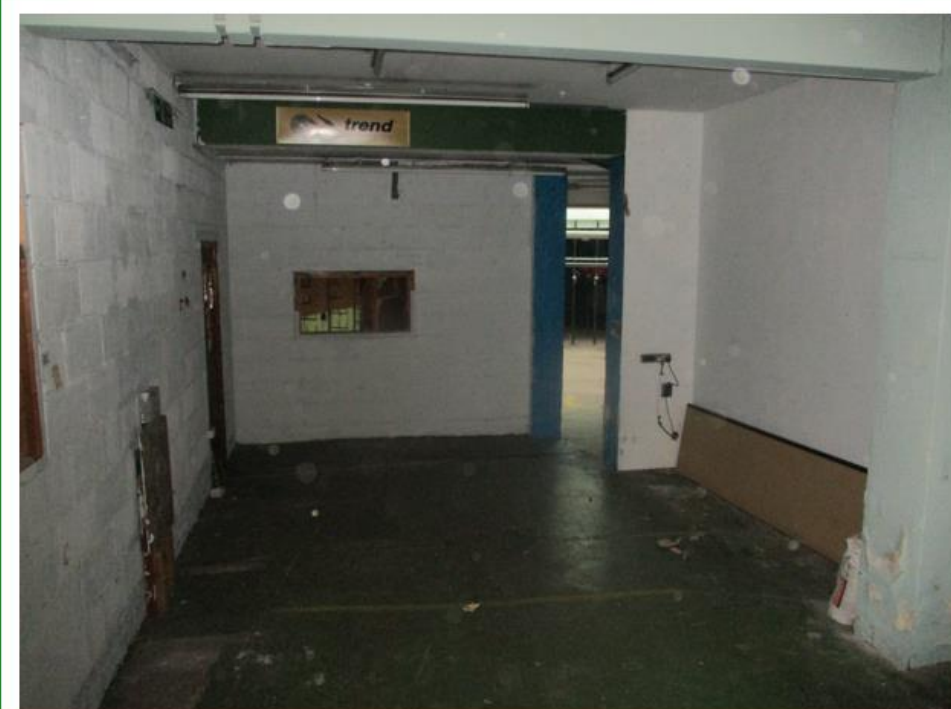
**Photo No.8: facing east inside the access to units No.2-6 showing unoccupied, former commercial floorspace**

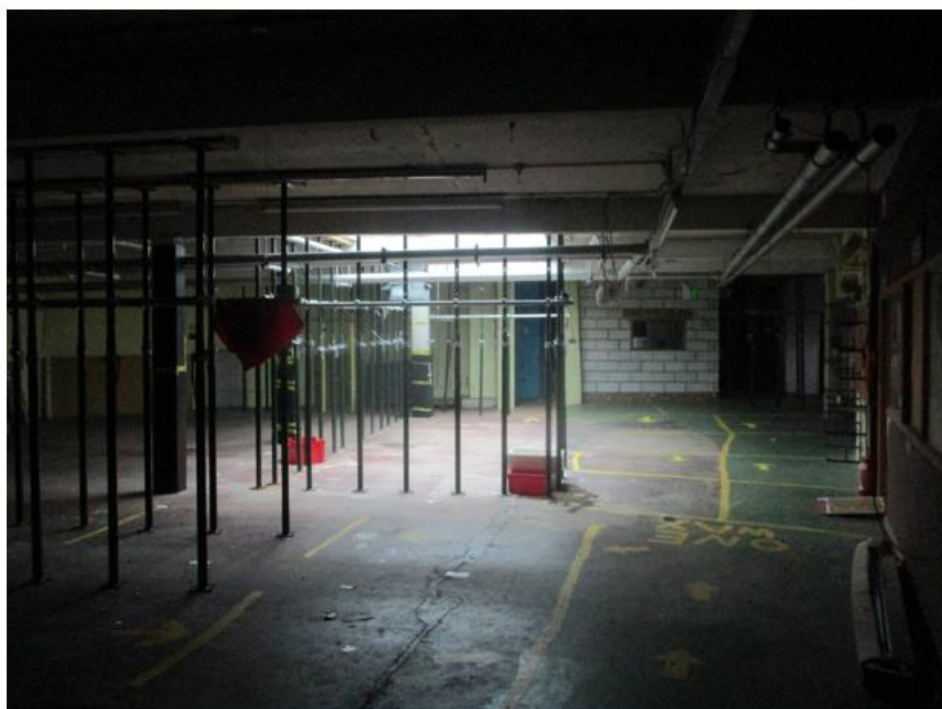
**Photo No.9: Example shot of the interior of the largest room comprising units No.2-6 (also showing skylight)**

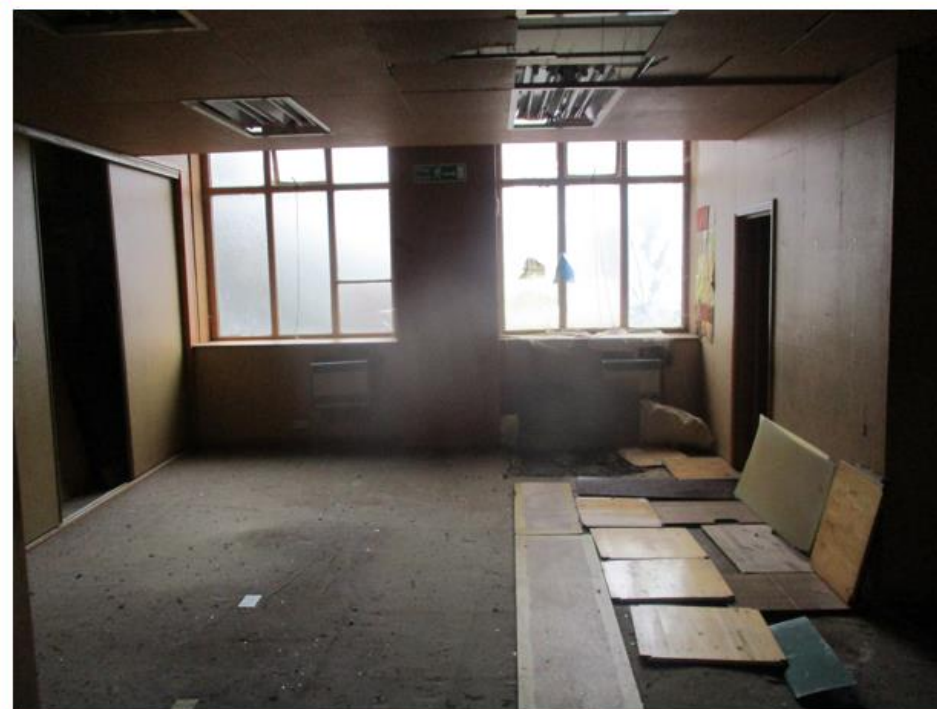
**Photo No.10: Facing north showing former office-space in units No.2-6**

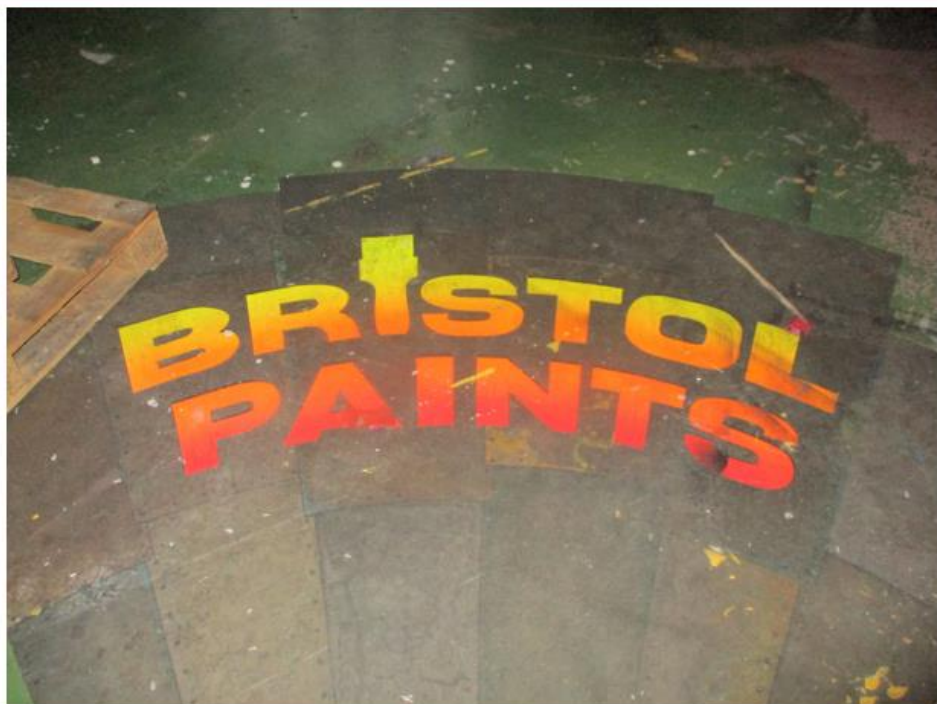
**Photo No.11: facing west in the western extent of units No.2-6 showing concrete flooring and former paint-shop usage**

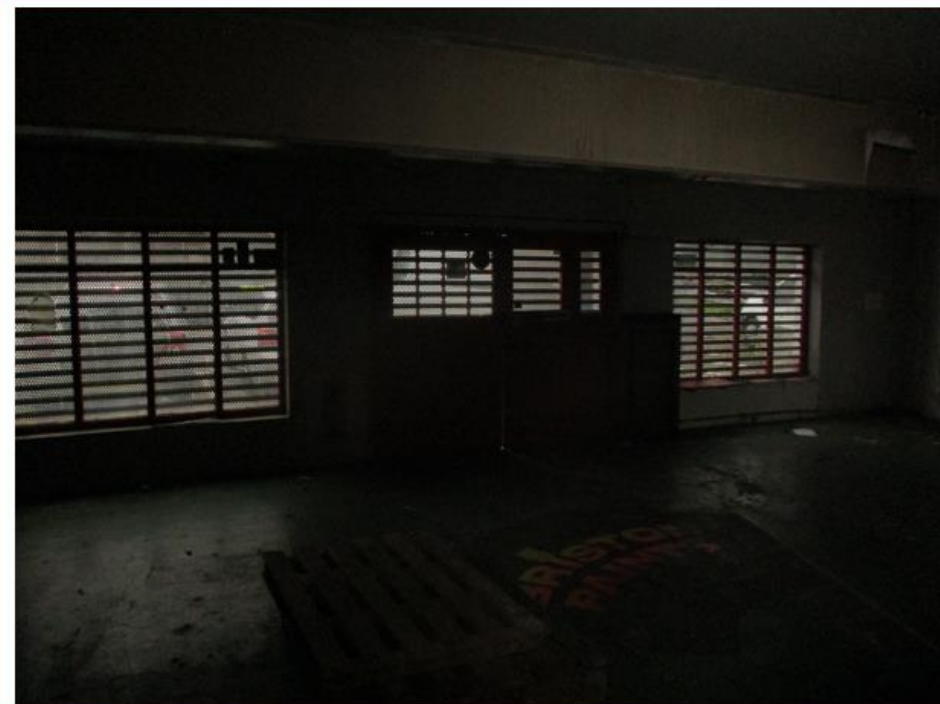
**Photo No.12: Facing west in the former paint-shop showing the inside of the western face of the Hawthorne Court**

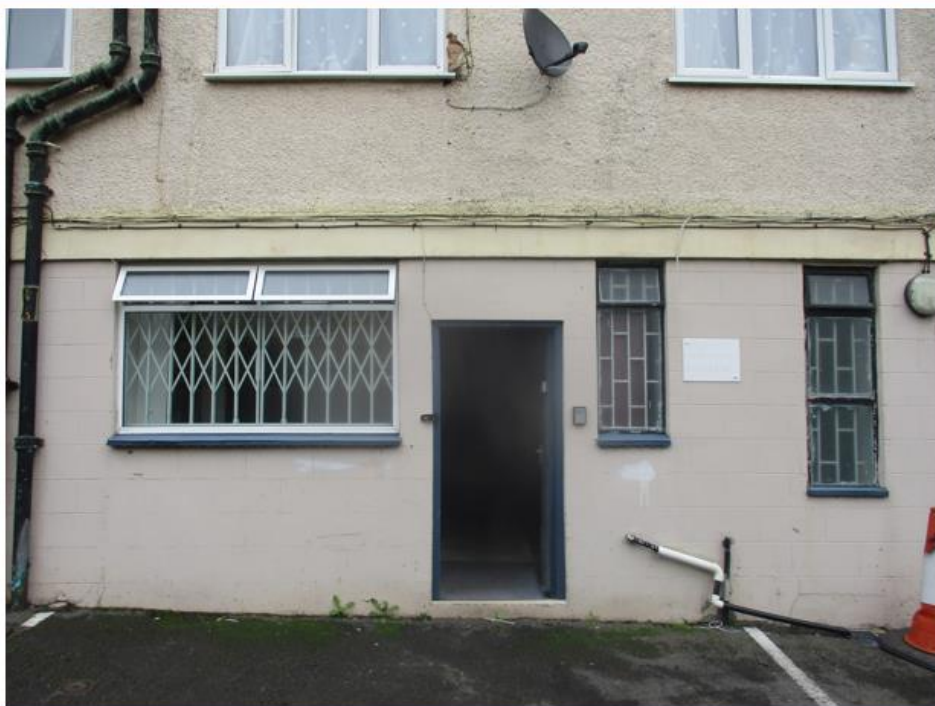
**Photo No.13: Facing north from outside the southern face of the building showing access to units No.18-20**

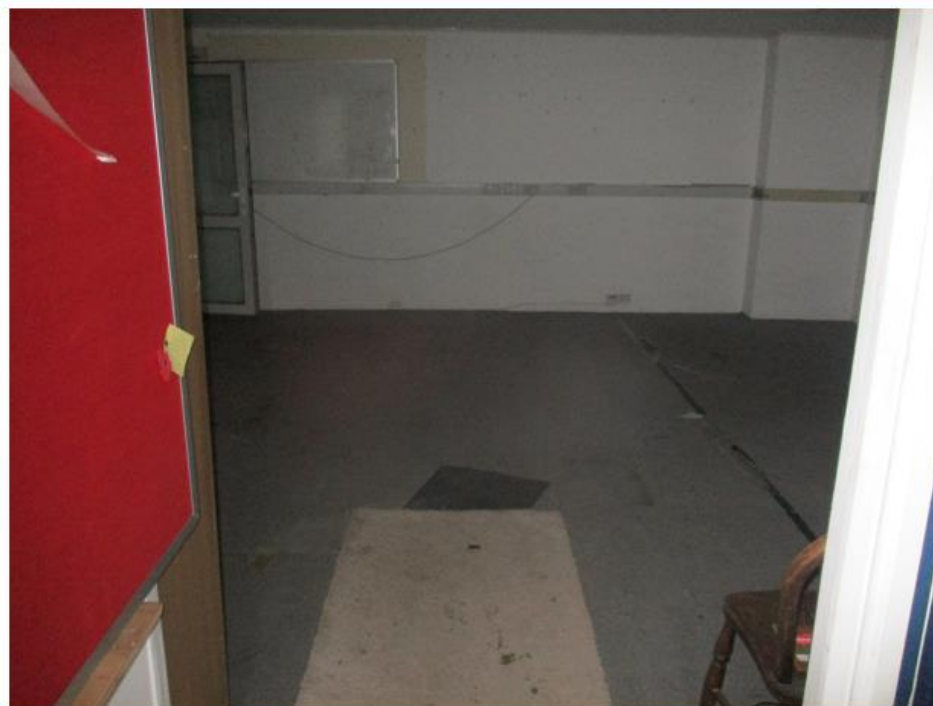
**Photo No.14: Facing north from just inside the access of unit No.20 (access to units No.18/19 off to left of photo)**

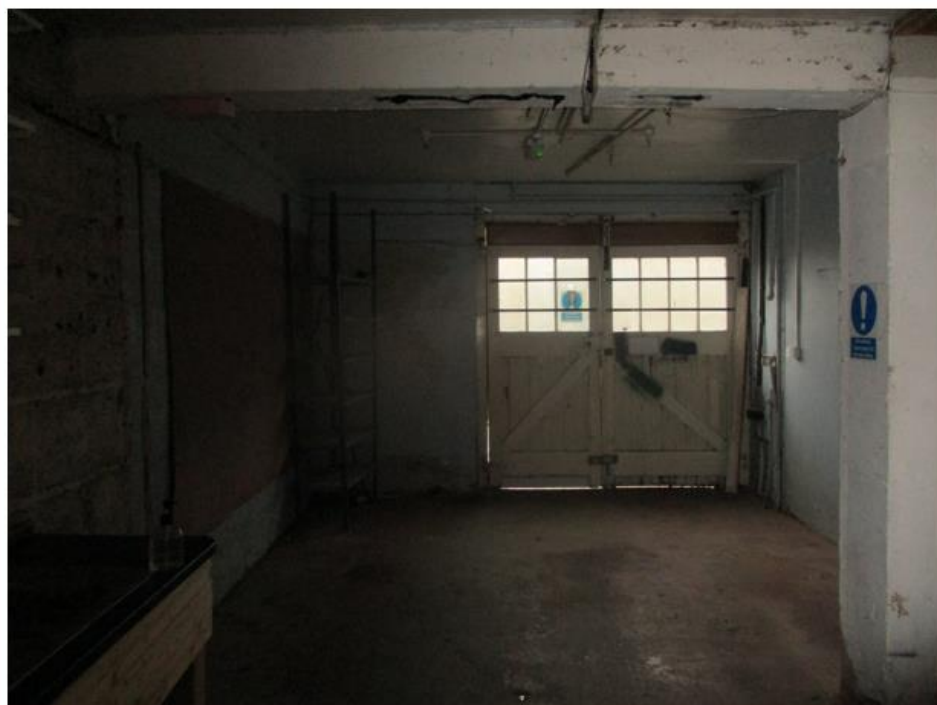
**Photo No.15: Facing south from inside the garage-door of unit No.18 showing concrete floors and being unoccupied**

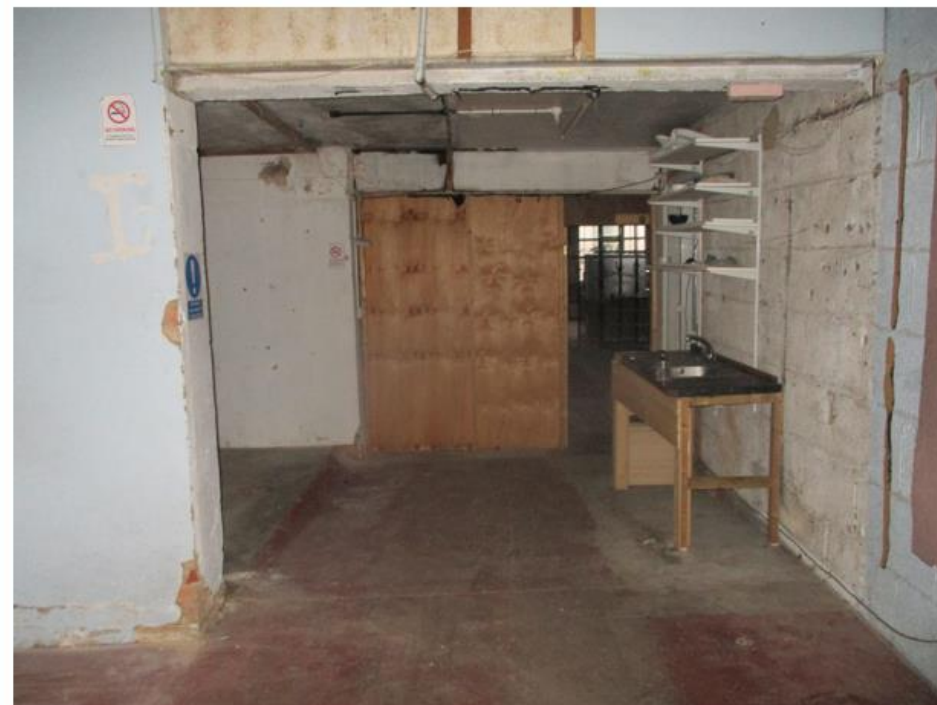
**Photo No.16: Facing north from the same spot looking towards the entrance to unit No.18 from unit No.20 (right)**

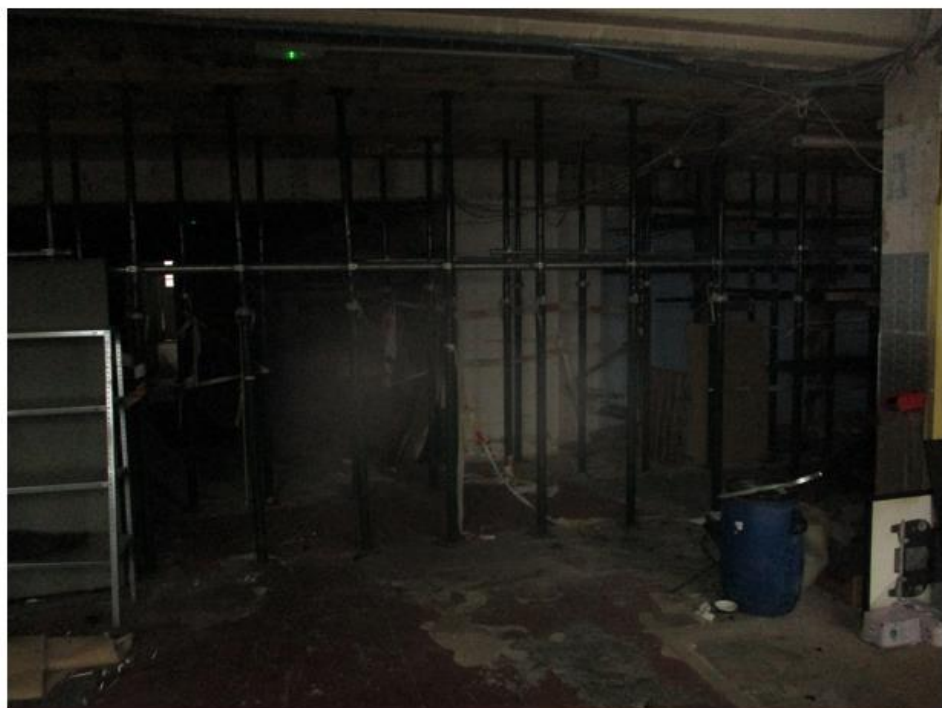
**Photo No.17: Facing south from inside the northern face of unit No.18 showing acrows supporting the roofing here**

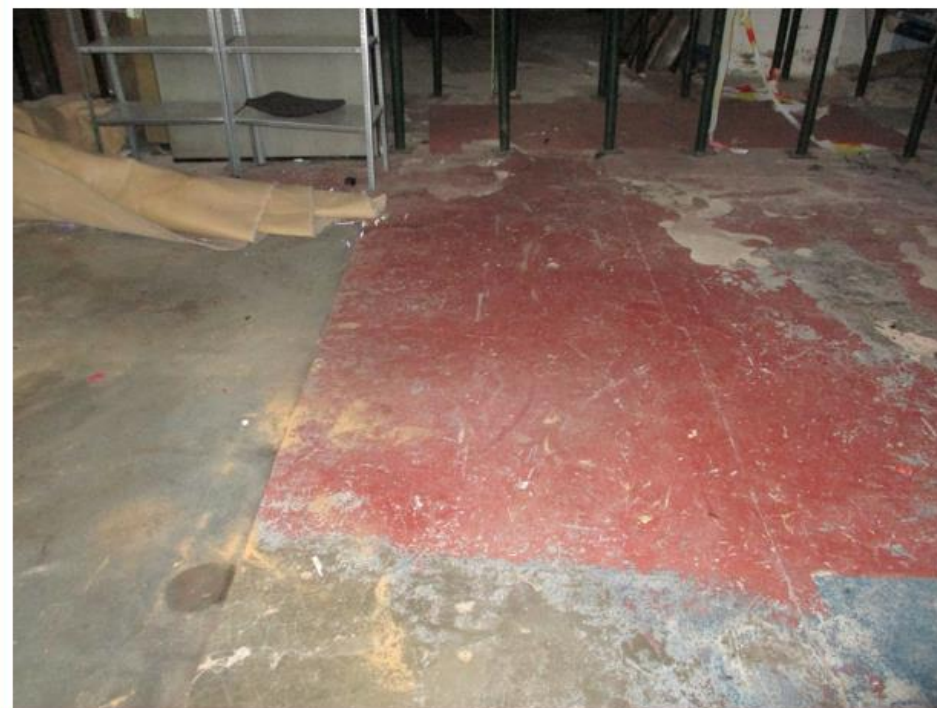
**Photo No.18: Example shot of flooring conditions within units No.18-20**

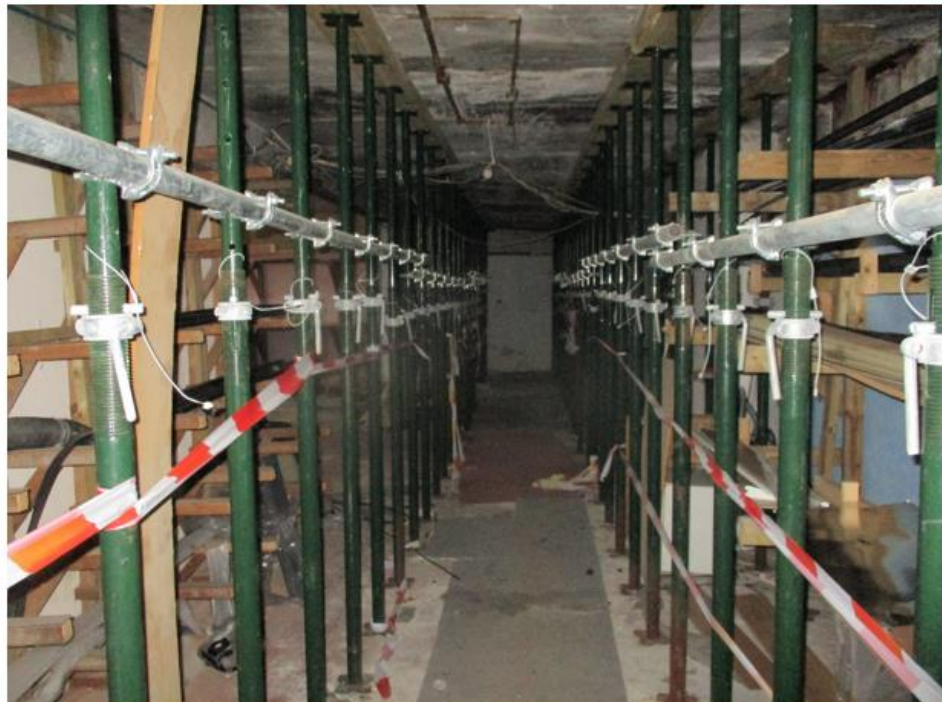
**Photo No.19: Facing slightly SE from the NW extent of units no.18/19 showing further supporting acrows and shelving**

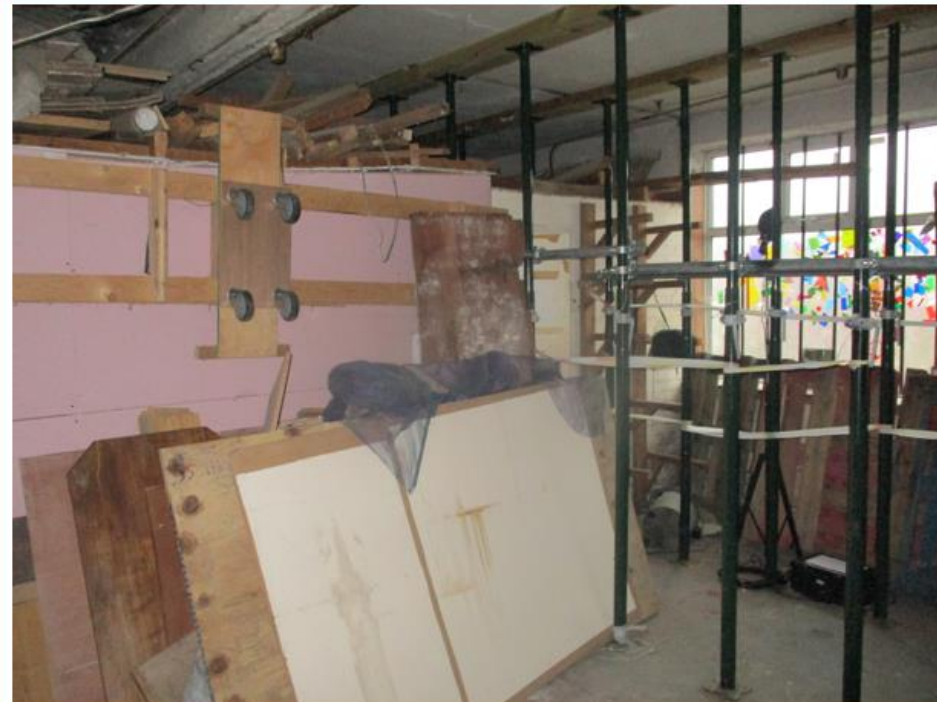
**Photo No.20: Facing NW from the same spot showing a toilet enclosure in the far NW of units No.18/19**

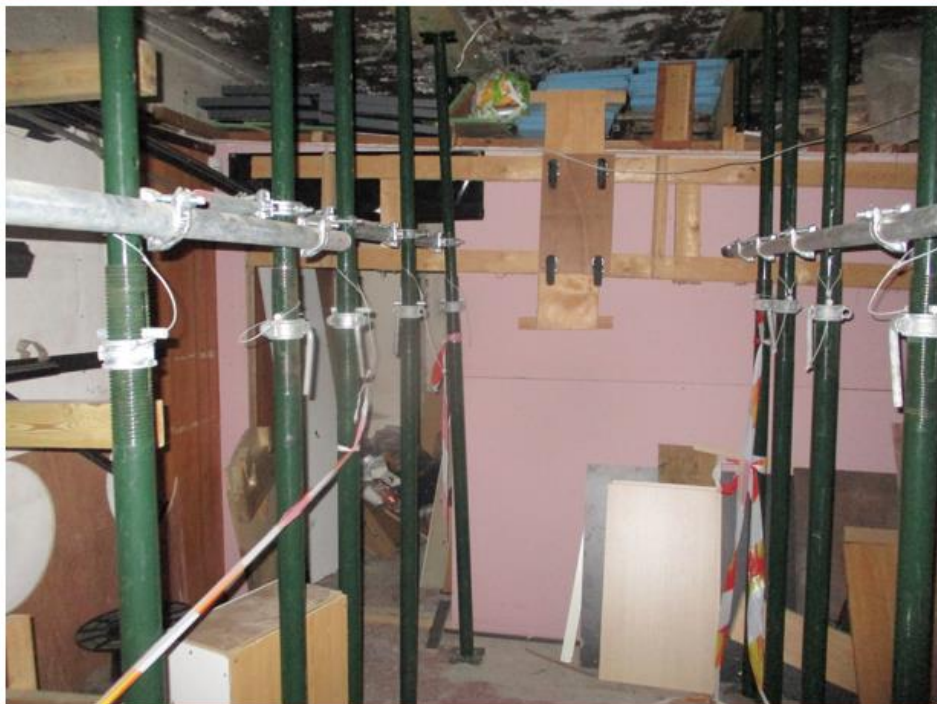
**Photo No.21: Facing west showing entrance to toilet enclosure and miscellaneous joinery materials storage**

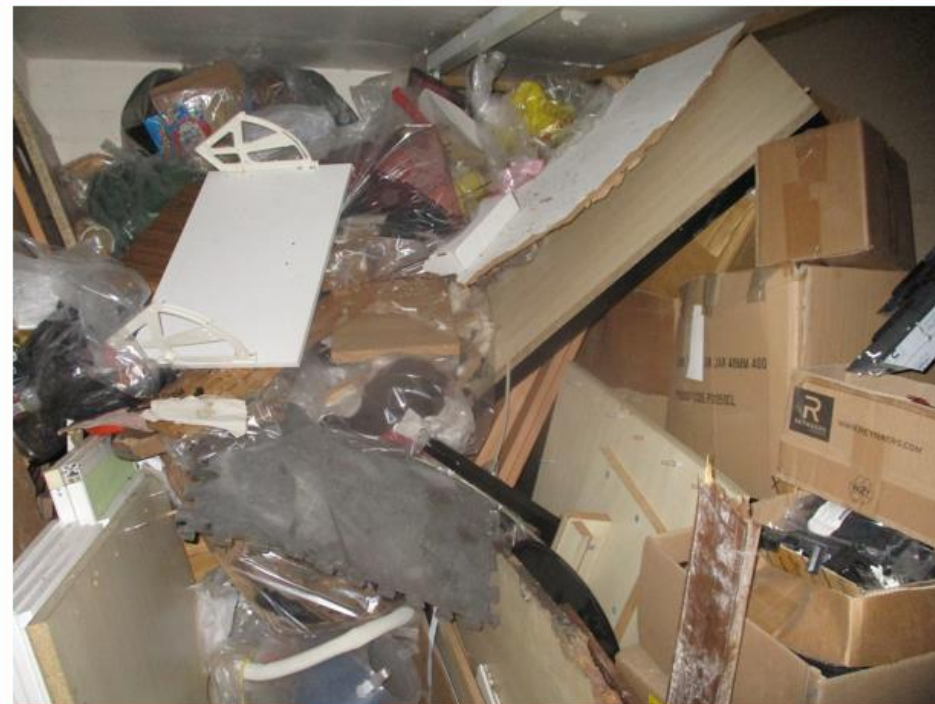
Access to unit No.20 was then provided via a pedestrian entrance on the southern face of the building. This unit was also noted to be unoccupied and comprised what appeared to be former office and storeroom space with a limited kitchen area and toilets. Garage doors adjacent to the pedestrian entrance were noted, providing access to both unit.20 and the rear unit No.18/19. Units No.18/19 comprised what appeared to be a former joinery workshop with concrete flooring, wooden shelving and other miscellaneous materials noted. Further, numerous acrows were noted supporting the ceiling in this unit. The far north western corner of this unit was noted to contain a wooden toilet enclosure, itself occupied by a large number of plastic and cardboard bags and boxes, filled with materials, fittings and other, undiscernible debris.

**Photo No.22: Heaps of refuse, debris, materials and equipment noted inside toilet enclosure of units No.18/19**

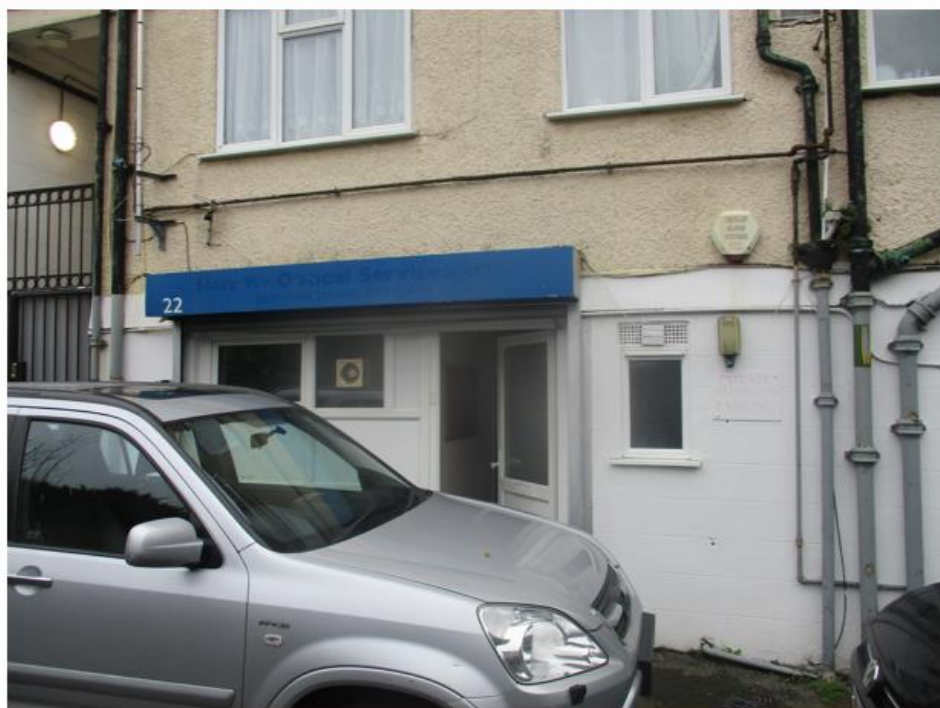
**Photo No.23: Facing north from outside the southern face of the building showing the access to unit No.22**

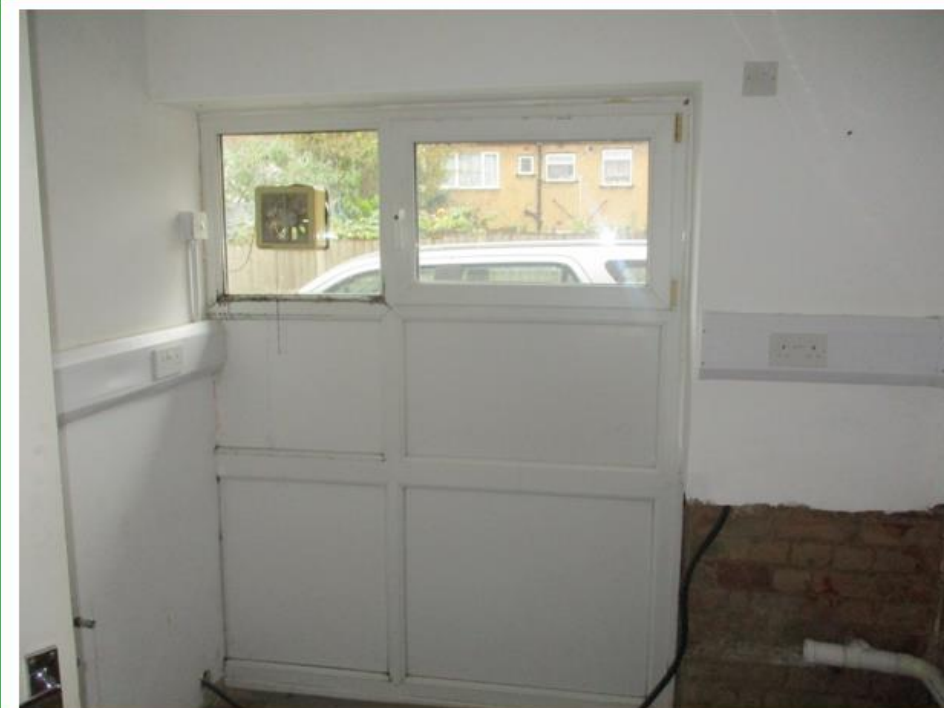
**Photo No.24: Facing south from inside unit No.22 showing former office/reception space and service entries**

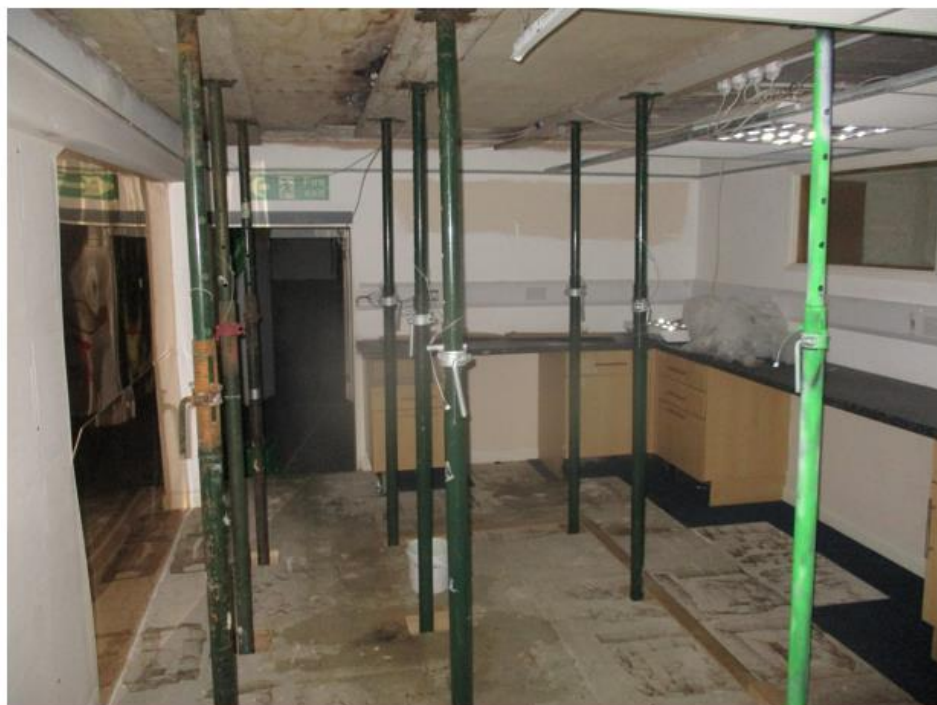
**Photo No.25: Facing east in unit No.22 showing former kitchen space of the former nursery and supporting acrows**

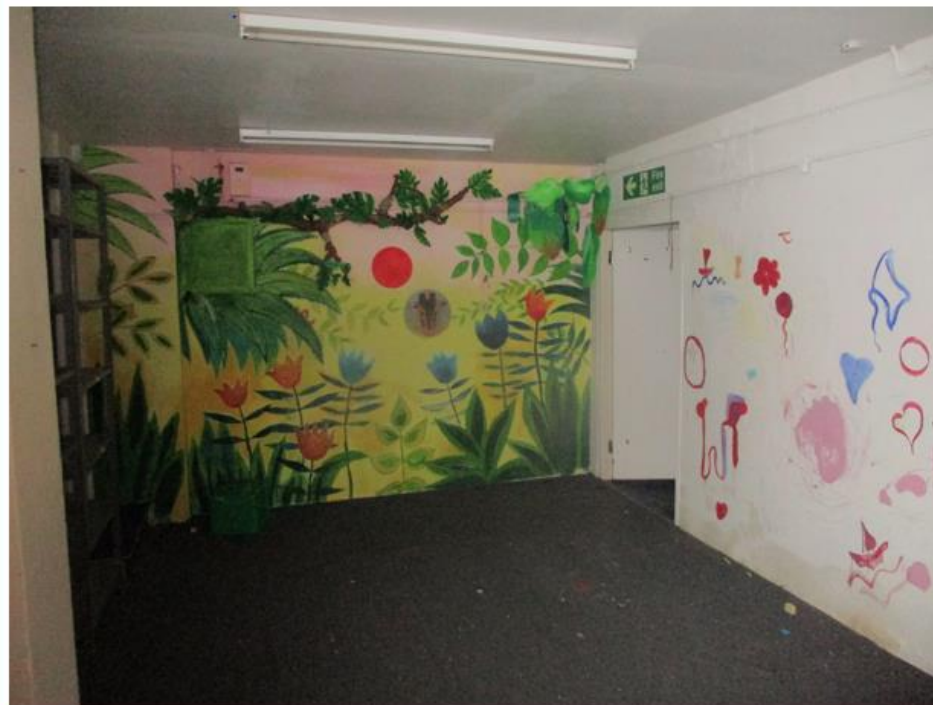
**Photo No.26: Facing north in unit No.22 showing evidence of former nursery usage**

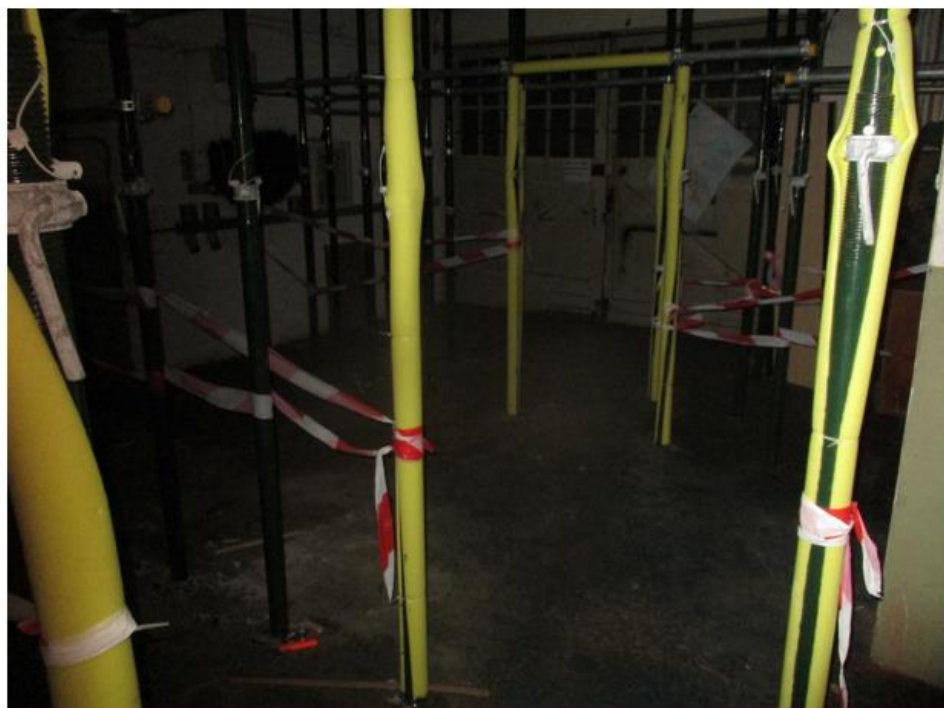
**Photo No.27: Facing SE in unit No.28 towards the garage door access and showing further supporting acrows**

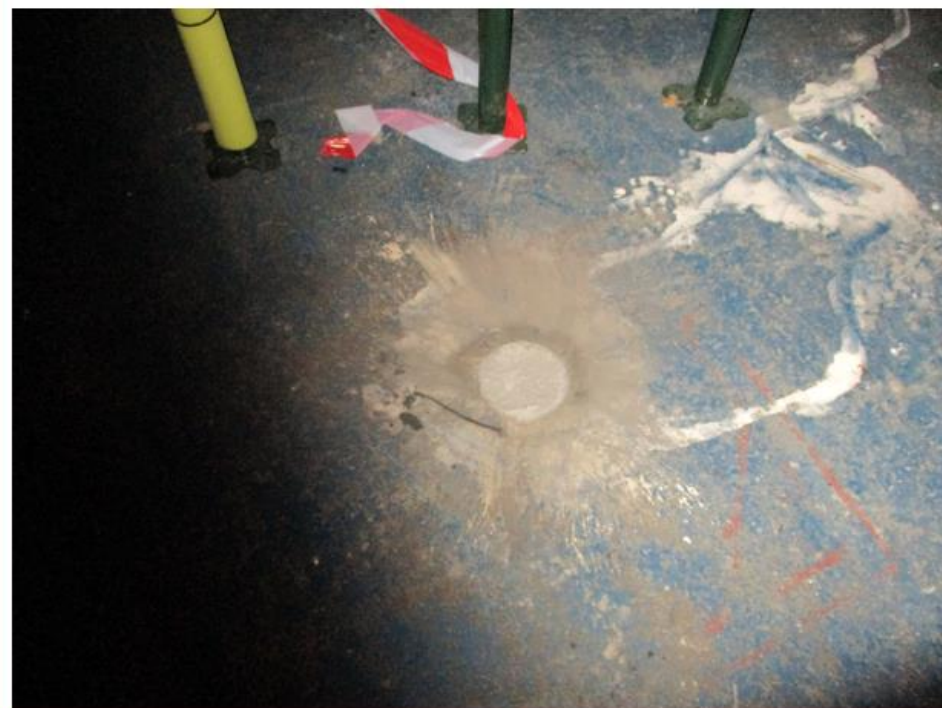
Moving eastwards once again, access to unit No.22 was provided via shuttered and pedestrian entrance. This unit was noted to be unoccupied save for remnants of what appeared to be a former nursery with toilets and a small kitchen – as evidenced by some toys, plastic ball-pit balls, colourful children's decorations on the walls. Further acrows were noted in this unit. Access to unit No.28 was provided via leading east through the nursery, leading into the already-investigated unit No.28. This unit was noted to remain occupied by noise monitoring equipment and a large number of supporting acrows. Evidence of the former hazardous vapours investigated was noted in this unit via concreted, former VOC inspection pits formed by concrete coring (photo No.28 in the site walkover photographs).

**Photo No.28: Former coring location for vapour testing during previous investigation of unit No.28**

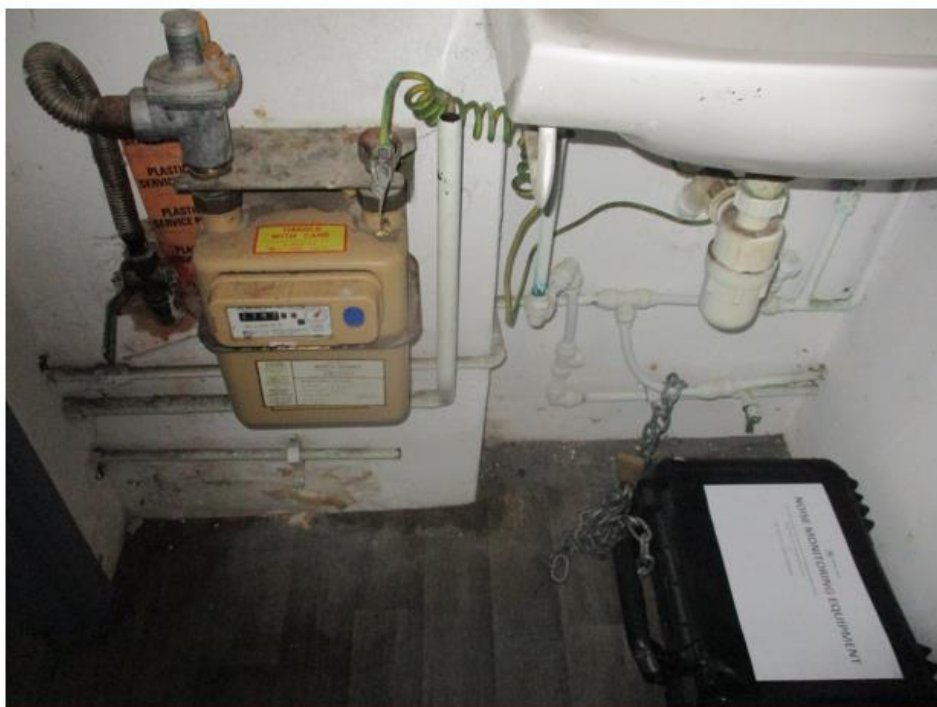
**Photo No.29: Service entry noted on the southern face of the building in unit No.28**

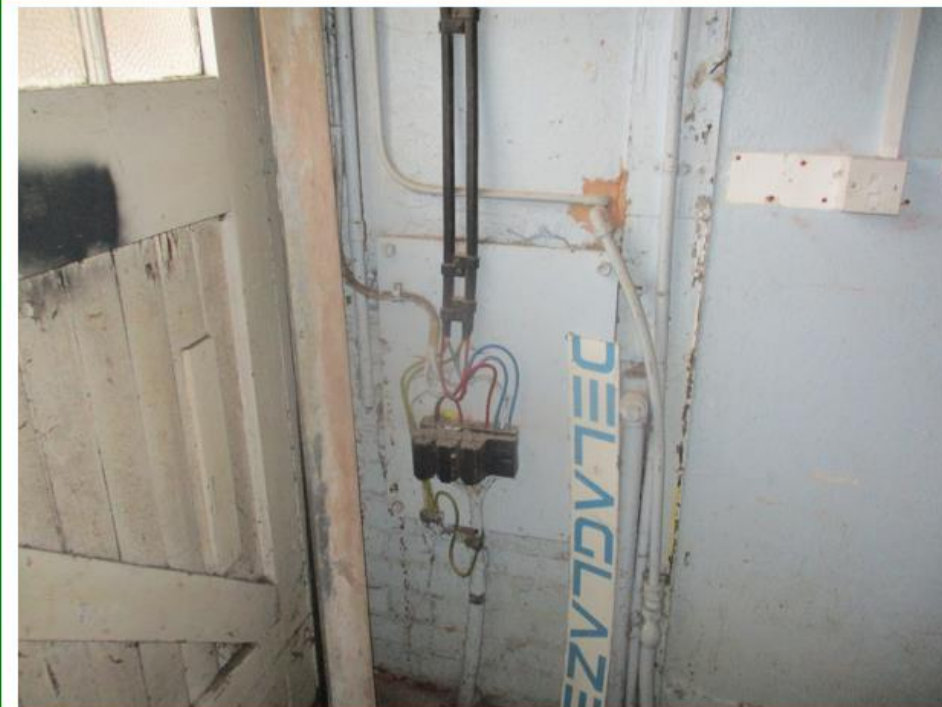
**Photo No.30: Service entry noted on the southern face of the building in unit No.22**

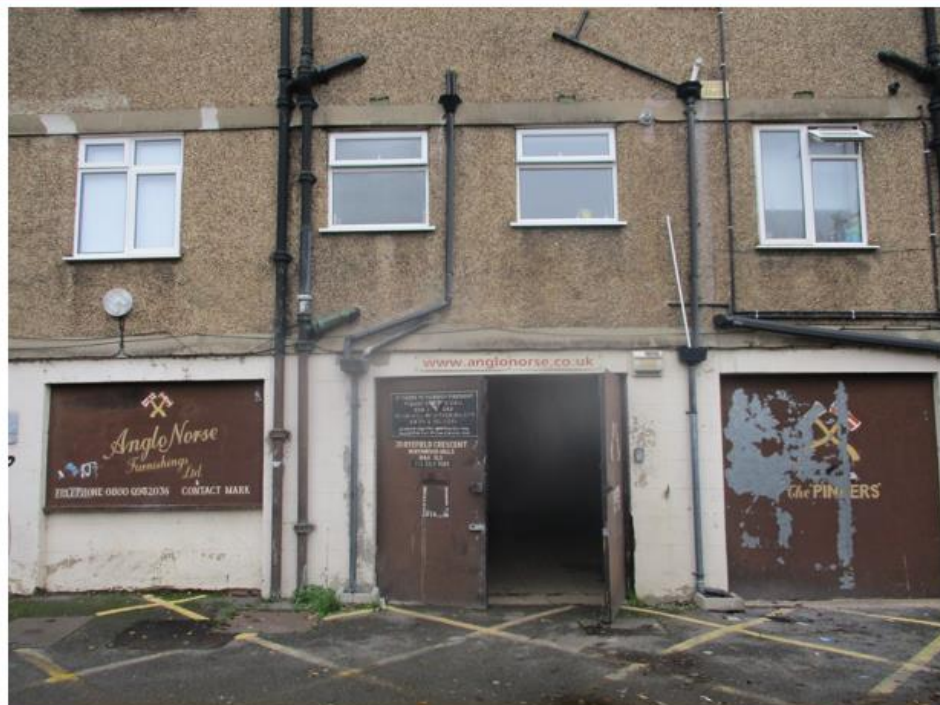
**Photo No.31: Facing west from outside the eastern face of the building showing entrance to unit No.30 (former furniture maker)**

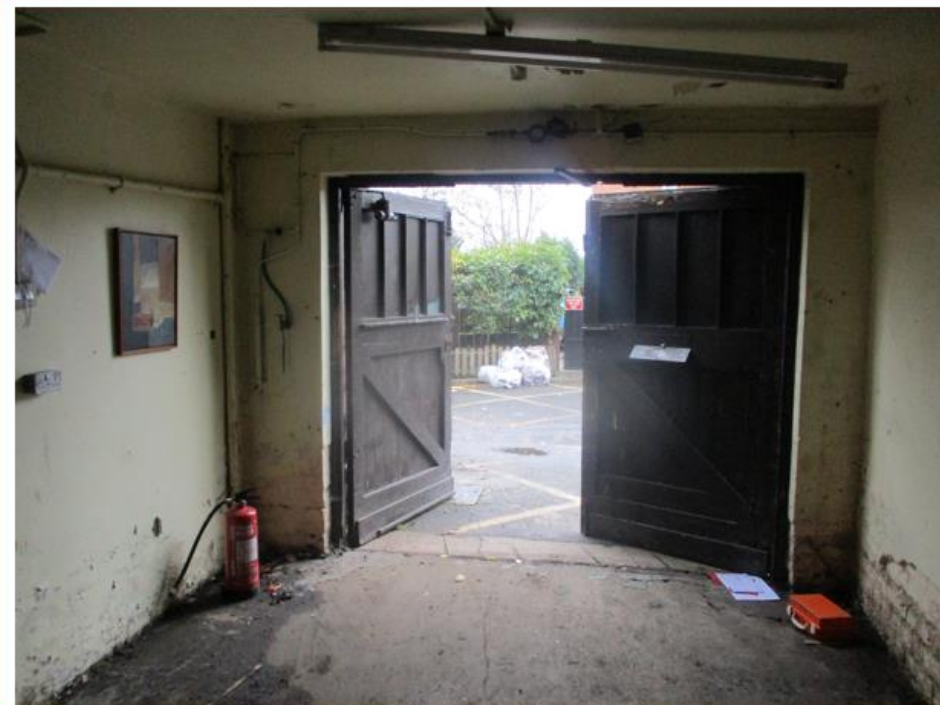
**Photo No.32: Facing east from inside the entrance of unit No.30**
