**Phase 1 Land Contamination  
Risk Assessment**

**Proposed Conversion of  
Commercial Floorspace  
(Charitable Service Units  
to Residential Use)**

**Units No.2-6, 8-12, 15-20, 22-30,  
Hawthorne Court, Ryefield Crescent,  
Northwood  
HA6 1LJ**

**Date: December 2022**

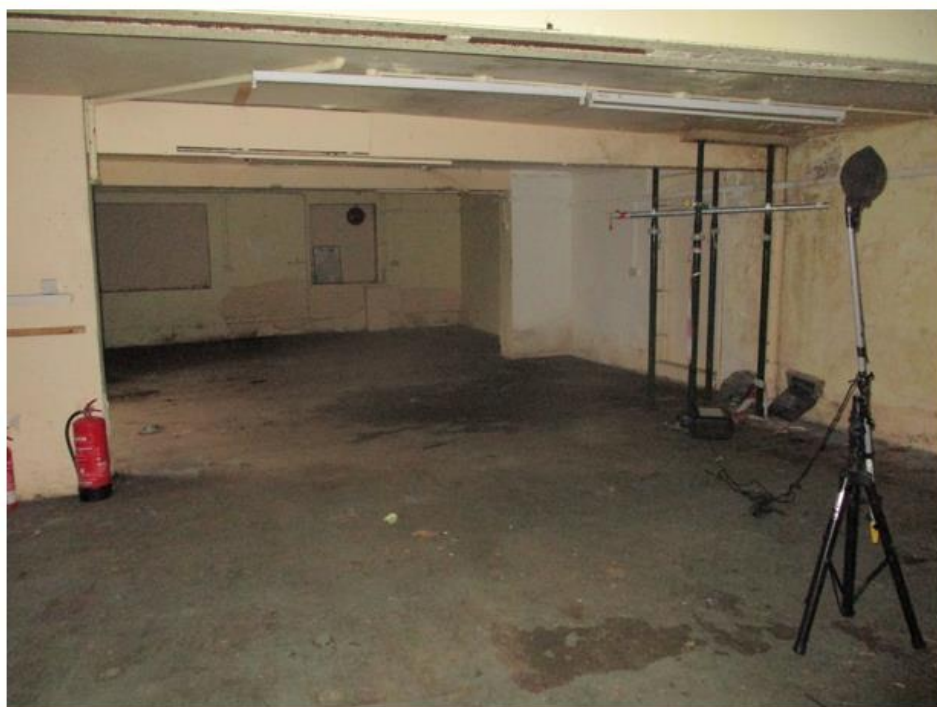
**Photo No.33: Facing SW from the NE corner of unit No.30 showing concrete flooring and noise monitoring equipment**

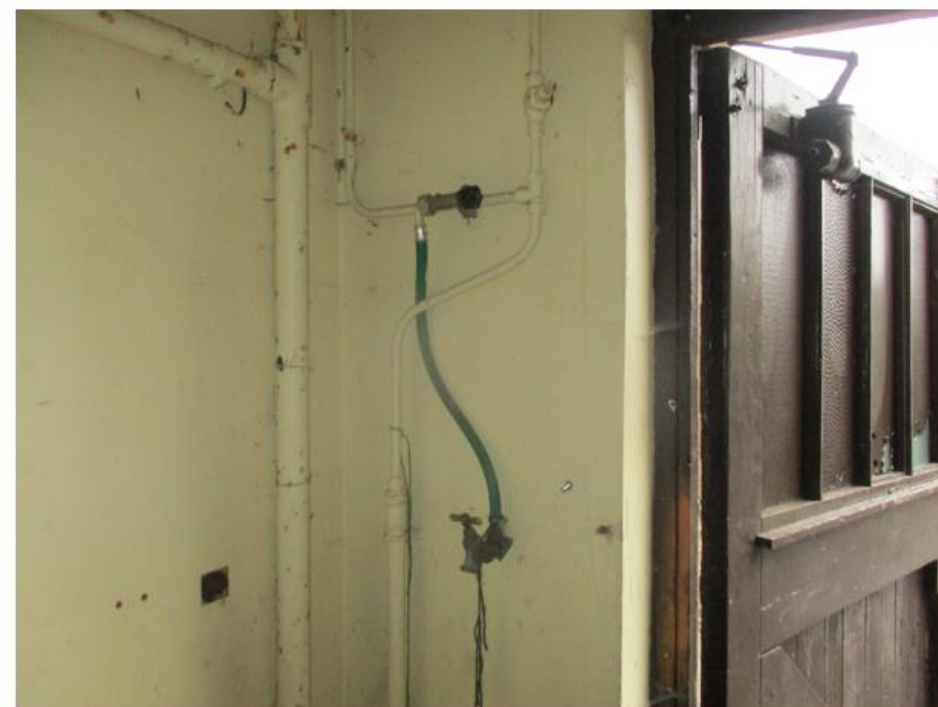
**Photo No.34: Service entries noted on eastern face of Hawthorne Court in unit No.30**
