Arboricultural Consultancy for Methodist Insurance Plc

Insured	Harrow & Hillingdon Methodist Circuit	Address	19 Mount Pleasant, ruislip, middlesex, HA4 9HG		
Client	Subsidence Management Services	Contact	Alun Dwyer	Claim No.	IFS-MET-SUB-22-0104780
ES Ref	SA-251876	Consultant	Keith Burgess	Contact No.	0330 380 1036
Report Date	27/01/2023

GEOTECHNICAL

19 Mount Pleasant, Ruislip, Middlesex, HA4 9HG

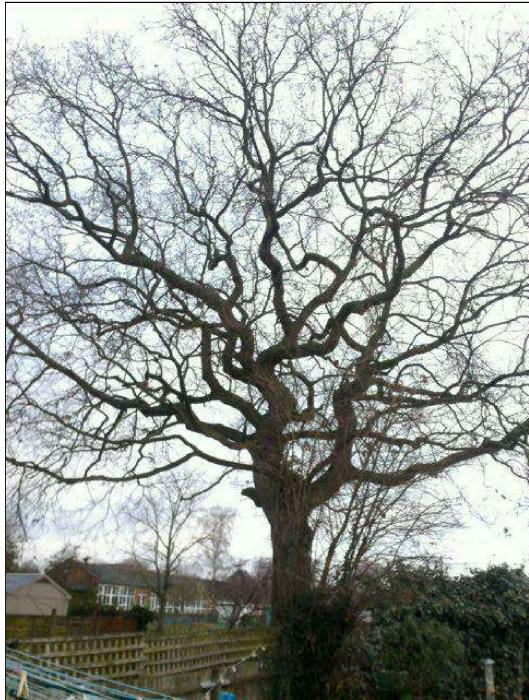
With due regards to species profile, size and proximity, the Oak (T1) is considered the dominant feature proximate to the focal area of movement and accordingly, where vegetation is confirmed as being causal, we have identified it as the primary cause of the current subsidence damage.

Tree No.	Species	Age Cat	Approx. Height (m)	Distance to Building (m) *	Ownership	Action	Requirement
T1	Oak	3	19	19.5 21	A - Third Party	Remove	Remove close to ground level and treat stump to inhibit regrowth.

T1 - Oak

Consequently, we have advocated the complete removal of T1 as it will offer the most certain arboricultural solution likely to restore long-term stability.

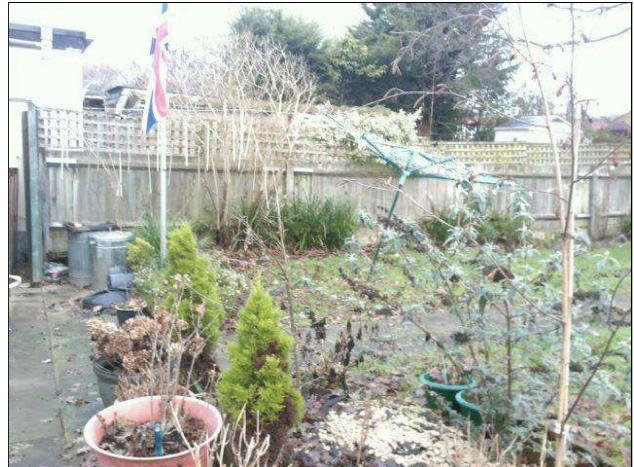
Note: additional minor vegetation has been noted on site and, depending on trial-pit location may be identified within future site investigations; however, unless specifically identified within this report, these plants are not deemed material to the current claim nor pose a significant future risk.

TG1 - Mixed species group

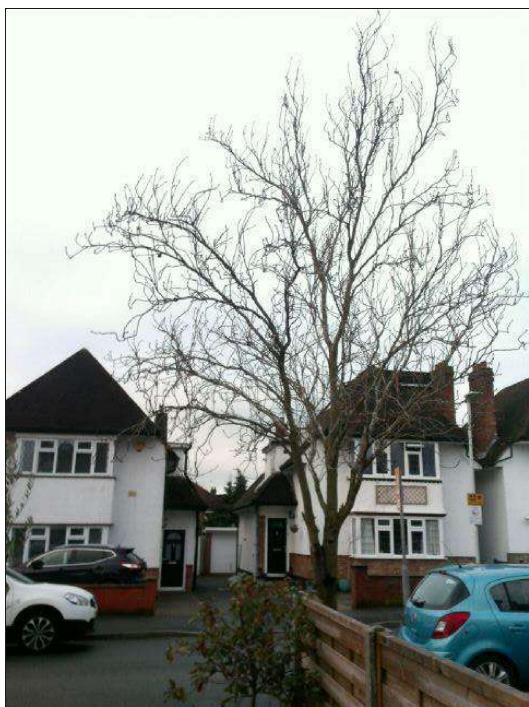
Tree No.	Species	Age Cat	Approx. Height (m)	Distance to Building (m) *	Ownership	Action	Requirement
T2	Cherry	1	6	9.6	B - Local Authority	Action to avoid future risk	Maintain at broadly current dimensions by way of regular pruning.
TG1	Mixed species group	1	2	2.0	C - Insured	Action to avoid future risk	Mixed species including Lilac, Oak & Hazel. Maintain at broadly current dimensions by way of regular pruning.

T2 - Cherry

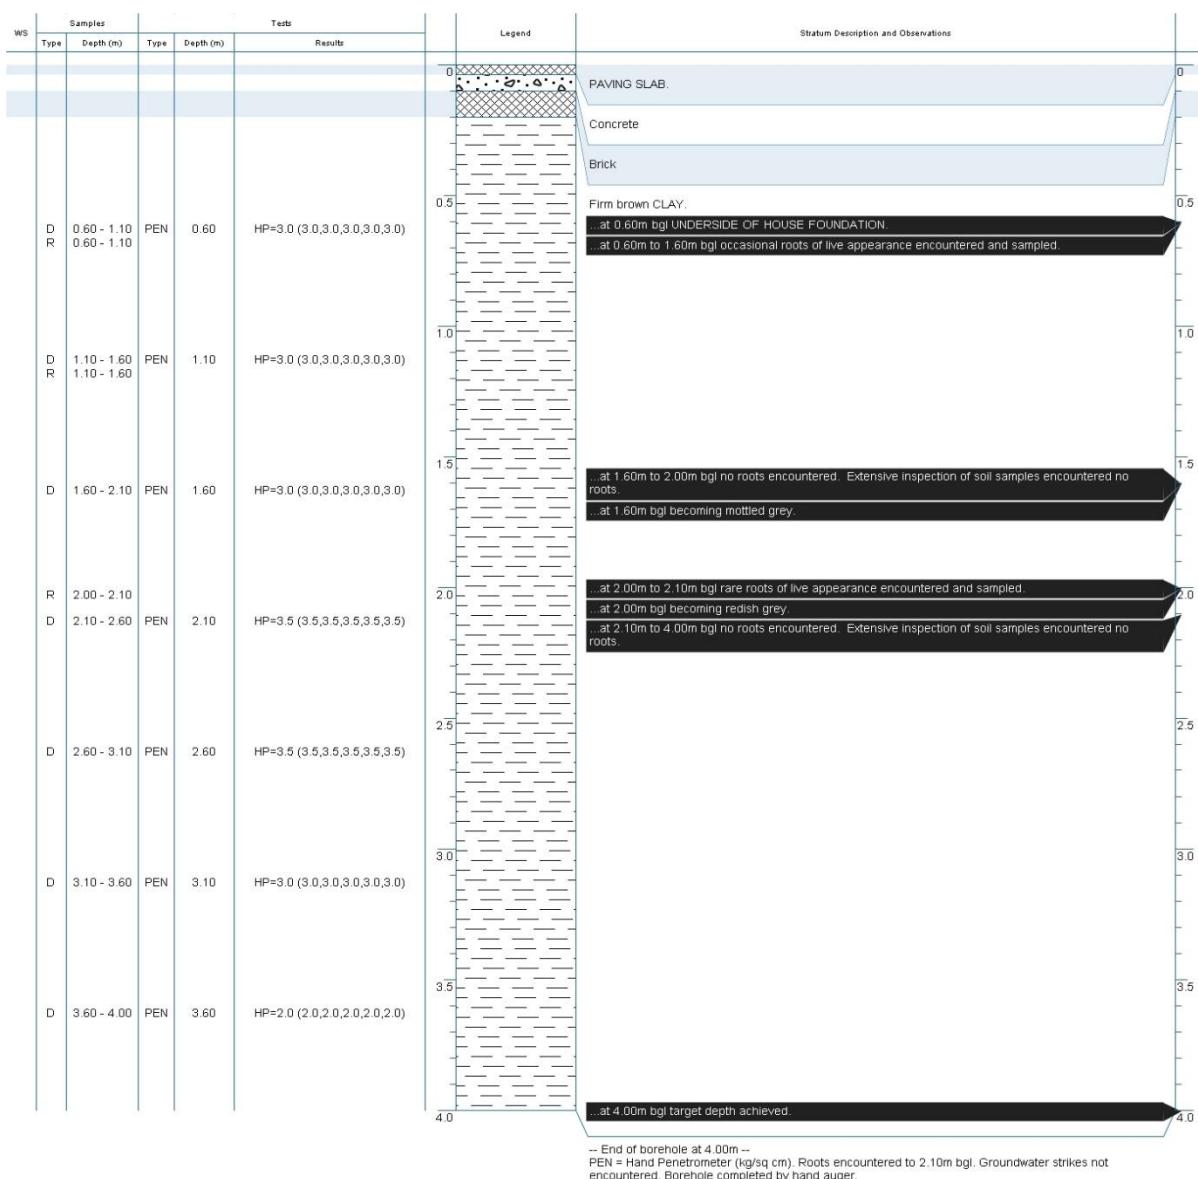
BH2 Borehole Log

At 0.60m bgl UNDERSIDE OF HOUSE FOUNDATION in BH2.

At 0.60m to 1.60m bgl occasional roots of live appearance encountered and sampled in BH2.

At 1.60m to 2.00m bgl no roots encountered. Extensive inspection of soil samples encountered no roots in BH2.

At 2.00m to 2.10m bgl rare roots of live appearance encountered and sampled in BH2.

At 2.10m to 4.00m bgl no roots encountered. Extensive inspection of soil samples encountered no roots in BH2.
