Wellington House, 4 - 10 Cowley Road, Uxbridge, UB8 2XT

**A REPORT PREPARED  
FOR AND ON BEHALF OF DUNMOORE GROUP  
BRIGHTWALTON HOUSE, BRIGHTWALTON, NEWBURY BERKSHIRE, RG20 7BZ**

Issue Date: 17 June 2016  
Revision NO:  
Revision Date:

REFERENCE: 16.0468

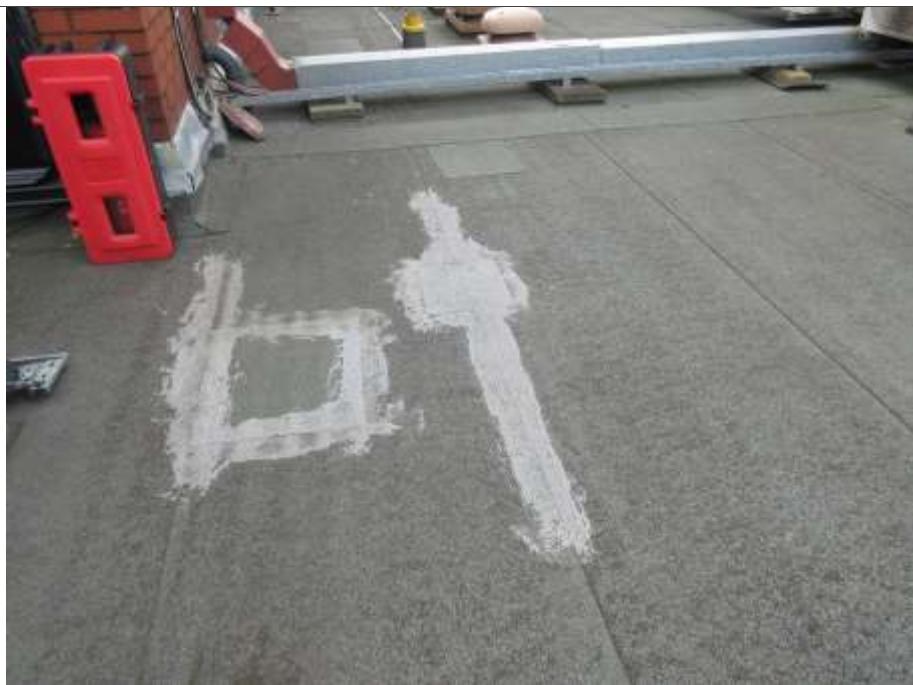
3.2	<b>Roofs</b>	
3.2.1	The bitumen felt weathering to the flat roof is in poor condition and nearing the end of its serviceable life as evidenced by the numerous patch repairs present. The current maintenance regime is undertaken on a reactionary basis and it is likely that further ad hoc localised repairs will be required in the short term. Consideration should be given to over coating the bitumen felt with a proprietary liquid applied system which will provide an additional ten years of useful life.	M

01: Historic repairs to roof covering

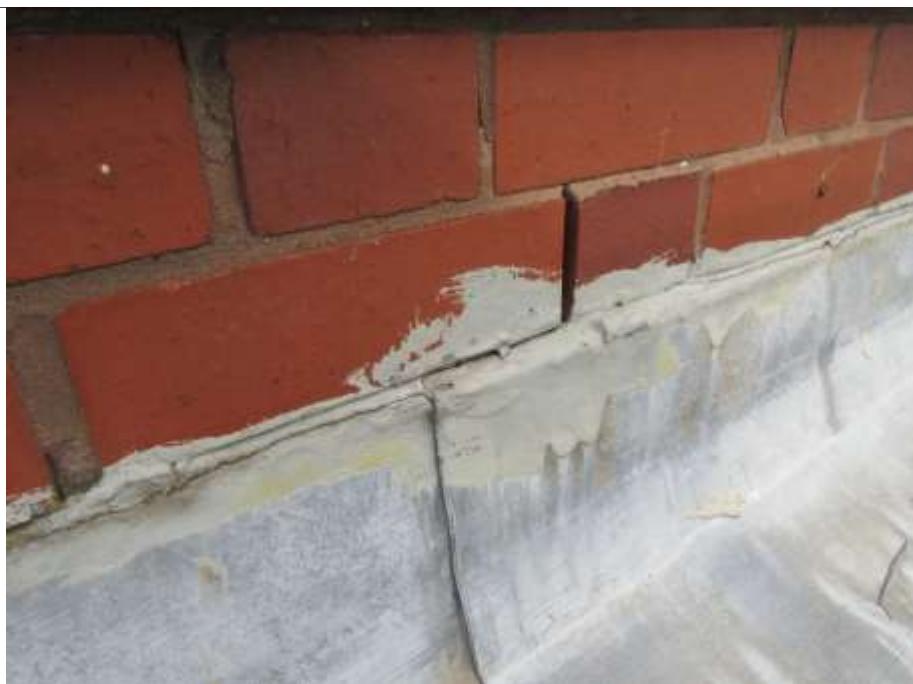
02: Repairs to roof flashing

3.2.2	A significant number of the joints to the pressed metal parapet copings have been overlaid with both flashband tape and bitumen felt indicating historic water ingress issues and localised fixings have worked loose. The factory finish to the copings has significantly degraded and the lead flashings have become detached locally. Ideally the copings should be lifted and the joints remade before being refixed. The lead flashings should also be resecured and pointed.	M

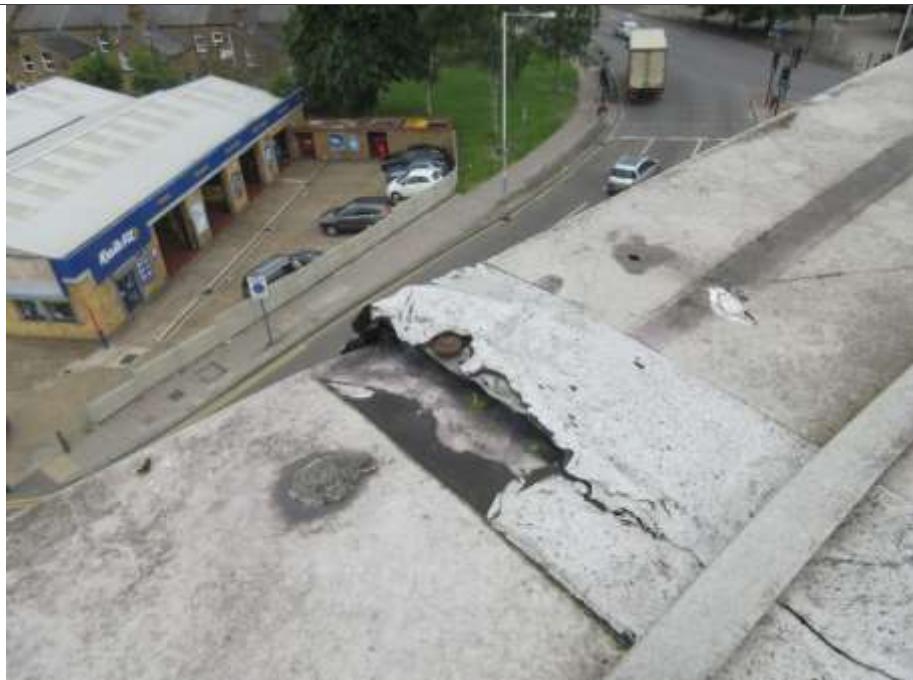
03: Defective pressed coping joint

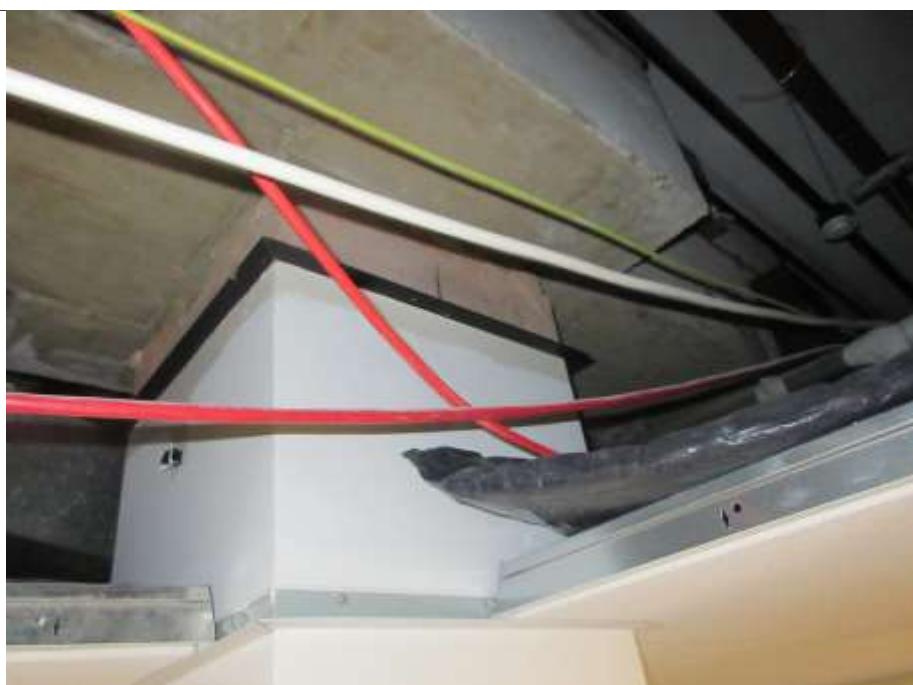
04: Concrete column junction with concrete roof slab

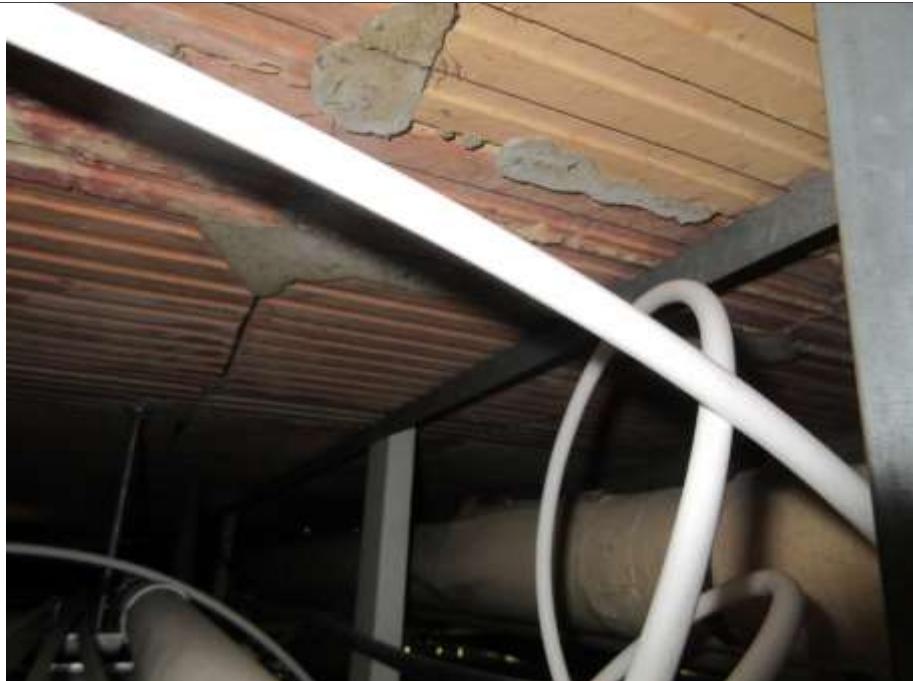
05: Screed hollow pot clay floor at 1<sup>st</sup> – 3<sup>rd</sup> floor levels

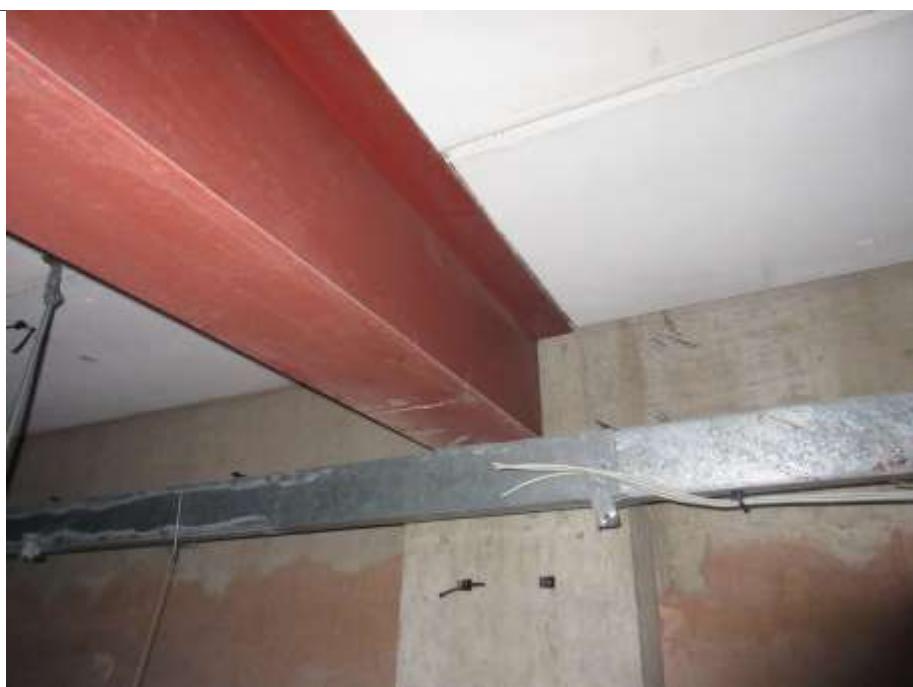
06: Pre-cast concrete planks overlaying steel I-beam roof raft member

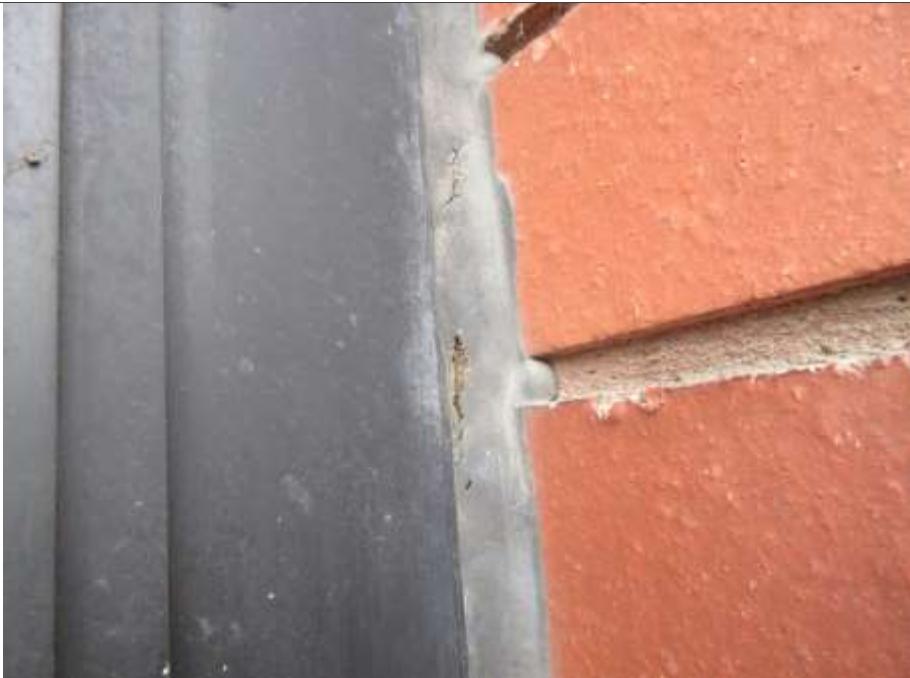
3.3.2	The mastic sealant to the junctions of window and door reveals along with the masonry expansion joints has become brittle and degraded requiring replacement, particularly to the rear elevation of the building.	M

07: Degraded mastic seal to window reveal

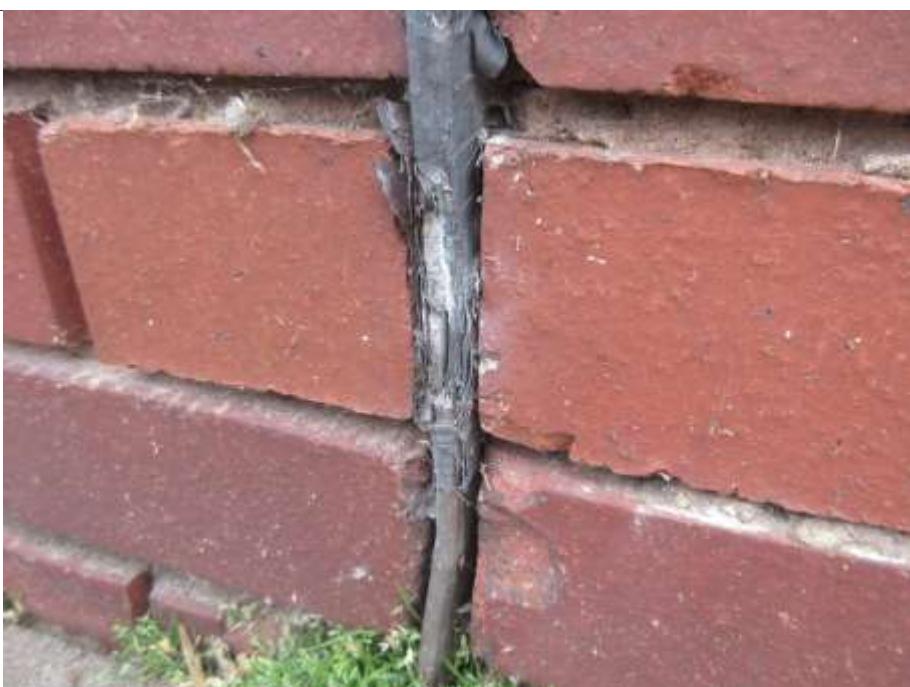
08: Degraded mastic infill to East elevation expansion joint

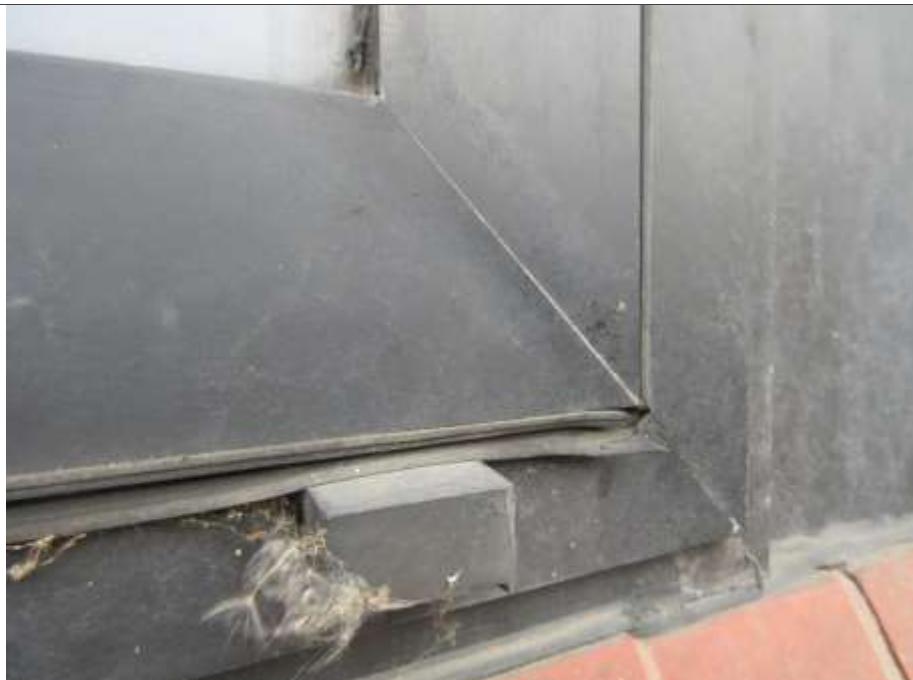
3.3	<b>Elevations</b>	
3.3.1	We understand that the windows are as originally installed and a number of the hermetically sealed double glazed windows have failed. This type of unit typically has a life expectancy in the region of 20-30 years and we would expect additional units to fail at an ever increasing rate going forward. The PPC finish to the aluminium window frames has also UV degraded. All defective glazing units should be replaced where necessary and the PPC frame would benefit from rejuvenation by a proprietary system to preserve the aesthetic appearance of the building. A cursory review of the occupational lease documentation confirms that the window frames and glass within is the responsibility of the tenant.	M

09: Loose seal to openable window

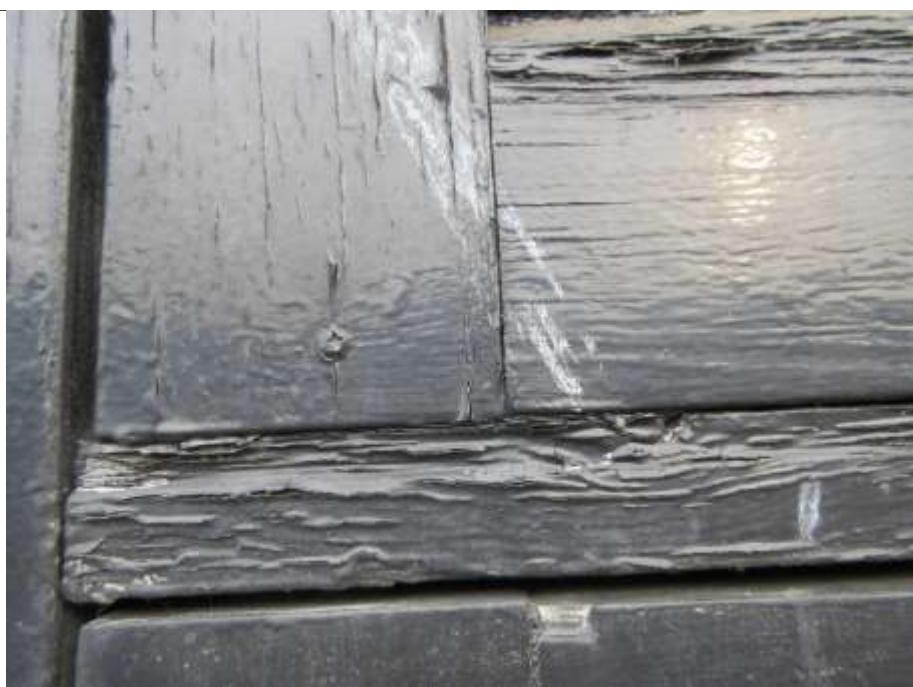
3.3.3	The decorative finishes to all external joinery items is in poor condition with widespread flaking and localised timber decay present. Joinery repairs are required prior to cyclical external redecoration works being undertaken.	M

10: Defective paint finishes to external timber features

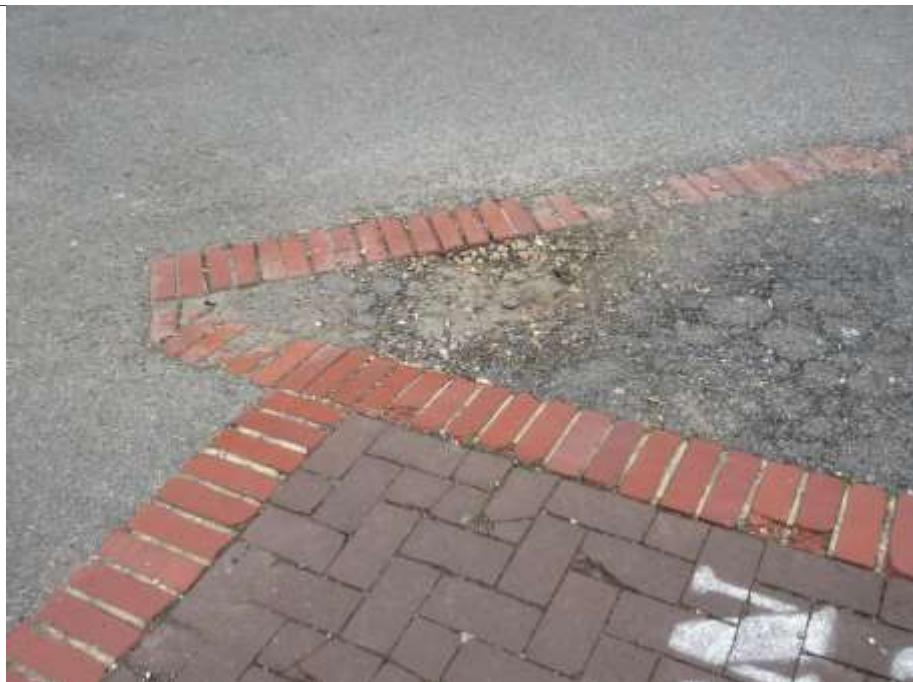
3.4.4	The macadam surface to the traffic routes to the rear car park are worn but remain serviceable. However, localised sections of macadam surface, where adjacent to the parking bays, are in poor condition and pitted and backfilling is required to eradicate the uneven surfaces.	L

12: Damaged and uneven macadam surfaces and blockwork demarcation to rear car park

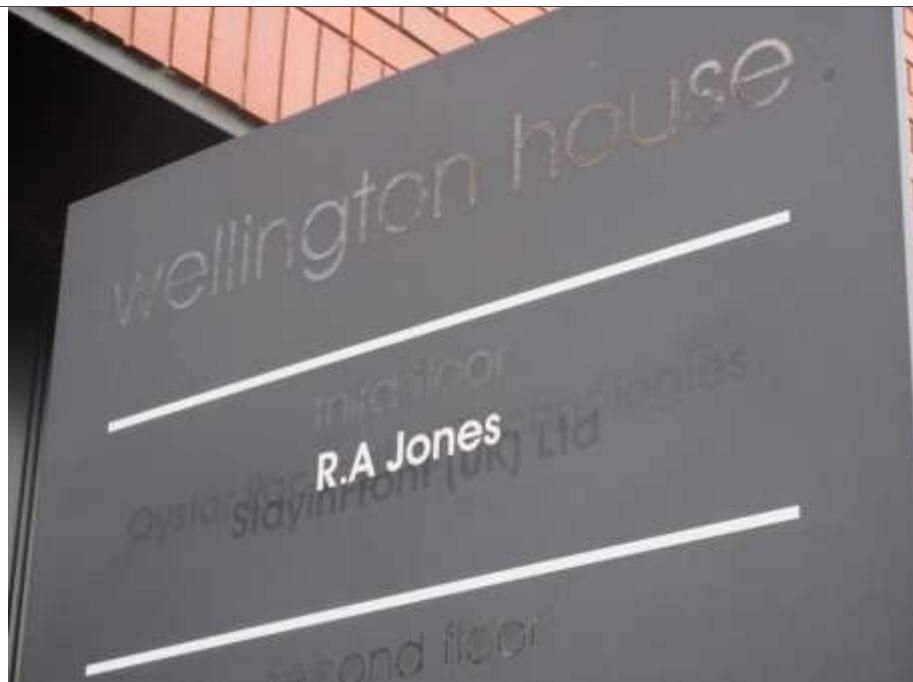
3.4.7	Totem signage to the raised flowerbed to the South West corner is significantly solar degraded with previous tenants' signage stained into the finish. The signage should be redecorated as part of the external redecoration works.	L
<b>3.5</b>	<b>Internal Areas</b>

13: Significantly solar faded totem signage to main entrance

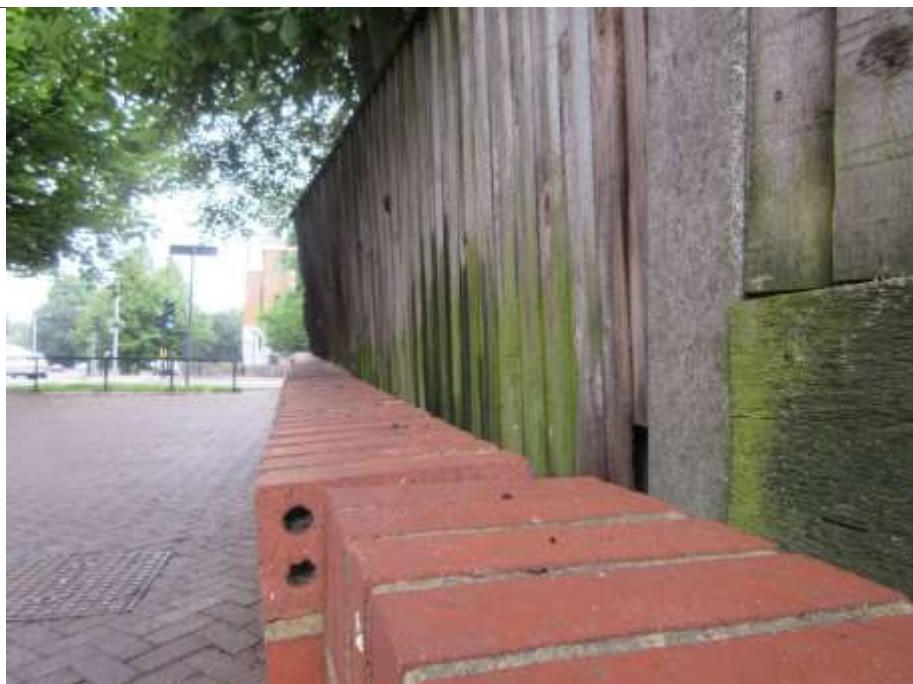
<b>3.4</b>	<b>External Areas</b>	
3.4.1	A section of the northern boundary wall has moved due to ground heave as a result of the close proximity of a tree located on the adjacent site. The pointing is noticeably cracked and the surrounding block paved areas are visibly uneven. The wall should be monitored going forward and repointed where necessary. It is likely that this issue will continue as long as the tree remains. All areas of uneven block paving should be remade to eradicate potential trip hazards.	M

14: Section of north boundary wall and block paving suffering from ground heave

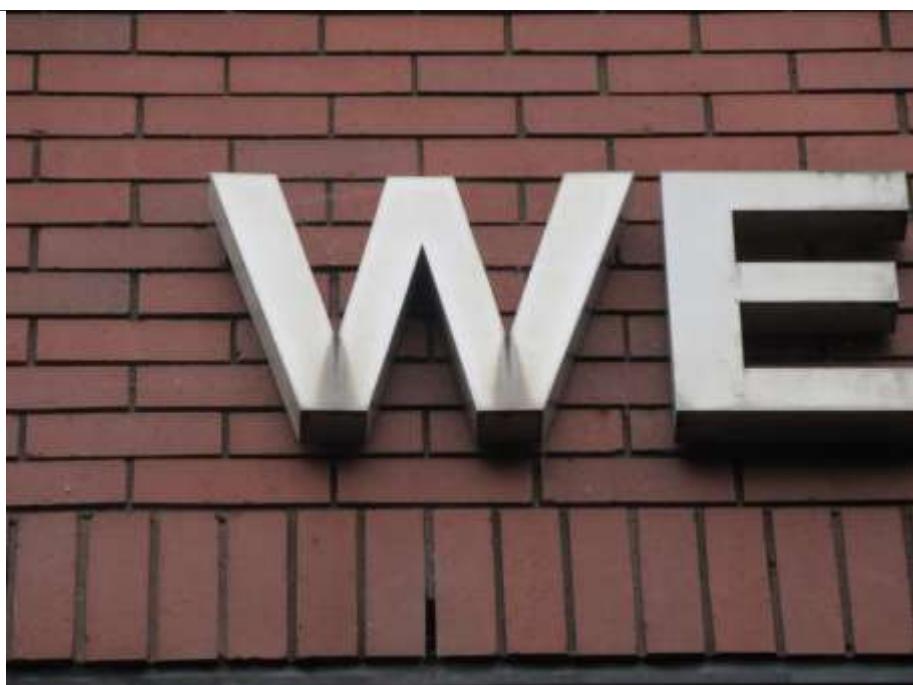
3.3.5	Localised corrosion is evident to the finishes of the 'Wellington House' signage affixed to the North, West and South elevations which should be treated and/or replaced to preserve the aesthetic appearance of the building.	L

16: Staining to external signage
