### Resistograph Test Analysis Report for Frithwood Primary School, Carew Road Northwood, HA6 3NJ

Prepared for Heritage Trees Limited

Date: 23<sup>rd</sup> February 2023

Ref: TH 3862

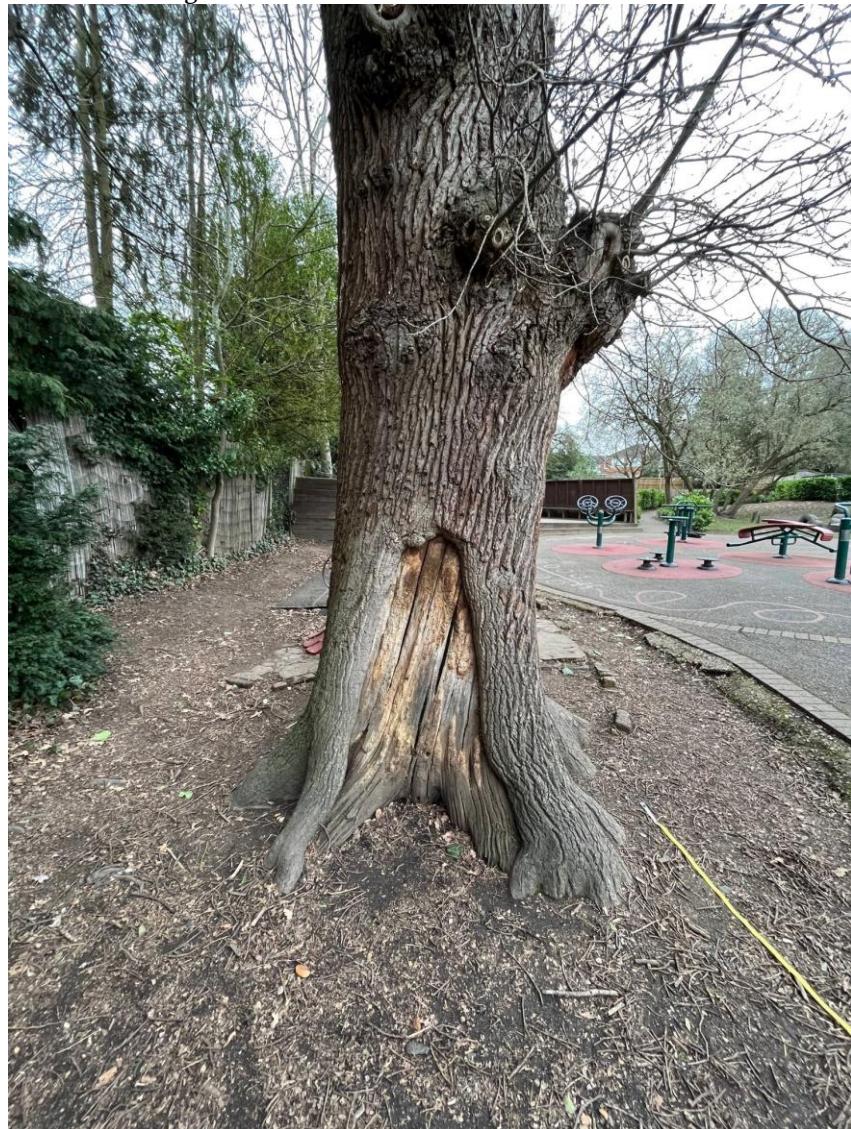
Photo 1. Looking west at Oak T1

6.5 The Oak is growing at the northern end of the school, at the northern end of the playground. The tree has been pruned before and has a large wound on the western side of its base.

6.6 It appears to me, from the shape and location of the wound, that it was caused by historic bonfire damage.

6.7 The edges of the wound are sealing well. The exposed heartwood sounded reasonably solid when tapped.

8.2 I am satisfied that, as long as the tree is re-inspected on a cyclical basis (every 2-3 years), it can be retained without any further intervention.

8.3 It may be prudent to re-prune the tree's crown in the future, but this is not considered necessary at present.

8.4 It may also be prudent to re-test the tree again in 5-10 years' time to check for any progression in the decay.

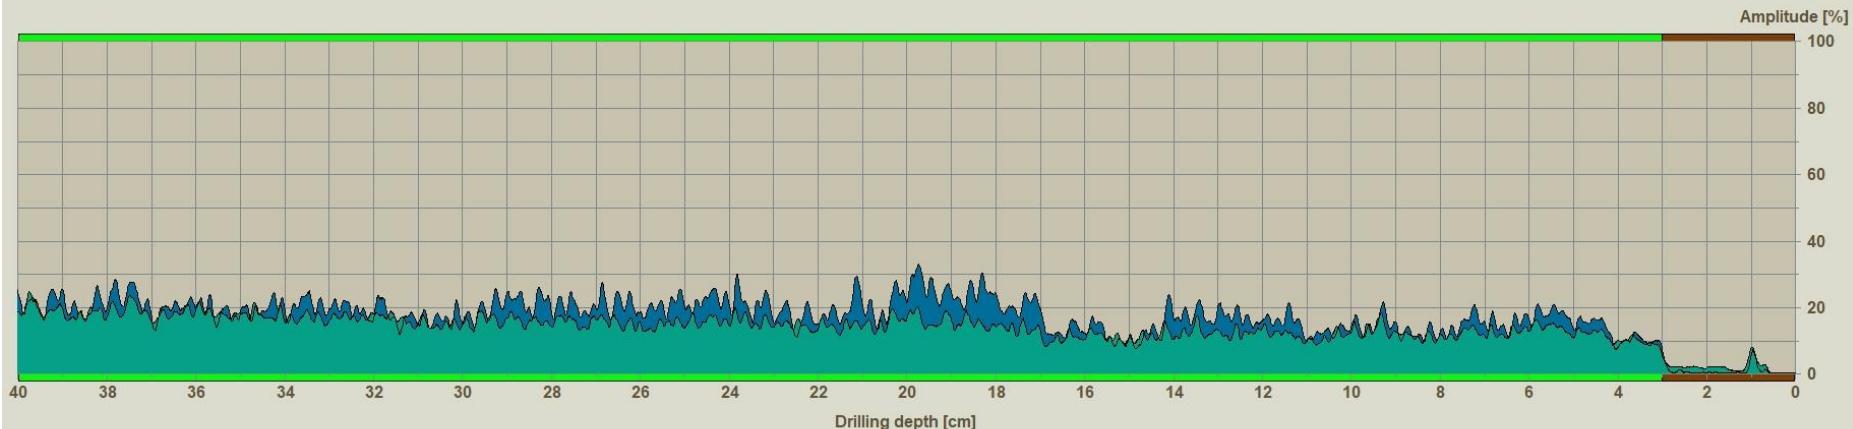
Measurement no.:	2	Speed :	2500 r/min	Diameter:
ID number :	OAK 500mm N	Needle state:	---	Level :
Drilling depth :	40,06 cm	Tilt :	---	Direction:
Date :	21.02.2023	Offset :	84 / 310	Species :
Time :	10:34:46	Avg. curve :	off / off	Location:
Feed :	50 cm/min			Name :

Northern side - 400 mm

From 0,02 cm to 3,00 cm :	Bark
From 3,00 cm to 39,98 cm :	Sound wood

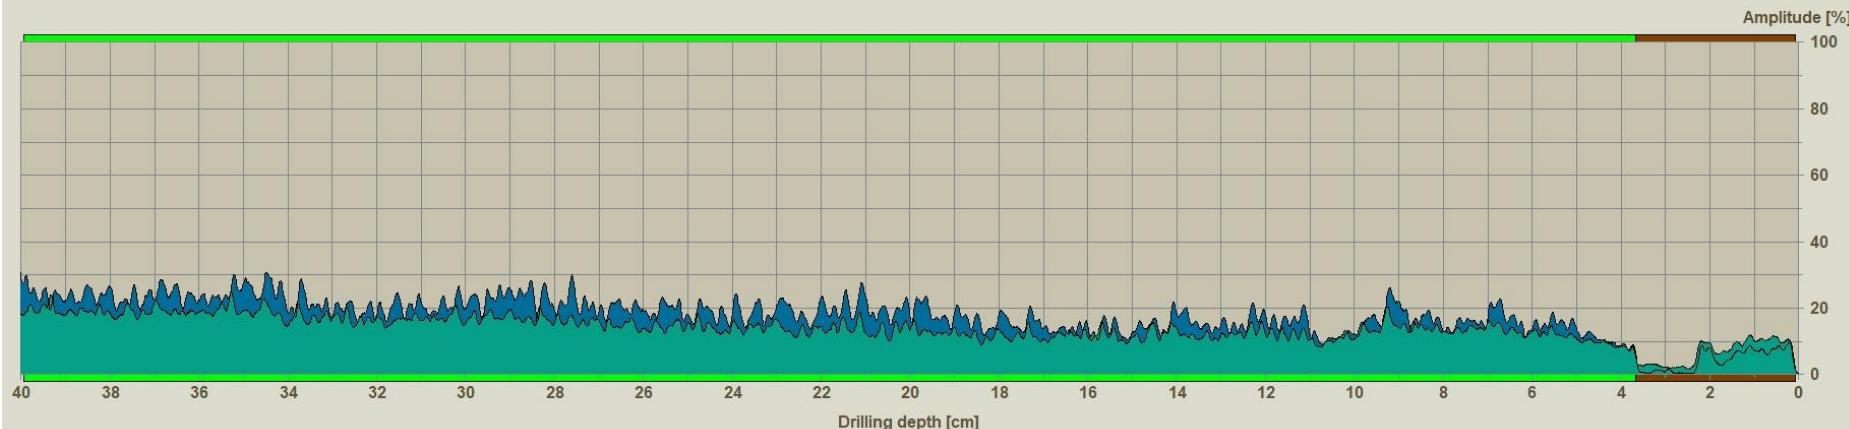
Measurement no.:	3	Speed :	2500 r/min	Diameter:
ID number	OAK 50mm NE	Needle state:	---	Level :
Drilling depth	40,04 cm	Tilt	---	Direction:
Date	21.02.2023	Offset	79 / 288	Species :
Time	10:36:13	Avg. curve	off / off	Location:
Feed	50 cm/min			Name :

North-eastern side - 400 mm

From 0,07 cm to 3,68 cm :	Bark
From 3,68 cm to 39,95 cm :	Sound wood

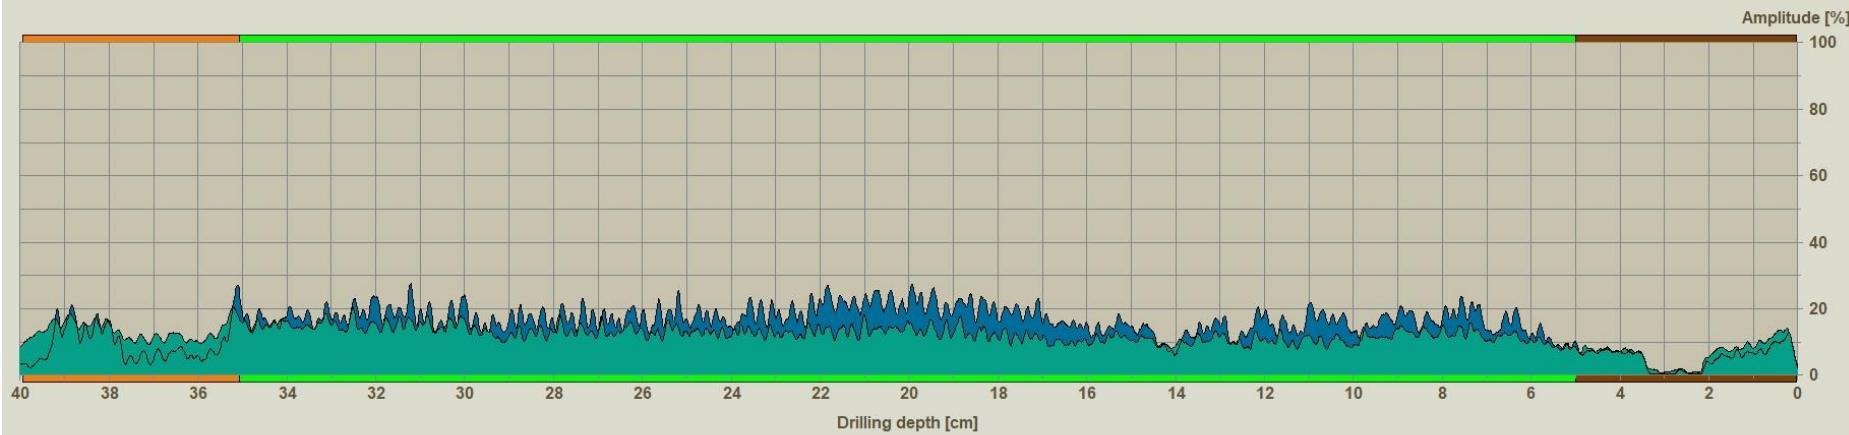
Measurement no.:	4	Speed :	2500 r/min	Diameter:
ID number	OAK 500mm E	Needle state:	---	Level :
Drilling depth	40,02 cm	Tilt	---	Direction:
Date	21.02.2023	Offset	79 / 361	Species :
Time	10:37:30	Avg. curve	off / off	Location:
Feed	50 cm/min			Name :

Eastern side - 400 mm

From 0,02 cm to 4,99 cm :	Bark
From 4,99 cm to 35,10 cm :	Sound wood
From 35,08 cm to 39,95 cm :	Degraded wood

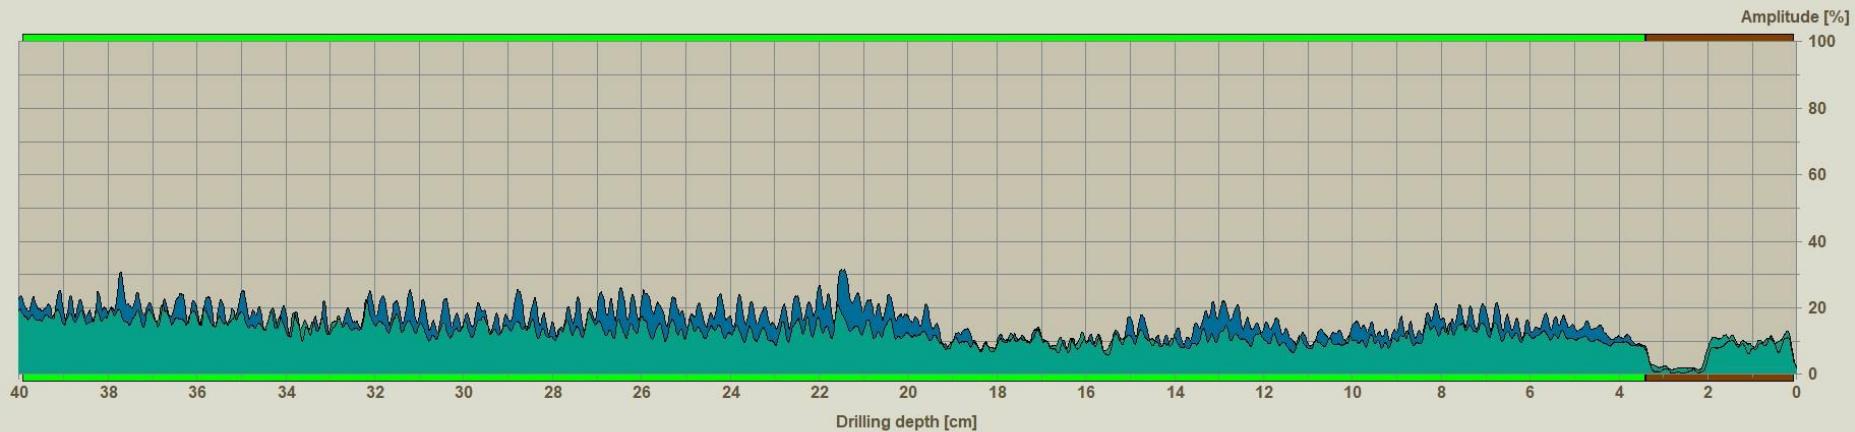
Measurement no.:	5	Speed :	2500 r/min	Diameter:
ID number :	OAK 500mm SE	Needle state:	---	Level :
Drilling depth :	40,03 cm	Tilt :	---	Direction:
Date :	21.02.2023	Offset :	77 / 344	Species :
Time :	10:38:54	Avg. curve :	off / off	Location:
Feed	50 cm/min			Name :

South-eastern side - 400 mm

From 0,09 cm to 3,39 cm :	Bark
From 3,41 cm to 39,93 cm :	Sound wood

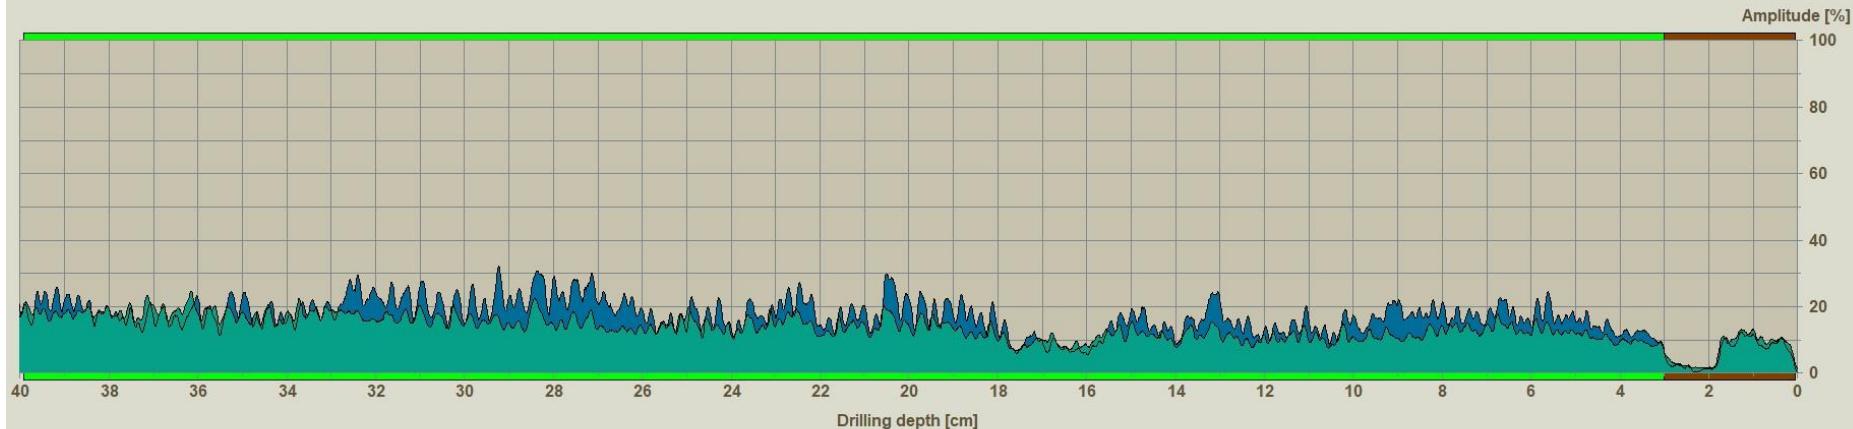
Measurement no.:	6	Speed :	2500 r/min	Diameter:
ID number	OAK 500mm S	Needle state:	--	Level :
Drilling depth	40,06 cm	Tilt	--	Direction:
Date	21.02.2023	Offset	78 / 345	Species :
Time	10:40:13	Avg. curve	off / off	Location:
Feed	50 cm/min			Name :

Southern side - 400 mm

From 0,05 cm to 3,00 cm : Bark  
  From 3,02 cm to 39,91 cm : Sound wood

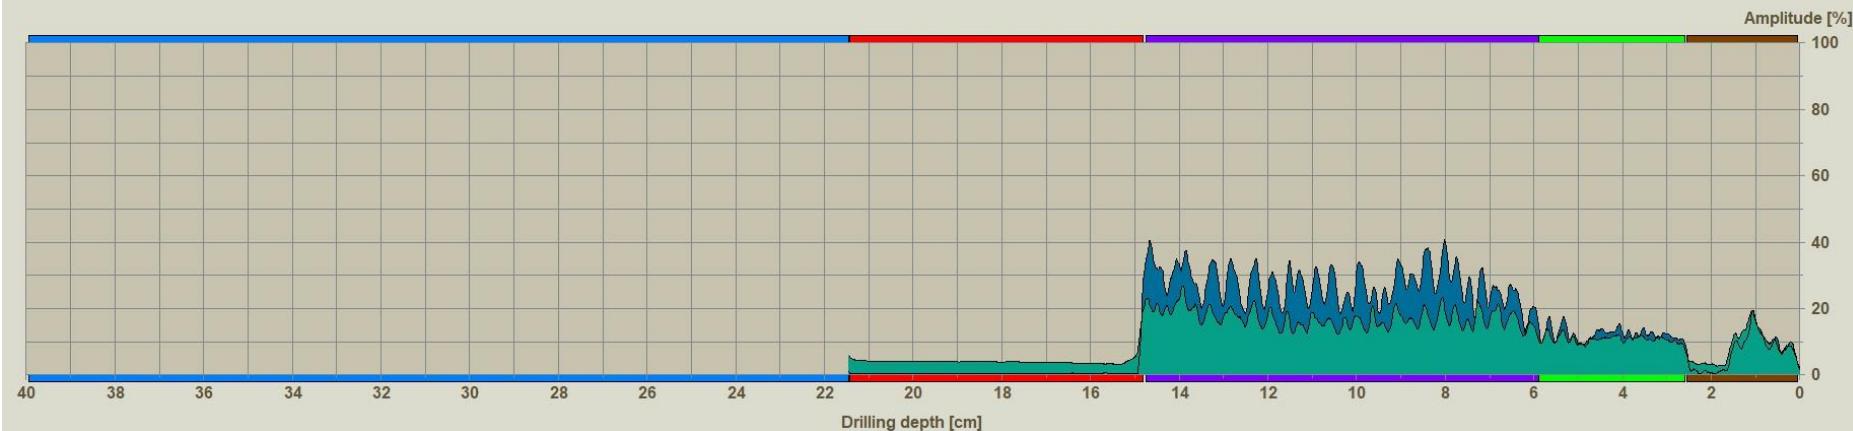
Measurement no.:	7	Speed :	2500 r/min	Diameter:
ID number	OAK 500mm SW	Needle state:	—	Level :
Drilling depth	21,46 cm	Tilt	—	Direction:
Date	21.02.2023	Offset	76 / 351	Species :
Time	10:41:35	Avg. curve	off / off	Location:
Feed	50 cm/min			Name :

7.1 The resistograph test for Oak T1 revealed very little degradation within the stem. The only decay was noted to either side of the wound, behind the reaction wood.

South-western side - 150 mm

From 0,05 cm to 2,56 cm :	Bark
From 2,59 cm to 5,93 cm :	Sound wood
From 5,90 cm to 14,74 cm :	Reaction wood
From 14,81 cm to 21,42 cm :	Cavity
From 21,46 cm to 39,95 cm :	Needle exit

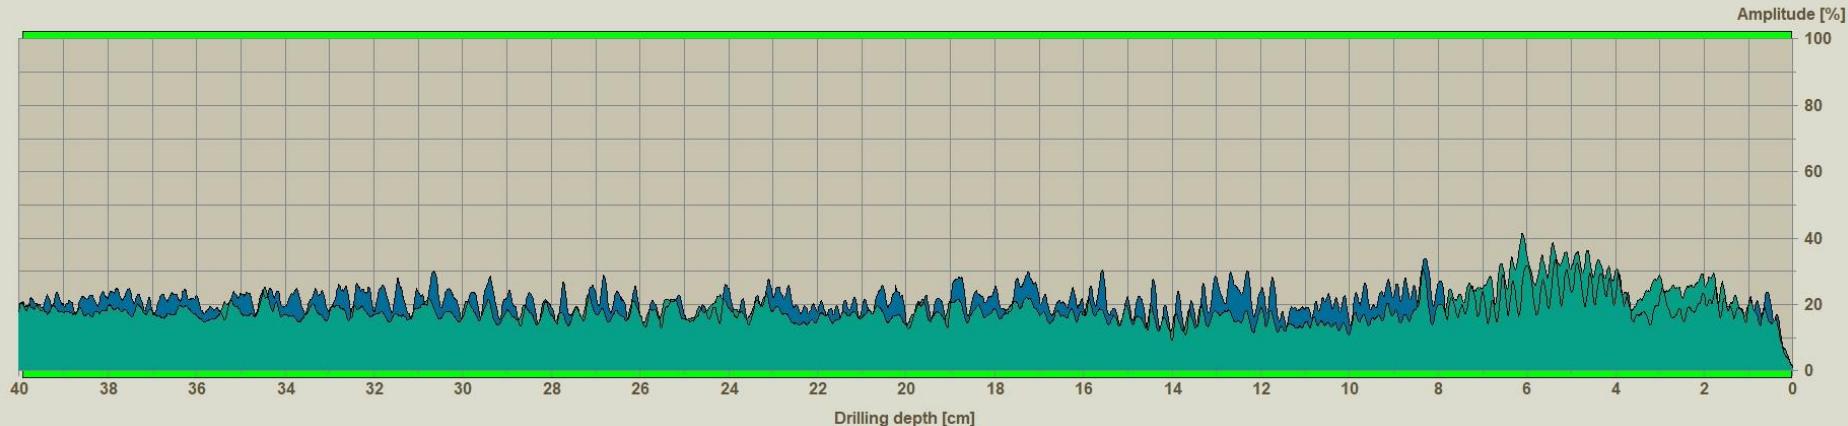
Measurement no.:	8	Speed :	2500 r/min	Diameter:
ID number	OAK 500mm W	Needle state:	---	Level :
Drilling depth	40.04 cm	Tilt	---	Direction:
Date	21.02.2023	Offset	79 / 371	Species :
Time	10:42:50	Avg. curve	off / off	Location:
Feed	50 cm/min			Name :

Western side - 400 mm

From 0,02 cm to 39,93 cm : Sound wood

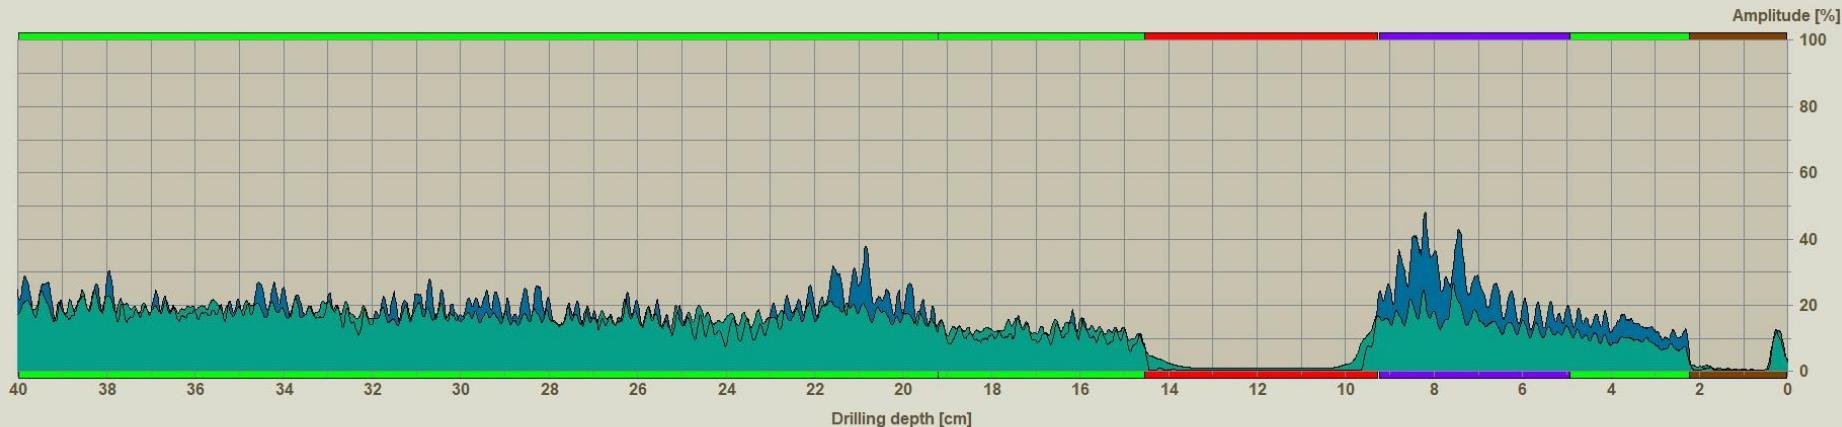
Measurement no.:	9	Speed :	2500 r/min	Diameter:
ID number :	OAK 500mm NW	Needle state:	---	Level :
Drilling depth :	40,04 cm	Tilt :	---	Direction:
Date :	21.02.2023	Offset :	80 / 474	Species :
Time :	10:44:16	Avg. curve :	off / off	Location:
Feed :	50 cm/min			Name :

North-western side - 150 mm

From 0,02 cm to 2,22 cm :	Bark
From 2,24 cm to 4,94 cm :	Sound wood
From 4,92 cm to 9,24 cm :	Reaction wood
From 9,27 cm to 14,55 cm :	Cavity
From 14,55 cm to 19,20 cm :	Sound wood
From 19,20 cm to 40,00 cm :	Sound wood
