## PINDORIA ASSOCIATES

kp/2122

### STRUCTURAL ENGINEERING REPORT 3 Copse Wood Way, Northwood, HA6 2TP

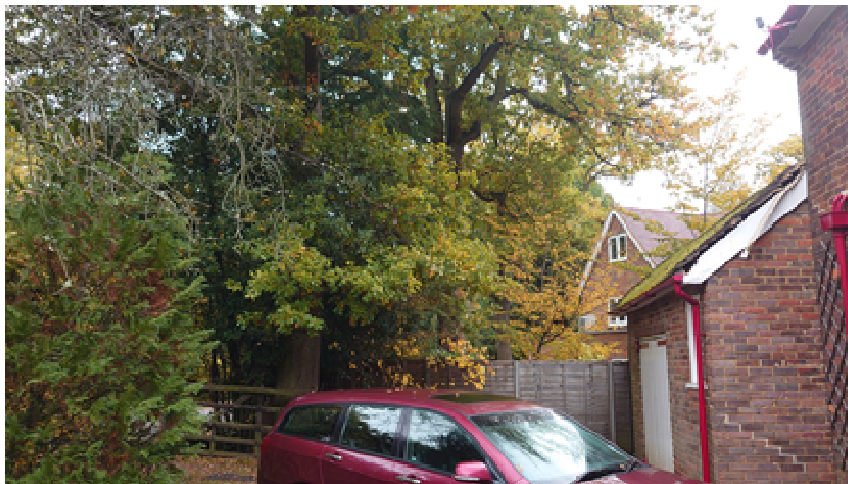
Trees at front and left side

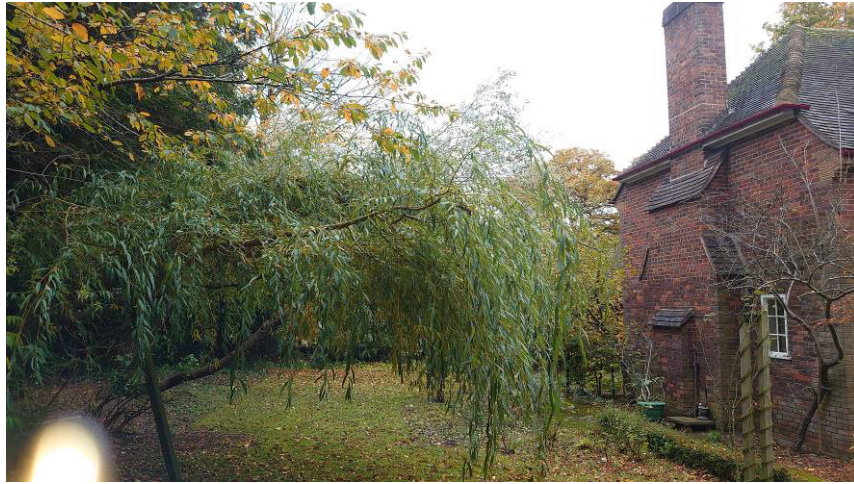
Trees right rear side

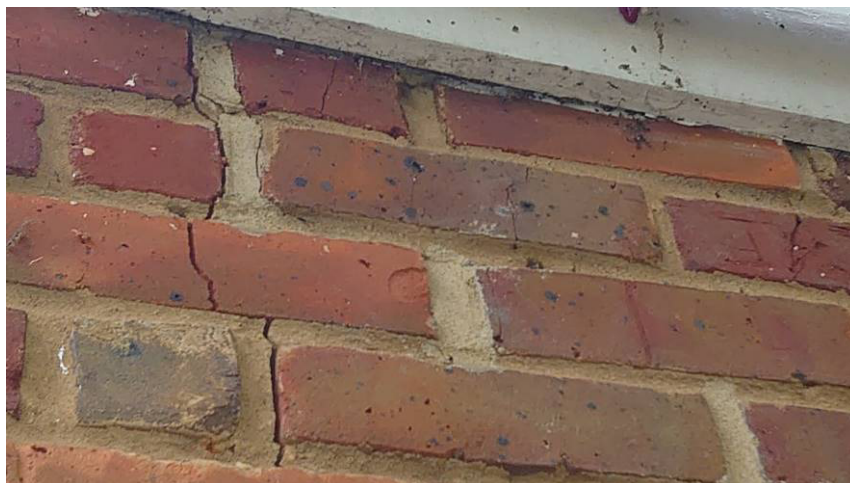
Cracking in brickwork and mortar

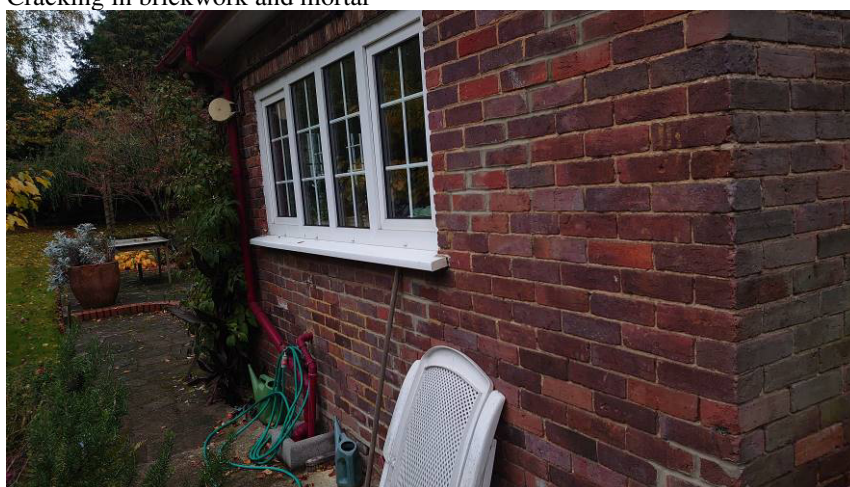
Previous repairs showing signs of opening up

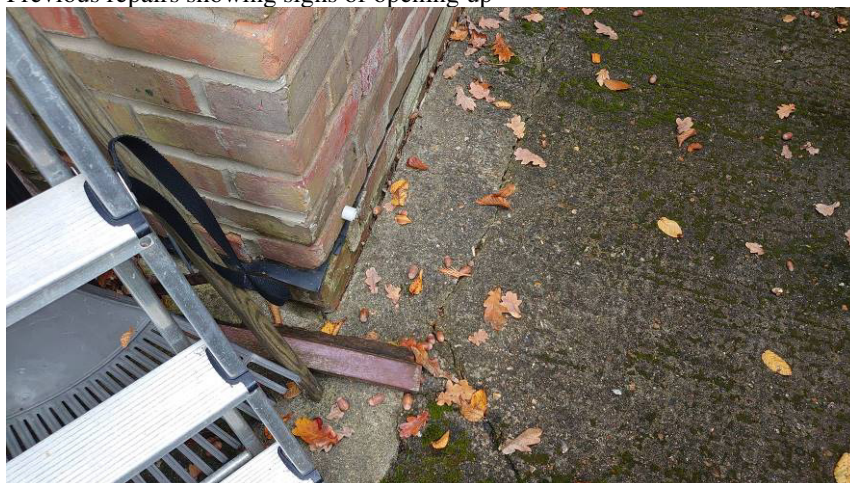
Settlement of wall below dpc

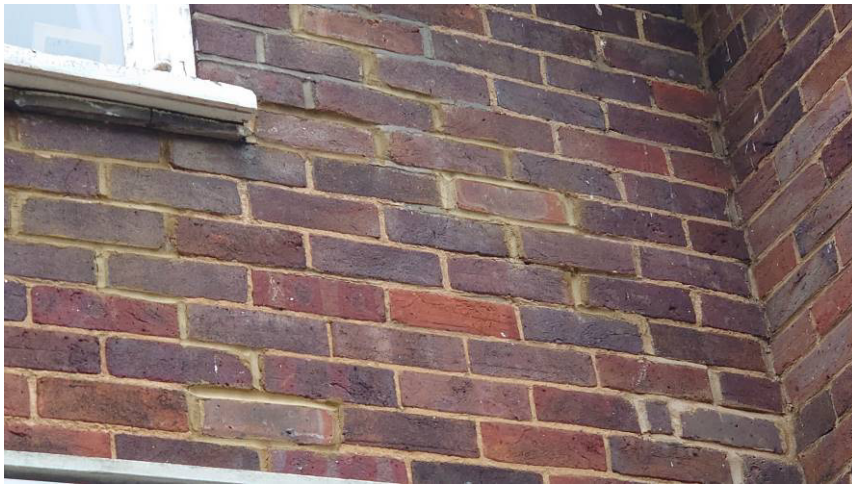
Cracking below window cill

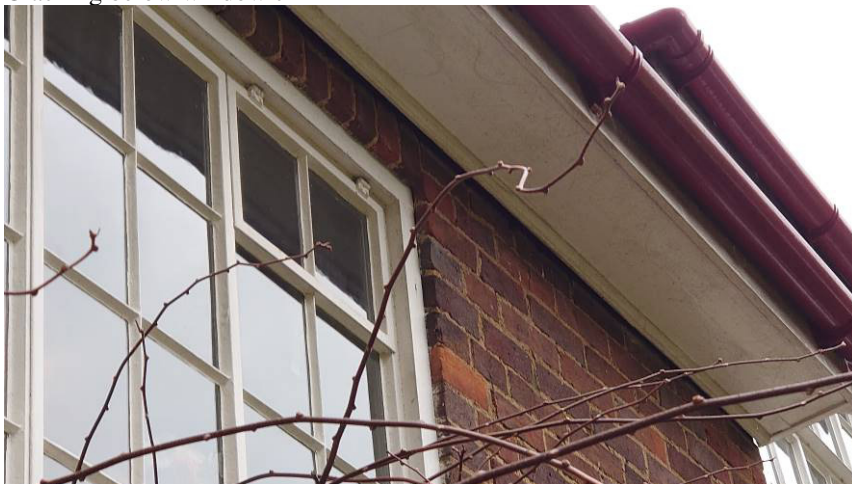
Gap at roof eaves and soffit due to outward movement of the roof

- a) Strip roof covering complete, provide temporary roof cover, replace existing roof structure (rafters and ceiling joists).
  - b) Install structural restraint measures to alleviate roof spread of rear elevation.

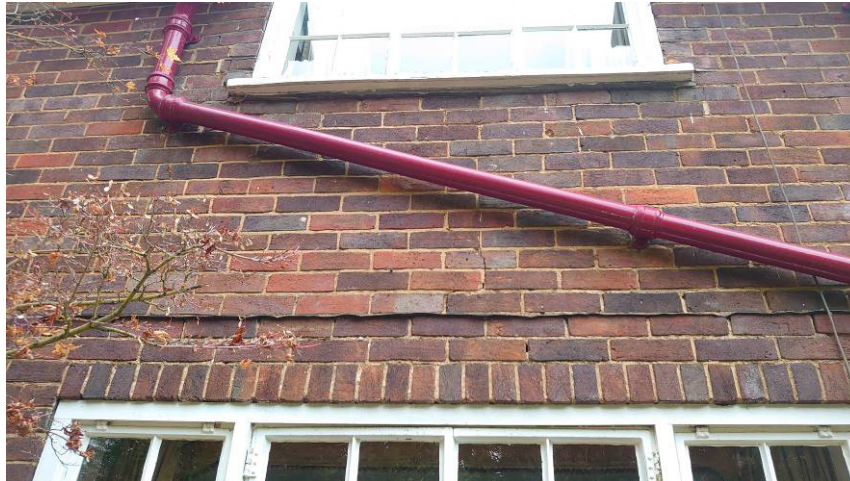
Outward movement of the wall

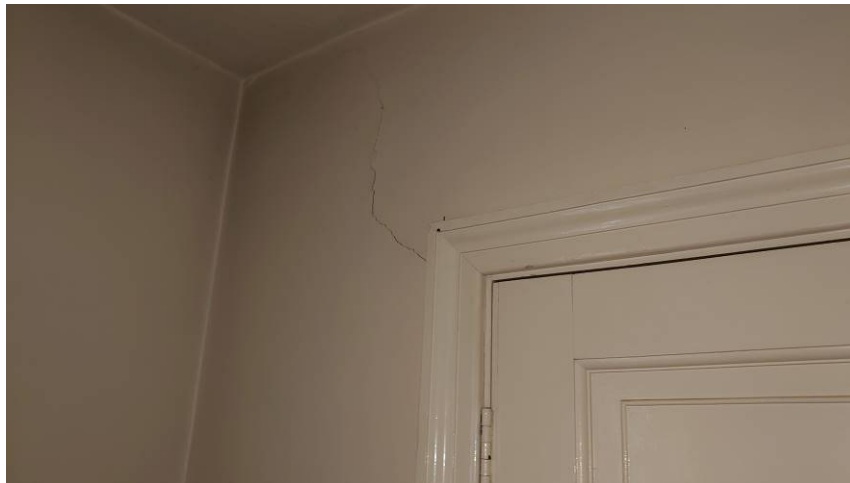
Internal cracks

- h) Reinstate roof coverings and rainwater goods & fascia and soffits.
  - i) Remove all cracked plaster and re-plaster, skim and paint.

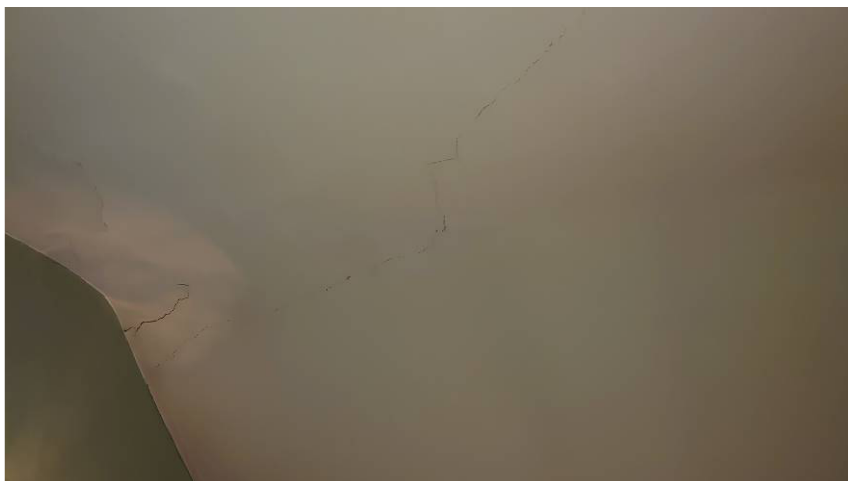
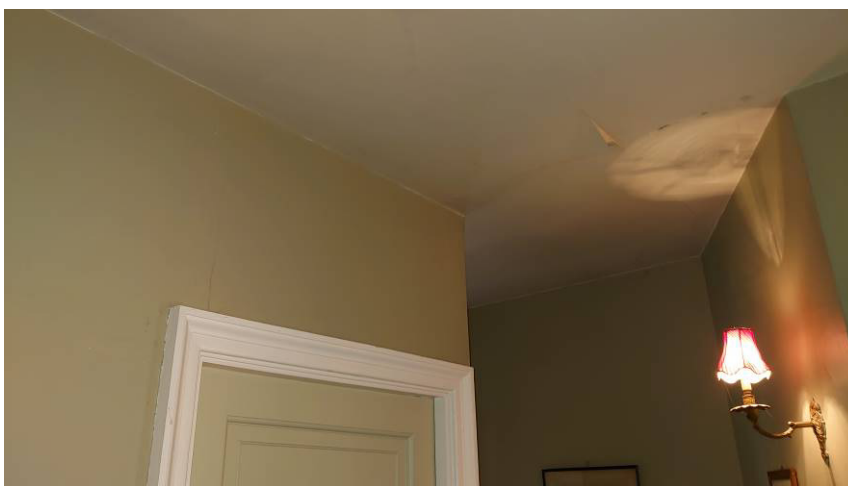
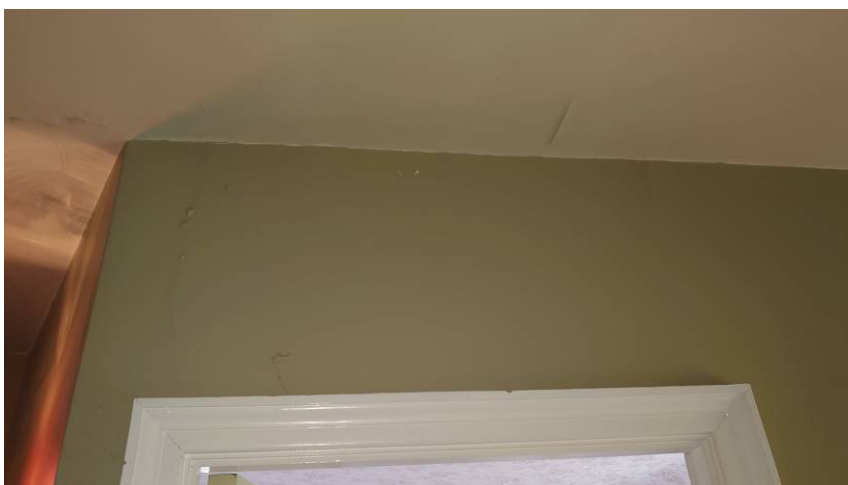
Internal cracks

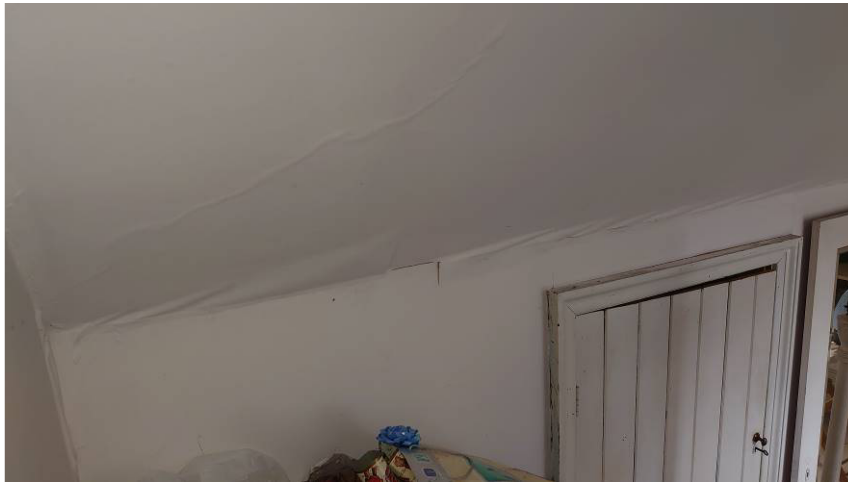
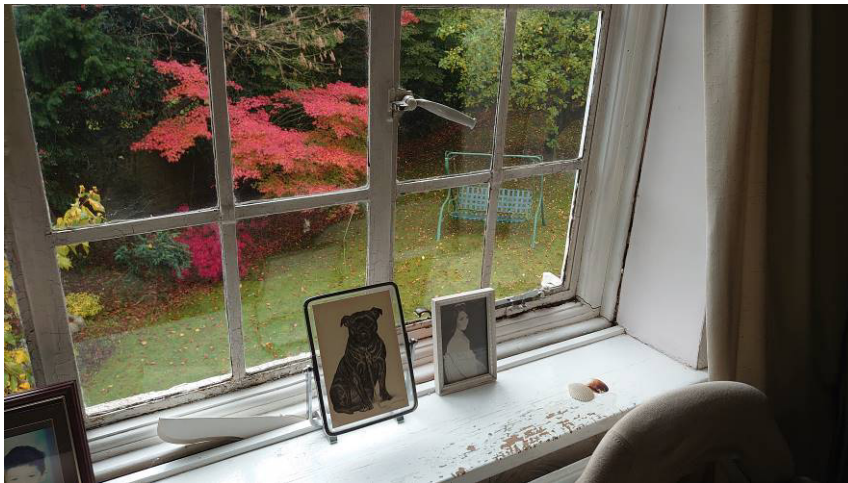
Outward movement of wall

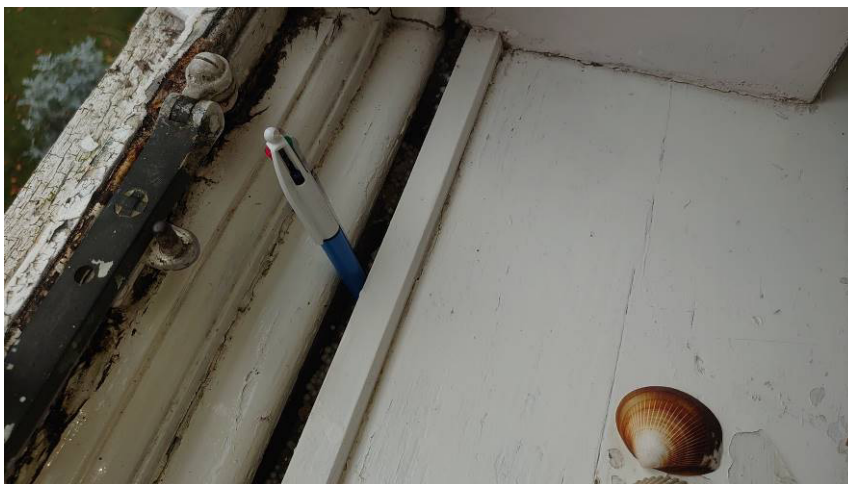
Large gap at window

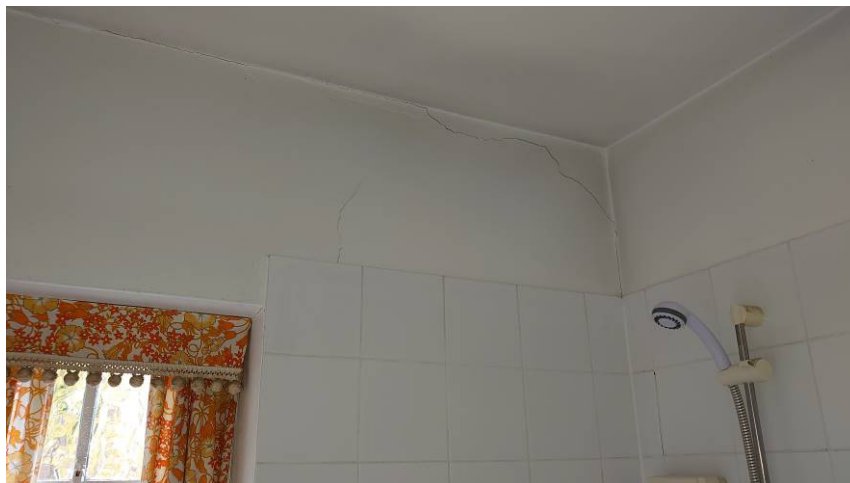
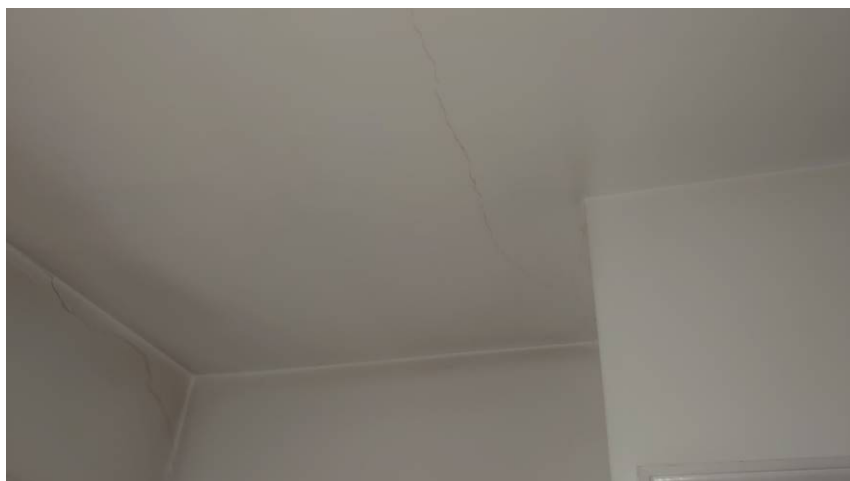
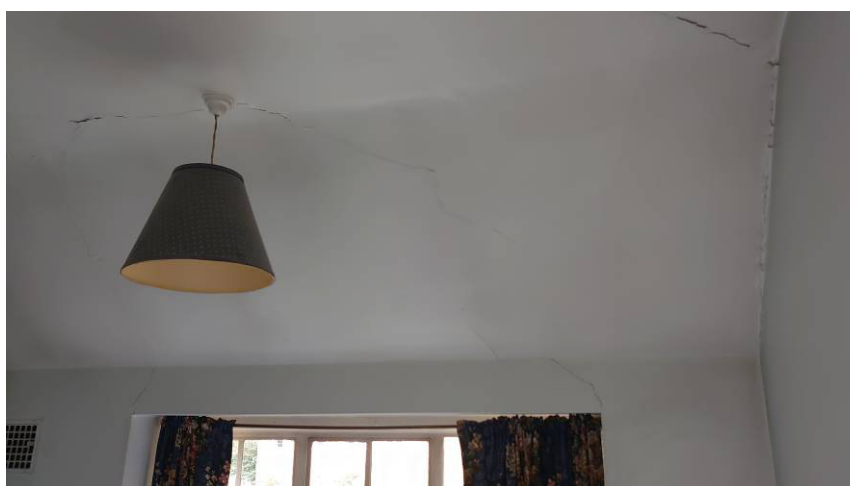
More internal cracks

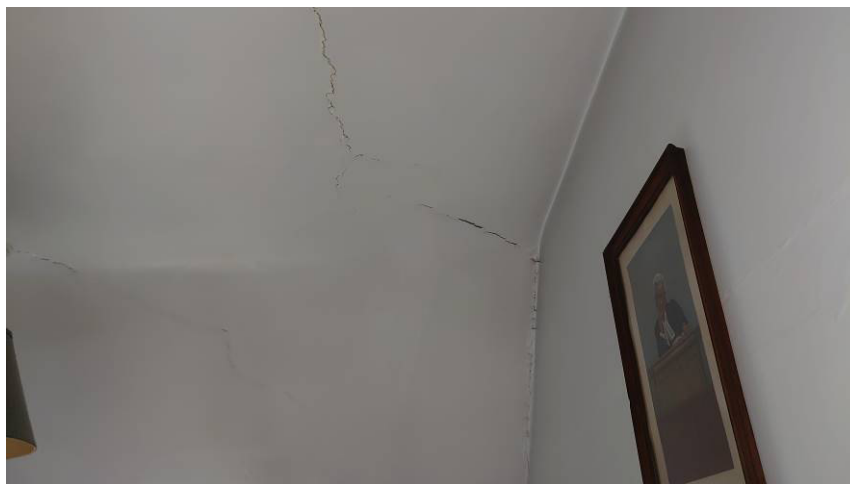
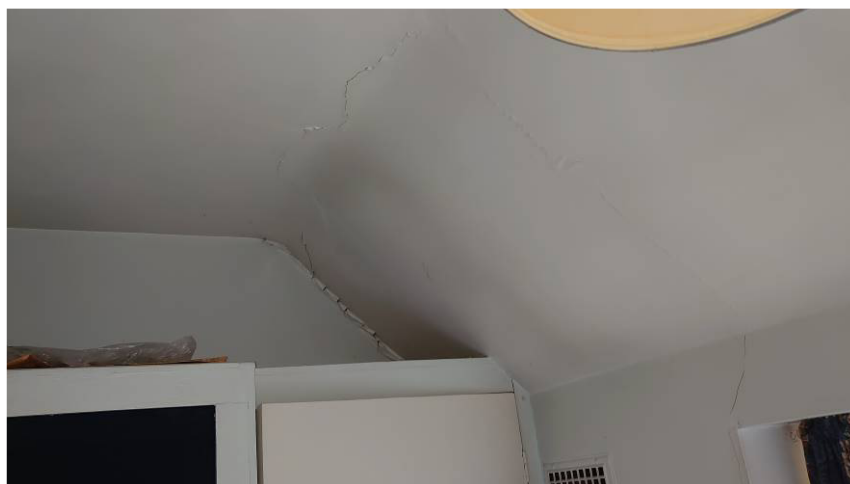
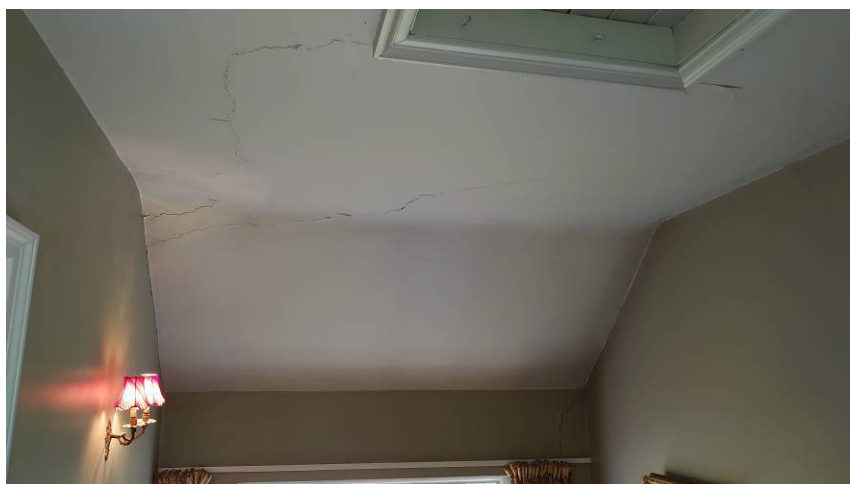
More internal cracks

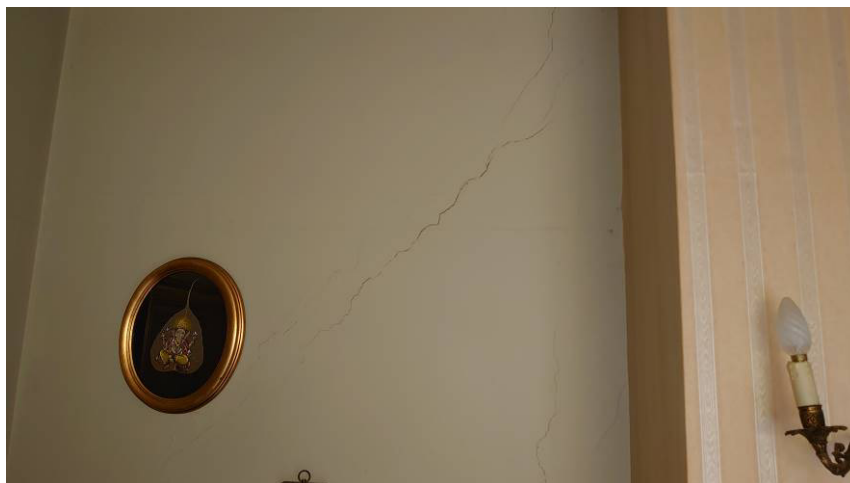
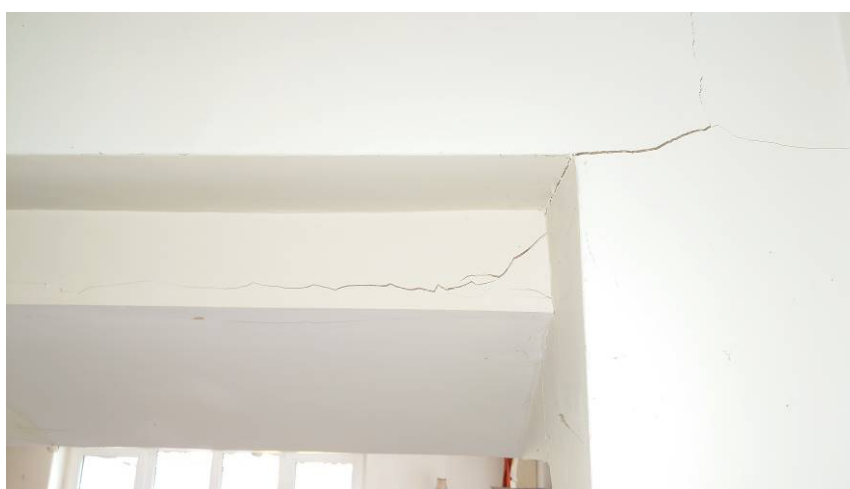
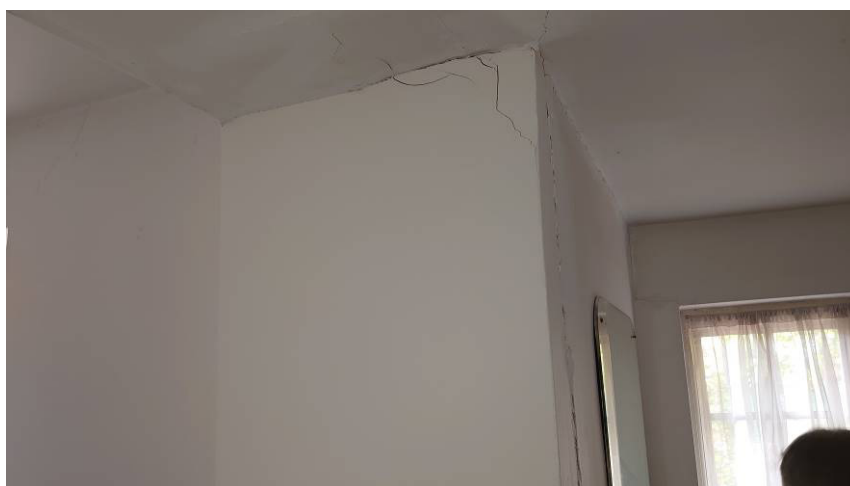
More internal cracks

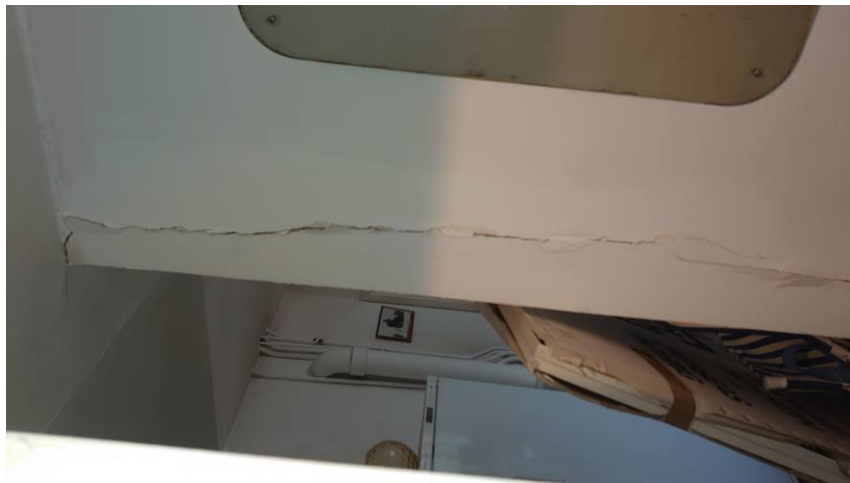
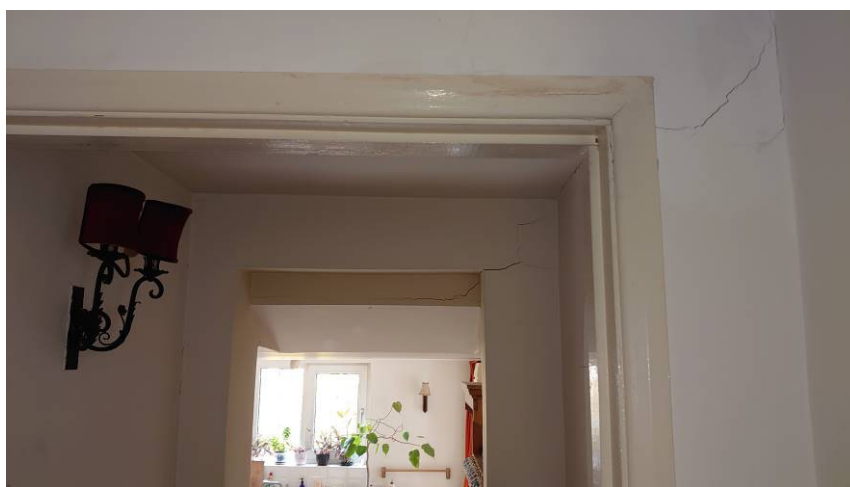
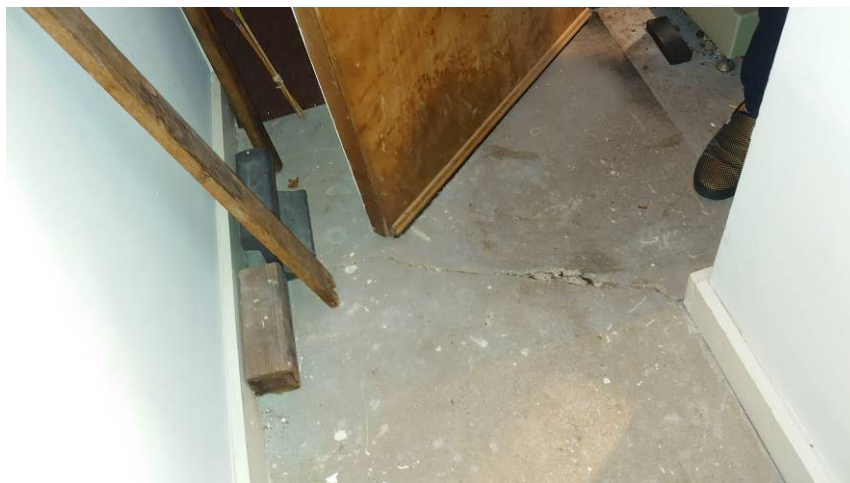
Cracking in ground floor

- Garage: Underpin 2No. internal spine walls and flank wall of original house to an average depth of 2.5m
    - Replace concrete ground floor slab
    - Replace wall plates embedded in walls and replace 25% of floor joists and level up floor boards.
