Broken wall

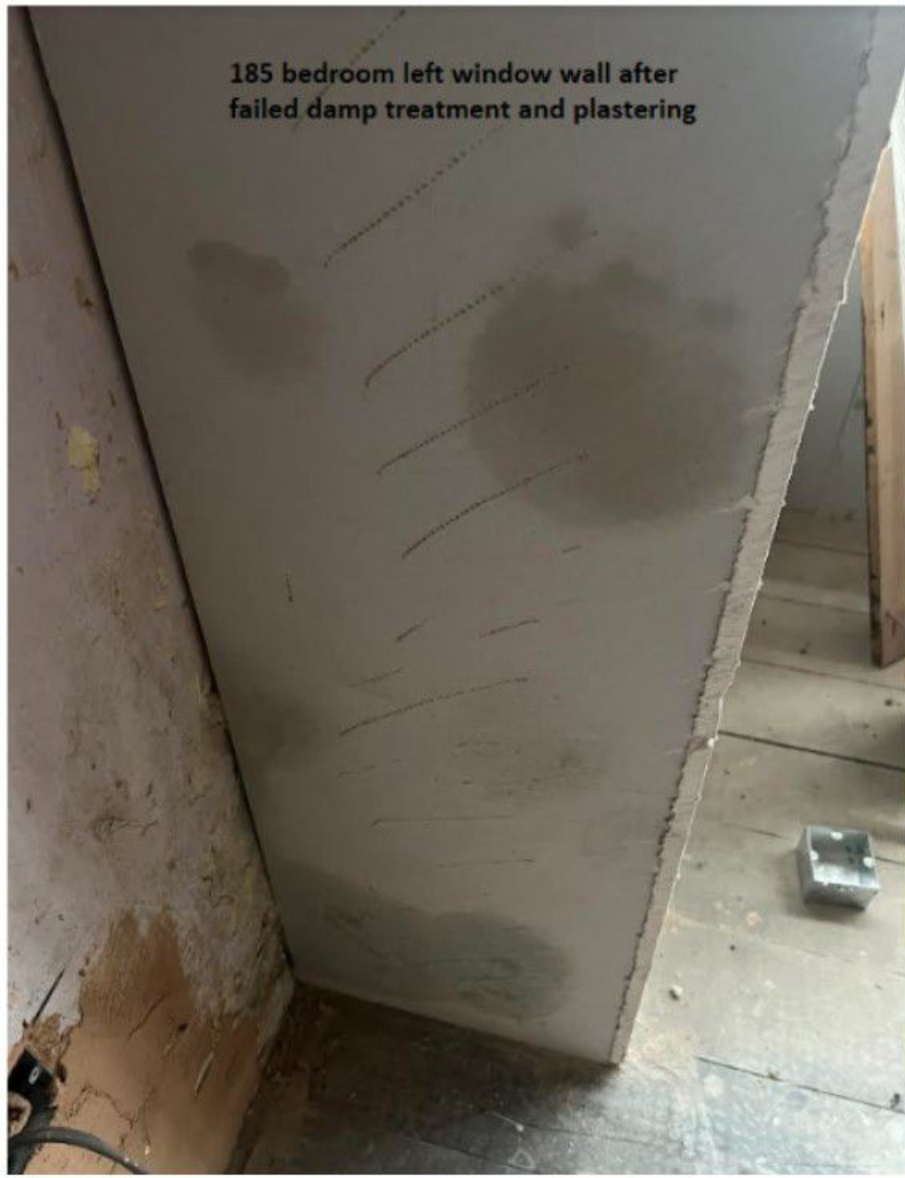
185 bedroom window sill after failed damp treatment course and plastering
