**ADDENDUM TECHNICAL REPORT**

**Crawford Reference: SU1803352**

**61 Park Avenue  
Ruislip  
Middlesex  
HA4 7UL**

**SUBSIDENCE CLAIM**

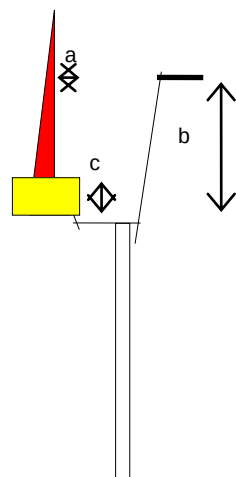
Foundation Details

A trial hole was excavated to expose the foundations - see site plan for location and the diagram below for details. Trial Hole 1a (house) revealed a concrete strip footing founded at a depth of 0.575m below ground level which bears onto firm mid brown/orange grey veined silty CLAY with gravel.

Trial Hole 1b (porch) revealed a concrete strip footing founded at a depth of 0.10 m below ground level which bears onto firm mid brown/orange grey veined silty CLAY with gravel.

Root activity of live appearance was noted to the underside of the foundations.

| No. | Borehole Depth | Footing (a) | Underside (b) | Thickness (c) |
|---|---|---|---|---|
| TH1a | 2.70 m. | 200 mm. | 575 mm. | 250 mm. |
| TH1b | 0.00 m. | 20 mm. | 100 mm. | 74 mm. |
