# **TECHNICAL REPORT ON A SUBSIDENCE CLAIM**

**Crawford Reference: SU1803352**

**[REDACTED]  
61 Park Avenue  
Ruislip  
Middlesex  
HA4 7UL**

## **SUBSIDENCE CLAIM**

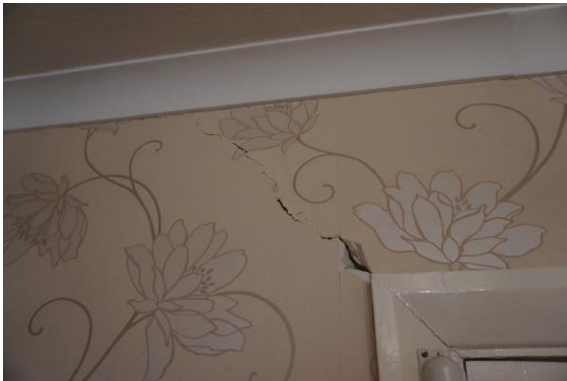
Lounge - Diagonal crack above door

Diagonal crack on front wall above door - 4mm  
Historical distortion noted to door opening

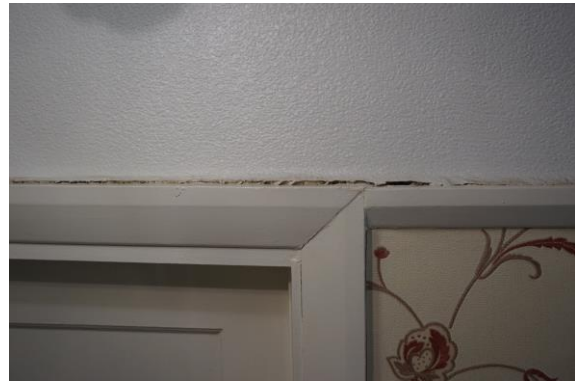
Hall - Drop in lounge door frame

Separation to top of rear lounge door - 5mm  
Separation above door - 3mm  
Diagonal crack above front door - 0.5mm  
Rucking of wallpaper above front door  
Front door has been planed  
Separation to stairs - 4mm  
Under stair door is now distorted and sticks

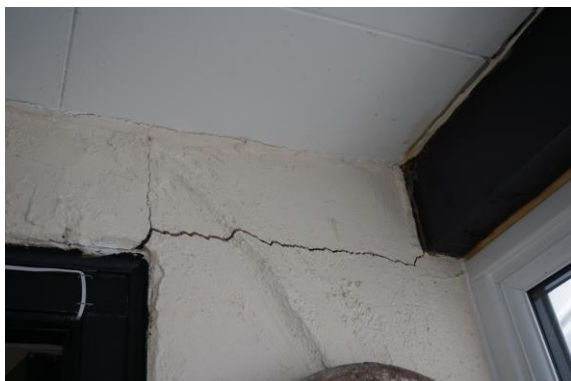
Horizontal crack to right of front door - 4mm  
Vertical separation to front right corner - 10mm  
Vertical separation to front right corner - 10mm  
Vertical separation to rear right - 3mm  
Front UPVC door won't open

Front Elevation - Horizontal crack to right of front door

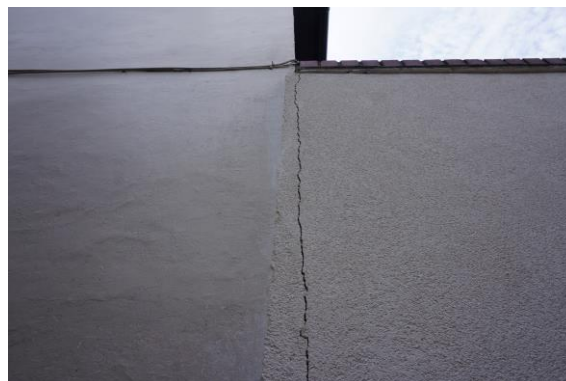
Right Elevation - Vertical crack at extension junction

Vertical crack at extension junction - 2mm

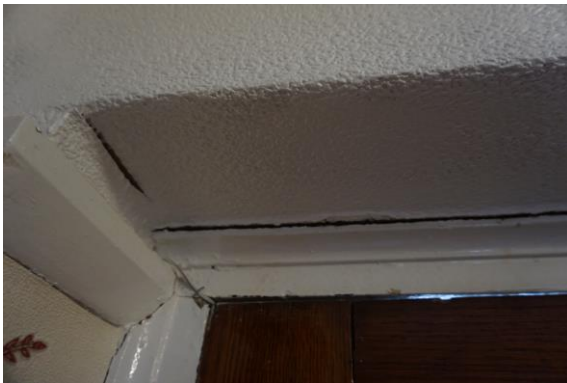
Hall - Separation to door frame

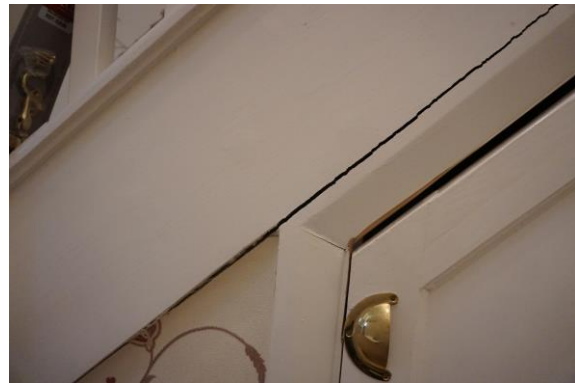
Hall - Drop in stairs

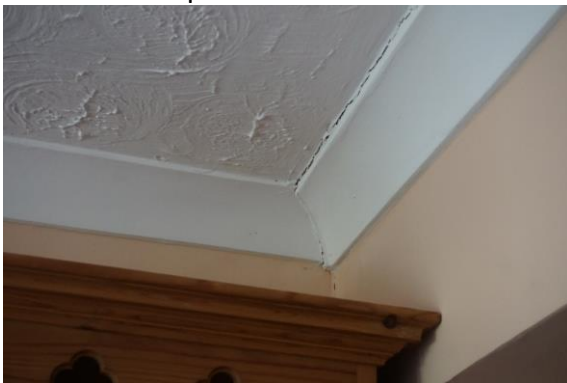
Ceiling junction separation at extension junction - 2mm  
Vertical crack to corner of extension - 2mm

Kitchen - Ceiling junction separation

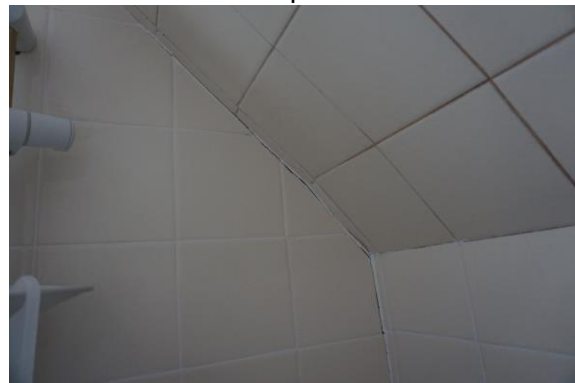
Vertical crack to front right corner - 2mm  
Undulation to tiles

Bathroom - Vertical crack to corner

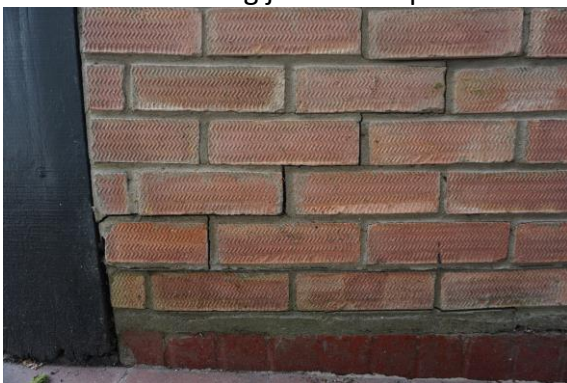
Stepped crack below porch window and slippage - 10mm

Right Elevation Porch - Stepped crack
