# Arboricultural Appraisal Report

## Subsidence Damage Investigation at:

61 Park Avenue  
Ruislip  
Middlesex  
HA4 7UL

| MWA REF: | SUB190822-5507 |

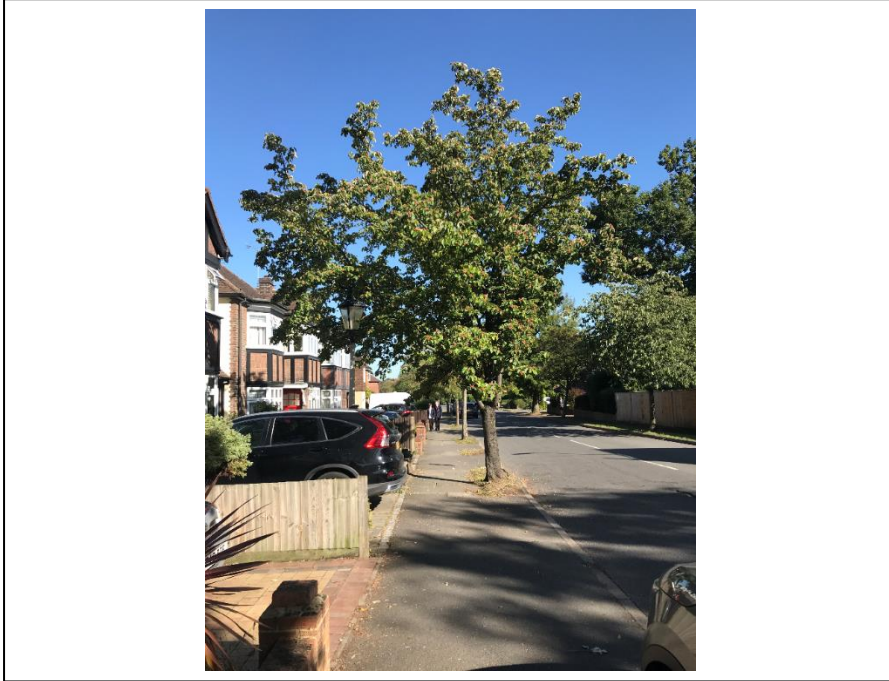
Roots were observed to a depth of 2200mm and 1700mm bgl in TP/BH1 and TP/BH2 respectively. Recovered samples have been positively identified (using anatomical analysis) as Pomoideae gp. and Quercus spp., the origin of which will be T1 (Apple) and T2 (Oak) confirming their influence on the soils below the foundations.

| Tree No. | Species | Ht (m) | Dia (mm) | Crown Spread (m) | Dist. to building (m) | Age Classification | Ownership |
|---|---|---|---|---|---|---|---|
| T1 | Apple | 6 | 280 | 6.5 * | 12 | Younger than Property | Local Authority |

View of T1 Apple, current claim.

| Tree No. | Species | Ht (m) | Dia (mm) | Crown Spread (m) | Dist. to building (m) | Age Classification | Ownership |
|---|---|---|---|---|---|---|---|
| Recommendation | | Reduce height by 2m and crown radius by 1.5m leaving balanced crown. Prune on a biennial cycle to maintain at broadly reduced dimensions. | | | | | |

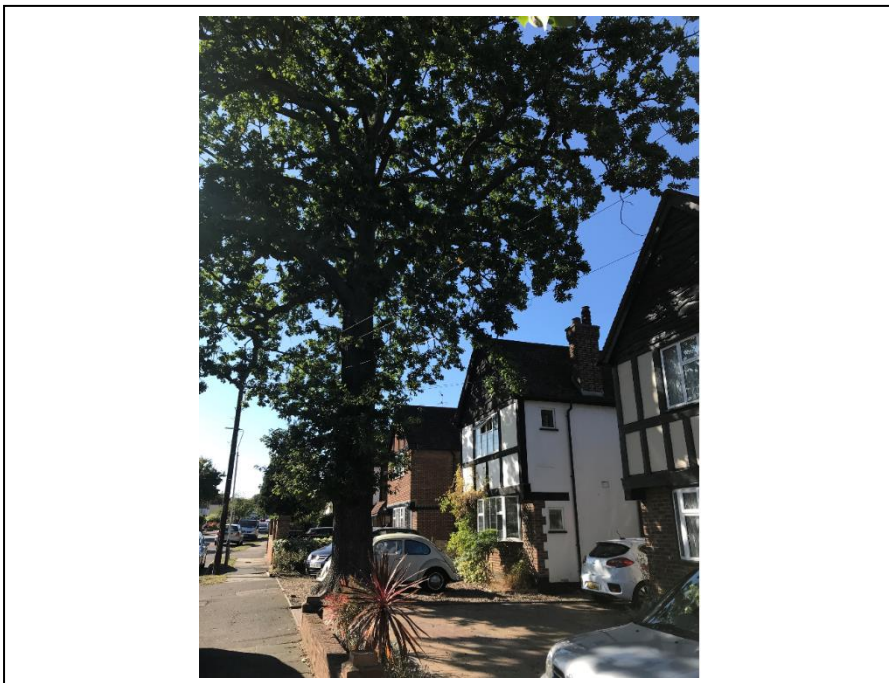
Based on the technical reports currently available, engineering opinion and our own site assessment we conclude the damage is consistent with shrinkage of the clay subsoil related to moisture abstraction by vegetation. Having considered the information currently available, it is our opinion that T2 is the principal cause of the current subsidence damage, with a secondary contribution from T1.

| Tree No. | Species | Ht (m) | Dia (mm) | Crown Spread (m) | Dist. to building (m) | Age Classification | Ownership |
|---|---|---|---|---|---|---|---|
| T2 | Oak | 16.5 | 1000 * | 13 * | 6 | Similar age or older than Property | Third Party:<br>59 Park Avenue<br>HA4 7UL |

View of T2 Oak, current claim.

Due to the size and proximity of T2 and in view of the previous subsidence event, removal offers the most predictable arboricultural solution. The apple T1 should be reduced.

| Tree No. | Species | Ht (m) | Dia (mm) | Crown Spread (m) | Dist. to building (m) | Age Classification | Ownership |
|---|---|---|---|---|---|---|---|
| Recommendation | | Remove (fell) to near ground level and treat stump to inhibit regrowth. | | | | | |

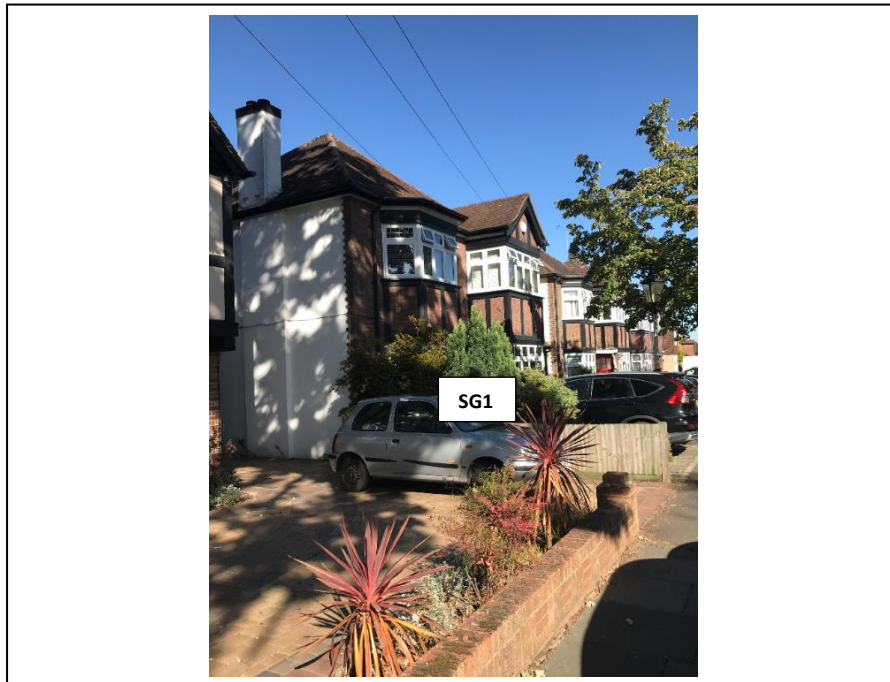
| Tree No. | Species | Ht (m) | Dia (mm) | Crown Spread (m) | Dist. to building (m) | Age Classification | Ownership |
|---|---|---|---|---|---|---|---|
| SG1 | Species include Juniper | 2.1 | 60 * | 3.7 | 2.8 | Younger than Property | Third Party:<br>63 Park Avenue<br>HA4 7UL |

View of SG1 mixed species, future risk.

| Tree No. | Species | Ht (m) | Dia (mm) | Crown Spread (m) | Dist. to building (m) | Age Classification | Ownership |
|---|---|---|---|---|---|---|---|
| Recommendation | | Maintain broadly at no more than current dimensions by periodic pruning. | | | | | |

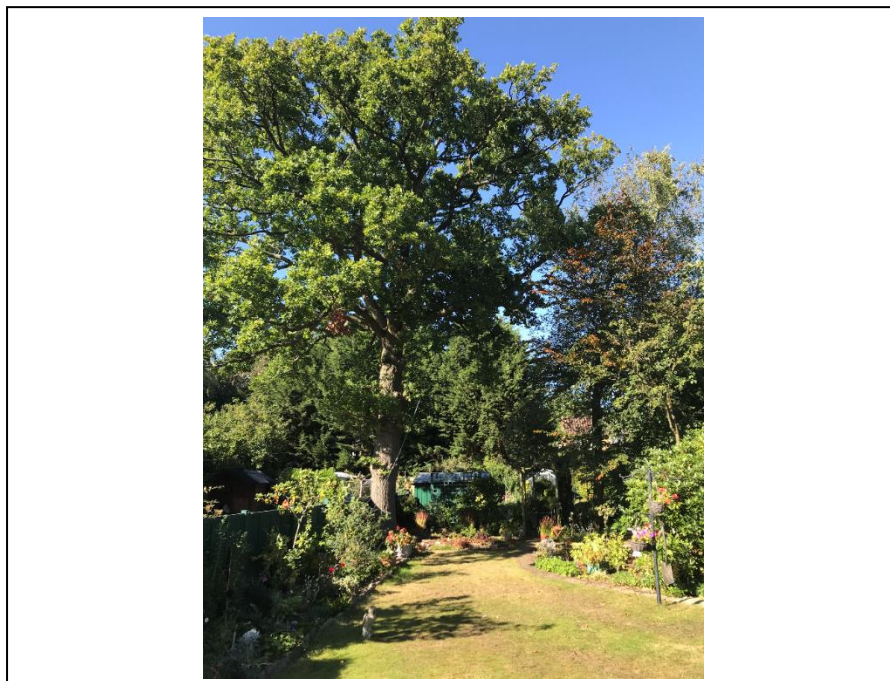
| Tree No. | Species | Ht (m) | Dia (mm) | Crown Spread (m) | Dist. to building (m) | Age Classification | Ownership |
|---|---|---|---|---|---|---|---|
| T3 | Oak | 13 | 700 | 10 | 17.5 | Younger than Property | Policy Holder |

View of T3 Oak, future risk.

| Tree No. | Species | Ht (m) | Dia (mm) | Crown Spread (m) | Dist. to building (m) | Age Classification | Ownership |
|---|---|---|---|---|---|---|---|
| Recommendation | | Maintain broadly at no more than current dimensions by periodic pruning. | | | | | |
