Tree Survey Report

Site Details: 114 Bushey Road, Ickenham, UB10 8JX

Title: NAG_114BR_TSR_001

Published Date: 18th February 2026

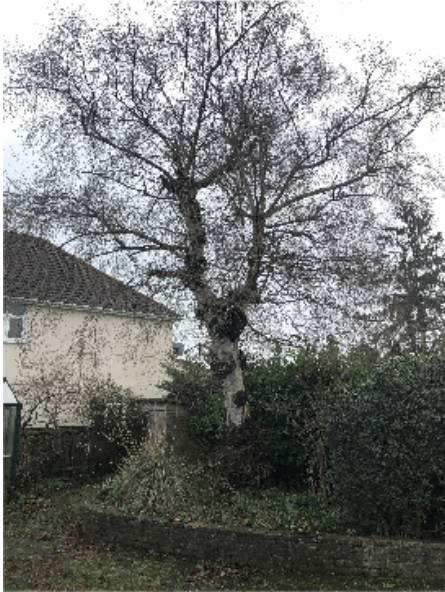
T9 - Silver Birch, shown in Photo 1 located in the south side raised planting bed which is proposed to be removed as part of the rear garden landscaping element of the development.

The tree is Over Mature in terms of its age classification for the species and has been deemed to exceed risk tolerance levels for safe long term retention.

The Silver Birch (T9) is the dominant tree at the rear of the property, but following the Stage 1 Visual Tree Assessment (VTA) of this tree, its structural condition was of serious concern as detailed in Section 5.0 and highlighted with supporting photographs in Appendix A. T9 is to be removed along with the other trees and plants which are growing from the raised planting bed on the south side of the garden, which is to be removed and the soil level reduced to the natural ground level of the garden.

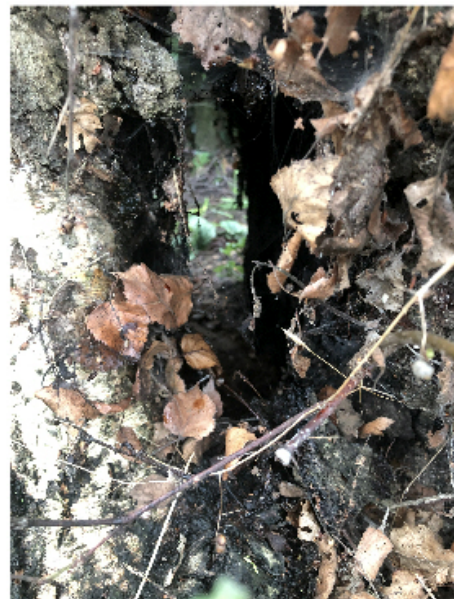
Photo 4 shows the completely hollowed out trunk from decay. Photo taken from the west side of the tree with daylight and the garden visible through the hollowed out stem.

Sounding hammer testing above and around the cavity suggested significant internal decay and hollowing up to approx. 2m high in the stem.
