**Arboricultural report for  
an oak tree  
(*Quercus robur*)  
at  
The Spinney  
Vine Grove  
Hillingdon  
Uxbridge  
UB10 9LW**

**Client: Adam Cuncell  
The Spinney  
Vine Grove  
Hillingdon  
Uxbridge  
UB10 9LW**

**Prepared by**  
Simon Hawkins Dip Arb L6 (ABC) N.D Arbor M. Arbor. A.

03/09/2026

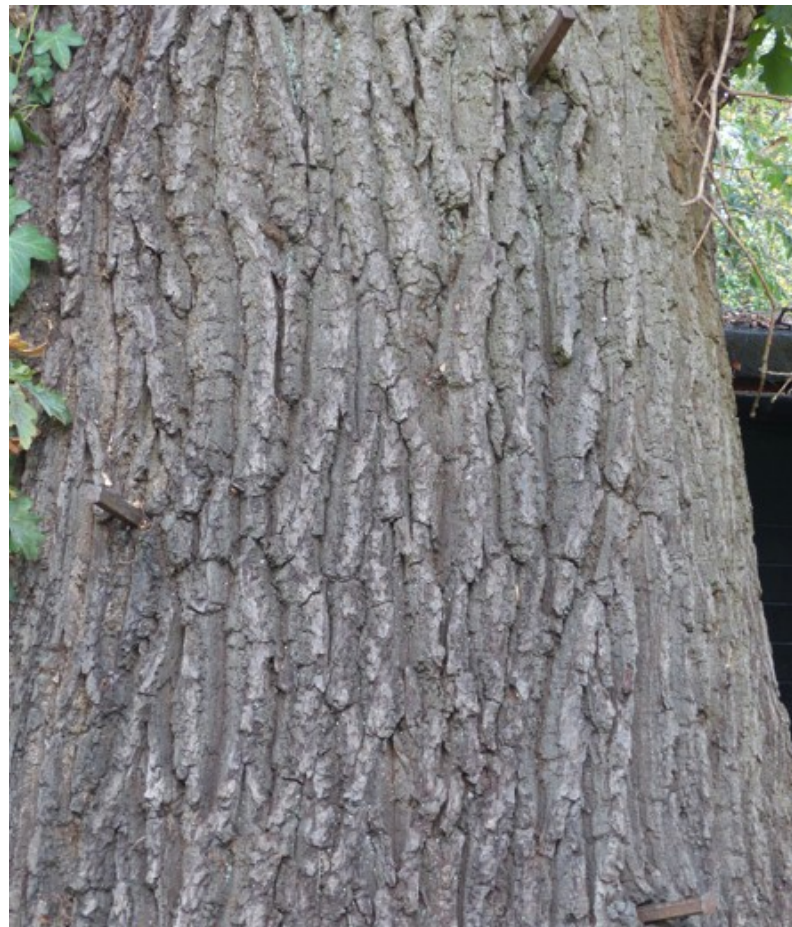
- 3.5 The main stem has a more or less upright habit, with a slight initial lean to the south. There are more pronounced buttress roots on the north side that have grown in response to the lean to provide more support to the tree, which is a normal growth phenomenon.
- 3.6 The stem has had four steel pegs inserted into the stem historically. These are positioned on the north side of the tree at 40cm, 1.5m, 1.7m and 2m (picture 2). The purpose of these is not known, but if this was an attempt to kill the tree it has failed completely.

Picture 2. The steel pegs driven into the bark do not appear to serve any purpose

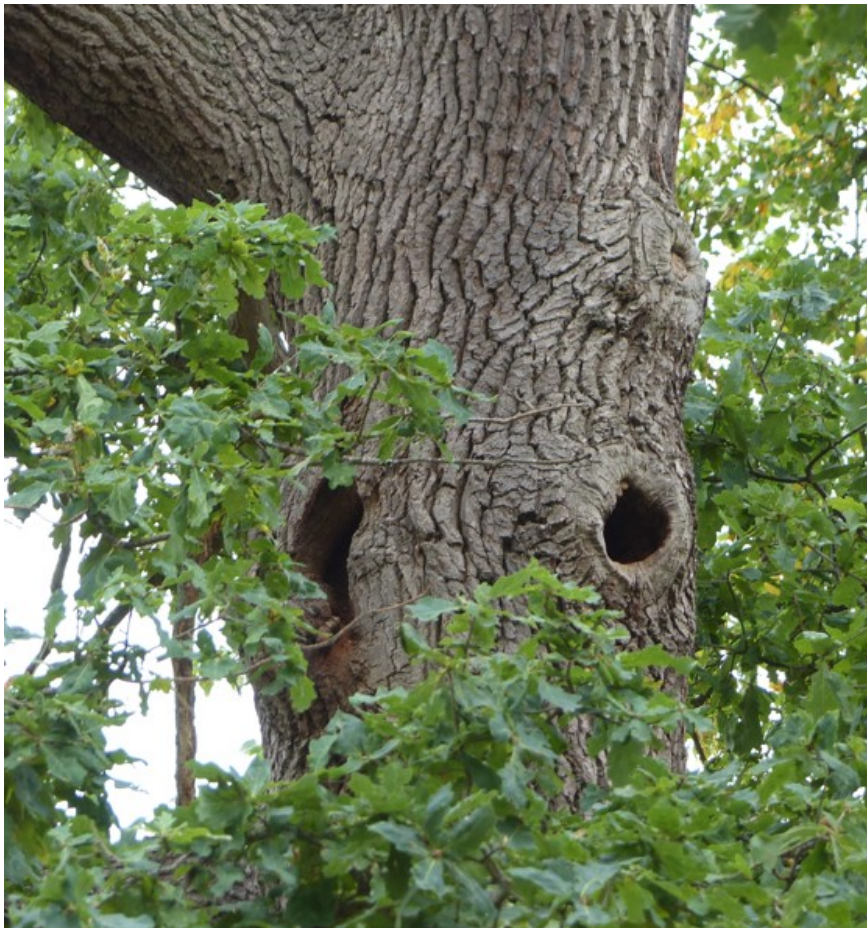
- 3.8 Just above the second scaffold branch there is a major cavity in the stem of the tree with two separate openings. It was not possible to view the cavity up close, but footage from a video provided by a tree surgeon has been reviewed.
- 3.9 One opening is on the east side of the stem and comprises a circular hole measuring about 15cm diameter. The opening of the cavity is completely surrounded by reaction wood, showing an excellent response to the wounding by the tree.
- 3.10 The other opening is located on the south side and is larger. The wound response around the edge of the opening cannot be seen as clearly and it cannot be confirmed that the wound response covers the whole of the opening. There is jagged bark around part of the cavity which obscures a full view.

Picture 3. The cavity on the main stem at 6m seen from the south east. Both openings are visible in the picture.

- 3.11 The video footage confirms that the two openings are joined. From the footage, it can be seen that the decay within appears to be a brown rot and that this rot is likely being contained by the tree with limited spread at present. Full confirmation of this would be possible using a microdrill if required.

- 4.2 The tree has also been subjected to storm damage with limbs being torn off. The appearance of the larger cavity on the south side of the main stem is consistent with this.

- 4.3 The smaller cavity on the east side may be the result of branch removal or natural dieback. It is obvious that decay developing in both cavities has met deeper in the stem and that this has resulted in the one large cavity.

- 4.4 It seems that the tree is containing the spread of the decay at present and that the wood in between the two cavities as well as surrounding the remaining stem is thick enough to continue to provide satisfactory support for the upper crown.

- 4.5 However, as the tree ages and weakens the decay may begin to gain an upper hand, resulting in a failure. It is unlikely that this will happen in the near future and may speculatively it take a couple of decades for this to come about.

| Part of tree at risk of failure | Nature of failure | Likelihood of failure | Target affected | Level of risk of harm attributed |
|---|---|---|---|---|
| Mid stem | Tree stem fails around area of the cavity | Possible due to presence of cavity and unassessed extent of possible decay in the stem | Garden area.<br>Garden buildings including neighbours' structure | <b>Medium risk</b> |

- 7.4 In addition it is recommended that a further inspection is made of the cavity in the future (no more than 5 years' time) , using a microdrill to fully ascertain the condition of the wood around the cavity. This will involve either climbing the tree or using an elevated platform (preferred) to reach the cavity.

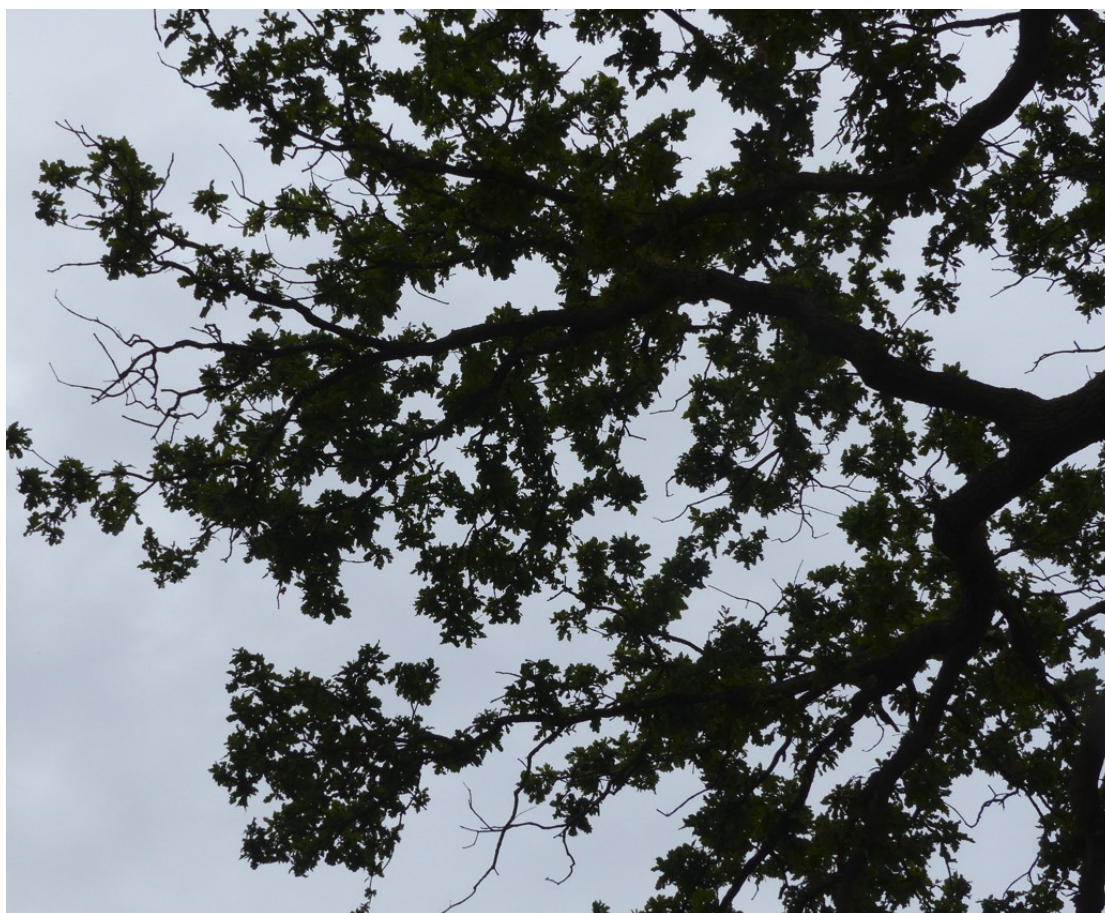
- 3.21 There is a notable amount deadwood throughout the crown varying in size from twigs to larger pieces (pic.4). Furthermore the tree displays apical dieback and has a stag headed appearance.

Picture 4. Tip dieback of branches manifesting throughout the crown

- 4.6 In the meantime the tree is showing signs of dying back and may be preparing to develop a smaller, more compact crown in old age. This is part of the ageing process for oak trees and can be viewed as normal, although limb failure is associated with this process.

| Part of tree at risk of failure | Nature of failure | Likelihood of failure | Target affected | Level of risk of harm attributed |
|---|---|---|---|---|
| Branches | Larger dead branches/ parts of branches break off | Possible given the overall condition of the tree - limited consequences | Garden area.<br>Garden buildings including neighbours' structure | <b>Medium low risk</b> |

- 7.2 Option 2 would be to prune the tree by crown reduction. A reduction of the crown volume should not exceed 30% and would include pruning back the ends of the branches by no more than 4m.

- 7.3 Reducing the tree will potentially reduce the weight borne by the limbs and therefore may reduce the potential for failure and further limit the area affected by damage in the event of failure. This is my preferred recommendation. Excessive pruning should be avoided as this would be of little benefit to the tree and would only serve to weaken the tree.
