# Flood Risk Assessment in Accordance with NPPF & Drainage Strategy

**Project :** Proposed Mixed Use Retail and  
Residential Development  
Morrisons, 43-67 High St,  
Yiewsley, UB7 7QQ

**Job No.** : 10/4897

**Date** : July 2018

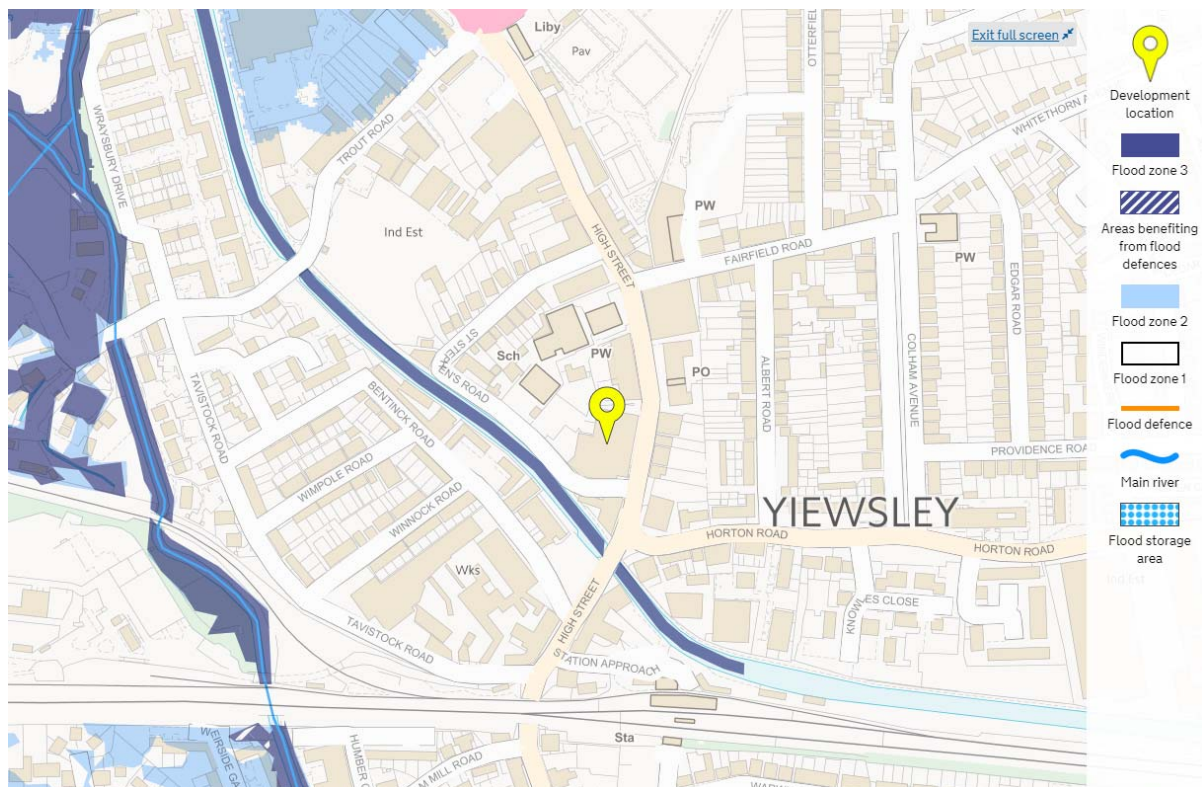
*Fig. 1 : EA Flood Map – River and Tidal Flooding*

Designated main rivers closest to the site are Fray's River approximately 340m to the west and the River Colne a little further west. These rivers are considered too remote to pose fluvial flood risk to the project site. Closer to the site is the Grand Union Canal and this too is not a source of flood risk as it is constrained within its banks. This can be seen in the EA flood map below.

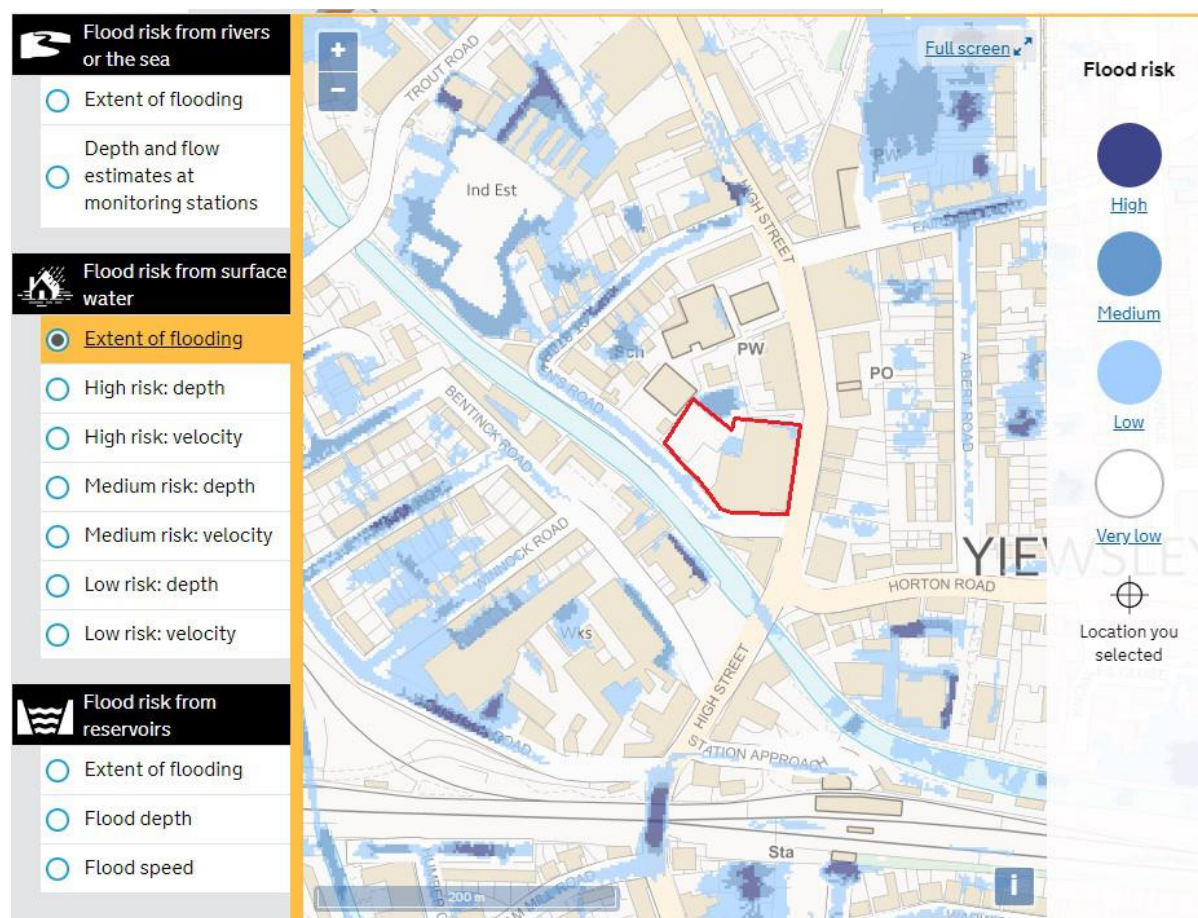
Fig. 2: EA Flood Map – Surface Water Flooding

Pluvial or surface water flooding arises out of the inability of surface water runoff to infiltrate into the ground during intense or prolonged rainfall. Urban development adds to the problem by replacing natural open spaces with hard paved impermeable surfaces. Surface water flooding is exacerbated when natural drainage channels or artificial drainage systems have insufficient capacity to absorb the additional runoff. The EA's online flood risk map indicates that the risk of flooding from surface water runoff on the site is very low (see Fig. 2 below).

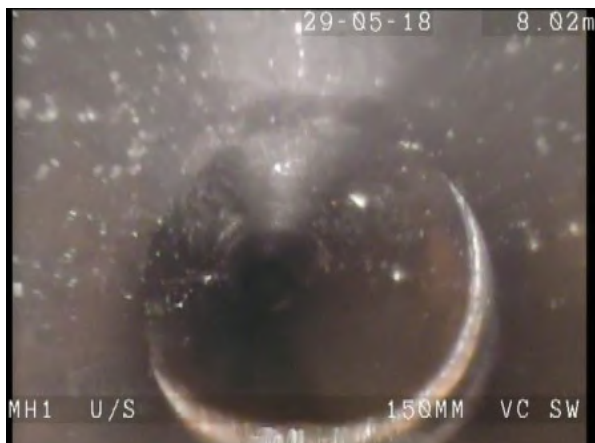
MH3X\_a3ddf67a-6157-40fe-801c-e0e08bedef87\_20180604\_105126\_505.jpg, 00:00:36, 8.10m  
Joint displaced, medium

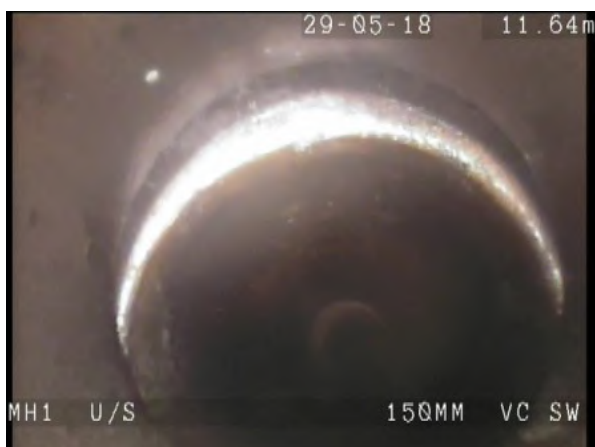
MH3X\_d36944c7-39db-467e-8472-70c44a59c664\_20180604\_105151\_525.jpg, 00:00:48, 11.60m  
Joint displaced, medium

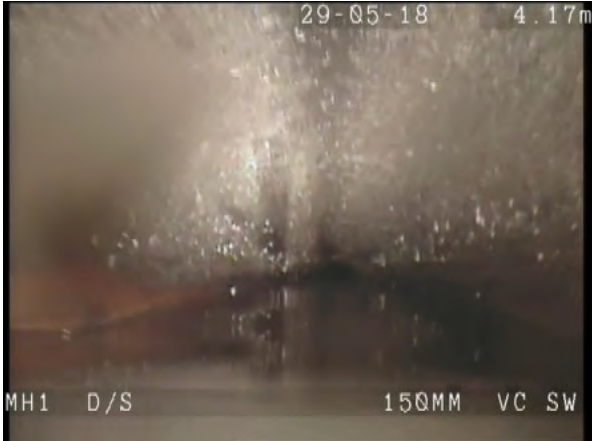
MH1X\_4239433d-b5af-4ddc-a80a-48b68d4cb309\_20180604\_1  
 05613\_527.jpg, 00:00:18, 4.10m  
 Water level, 40% of the vertical dimension

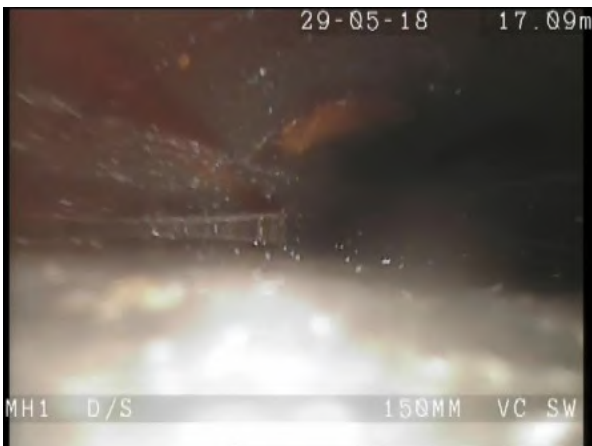
MH1X\_df6d95d8-c6d1-46e8-9f07-eb4d7e02ebd3\_20180604\_1  
 10121\_139.jpg, 00:01:07, 17.10m  
 Water level, 30% of the vertical dimension

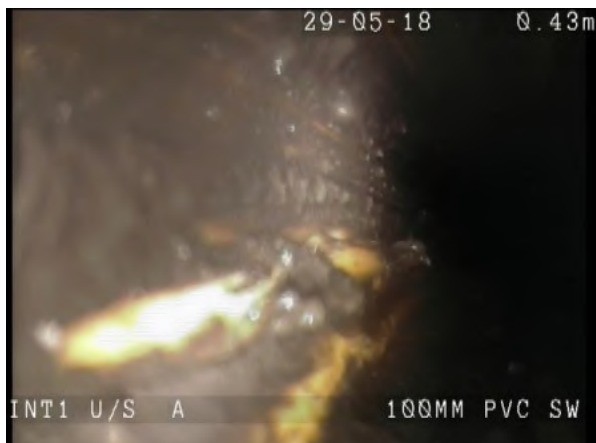
Settled deposits, fine, 5% cross-sectional area loss

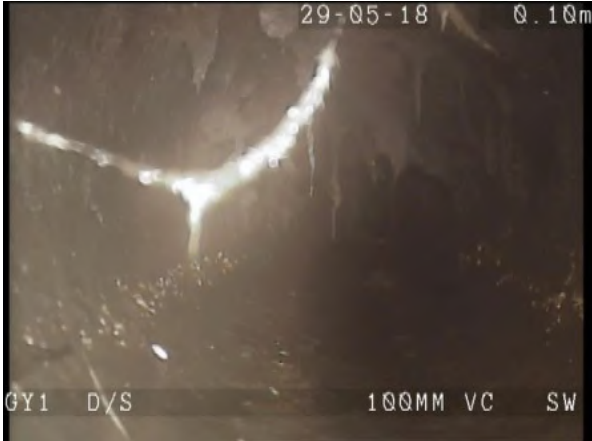
GY1X\_4ae48c69-bb7e-4f0a-8a19-bf8cd0d8e4c5\_20180604\_113150\_073.jpg, 00:00:06, 0.10m  
 Settled deposits, fine, 5% cross-sectional area loss, start

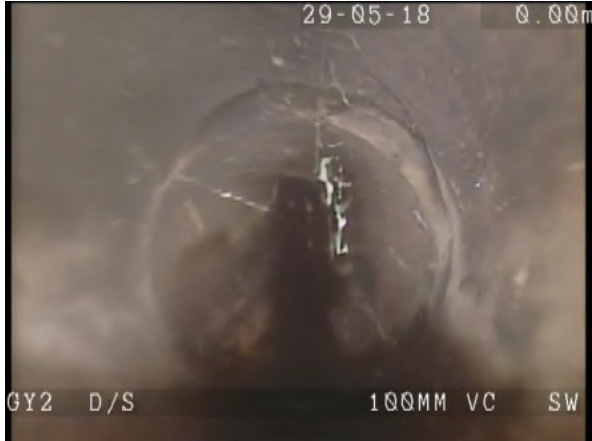
GY2X\_dd061343-718e-4456-898a-1efea845b377\_20180604\_114119\_072.jpg, 00:00:07, 0.20m  
 Hole in drain or sewer at a joint from 11 o'clock to 3 o'clock

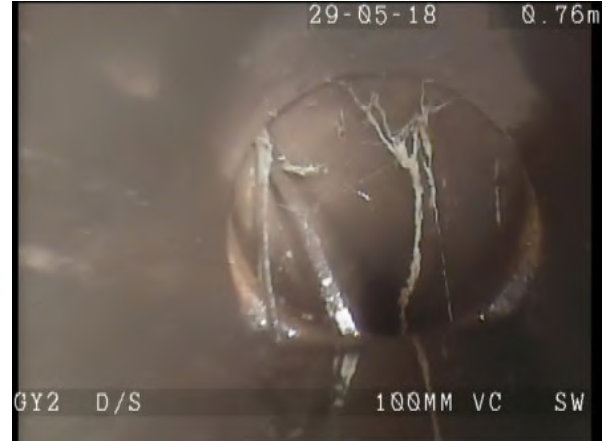
GY2X\_33c5c1ea-f169-4d8f-ada0-a495ecdef433\_20180604\_114148\_482.jpg, 00:00:12, 0.80m  
 Joint displaced, medium

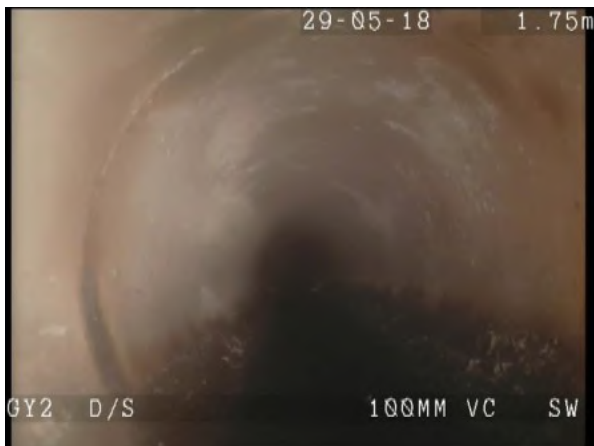
| 1:120 | Position [m] | Code | Observation | MPEG | Photo | Grade |
|---|---|---|---|---|---|---|
| | 1.80 | CC | Crack, circumferential from 12 o'clock to 12 o'clock | 00:00:19 | | 2 |

GY2X\_d3e3e17c-9730-48b7-b2a5-2de544580fdd\_20180604\_114259\_842.jpg, 00:00:19, 1.80m  
 Crack, circumferential from 12 o'clock to 12 o'clock

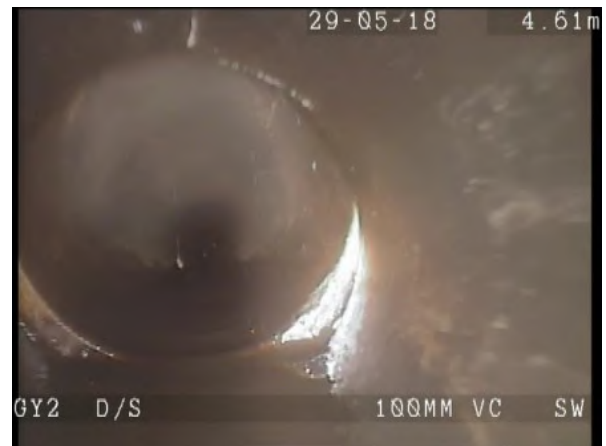
GY2X\_a79ea17b-9a1f-4af5-83d4-555353067472\_20180604\_114230\_449.jpg, 00:00:34, 4.70m  
 Joint displaced, medium

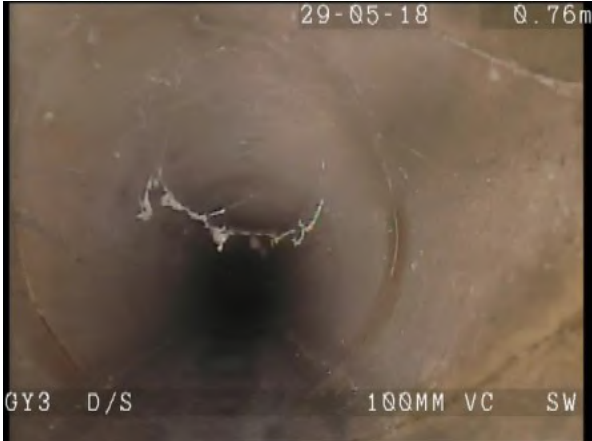
| 1:54 | Position [m] | Code | Observation | MPEG | Photo | Grade |
|---|---|---|---|---|---|---|
| | 0.80 | CC | Crack, circumferential from 12 o'clock to 12 o'clock | 00:00:10 | | 2 |

GY3X\_dd9d2f66-7a16-4d3e-a03f-82c0c425fc5c\_20180604\_115332\_276.jpg, 00:00:10, 0.80m  
 Crack, circumferential from 12 o'clock to 12 o'clock

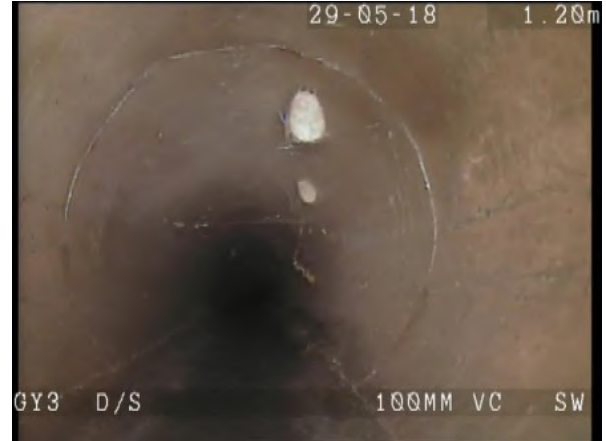
| 1:54 | Position [m] | Code | Observation | MPEG | Photo | Grade |
|---|---|---|---|---|---|---|
| | 1.30 | CC | Crack, circumferential from 12 o'clock to 12 o'clock | 00:00:13 | | 2 |

GY3X\_50057357-3fb3-43e8-84e6-5fc63ff7c92e\_20180604\_115348\_849.jpg, 00:00:13, 1.30m  
 Crack, circumferential from 12 o'clock to 12 o'clock

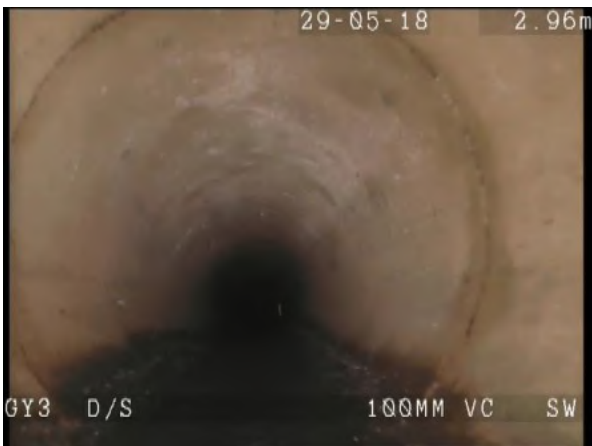
| 1:54 | Position [m] | Code | Observation | MPEG | Photo | Grade |
|---|---|---|---|---|---|---|
| | 3.00 | CC | Crack, circumferential from 7 o'clock to 5 o'clock | 00:00:23 | | 2 |

GY3X\_f5782e97-a6ba-4fec-a11c-89e9b0a02103\_20180604\_115415\_309.jpg, 00:00:23, 3.00m  
 Crack, circumferential from 7 o'clock to 5 o'clock

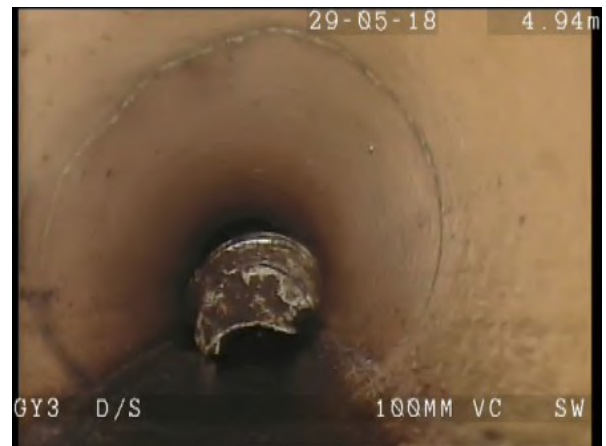
| 1:54 | Position [m] | Code | Observation | MPEG | Photo | Grade |
|---|---|---|---|---|---|---|
| | 5.00 | CC | Crack, circumferential from 7 o'clock to 5 o'clock | 00:00:31 | | 2 |

GY3X\_b9039a48-1108-4694-bd18-1360eff10592\_20180604\_115439\_085.jpg, 00:00:31, 5.00m  
 Crack, circumferential from 7 o'clock to 5 o'clock

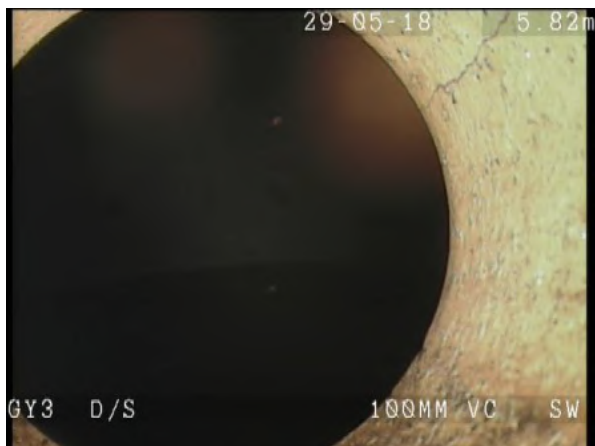
| 1:54 | Position [m] | Code | Observation | MPEG | Photo | Grade |
|---|---|---|---|---|---|---|
| | 5.80 | CL | Crack, longitudinal at 2 o'clock | 00:00:37 | | 2 |

Crack, longitudinal at 2 o'clock

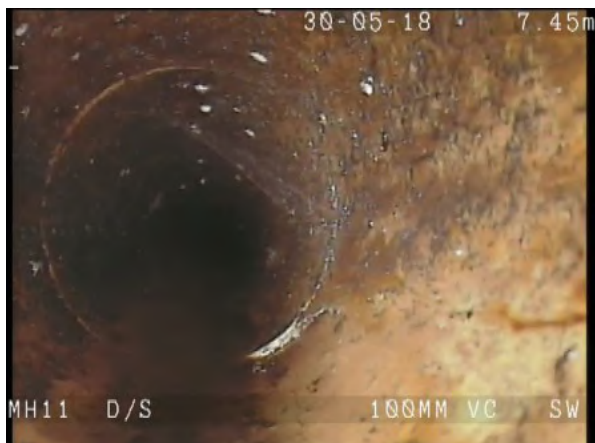
| 1:143 | Position [m] | Code | Observation | MPEG | Photo | Grade |
|---|---|---|---|---|---|---|
| | 7.50 | FLJ | Fracture, longitudinal at joint at 4 o'clock | 00:00:57 | | 3 |

Fracture, longitudinal at joint at 4 o'clock

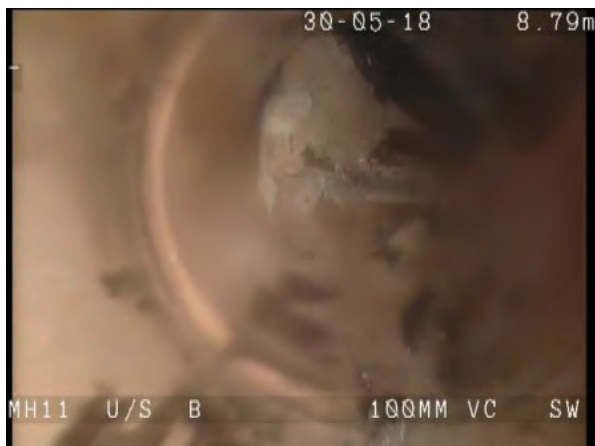
| 1:80 | Position [m] | Code | Observation | MPEG | Photo | Grade |
|---|---|---|---|---|---|---|
| | 8.80 | DER | Settled deposits, coarse, 50% cross-sectional area loss: POSSIBLY LINE UP | 00:01:07 | | 4 |

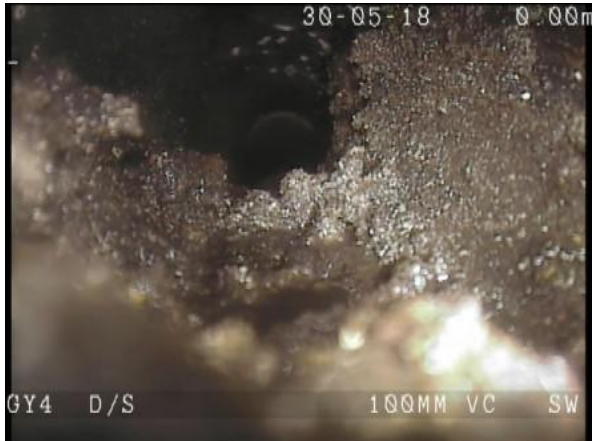
GY4X\_89492c26-b0de-426a-9dc6-f6b212b91f96\_20180604\_132822\_598.jpg, 00:00:00, 0.10m  
 Settled deposits, fine, 10% cross-sectional area loss

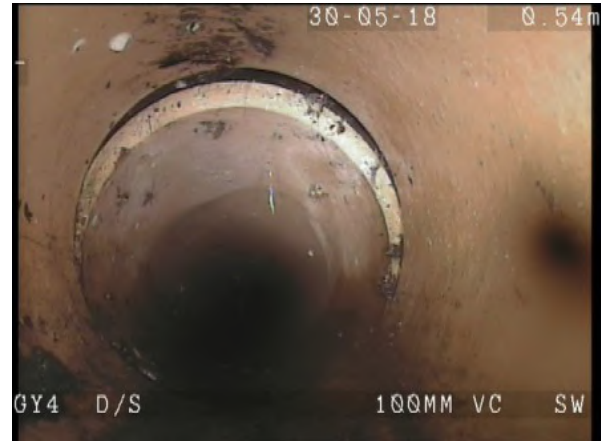
GY4X\_fb7ebc75-bacb-4bc7-9aa2-9c46b27d4ab2\_20180604\_132856\_232.jpg, 00:00:18, 0.60m  
 Joint displaced, medium

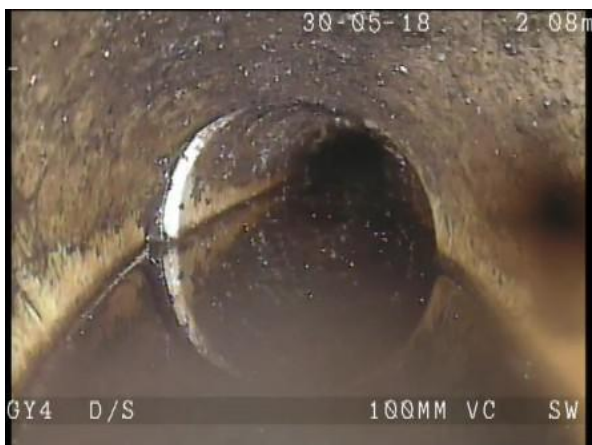
GY4X\_f2a9412c-e04b-47e4-a18a-4c80e63c3138\_20180604\_132918\_034.jpg, 00:00:28, 2.10m  
 Water level, 20% of the vertical dimension

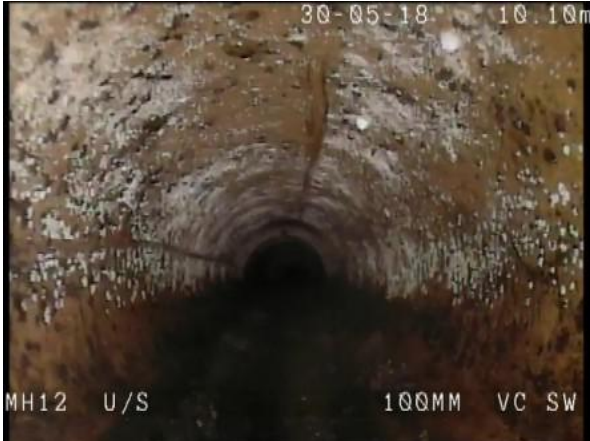
U\_S  
 MH12X\_427be56e-b667-4e80-a128-1737d92584ef\_20180604\_  
 133524\_873.jpg, 00:01:11, 10.10m  
 Settled deposits, fine, 5% cross-sectional area loss, start

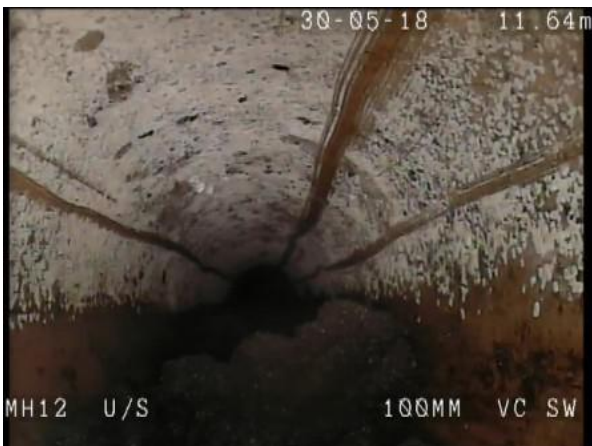
U\_S  
 MH12X\_2bbc4dde-a064-4af7-8145-a1a1beeace39\_20180604\_  
 133947\_373.jpg, 00:01:21, 11.70m  
 Settled deposits, fine, 10% cross-sectional area loss

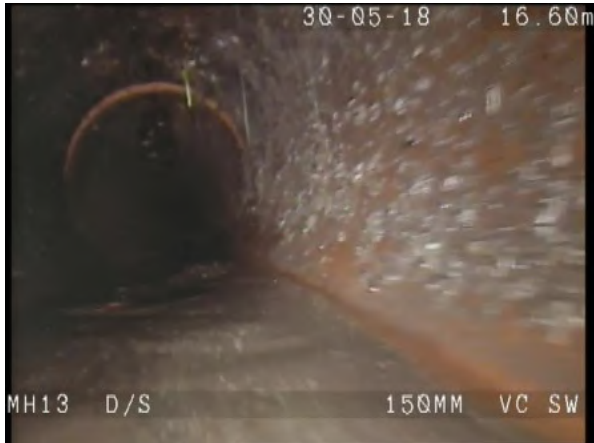
MH13X\_3a5ea860-e9c1-4aa8-bd1c-61770eea8ec1\_20180604\_140213\_355.jpg, 00:01:44, 16.60m  
 Settled deposits, fine, 5% cross-sectional area loss, start

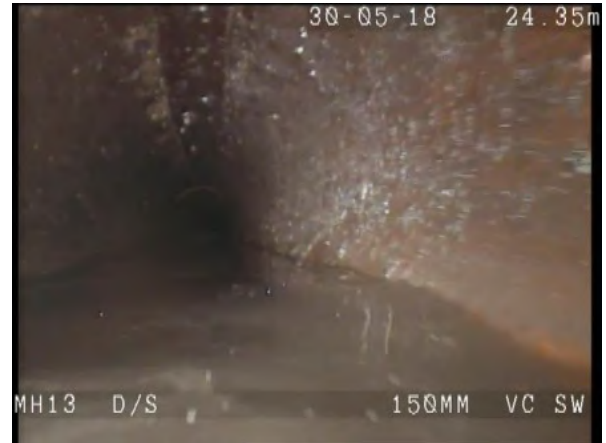
MH13X\_7c3a29fa-817e-4c34-b5ab-992eafca8806\_20180604\_140331\_807.jpg, 00:02:23, 24.30m  
 Water level, 20% of the vertical dimension

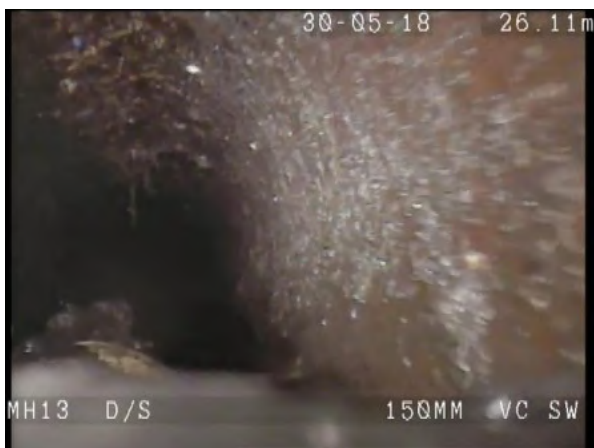
MH13X\_5646dd2b-e2fd-4983-bc3b-baadbd282d9a\_20180604\_140400\_848.jpg, 00:02:36, 26.10m  
 Settled deposits, coarse, 10% cross-sectional area loss

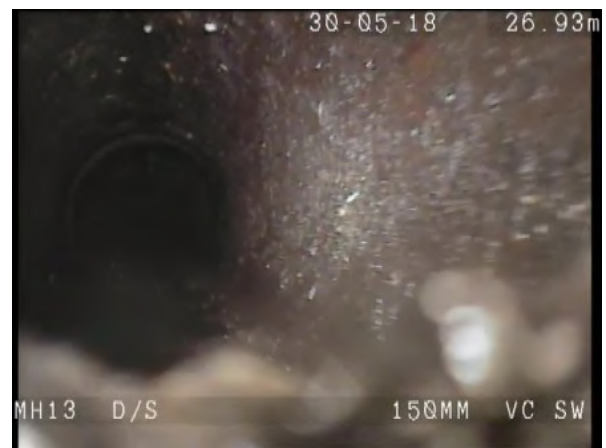
MH13X\_1bfd6dfd-bb9d-4c16-adf4-dd01b0b5bb0a\_20180604\_140445\_777.jpg, 00:02:42, 27.00m  
 Settled deposits, fine, 5% cross-sectional area loss, start

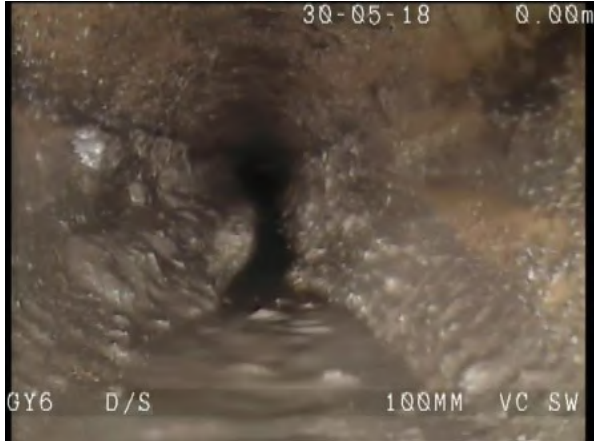
GY6X\_4f11b5a9-0457-4edd-8c58-6809d6ef90ec\_20180604\_141001\_233.jpg, 00:00:05, 0.10m  
 Settled deposits, fine, 20% cross-sectional area loss, start

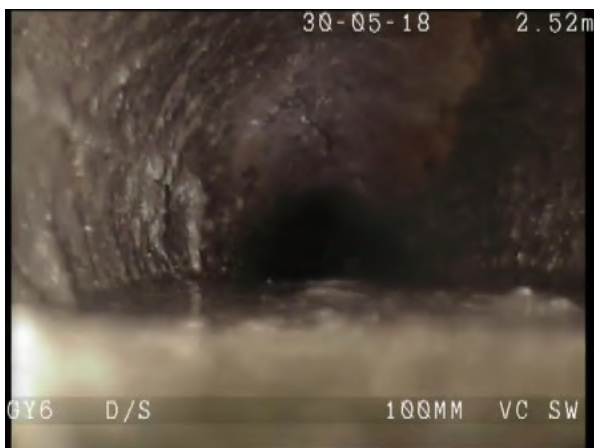
GY6X\_b725a713-67d4-4dc1-8d3a-32cf0ec695b7\_20180604\_141144\_644.jpg, 00:00:26, 2.60m  
 Water level, 20% of the vertical dimension

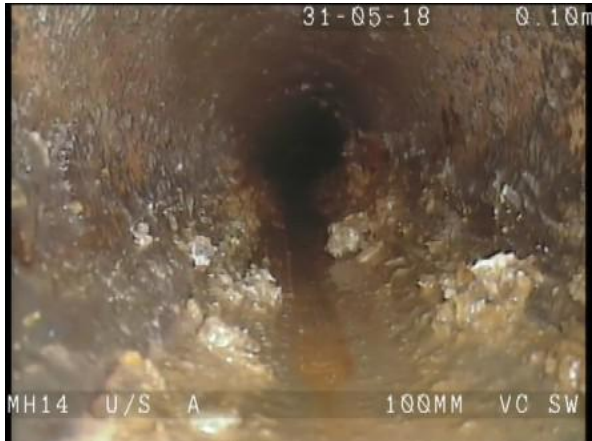
A\_MH14X\_04528b0a-7455-46eb-b22f-35010d4167e5\_20180604\_143517\_428.jpg, 00:00:05, 0.10m  
 Attached deposits, grease from 3 o'clock to 8 o'clock, 5% cross-sectional area loss

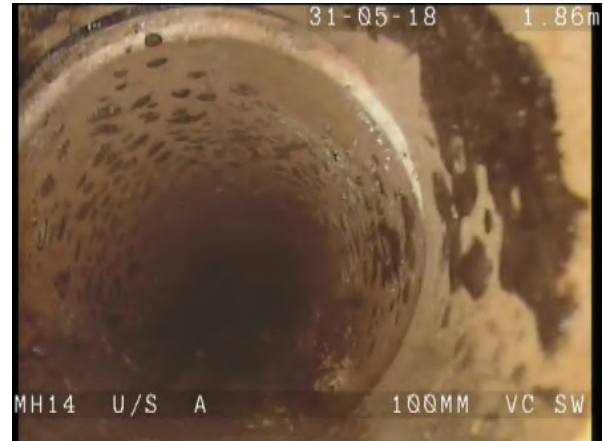
A\_MH14X\_0ebe5ef9-0fe6-42d8-a01f-5de9df510e83\_20180604\_143440\_621.jpg, 00:00:16, 1.90m  
 Joint displaced, medium

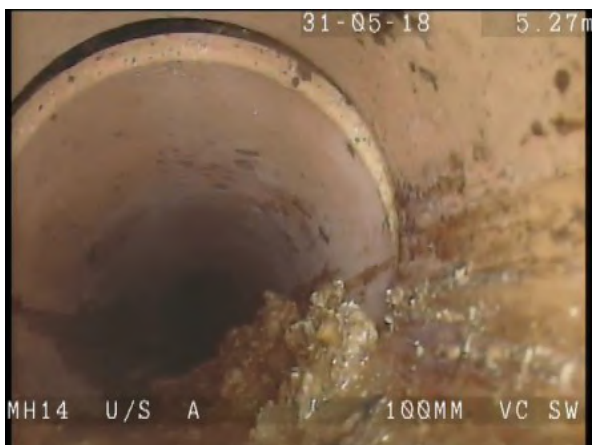
A\_MH14X\_f734058e-39ba-499b-9f6f-974fac535ce5\_20180604\_143727\_323.jpg, 00:00:38, 5.30m  
 Joint displaced, medium

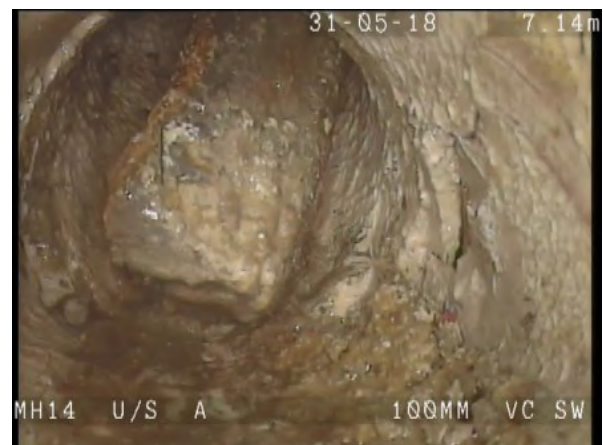
A\_MH14X\_9e96a233-ed1c-48e5-94ed-759369fd6198\_20180604\_143909\_323.jpg, 00:00:52, 7.20m  
 Other obstacles from 5 o'clock to 7 o'clock, 20% cross-sectional area loss

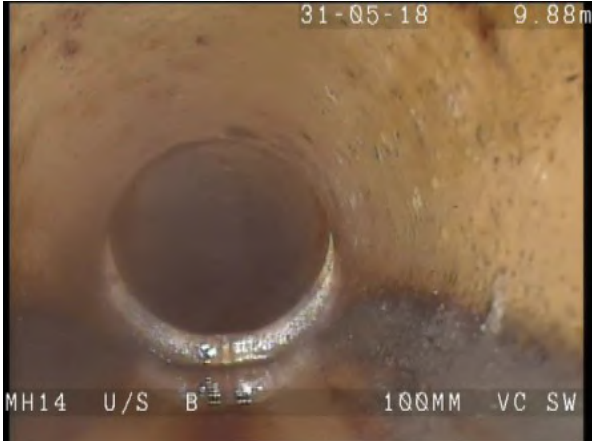
B\_MH14X\_f80fcc4a-b6ef-4fc9-a41e-e90103d837d1\_20180604\_145211\_035.jpg, 00:01:13, 10.00m  
 Joint displaced, medium

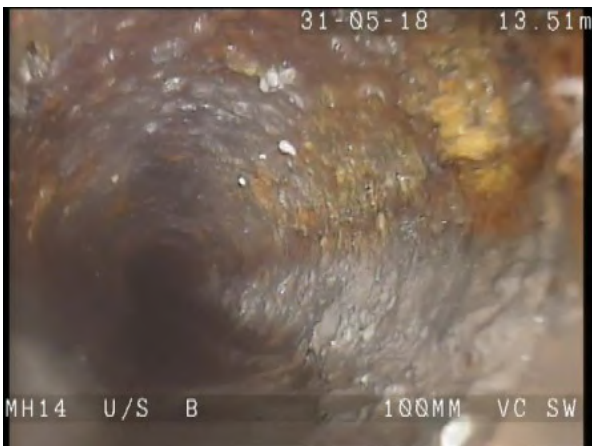
B\_MH14X\_18d6d96b-3466-4bf2-97b0-6d6743690ace\_20180604\_150518\_290.jpg, 00:01:44, 13.50m  
 Material changes to cast iron

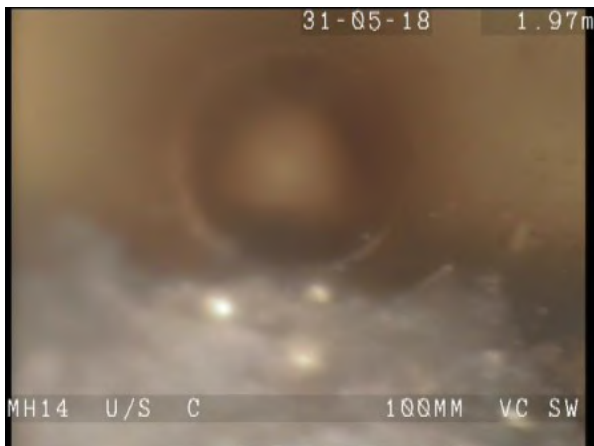
C\_MH14X\_4ecbaa30-d2c2-4194-8ce2-954695fa2ab7\_20180604\_151814\_784.jpg, 00:00:23, 2.00m  
 Settled deposits, fine, 5% cross-sectional area loss

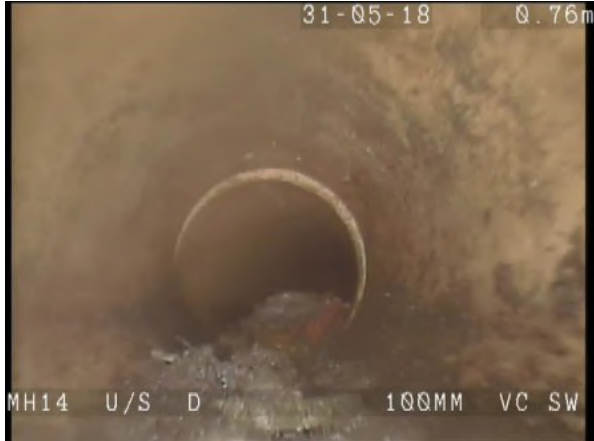
D\_MH14X\_b1db26ca-8089-47d0-a1ff-45bb5a26b379\_20180604\_152331\_678.jpg, 00:00:11, 0.80m  
 Settled deposits, fine, 10% cross-sectional area loss, start

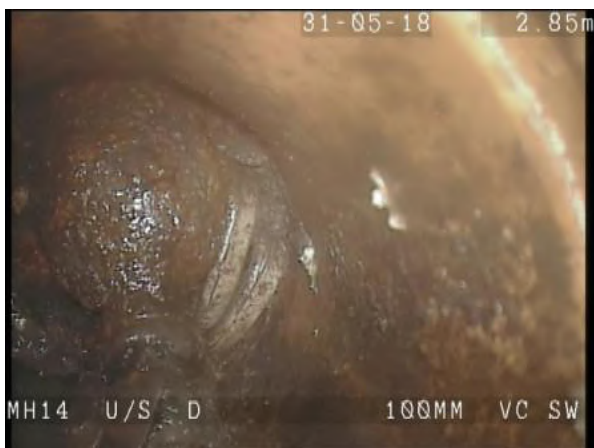
D\_MH14X\_a3025a4a-48bc-453f-b890-f5ff270501e4\_20180604\_154048\_176.jpg, 00:00:45, 2.90m  
 Other obstacles from 4 o'clock to 8 o'clock, 40% cross-sectional area loss

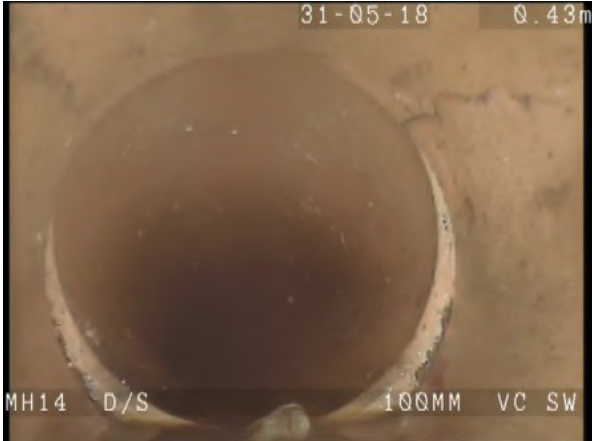
MH14X\_168c0c70-77c0-4d60-9b76-dbb6a92cb306\_20180604\_154812\_244.jpg, 00:00:09, 0.50m  
 Crack, longitudinal at joint at 2 o'clock

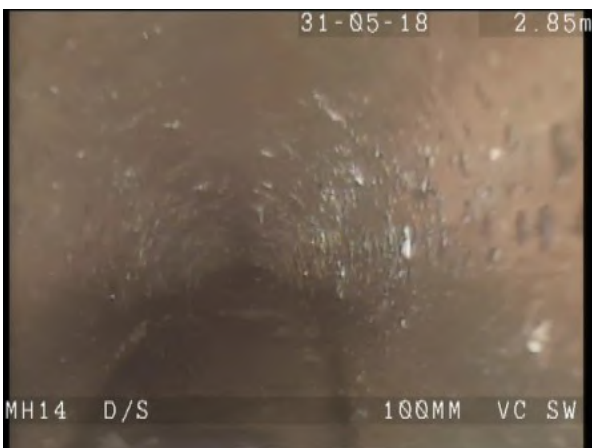
MH14X\_cb3f99e3-0051-486d-941d-521f01aa8701\_20180604\_154912\_875.jpg, 00:00:22, 2.90m  
 Water level, 20% of the vertical dimension
