| <b>Document:</b> | Flood Risk Assessment and Drainage Strategy | | |
| <b>Project Name:</b> | Mixed Use Retail and Residential Development, Morrisons, High Street, Yiewsley | | |
| <b>Project Reference:</b> | 10/4897 | | |
| <b>Date of First Issue:</b> | December 2022 | <b>Rev:</b> | B |

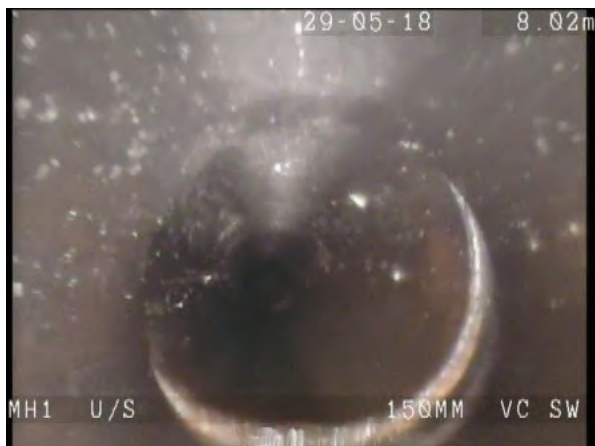
MH3X\_a3ddf67a-6157-40fe-801c-e0e08bedef87\_20180604\_105126\_505.jpg, 00:00:36, 8.10m  
Joint displaced, medium

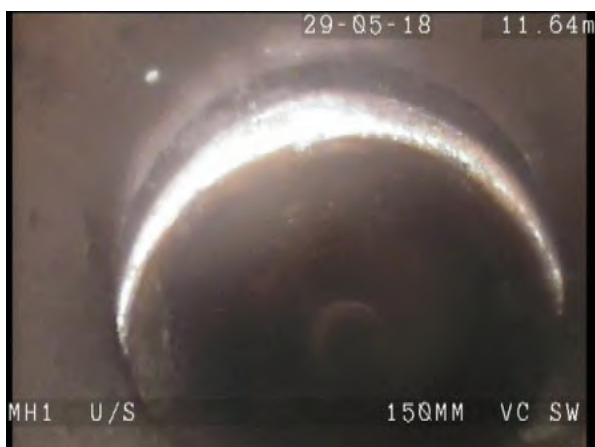
MH3X\_d36944c7-39db-467e-8472-70c44a59c664\_20180604\_105151\_525.jpg, 00:00:48, 11.60m  
Joint displaced, medium

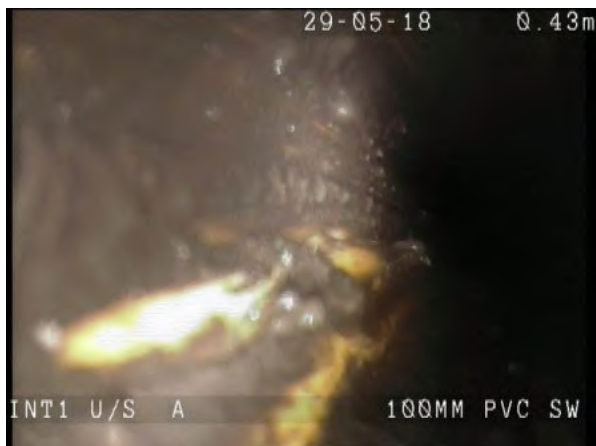
A\_INT1X\_d93bc85b-68b5-4cbd-a036-2f44e01cce6d\_20180604\_112539\_134.jpg, 00:00:08, 0.30m  
 Settled deposits, fine, 5% cross-sectional area loss

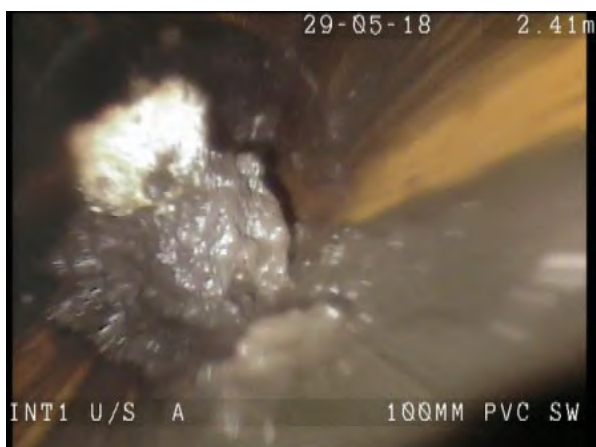
A\_INT1X\_e7e7eead-7a53-40b7-88a5-a5bca6dd5703\_20180604\_112635\_734.jpg, 00:00:23, 2.50m  
 Settled deposits, fine, 40% cross-sectional area loss

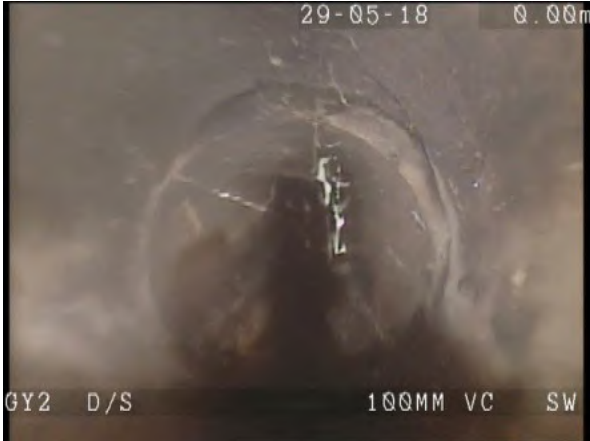
GY2X\_dd061343-718e-4456-898a-1efea845b377\_20180604\_114119\_072.jpg, 00:00:07, 0.20m  
 Hole in drain or sewer at a joint from 11 o'clock to 3 o'clock

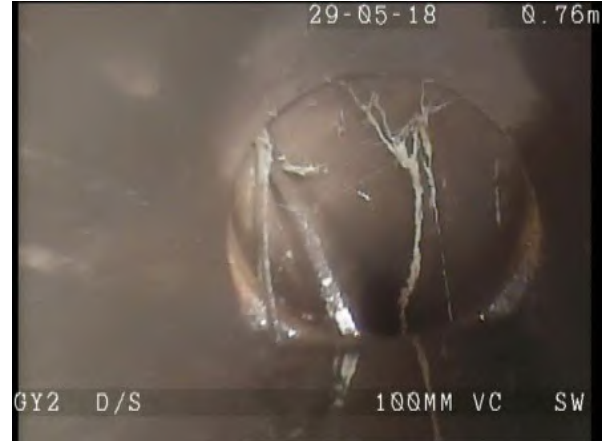
GY2X\_33c5c1ea-f169-4d8f-ada0-a495ecdef433\_20180604\_114148\_482.jpg, 00:00:12, 0.80m  
 Joint displaced, medium

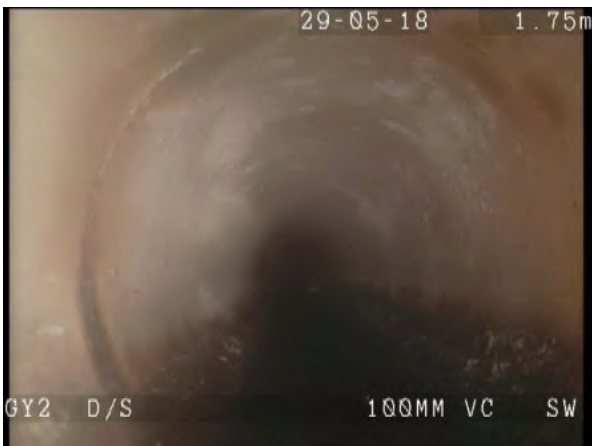
GY2X\_d3e3e17c-9730-48b7-b2a5-2de544580fdd\_20180604\_114259\_842.jpg, 00:00:19, 1.80m  
 Crack, circumferential from 12 o'clock to 12 o'clock

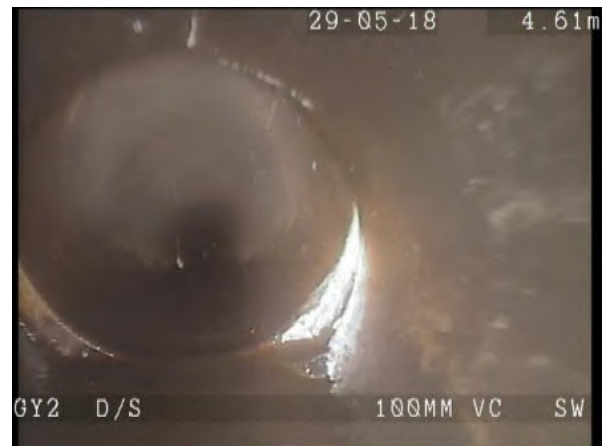
GY2X\_a79ea17b-9a1f-4af5-83d4-555353067472\_20180604\_114230\_449.jpg, 00:00:34, 4.70m  
 Joint displaced, medium

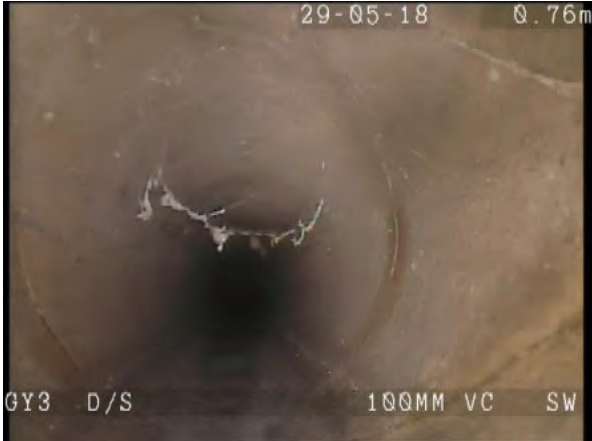
GY3X\_dd9d2f66-7a16-4d3e-a03f-82c0c425fc5c\_20180604\_115332\_276.jpg, 00:00:10, 0.80m  
 Crack, circumferential from 12 o'clock to 12 o'clock

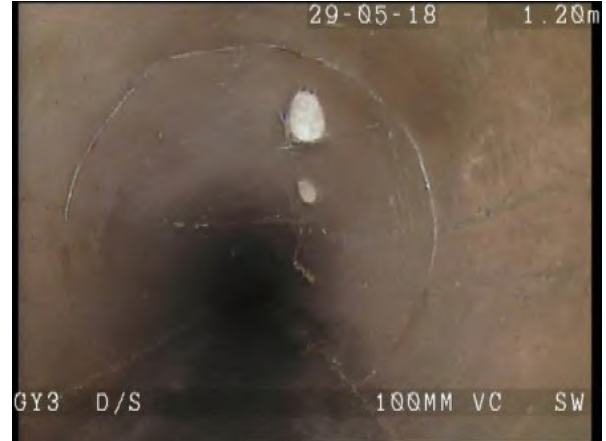
GY3X\_50057357-3fb3-43e8-84e6-5fc63ff7c92e\_20180604\_115348\_849.jpg, 00:00:13, 1.30m  
 Crack, circumferential from 12 o'clock to 12 o'clock

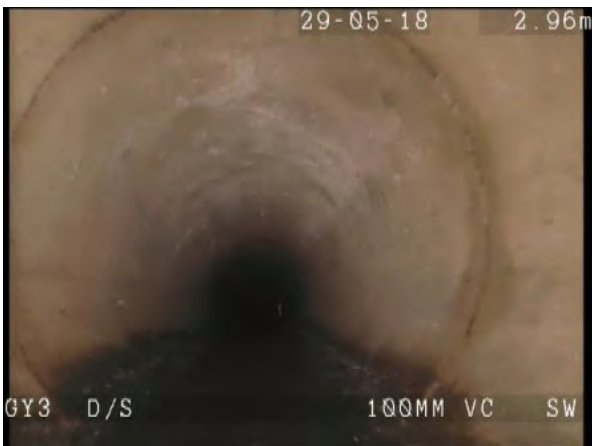
GY3X\_f5782e97-a6ba-4fec-a11c-89e9b0a02103\_20180604\_115415\_309.jpg, 00:00:23, 3.00m  
 Crack, circumferential from 7 o'clock to 5 o'clock

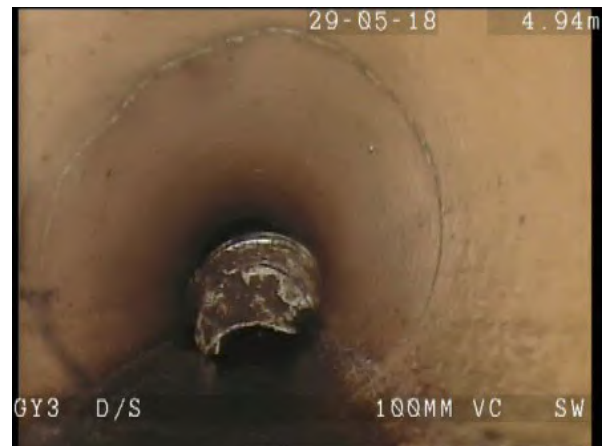
GY3X\_b9039a48-1108-4694-bd18-1360eff10592\_20180604\_115439\_085.jpg, 00:00:31, 5.00m  
 Crack, circumferential from 7 o'clock to 5 o'clock

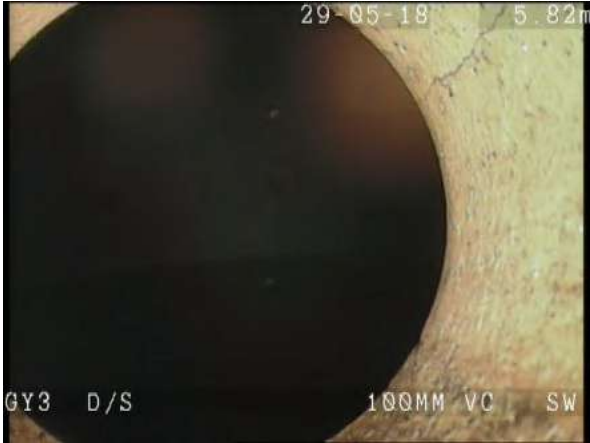
GY3X\_323402f6-742c-4e3a-aa89-da4814f1e971\_20180604\_11  
 5520\_333.jpg, 00:00:37, 5.80m  
 Crack, longitudinal at 2 o'clock

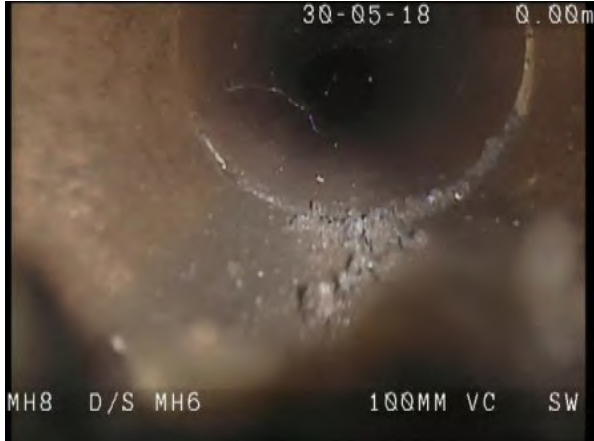
MH8X\_bee0a5bd-6969-44a3-b524-0a7d76b6459c\_20180604\_1  
 20848\_871.jpg, 00:00:06, 0.10m  
 Settled deposits, fine, 5% cross-sectional area loss

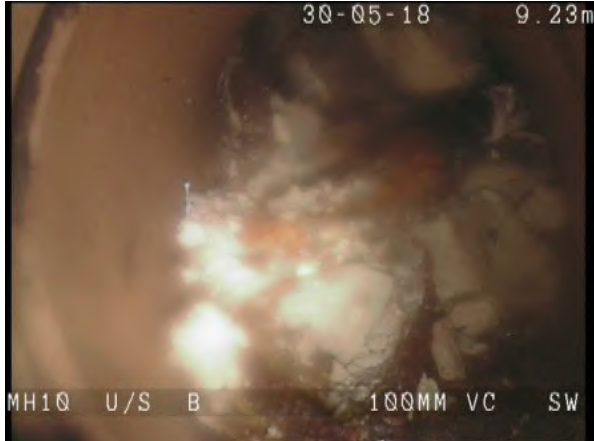
B\_MH10X\_4d6fb09f-78bf-47cb-b3e9-59aa1e942ddd\_20180604\_122311\_591.jpg, 00:00:54, 9.30m  
 Settled deposits, coarse, 90% cross-sectional area loss

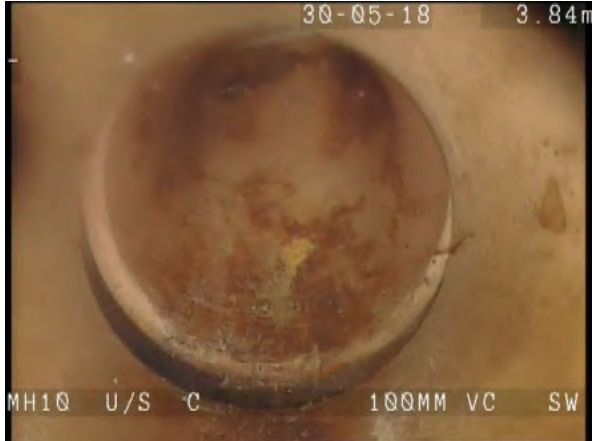
C\_MH10X\_194d6610-d4d8-461b-be4e-2840784a06d6\_201806  
 04\_122550\_959.jpg, 00:00:27, 3.90m  
 Joint displaced, medium

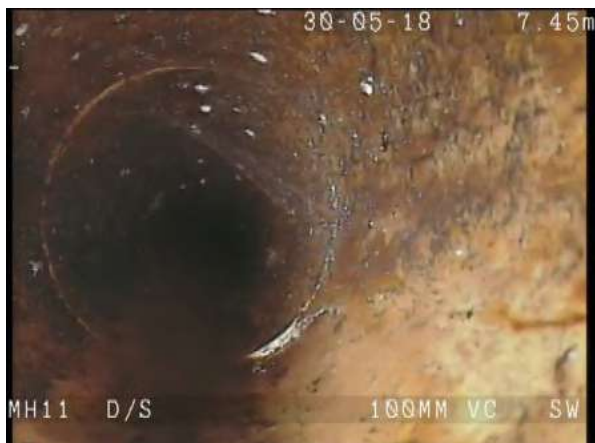
Fracture, longitudinal at joint at 4 o'clock

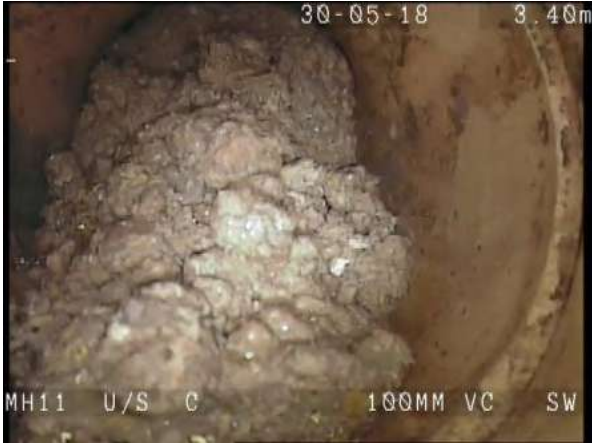
C\_MH11X\_2567db29-1375-41da-92e6-dec86a3494df\_20180604\_131952\_395.jpg, 00:00:29, 3.40m  
 Settled deposits, coarse, 95% cross-sectional area loss

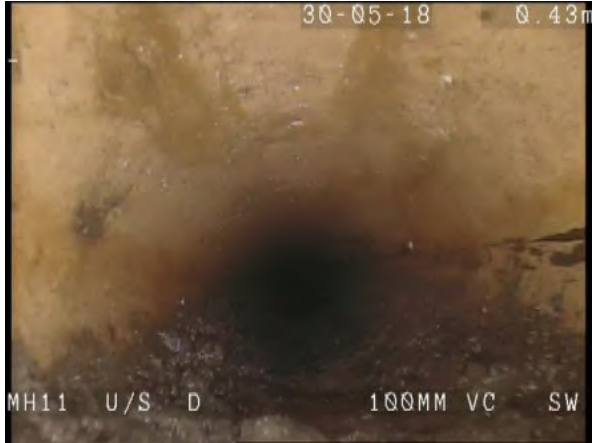
D\_MH11X\_836448f8-7026-4146-97aa-9682418fdd29\_20180604\_132208\_441.jpg, 00:00:10, 0.40m  
 Settled deposits, fine, 10% cross-sectional area loss, start

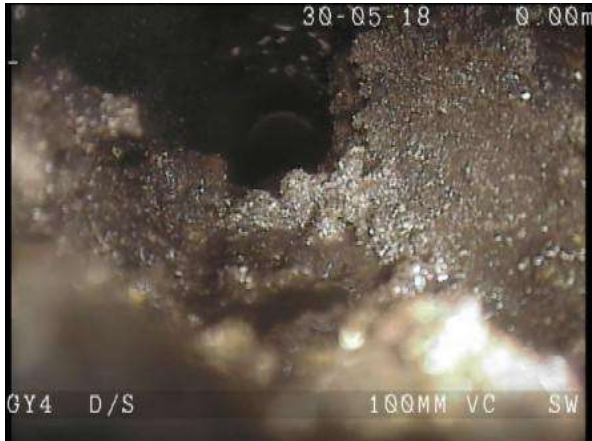
GY4X\_89492c26-b0de-426a-9dc6-f6b212b91f96\_20180604\_132822\_598.jpg, 00:00:00, 0.10m  
 Settled deposits, fine, 10% cross-sectional area loss

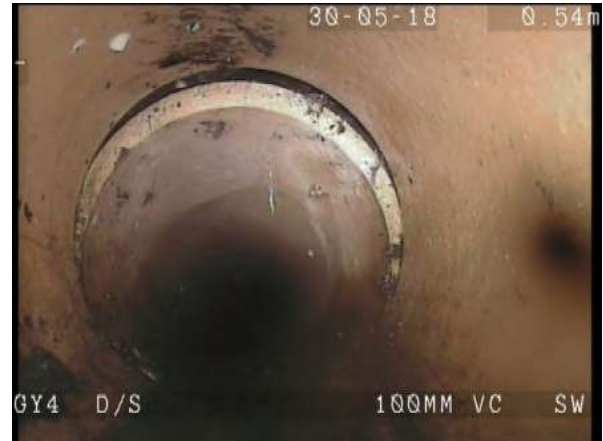
GY4X\_fb7ebc75-bacb-4bc7-9aa2-9c46b27d4ab2\_20180604\_132856\_232.jpg, 00:00:18, 0.60m  
 Joint displaced, medium

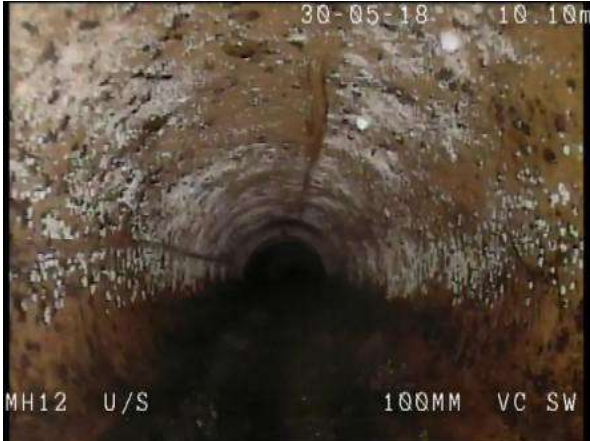
U\_S  
 MH12X\_427be56e-b667-4e80-a128-1737d92584ef\_20180604\_  
 133524\_873.jpg, 00:01:11, 10.10m  
 Settled deposits, fine, 5% cross-sectional area loss, start

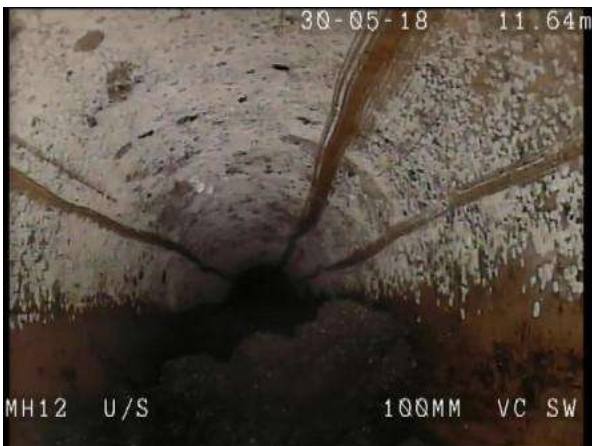
U\_S  
 MH12X\_2bbc4dde-a064-4af7-8145-a1a1beeace39\_20180604\_  
 133947\_373.jpg, 00:01:21, 11.70m  
 Settled deposits, fine, 10% cross-sectional area loss

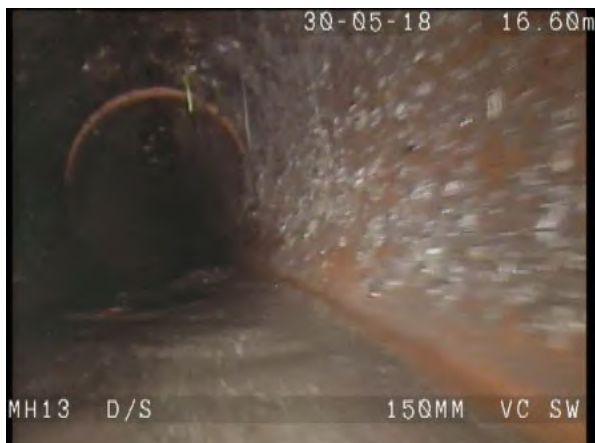
MH13X\_3a5ea860-e9c1-4aa8-bd1c-61770eea8ec1\_20180604\_140213\_355.jpg, 00:01:44, 16.60m  
Settled deposits, fine, 5% cross-sectional area loss, start

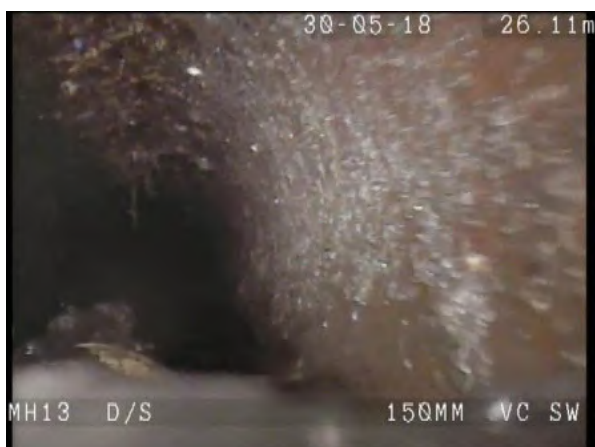
MH13X\_5646dd2b-e2fd-4983-bc3b-baadbd282d9a\_20180604\_140400\_848.jpg, 00:02:36, 26.10m  
Settled deposits, coarse, 10% cross-sectional area loss

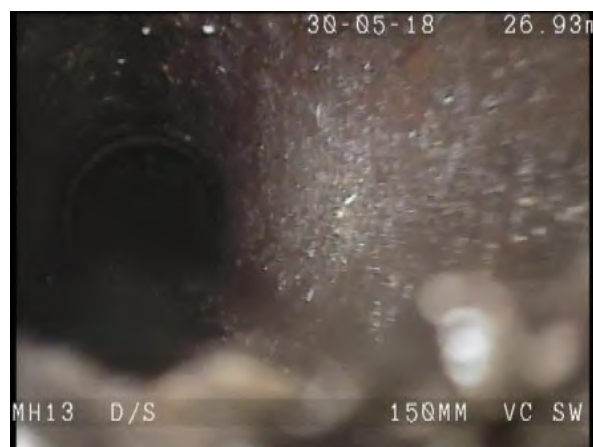
MH13X\_1bfd6dfd-bb9d-4c16-adf4-dd01b0b5bb0a\_20180604\_140445\_777.jpg, 00:02:42, 27.00m  
Settled deposits, fine, 5% cross-sectional area loss, start

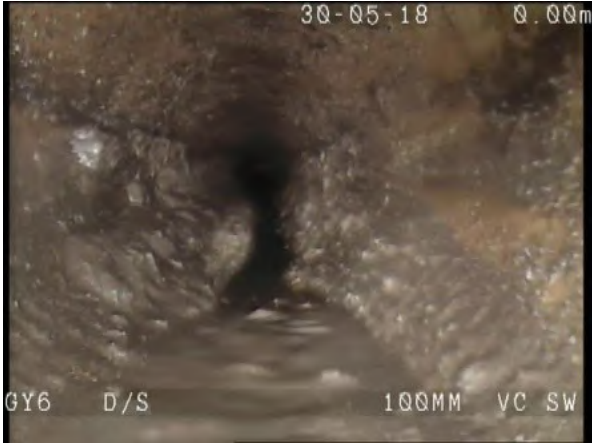
GY6X\_4f11b5a9-0457-4edd-8c58-6809d6ef90ec\_20180604\_141001\_233.jpg, 00:00:05, 0.10m  
 Settled deposits, fine, 20% cross-sectional area loss, start

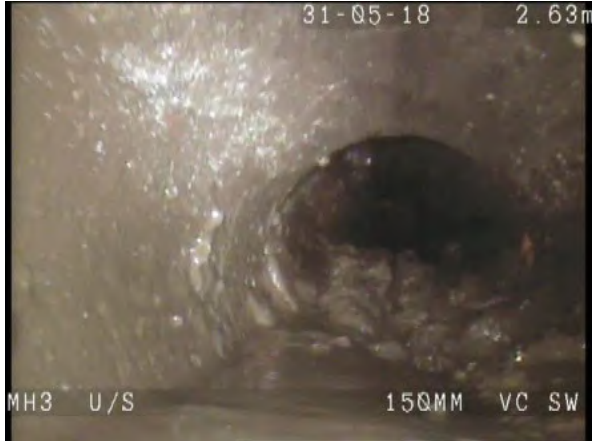
U\_S  
 MH3X\_f8612077-ef92-47e7-a340-44c9e82f0511\_20180604\_14  
 2336\_384.jpg, 00:00:26, 2.60m  
 Settled deposits, fine, 20% cross-sectional area loss

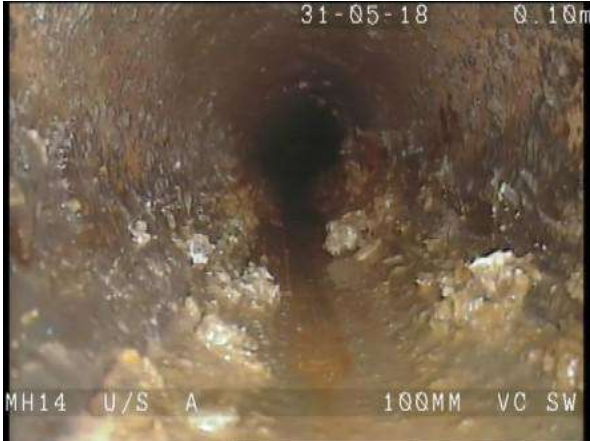
A\_MH14X\_04528b0a-7455-46eb-b22f-35010d4167e5\_20180604\_143517\_428.jpg, 00:00:05, 0.10m  
 Attached deposits, grease from 3 o'clock to 8 o'clock, 5% cross-sectional area loss

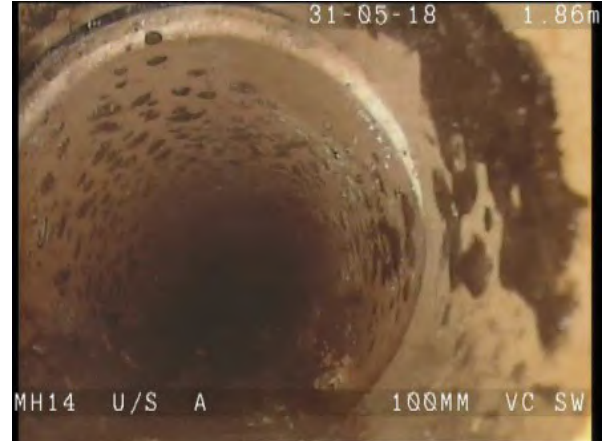
A\_MH14X\_0ebe5ef9-0fe6-42d8-a01f-5de9df510e83\_20180604\_143440\_621.jpg, 00:00:16, 1.90m  
 Joint displaced, medium

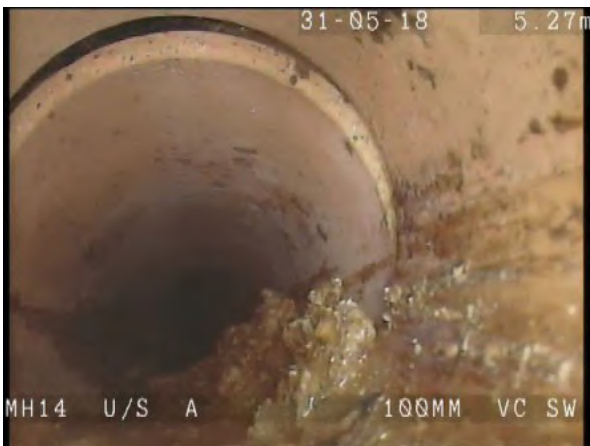
A\_MH14X\_f734058e-39ba-499b-9f6f-974fac535ce5\_20180604\_143727\_323.jpg, 00:00:38, 5.30m  
 Joint displaced, medium

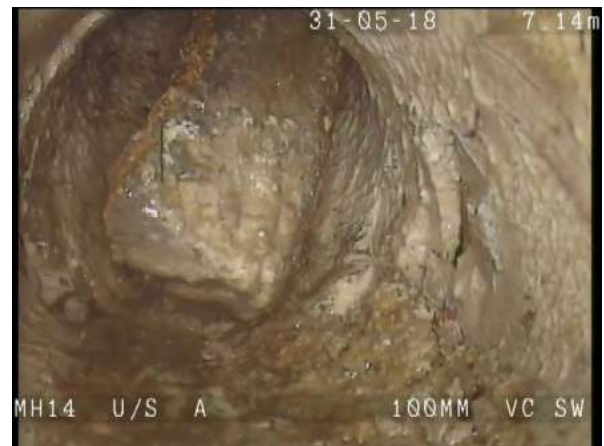
A\_MH14X\_9e96a233-ed1c-48e5-94ed-759369fd6198\_20180604\_143909\_323.jpg, 00:00:52, 7.20m  
 Other obstacles from 5 o'clock to 7 o'clock, 20% cross-sectional area loss

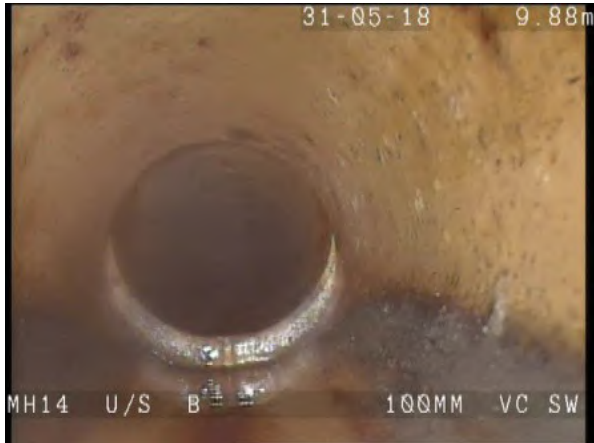
B\_MH14X\_f80fcc4a-b6ef-4fc9-a41e-e90103d837d1\_20180604\_145211\_035.jpg, 00:01:13, 10.00m  
 Joint displaced, medium

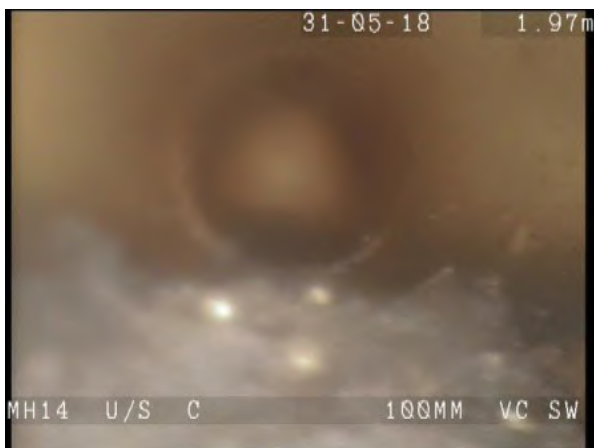
C\_MH14X\_4ecbaa30-d2c2-4194-8ce2-954695fa2ab7\_20180604\_151814\_784.jpg, 00:00:23, 2.00m  
 Settled deposits, fine, 5% cross-sectional area loss

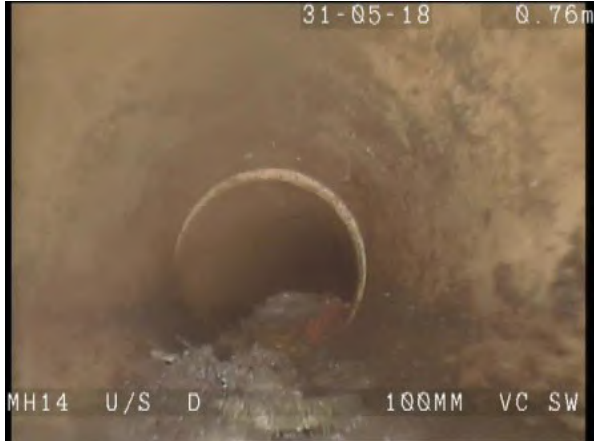
D\_MH14X\_b1db26ca-8089-47d0-a1ff-45bb5a26b379\_20180604\_152331\_678.jpg, 00:00:11, 0.80m  
 Settled deposits, fine, 10% cross-sectional area loss, start

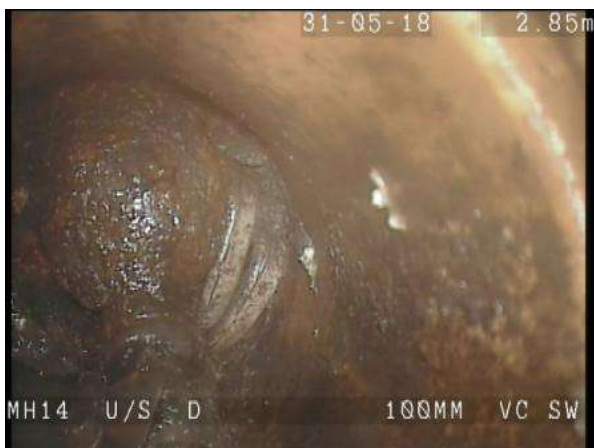
D\_MH14X\_a3025a4a-48bc-453f-b890-f5ff270501e4\_20180604\_154048\_176.jpg, 00:00:45, 2.90m  
 Other obstacles from 4 o'clock to 8 o'clock, 40% cross-sectional area loss

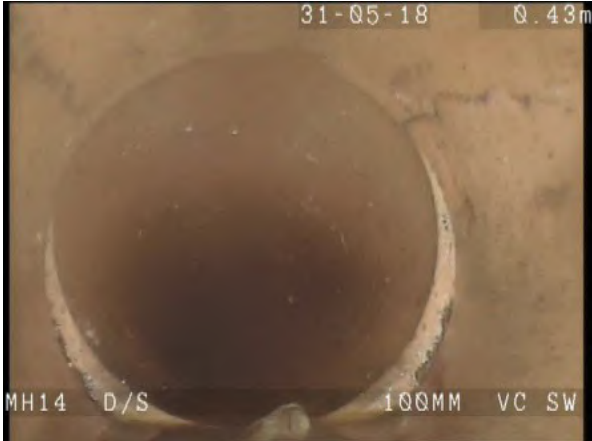
MH14X\_168c0c70-77c0-4d60-9b76-dbb6a92cb306\_20180604\_154812\_244.jpg, 00:00:09, 0.50m  
 Crack, longitudinal at joint at 2 o'clock
