Phase I Environmental Desk Study Report

Hillingdon Outdoor Activity Centre,

Report No: 22-10-12

November 2022

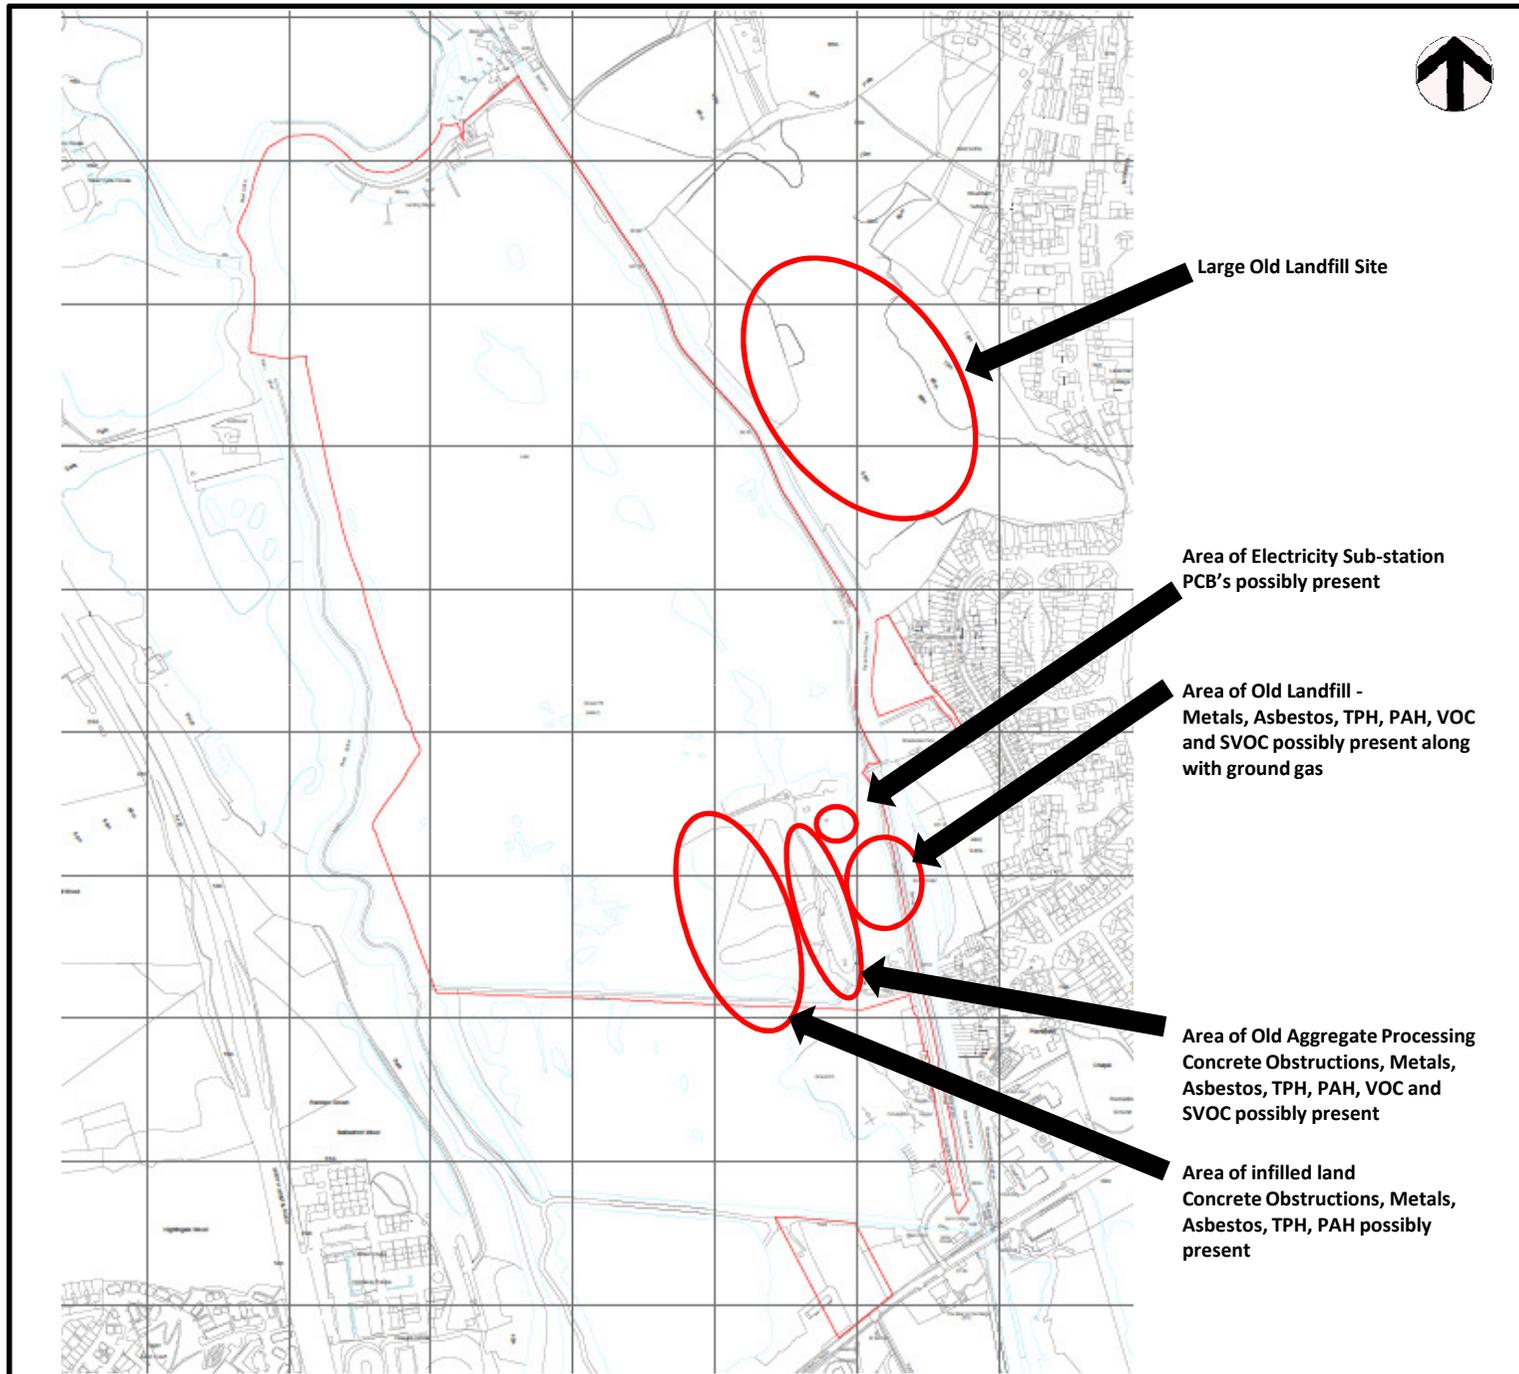
**Potential Contamination
Source Areas**

Area of Electricity Sub-station
PCB's possibly present

Area of Old Landfill -
Metals, Asbestos, TPH, PAH, VOC
and SVOC possibly present along
with ground gas

Area of Old Aggregate Processing
Concrete Obstructions, Metals,
Asbestos, TPH, PAH, VOC and
SVOC possibly present

Area of infilled land
Concrete Obstructions, Metals,
Asbestos, TPH, PAH possibly
present

Therefore, we recommended that further intrusive site investigation works are undertaken to establish contamination levels, mainly in the promontory land on the main site area to quantify any risks. In addition, in order to establish construction methods for the proposed development the ground profile and soil parameters will be required.

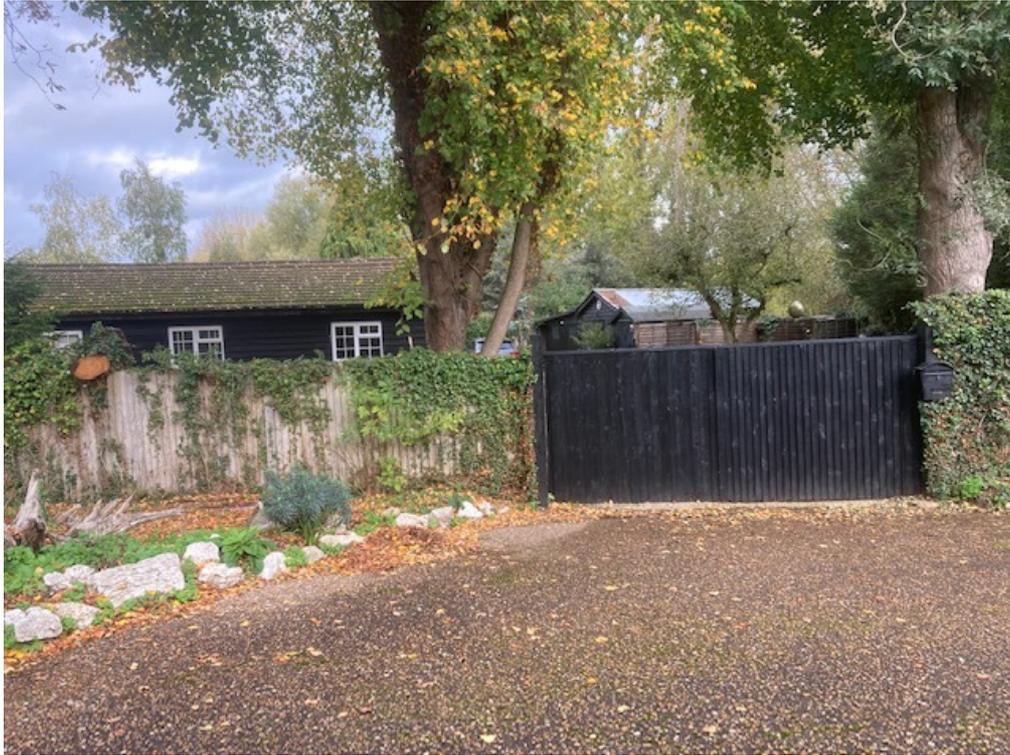
Residential House at site entrance

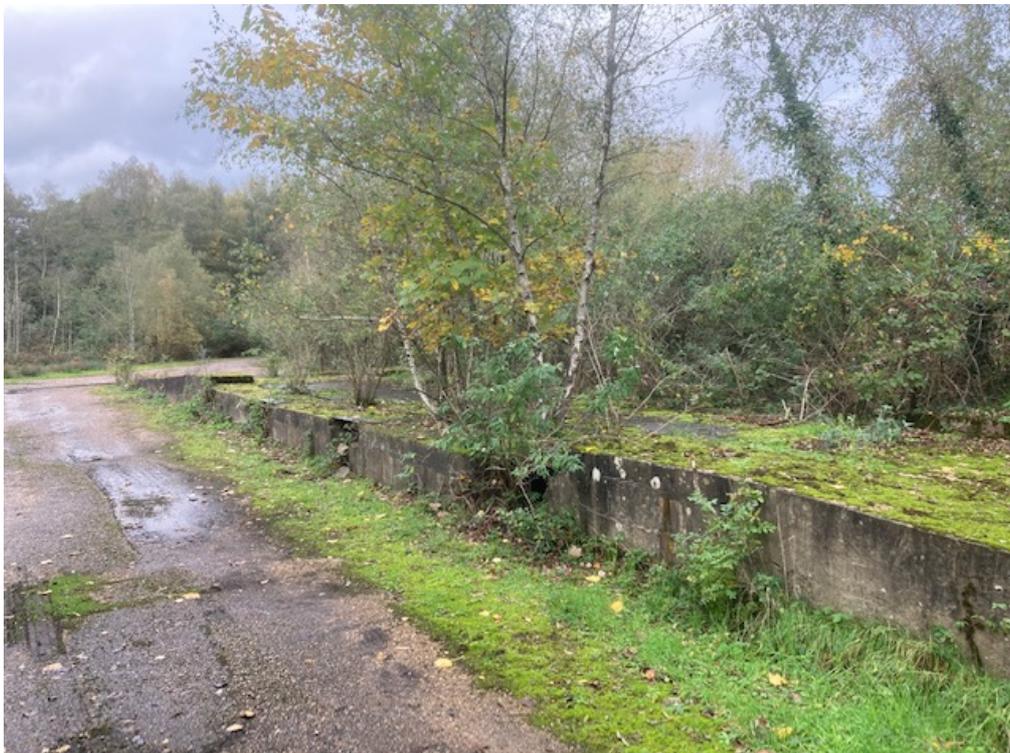
Weighbridge at site entrance

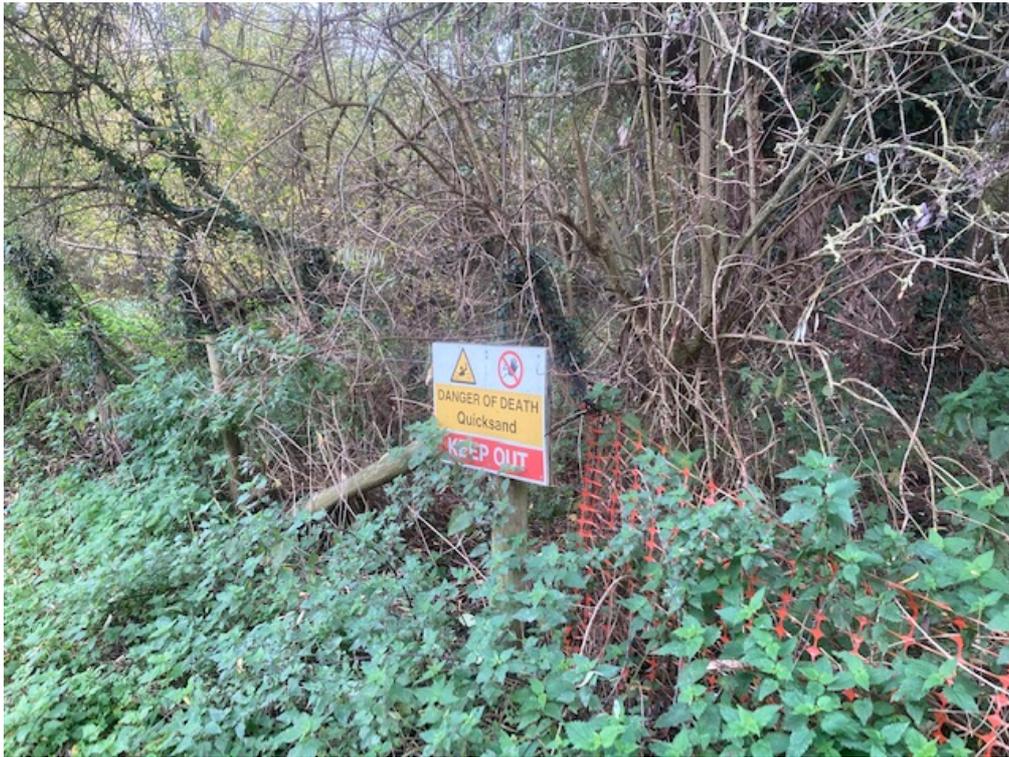
During the walkover survey a large area of land to the south of the main site was marked as dangerous from quicksand, this will have been from the infilling of a sand and gravel pit by silt wastes. In addition, the land areas on the site have been highly reworked and used as a landfill site in the past. As such, deep thicknesses of Made Ground should be anticipated across the whole site. Groundwater will also be within a metre or two of existing ground level

Quicksand to the immediate south of the site area

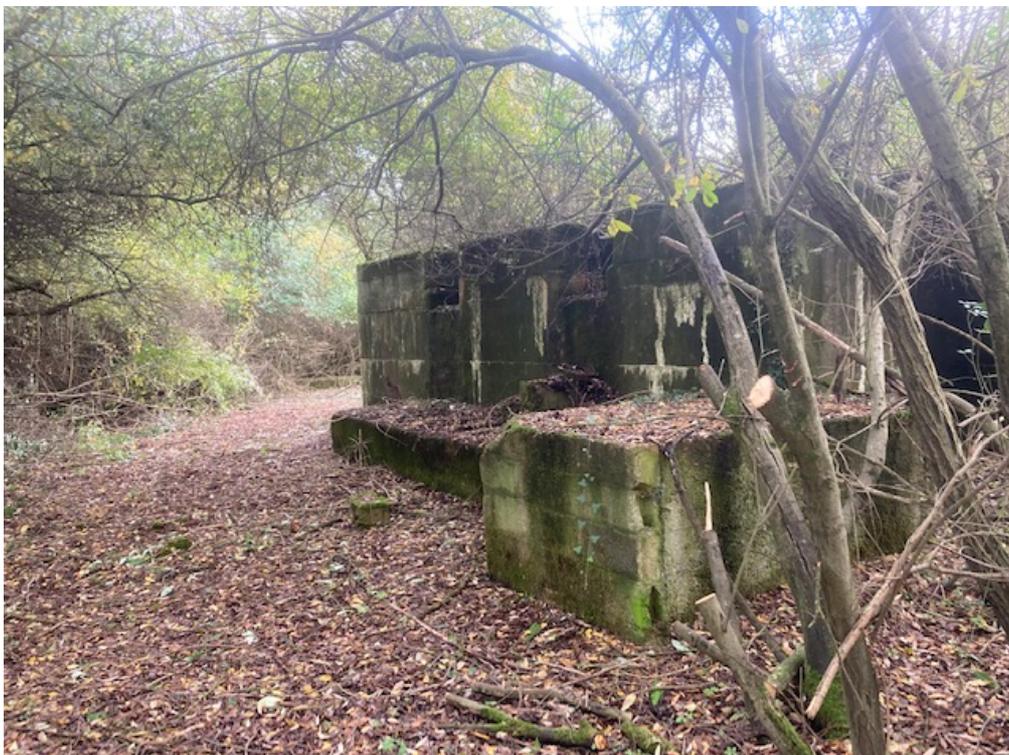
There were no significant pollution sources located on the site during the walkover. However, on the main land area of the main lake there were a number of historical industrial remnants (such as weighbridge, hoppers and conveyor gantries, electricity sub-station). These will obviously provide a point source of historical contamination, such as oil spillage.

Remnants of conveyor structure on main site

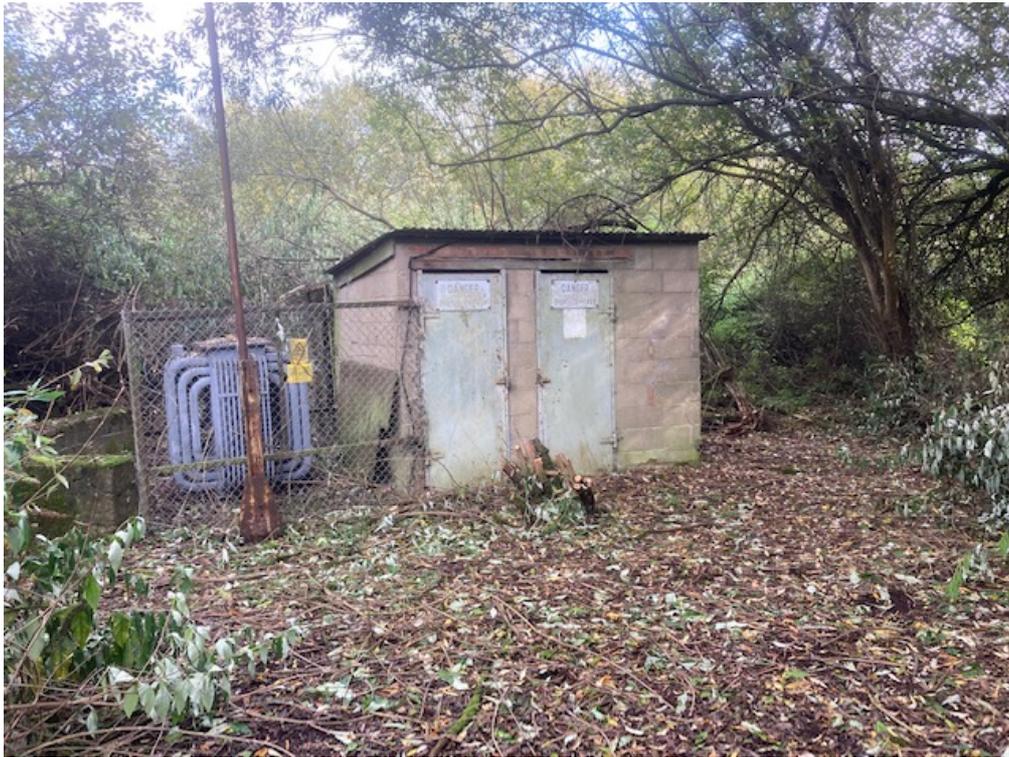
PCB from electricity sub-station	Ingestion, inhalation or absorption from direct contact with soil.	End Users and Construction Workers	Low to moderate

Electricity Sub-station on main site

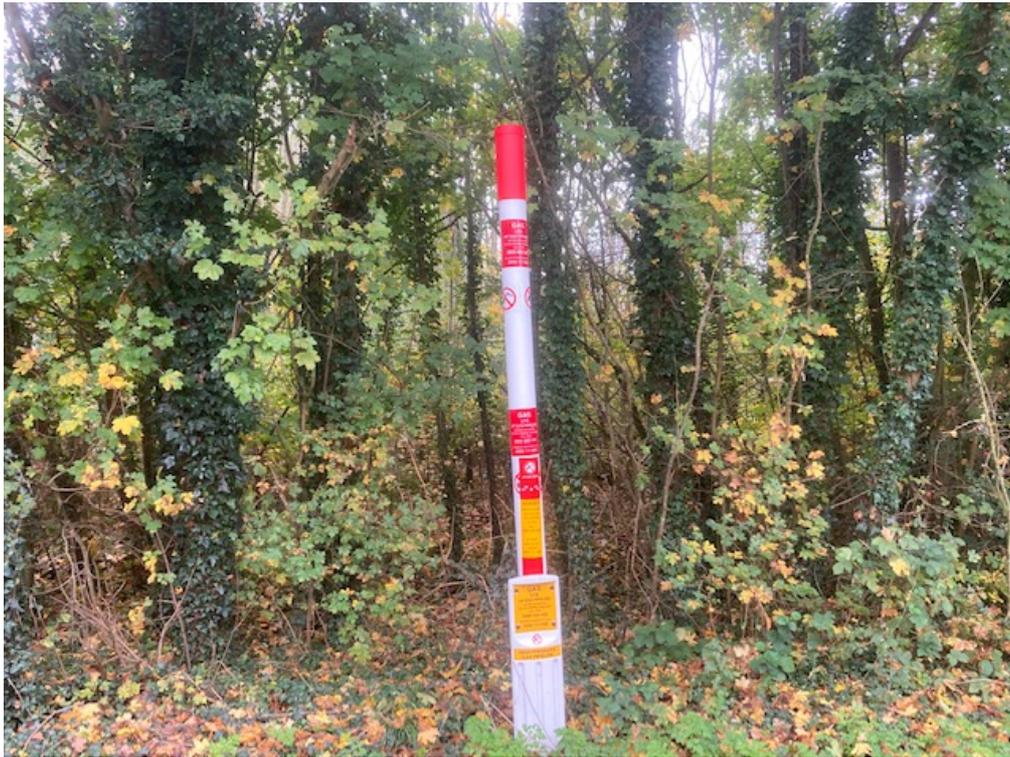
Gas main at top of site

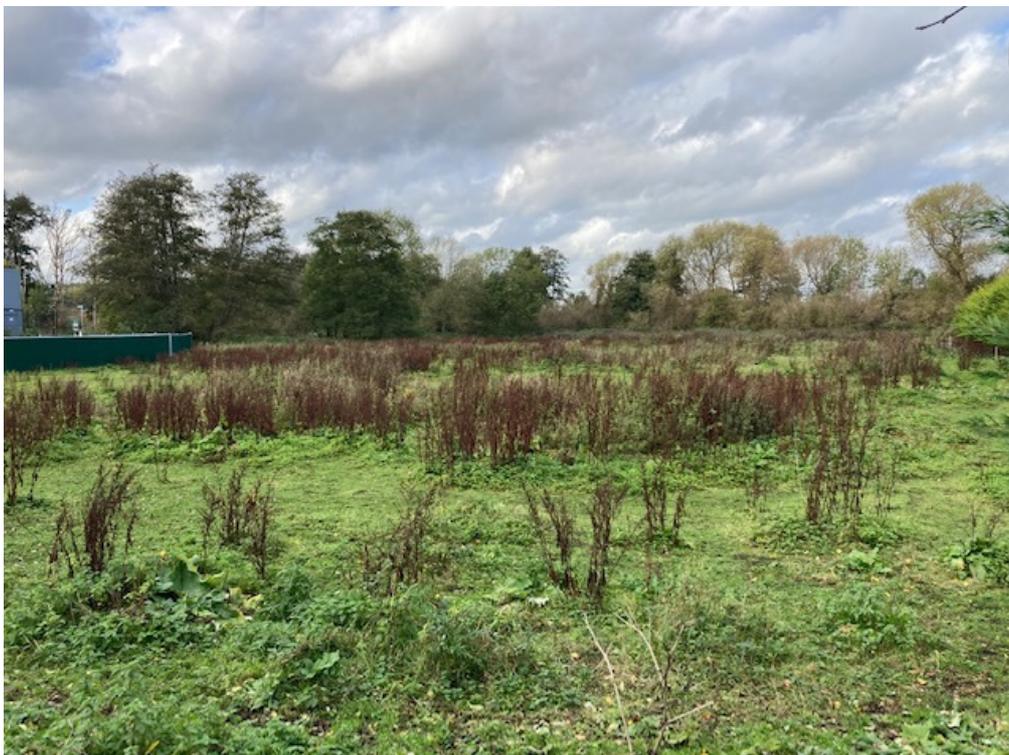
Site 1 from Moorhall Road – HS2 compound to the left of the photo
