Phase I Environmental Desk Study Report

Hillingdon Water Sports Facility and Activity Centre (HWSFAC)

Report No: 23-09-03A

September 2023

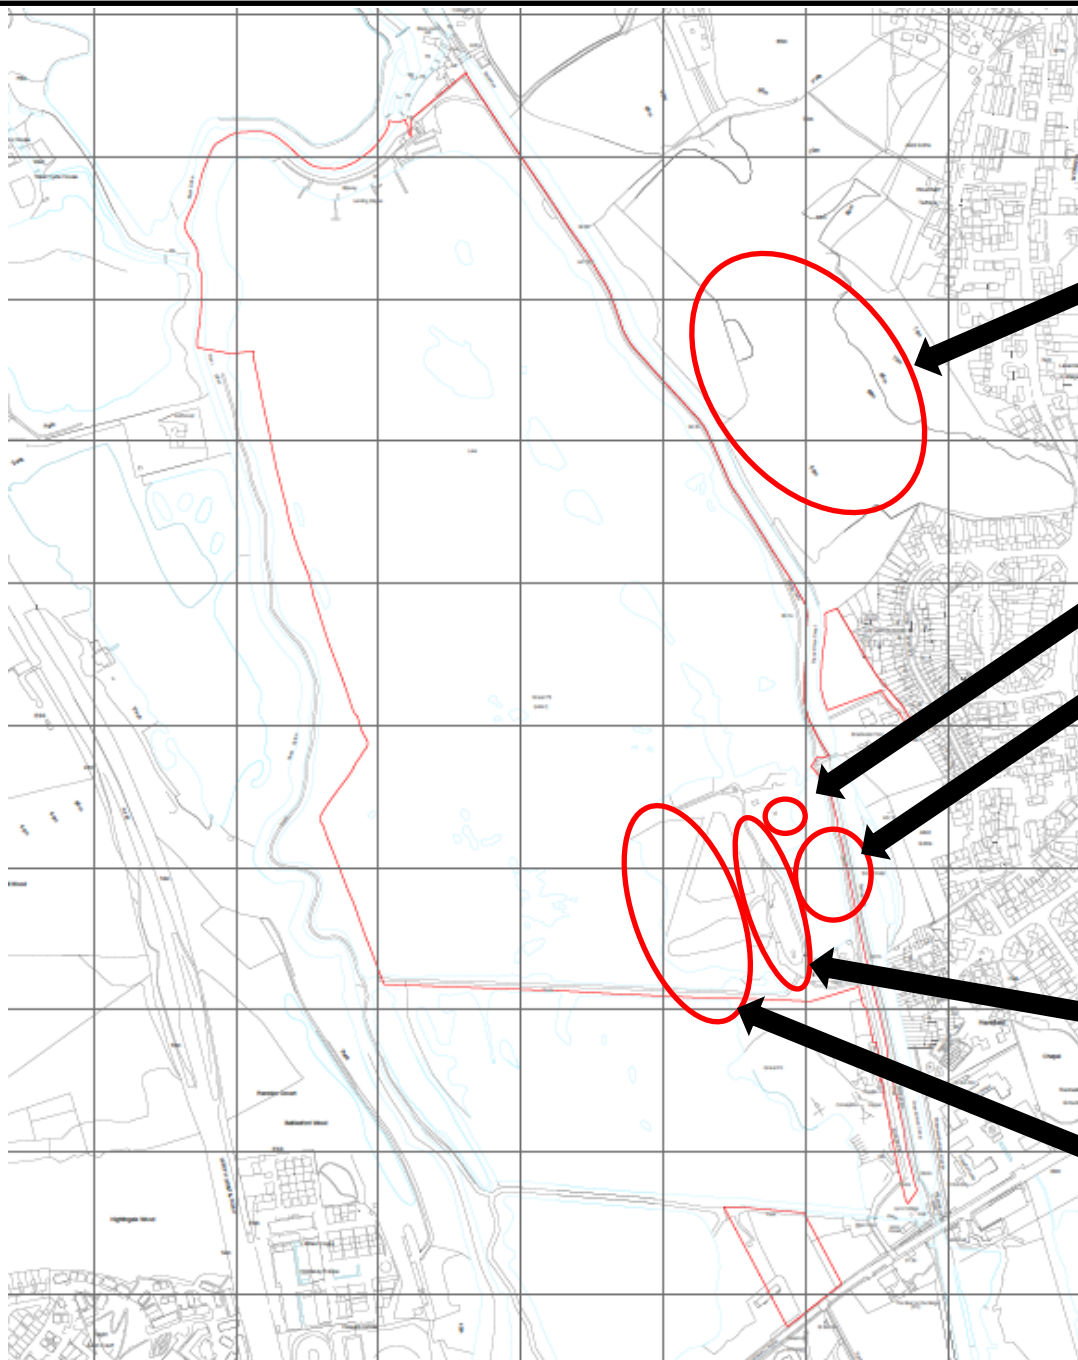
**Area of Old Aggregate Processing
Concrete Obstructions, Metals,
Asbestos, TPH, PAH, VOC and
SVOC possibly present**

**Area of infilled land
Concrete Obstructions, Metals,
Asbestos, TPH, PAH possibly
present**

Therefore, we recommended that further intrusive site investigation works are undertaken to establish contamination levels, mainly in the promontory land on the main site area to quantify any risks. In addition, in order to establish construction methods for the proposed development the ground profile and soil parameters will be required.

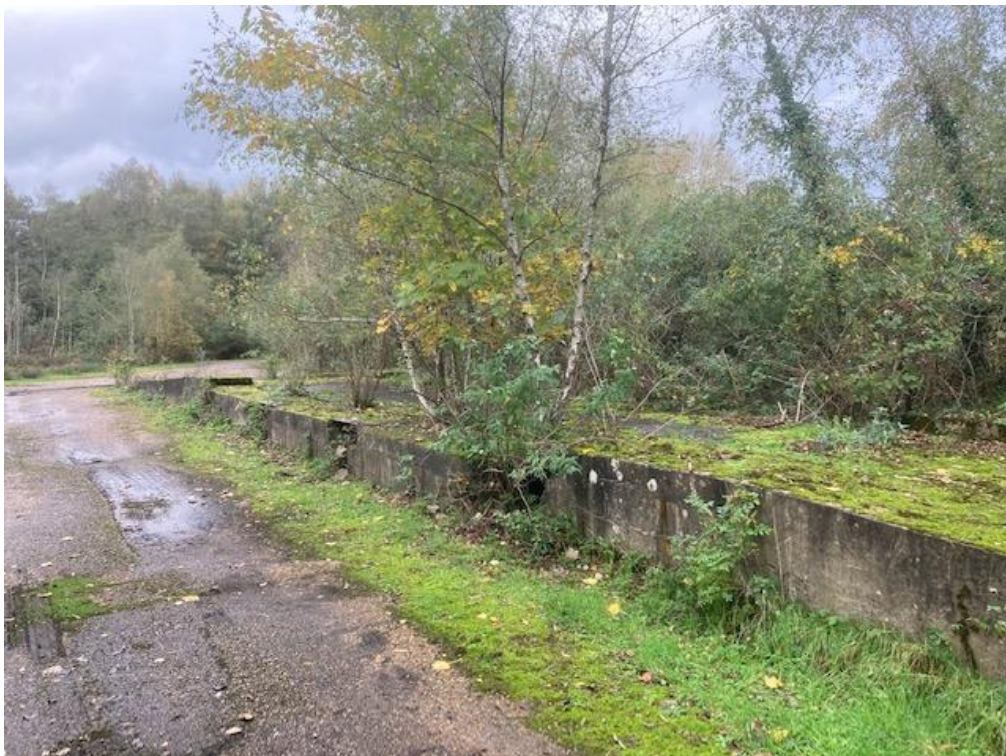
There were no significant pollution sources located on the site during the walkover. However, on the main land area of the main lake there were a number of historical industrial remnants (such as

weighbridge, hoppers and conveyor gantries, electricity sub-station). These will obviously provide a point source of historical contamination, such as oil spillage.

Weighbridge at site entrance

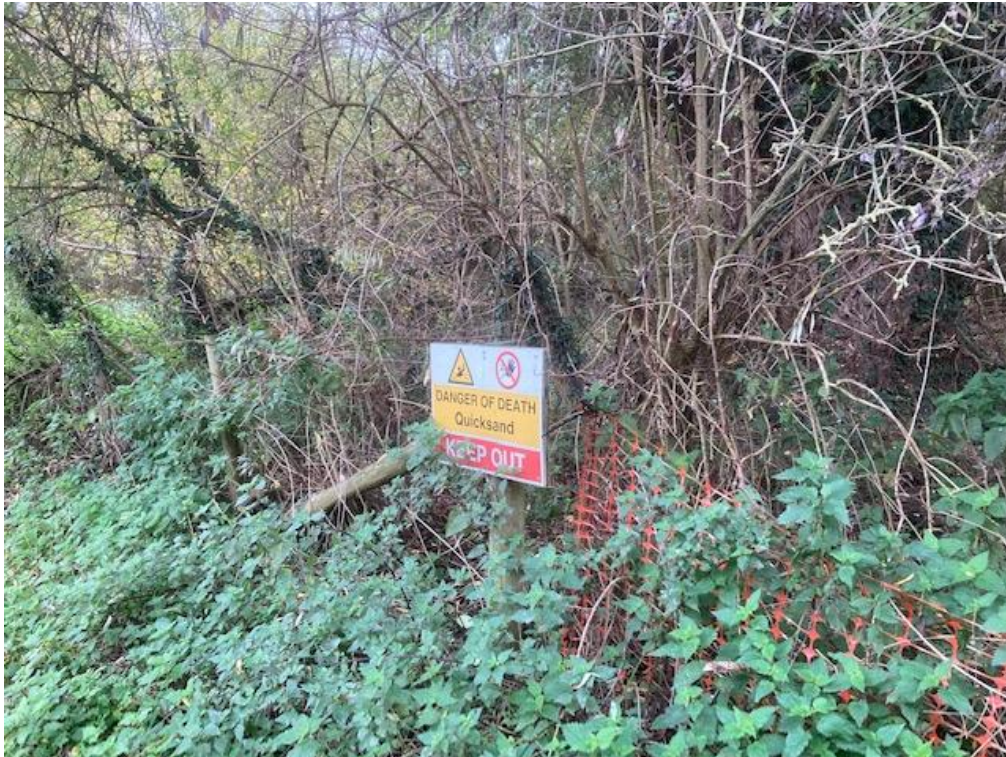
Quicksand to the immediate south of the site area

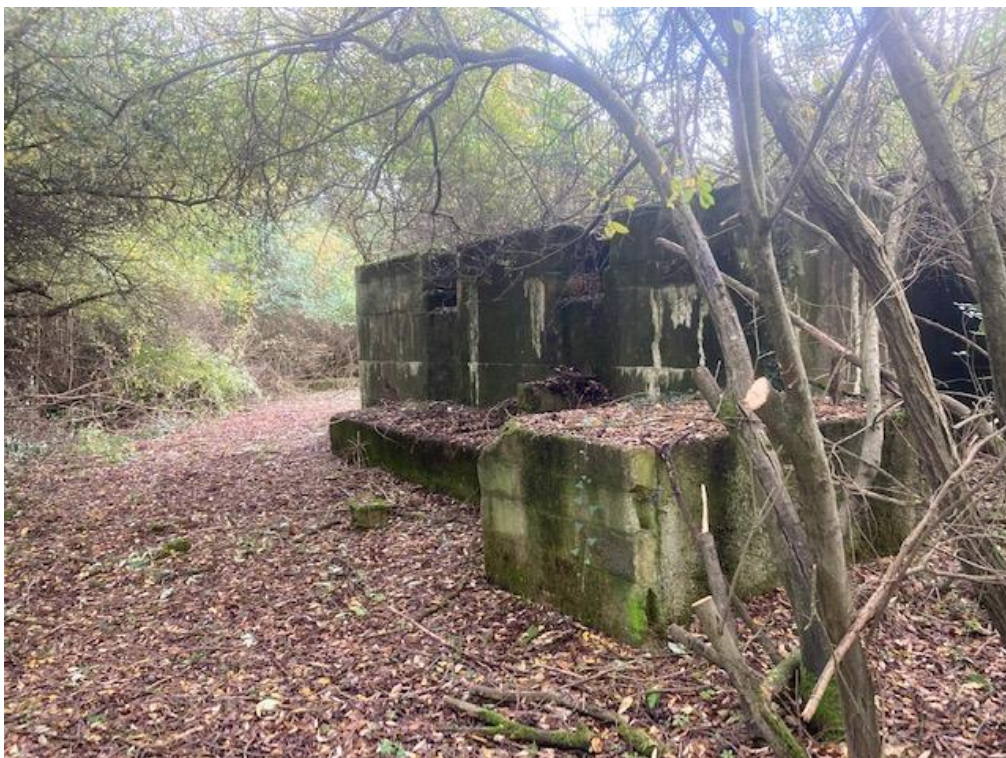
Remnants of conveyor structure on main site

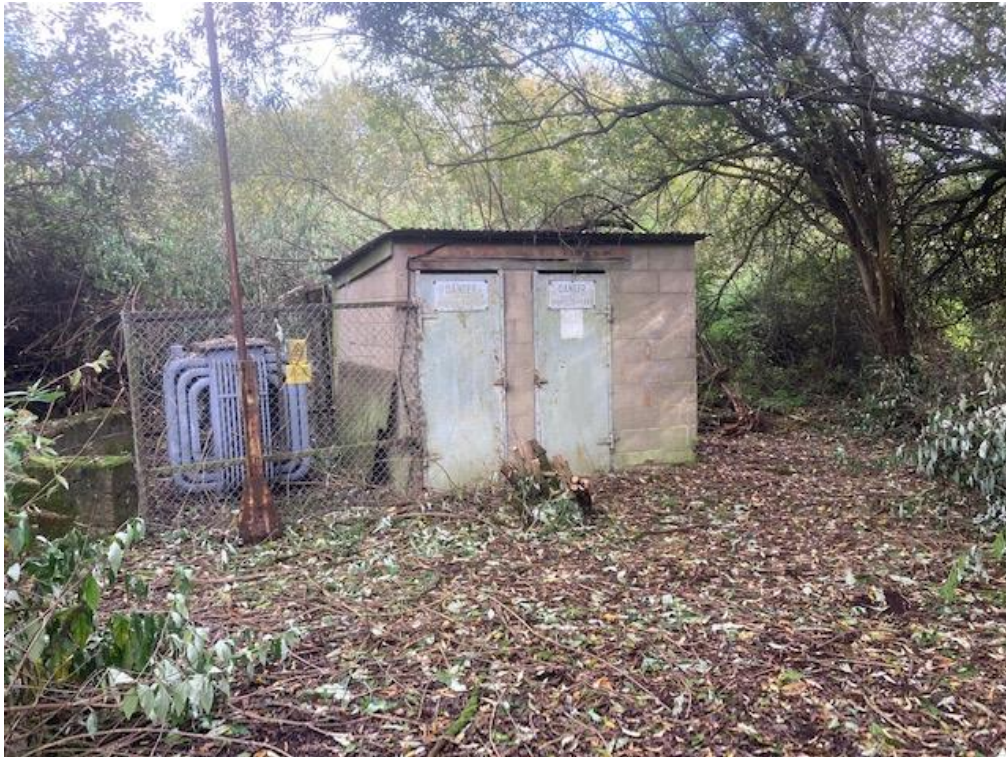
Electricity Sub-station on main site

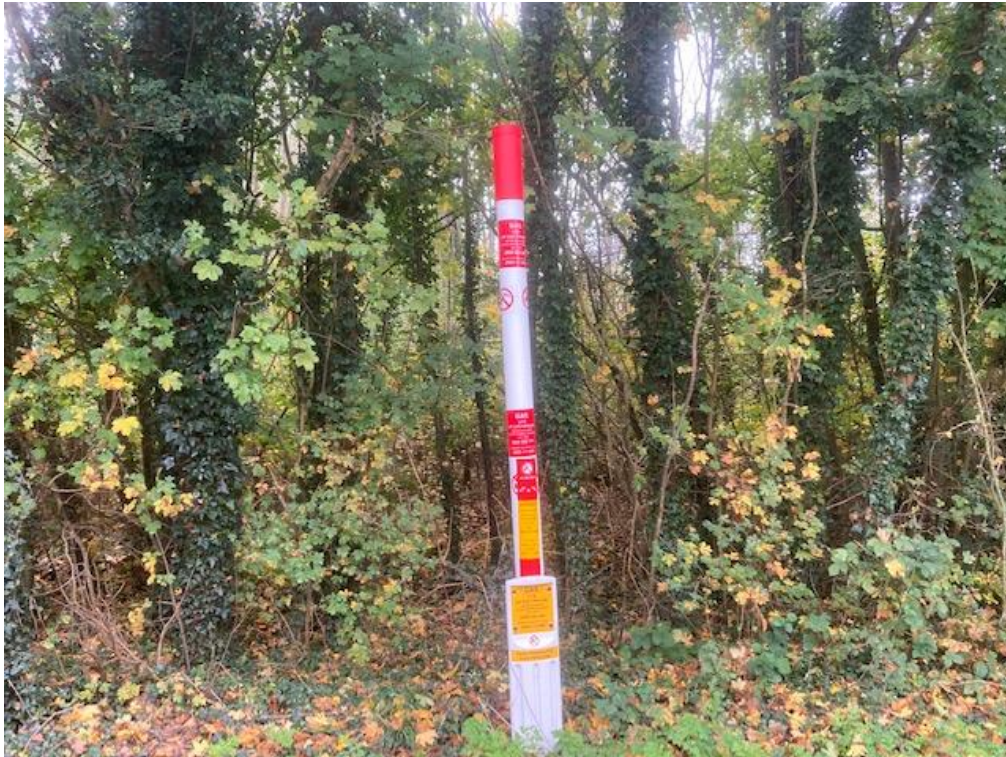
Gas main at top of site
