Geotechnical and Geo-Environmental Report

Hillingdon Water Sports Facility and Activity Centre (HWSFAC)

Report No: 23-09-03B

September 2023

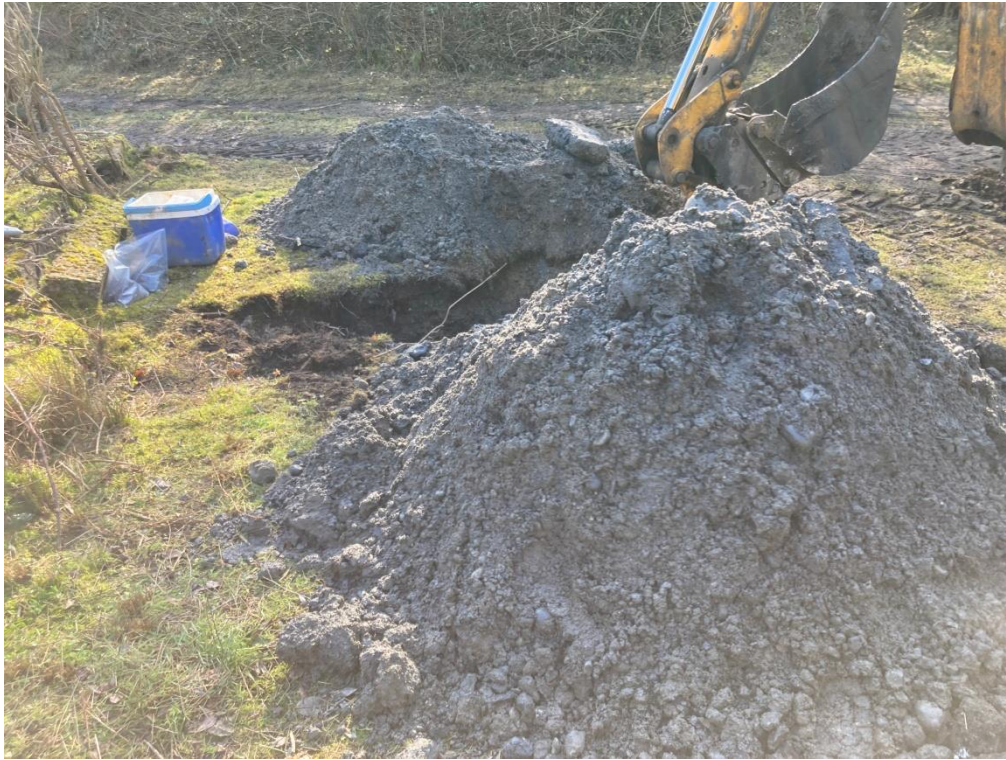
Distinct hydrocarbon staining and odour was encountered within the Made Ground soils surrounding the historic concrete bund located at the north of the site covered by TP4 and CBR5. Additional trial pits were undertaken around the historic concrete bund which did not encounter hydrocarbon staining and odour these include TP3, TP5, BH7. As such, it is considered the main impact from hydrocarbons is localised to the immediate west side of the historic bund.

Some obvious signs of contamination were identified locally within the Made Ground soils encountered during the field work. This relates to significant hydrocarbon staining and odour within two trial pits (TP4 and CBR5) positioned next to a historic concrete bund situated at the north of the site. In addition, some man-made materials were encountered within the Made Ground such as brick, concrete, ash, slag and slate with occasional cobbles and boulder size fragments of concrete.

To break the exposure pathways to site users, it is considered that the pathway between the zoned area of impacted Made Ground soils and the end users needs to be broken (area shown on the remedial plan in Appendix A).

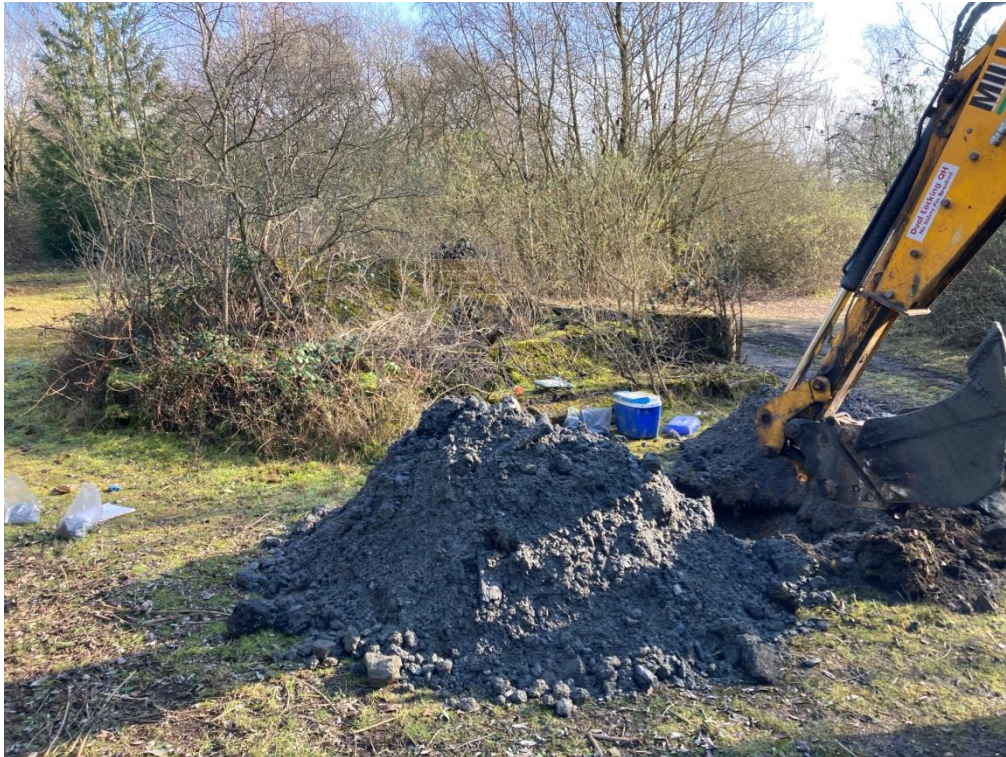
TP4 and historic bund

The intrusive investigation identified a localised area of hydrocarbon odour and staining within TP4 and CBR5 situated adjacent to a historic concrete bund located at the north of the site. As such specific testing including an assessment of both aromatic and aliphatic hydrocarbons was undertaken on three representative samples. When compared to the relevant S4UL's for a 'Commercial' land-use scenario no significantly elevated levels were recorded.

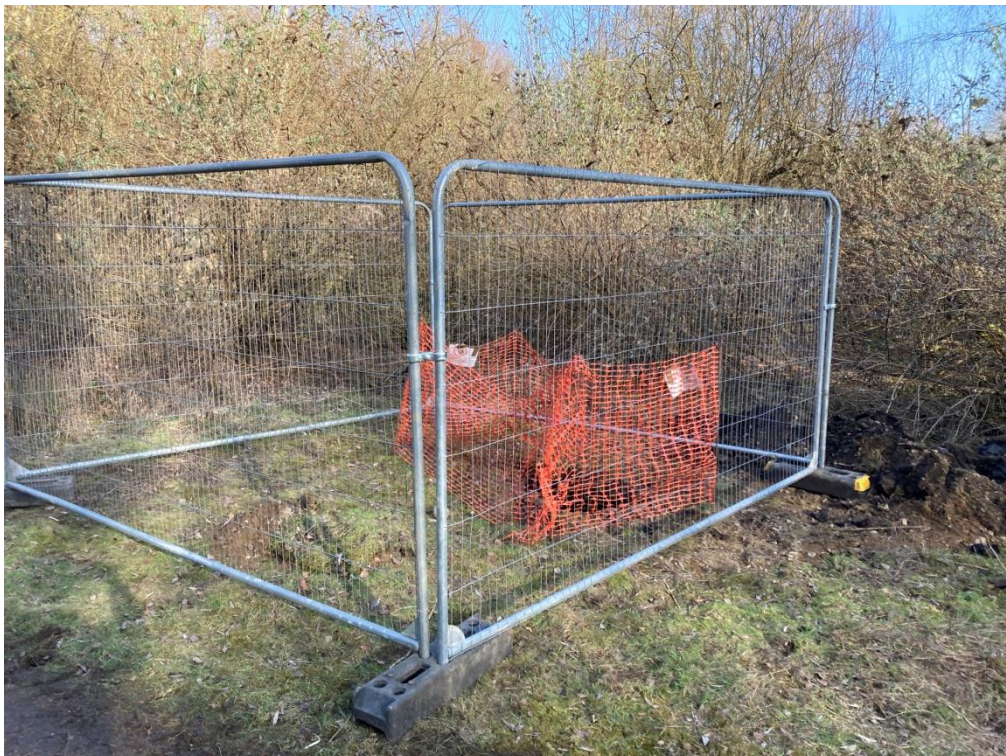
SA1

The infiltration test undertaken within the Alluvium (SA1) recorded no drop in water level over a period of 44 hours.

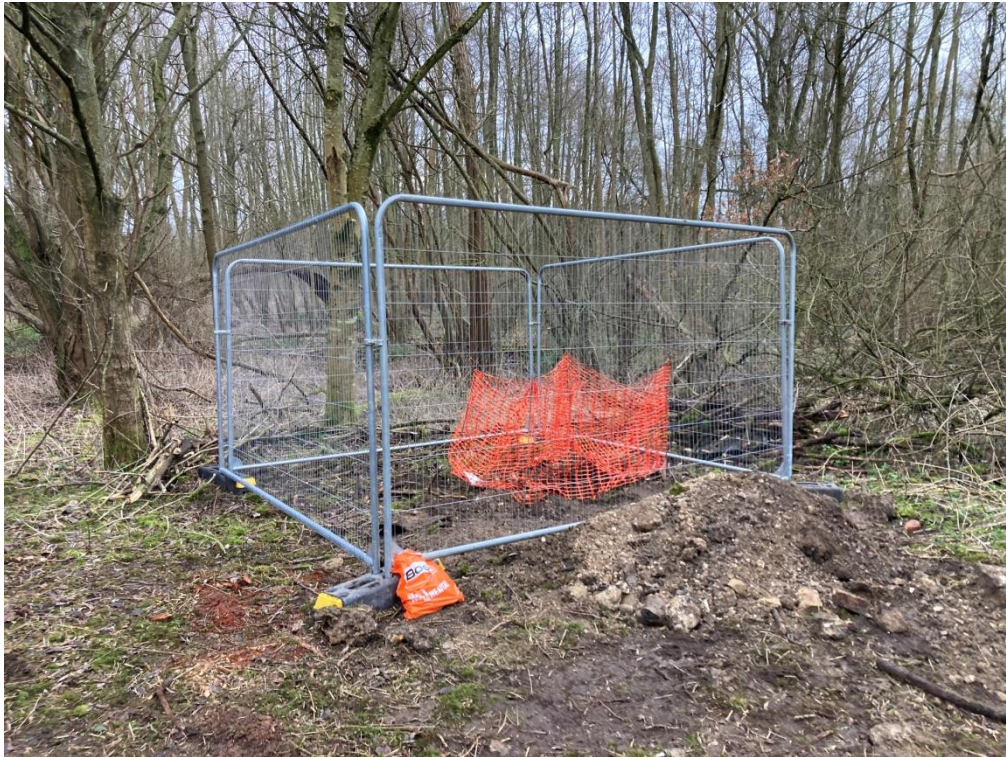
Test Location	Infiltration Rates (m/s)			
	Test 1	Test 2	Test 3	Average
SA1	No recorded drop in water level over 44 hours	-	-	-
SA2	2.94×10^{-4}	1.99×10^{-4}	1.95×10^{-4}	2.29×10^{-4}
SA3	5.72×10^{-4}	1.99×10^{-4}	3.53×10^{-4}	3.74×10^{-4}

The results indicate three repeat infiltration tests were completed within the Made Ground soils of SA2 and SA3 as required by the guidance within BRE 365 Digest. As such it is considered conventional soakaways are viable at this site within the Made Ground soils.
