Optera Structural Solutions

OPT-20188 Agreement to install a root barrier for Graham High Group Ltd

CLIENT NAME:	Graham High Group Ltd
CLIENT ADDRESS:	Barclay House, 20-24 Upper Market Street, Eastleigh, Hampshire, SO50 9FD
POLICY HOLDER:	Mr Peter Sims
POLICY HOLDER ADDRESS:	Oak Tree House, Wood Lane, Ruislip. HA4 6EY
CLIENT REFERENCE:	S2516983
OUR REFERENCE:	OPT-20188
PROJECT MANAGER:	Paul Milliam
DATE	16/10/2025
ETSIMATED DURATION:	3- 4weeks

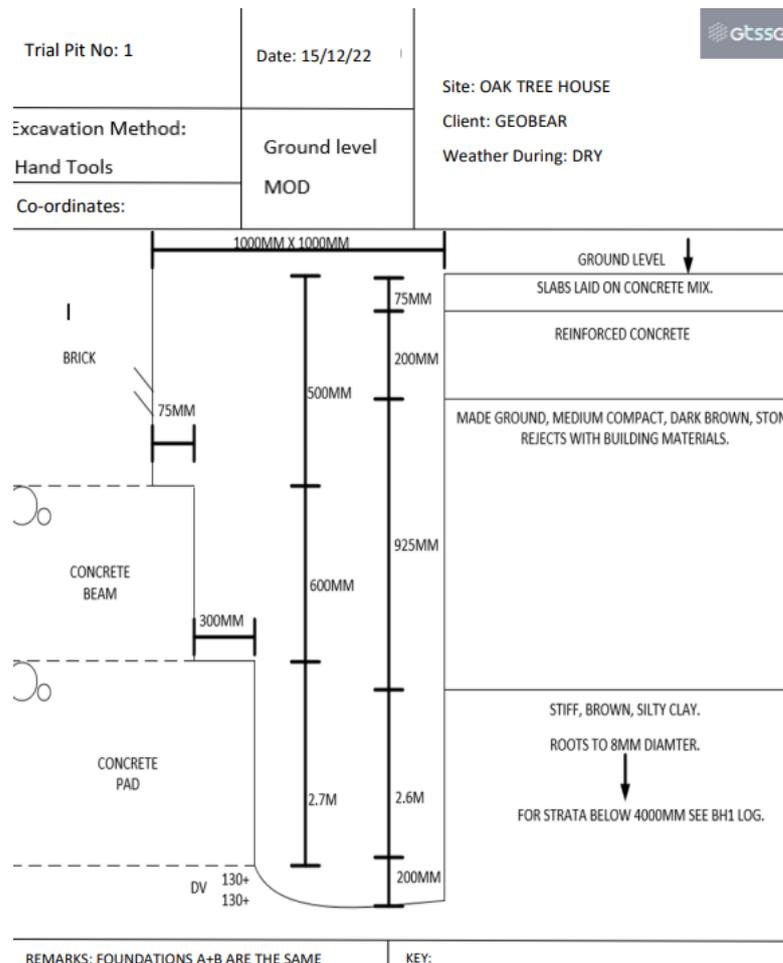
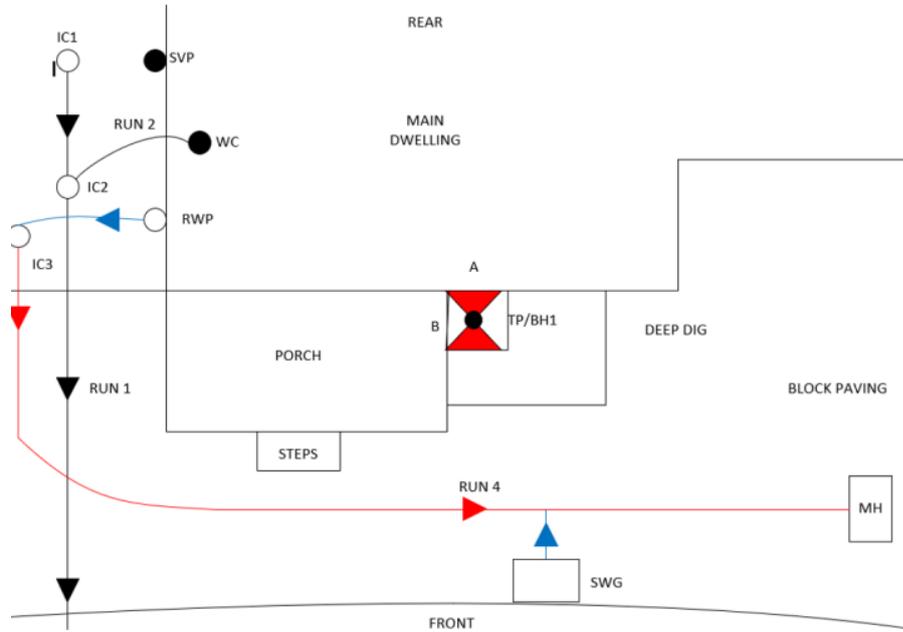
The site investigation undertaken by Gtsse 15/12/2022 shows the foundation detail to the front right side of the porch at its junction with the main house. The investigations show the pad foundation to be 2.7m deep supporting a 600mm concrete beam. No roots were found below 3m. Drainage was found to extend down the left side with foul drains running out to the highway and the surface water drain sweeping across the front of the property to a manhole within the driveway. The drains have been surveyed and dismissed as being causal.

The investigations proved that Oak roots have extended below the pad foundation and will have induced shrinkage of the clay that caused the pad to drop. The two nearest pads appear to have been affected at present, and this is supported by the cracking that has occurred not only to the porch but the main house as well. As the pads lose support the connecting beams spanning to the opposing pads will also have dropped causing the damage further back along the flank wall and front elevation.

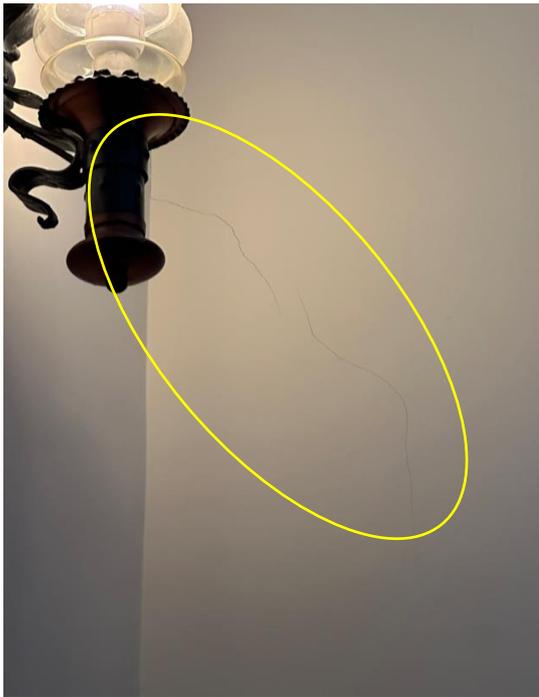
During our inspection we observed cracking to the front porch as well as cracking to the front elevation and left flank wall. Cracking was also noted to the stairwell flank wall tapering down from its abutment with the front partition wall, as well as minor cracking noted below the lounge window.

Crack on flank wall of stairwell

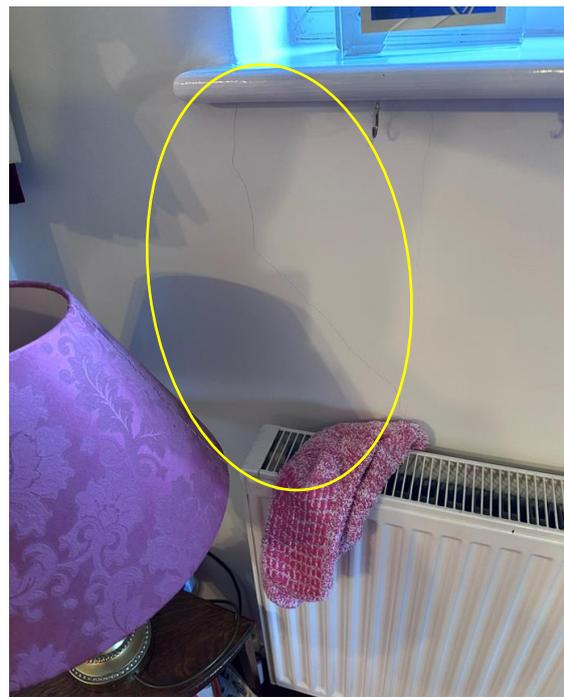
Crack below front lounge window

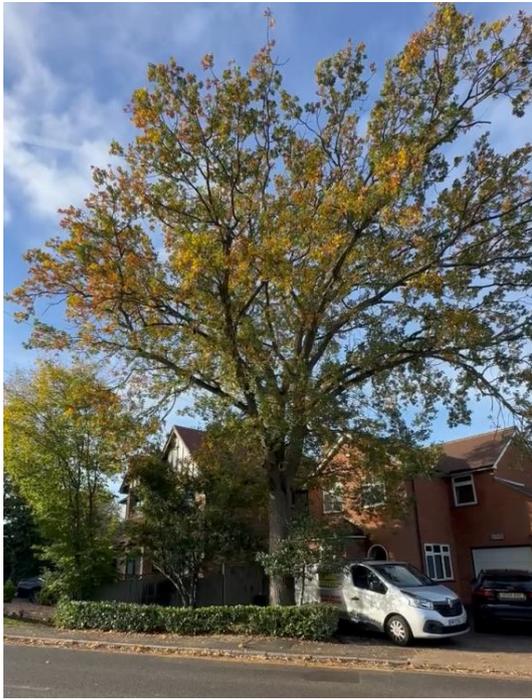
We have not been provided with an Arborist report and consider at this stage damage is solely influenced by the Oak tree at the front. This tree stands 5m from its center to the closest front right corner of the porch. The tree is a significant and mature specimen standing c18m high and protected with a TPO.

Front view of property and Oak tree

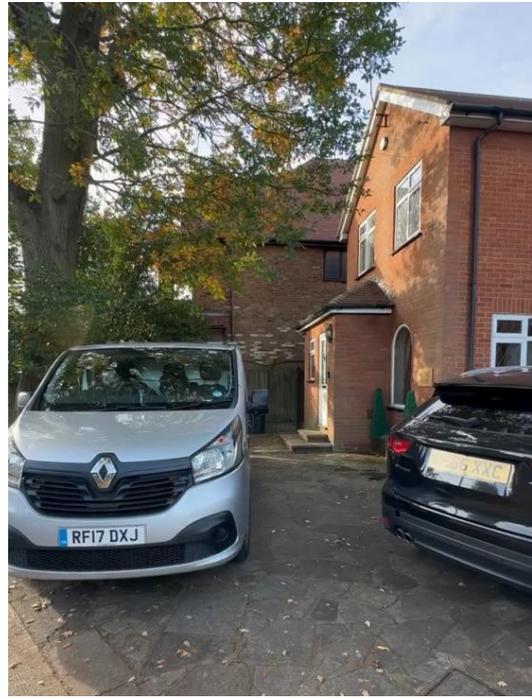
Oak tree position to front porch.

Given the above considerations we suggest an Optera compact root barrier be considered in the first instance as a primary solution. However, the Oak tree is protected and stands just under 5m from the nearest point of the property. As the tree is protected, we will need to gain a root severance agreement (RSA) from the Local Authority Planning Department. Ordinarily they require the barrier to be no closer than 5m to minimise any damage and harm to the protected tree, although we have in the past been provided permission where only a slight breach occurs. In this regard discussion will need to take place as the barrier with careful design will only encroach the 5m radius for a short section. The Council may require a slight reduction of the tree in order to reduce its sail effect when the barrier is installed or may require further investigations to be undertaken so that they can understand the root system better.

If the RSA can be obtained then the barrier will need to extend from the left hand boundary across the face of the porch kicking back to extend across the main house and garage. To facilitate the barrier installation the front step will need to be removed the crazy paving lifted along the barrier line. Nearby conflicting drainage will need to be cut through and reinstated once the barrier has been installed. The water main run in from the left side of the driveway and will be cut and reconnected. Gas and electrical services are understood to enter from the right side boundary and are considered appropriately spaced to allow the barrier to be installed. This will need to be confirmed prior to works starting along with Sonde mapping of the drains.
