INVESTIGATION FACTUAL REPORT

CLIENT: B Maule & Co Ltd
NAME: Sims
ADDRESS: Oak Tree House, Wood Lane, Ruislip, HA4 3EY
CLIENT REF: 20206310
OUR REF: HH/20/65759

SITE AND DRAINAGE LAYOUT

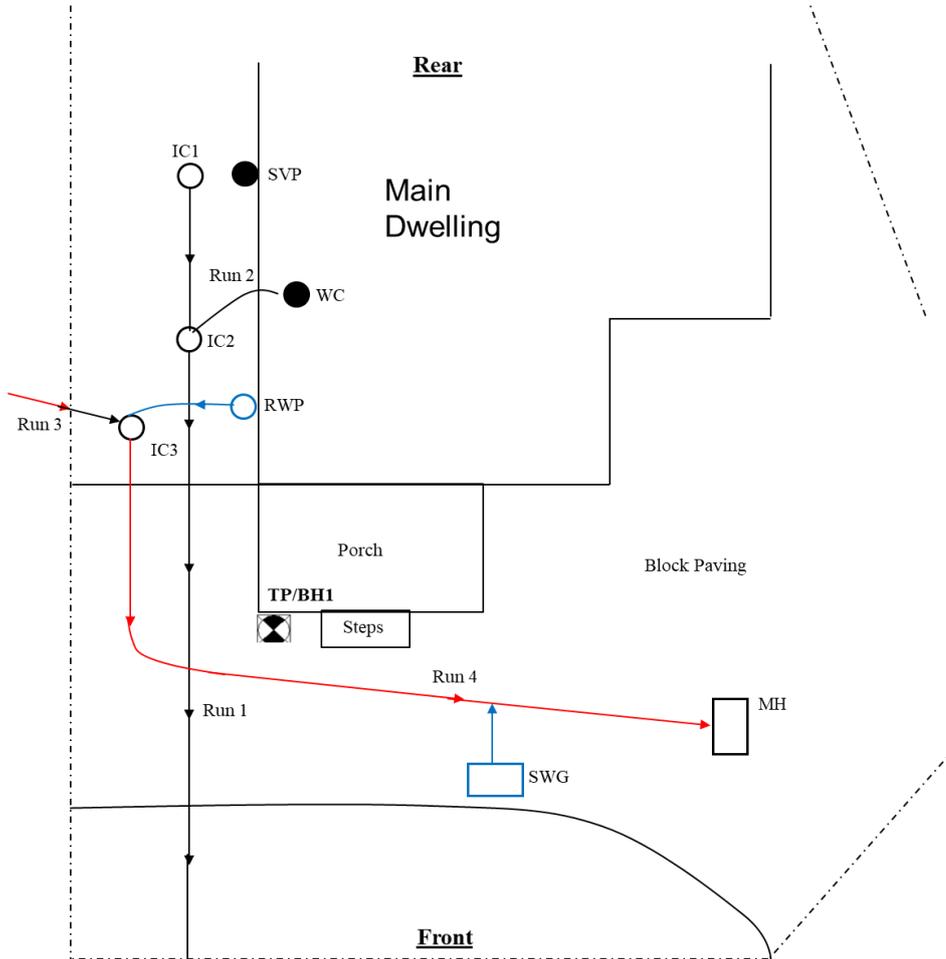
General Comments: TPBH1 relocated to new position due to the presence of drains as agreed by the engineer.

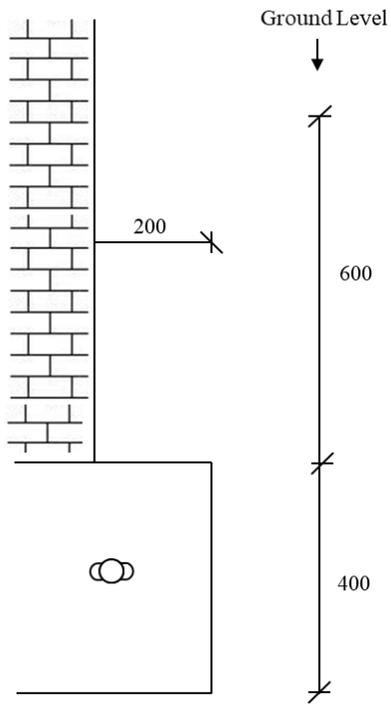
FOUNDATION PIT RECORD

For strata information, please refer to borehole log TPBH1.
