EXTERNAL  
STRUCTURAL  
REPAIRS

Elmsdale House,  
31 The Green,  
Money Lane,  
West Drayton  
UB7 7PN

dwg no:- 21.35.11 scale:- 1:100 @ A3 date:- 11 Jan 2022

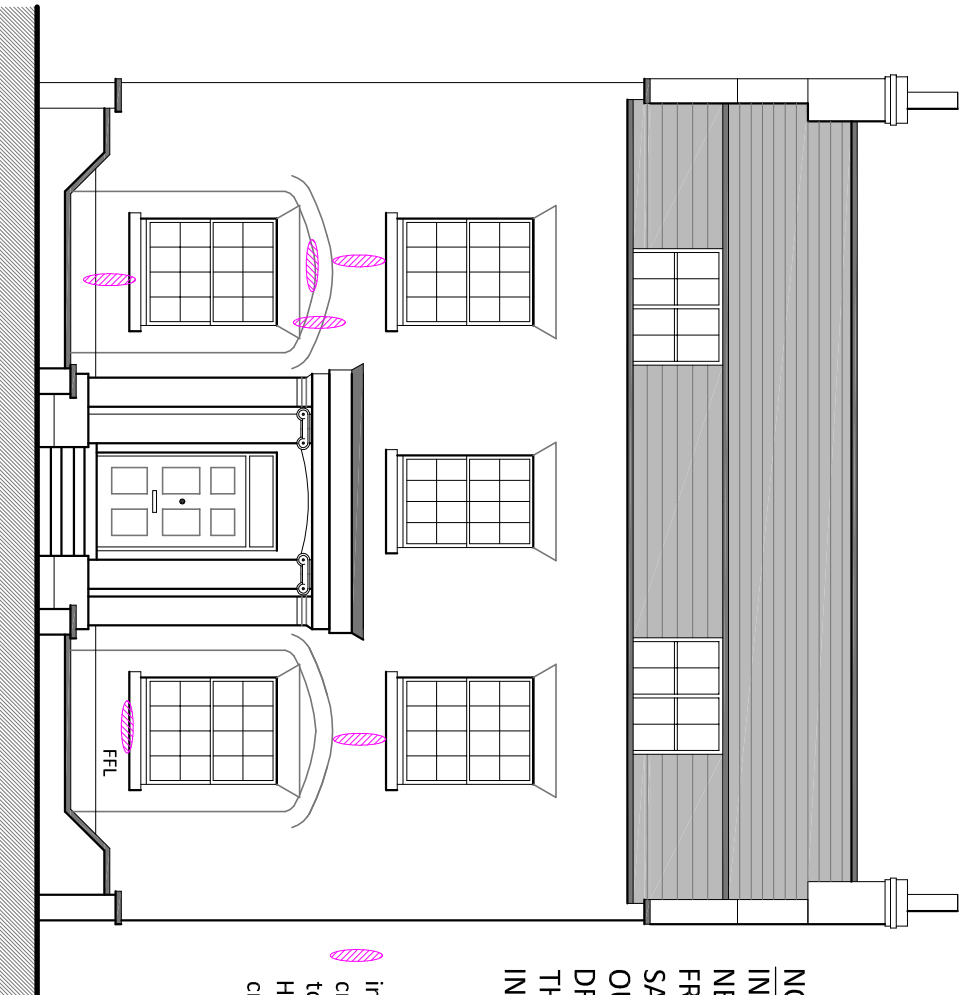
Front Elevation (West Facing)

indicates structural cracks in brickwork to be repaired with Helifix masonry crack stitching

NOTE:- ALL WINDOWS TO BE INSPECTED & CHECKED. ANY NECESSARY REPAIRS TO FRAMES, WINDOW BARS, SASHES ETC TO BE CARRIED OUT WITH 'REPAIR CARE DRY-FLEX 4' IN ACCORDANCE THE MANUFACTURERS INSTRUCTIONS

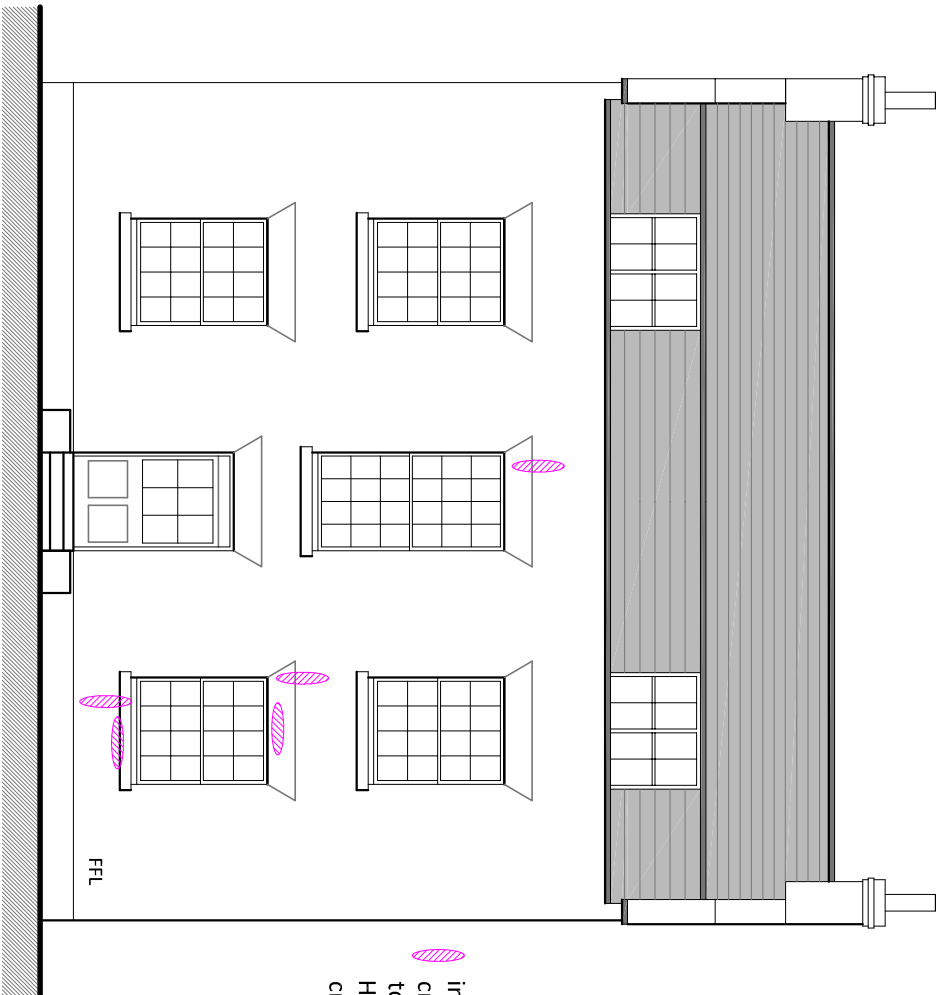
Rear Elevation (East Facing)

indicates structural cracks in brickwork to be repaired with Helifix masonry crack stitching

indicates 12mm dia. Helifix Bow Tie HDs lateral restraint straps @ 1200mm centres (at First & Second floor levels). Installation in accordance with Structural Engineer's instructions and to Helifix Technical Specification. SEE HELIFIX TECHNICAL BROCHURE SUBMITTED WITH APPLICATION DOCUMENTS
