**ENGINEERS SURVEY REPORT TO**

**ELMSDALE HOUSE, 31 THE GREEN, MONEY LANE  
WEST DRAYTON UB7 7PN**

**PREPARED BY PRADEEP GUPTA - MIStructE, CEng.**

**DATED – 15<sup>TH</sup> June 2021**

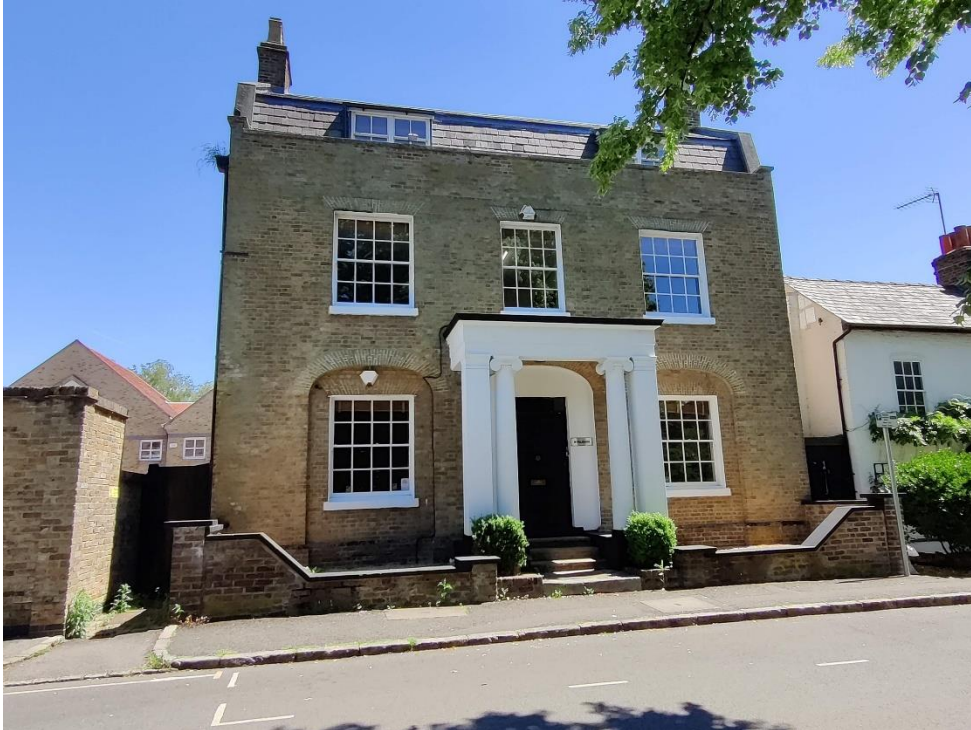
**Front elevation**

- 3.1 Inspection of the front elevation of the building indicated substantial movement to the left side of the building. This movement is present between the top of the ground floor left side window and the first-floor window directly above. This cracking is present in the flat soldier arch over the window, the relieving brick arch over the window and the brickwork between the windows. The sagging pattern of movement indicates inadequacy of the possible timber lintel over the window. The movement, although historic may be ongoing. I would therefore recommend the lintel over the window opening should be replaced with an adequately sized lintel. This will minimise any further movement. This work will need to be carried out very carefully without further disturbing the relieving arch. The external cracks, except for the flat arch and relieving arch can then be stitched across using helibars. The cracks to the flat arch and relieving arch can repointed as best as possible

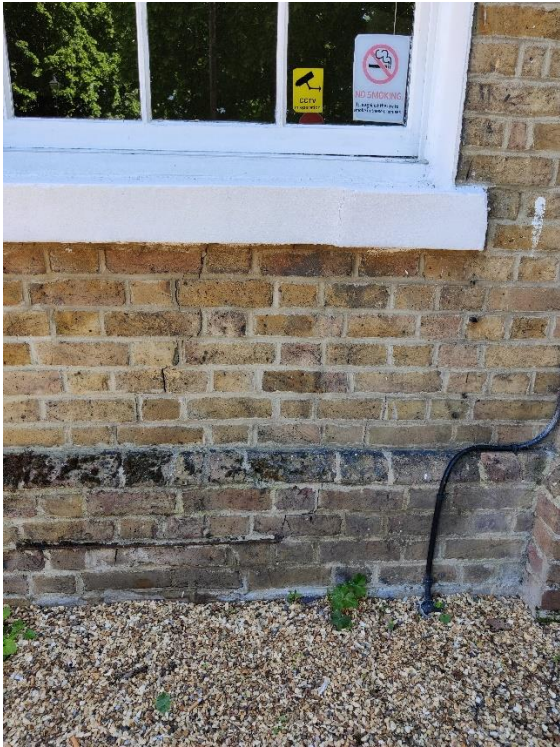
**Front ground floor window cill**

- 3.2 The inspection of the remaining front elevation indicated hairline vertical crackling above the ground floor right side window and the first-floor middle window. There is also cracking to the brickwork under the ground floor left side window These cracks should be stitched across using helibars.

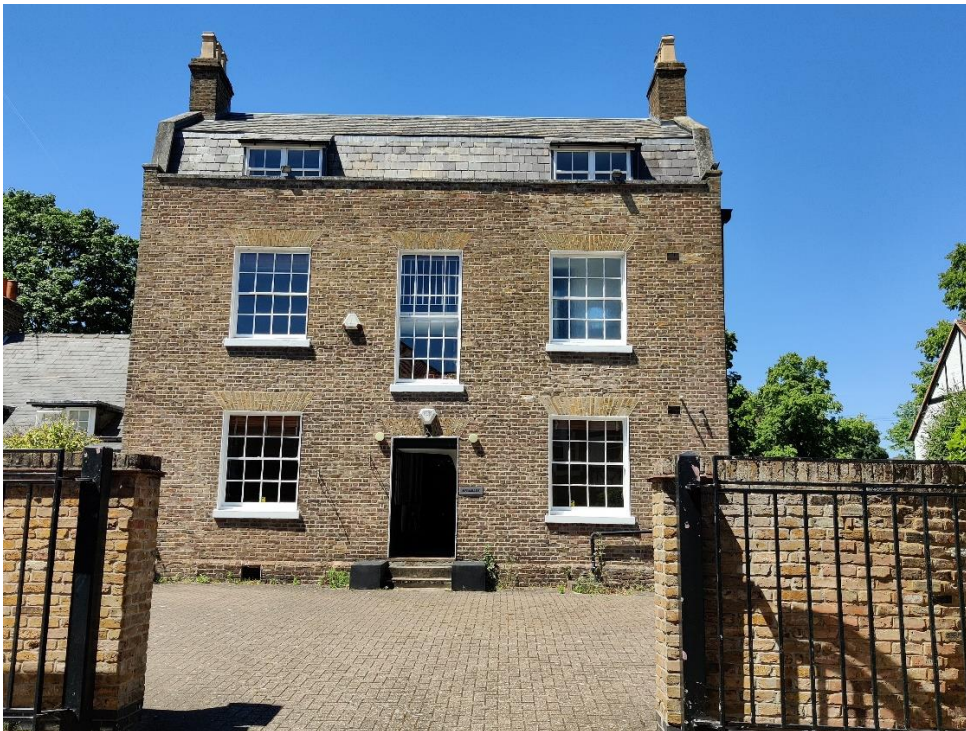
**Rear Elevation**

- 3.3 Inspection of the rear elevation indicated substantial movement to the ground floor right side window. There are vertical cracks from the ground level and damp-proof course level to the window. These cracks are due to the differential settlement of the wall to the cellar and the non-cellar. The flat arches over some of the other windows have also sagged due to the inadequacy of the timber lintels over the window openings. I would recommend any cracks visible externally should be stitched across using helibars.

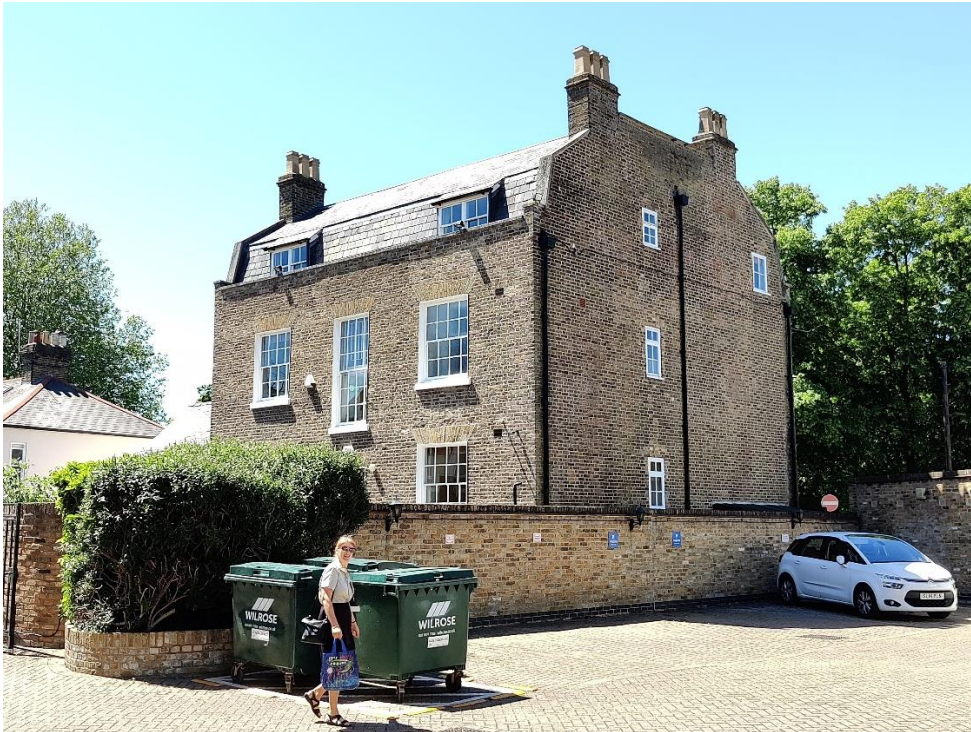
**Left side elevation.**

- 3.4 To the left side elevation there was approximately vertical cracking between the ground, first and second floor windows. This is due to the wall bowing significantly. The reason for this is the lack of horizontal restraint from the floors to the wall as the floor joists are spanning parallel to the wall. I would recommend that the wall is tied back to the floors and the external cracking is stitched across using helibars.

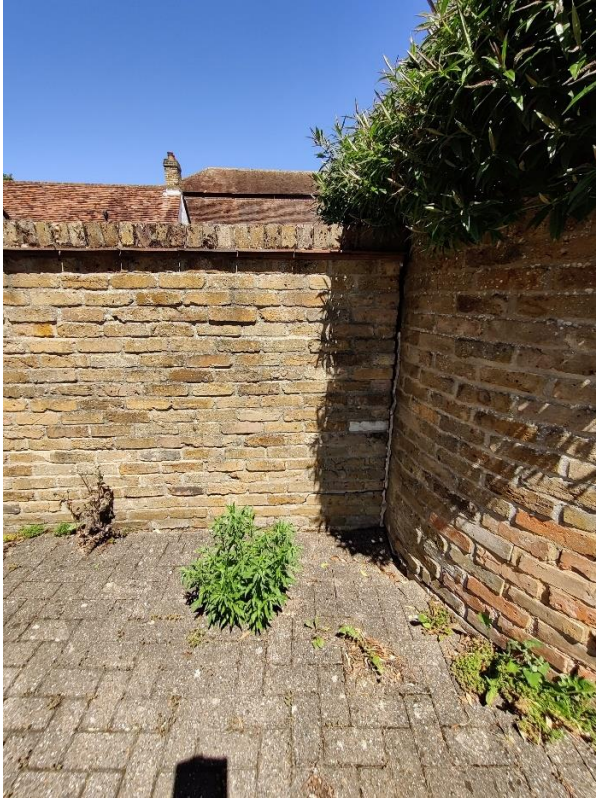
**Left side boundary wall at junction with curved rear wall.**

- 3.5 To the rear corner of left side boundary wall where it meets the curved boundary wall. The curved boundary wall is leaning outwards by 25mm at the top of the wall. There is also diagonal subsidence mode cracking to the bottom of the left side wall. This is due to the large shrubs in the adjoining planter with inadequate foundations to the wall. Trial pits will need to be dug to establish the foundation profile to the walls. The large shrubs will need to be removed and remained shrubs will need to be managed to ensure that they remain small. The walls will need to be underpinned locally, tied back to prevent any further lean and cracks will need to be stitched across using helibars.

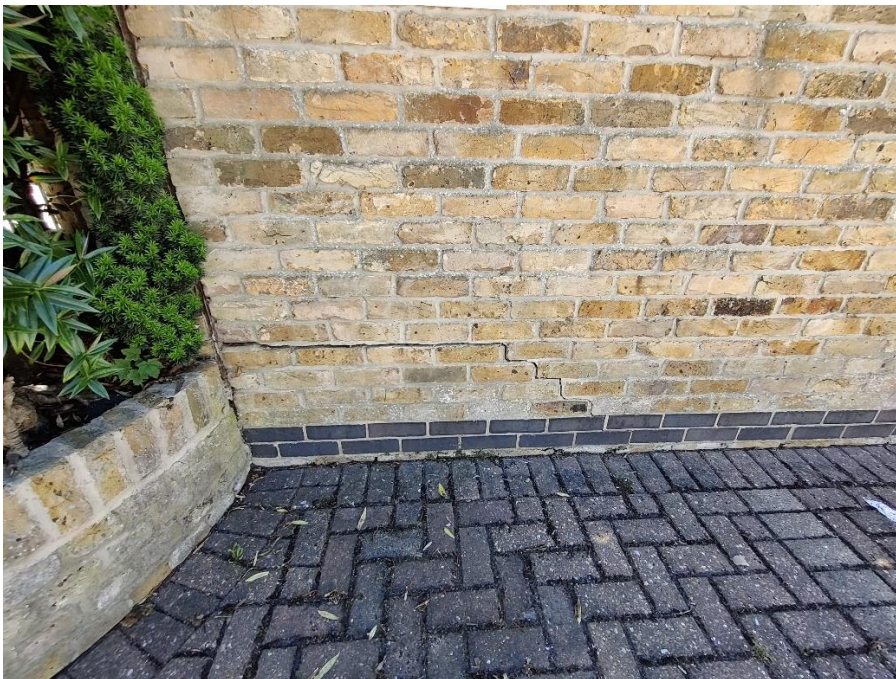
**Subsidence to boundary wall.**

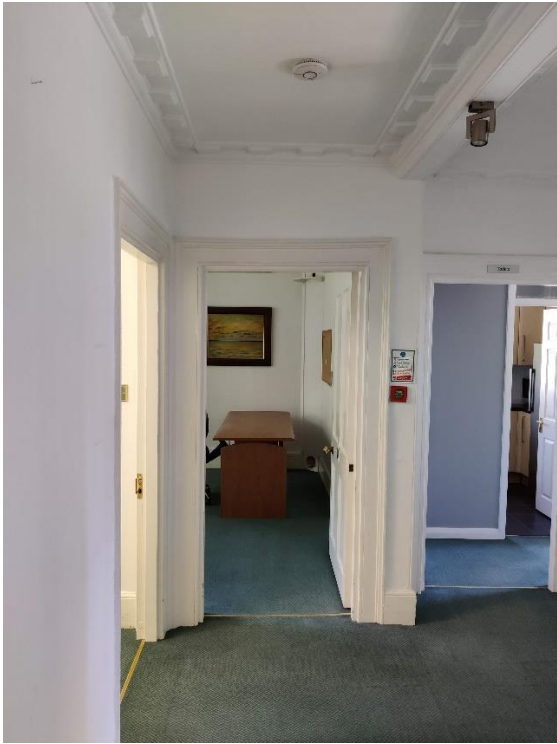
- 3.6 The internal inspection of the building indicated distortion to the door frame to the first-floor left side front office. This is due to the inadequacy of the first floor to support the partition to the door.
- 3.7 The front rainwater downpipe to the left side wall is blocked at the hopper head with vegetation growth. This downpipe is also leaking along its length causing dampness to the wall. The below ground water drainage is also blocked. I would recommend that the both the drainages are maintained in a satisfactory condition permanently.

**Distortion to first floor front left side door.**

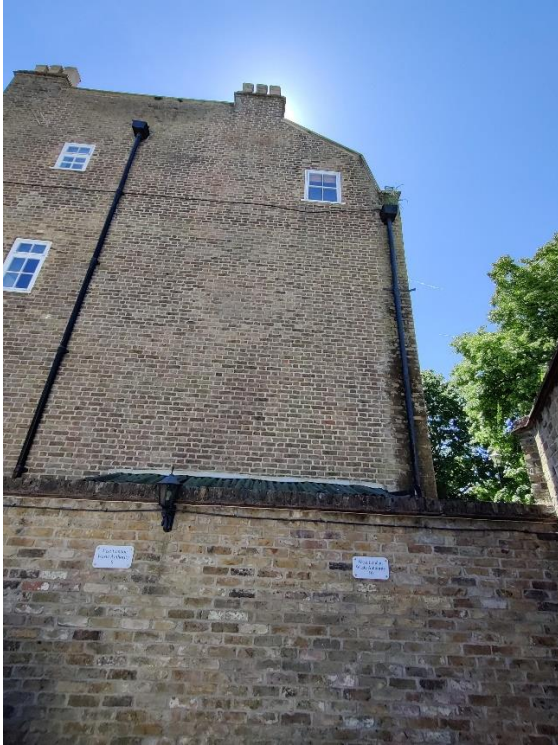
**Blocked rain water downpipe.**
