*(tree inspection report by the tree agency)*

*(re: x 2 rows of lombardy poplar trees at hewens campus, hewens road, hayes, middlesex ub4 8jp)*

*(ref: dp/itc/1119/11/176.tir)*

*(date: 20<sup>th</sup> november 2019)*

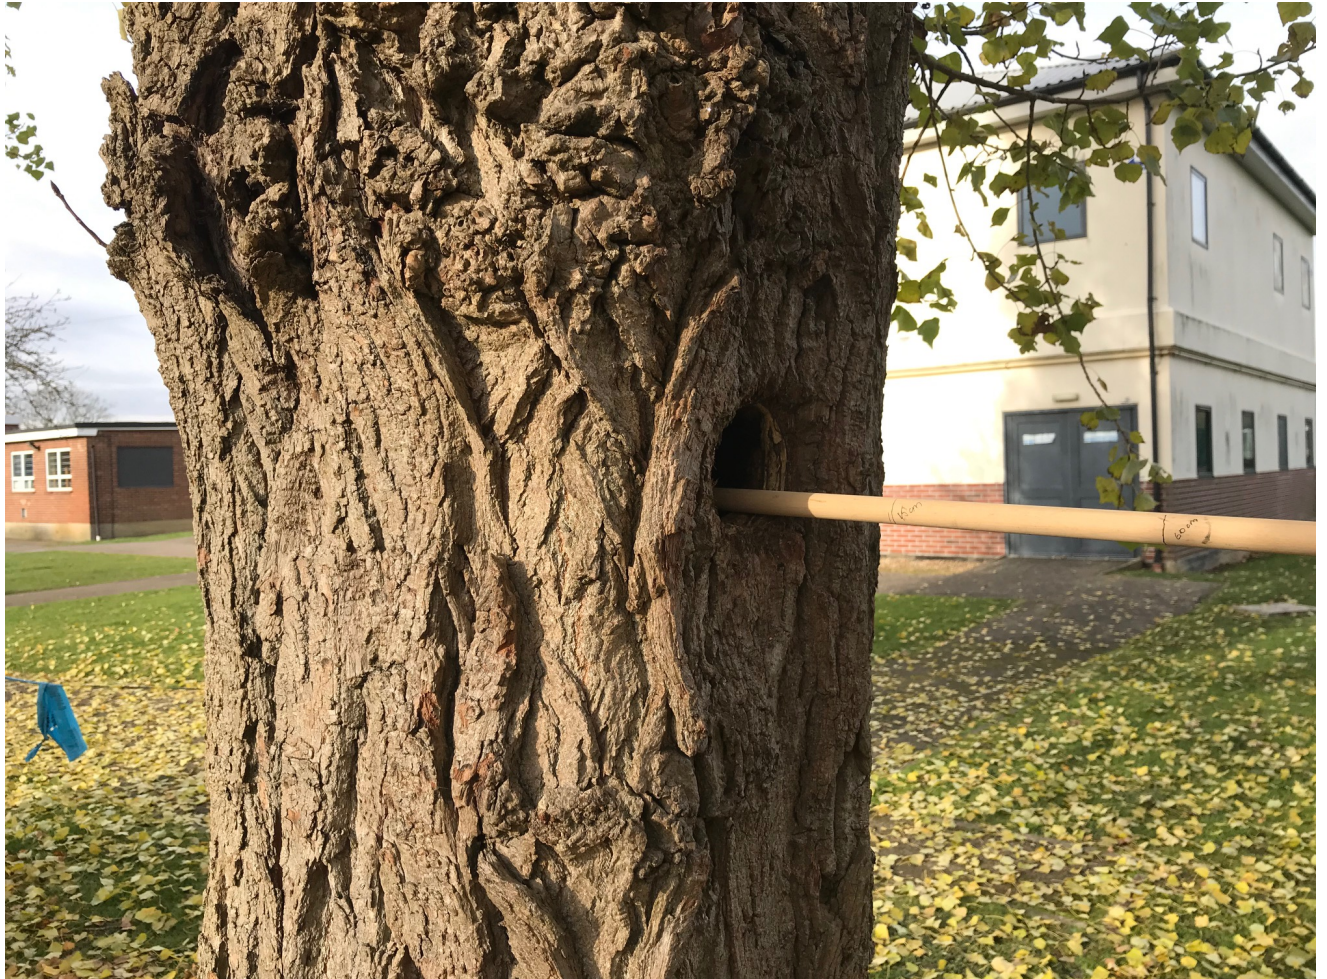
**Photo 4: Tree 2: Lower trunk woodpecker hole with probe.**

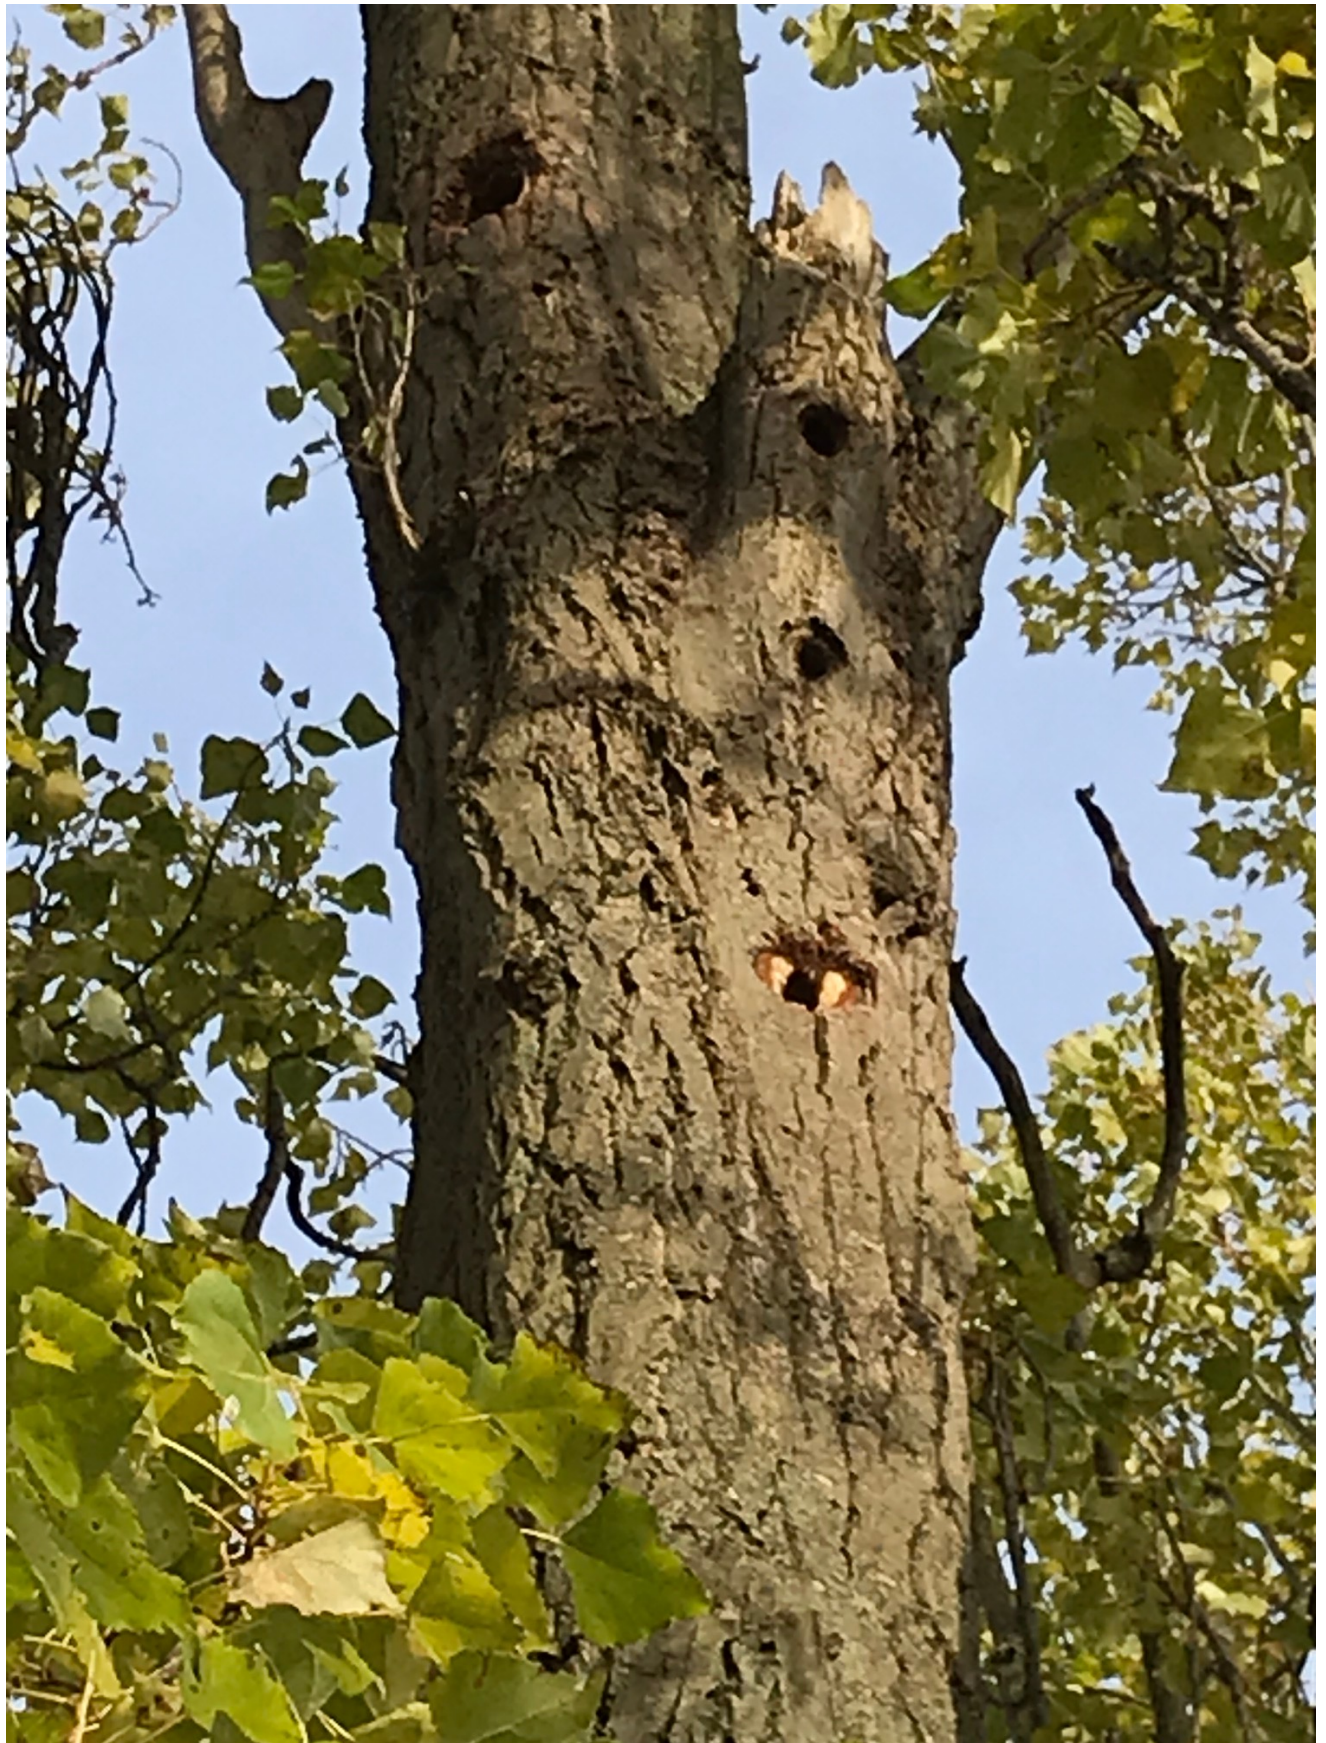
**Photo 5: Tree 4: Upper trunk x 4 woodpecker holes at 7-8 m from south**
