*(tree inspection report by the tree agency)*

*(re: x 2 rows of lombardy poplar trees at hewens campus, hewens road, hayes, middlesex ub4 8jp)*

*(ref: dp/itc/1119/11/176.tir)*

*(date: 20<sup>th</sup> november 2019)*

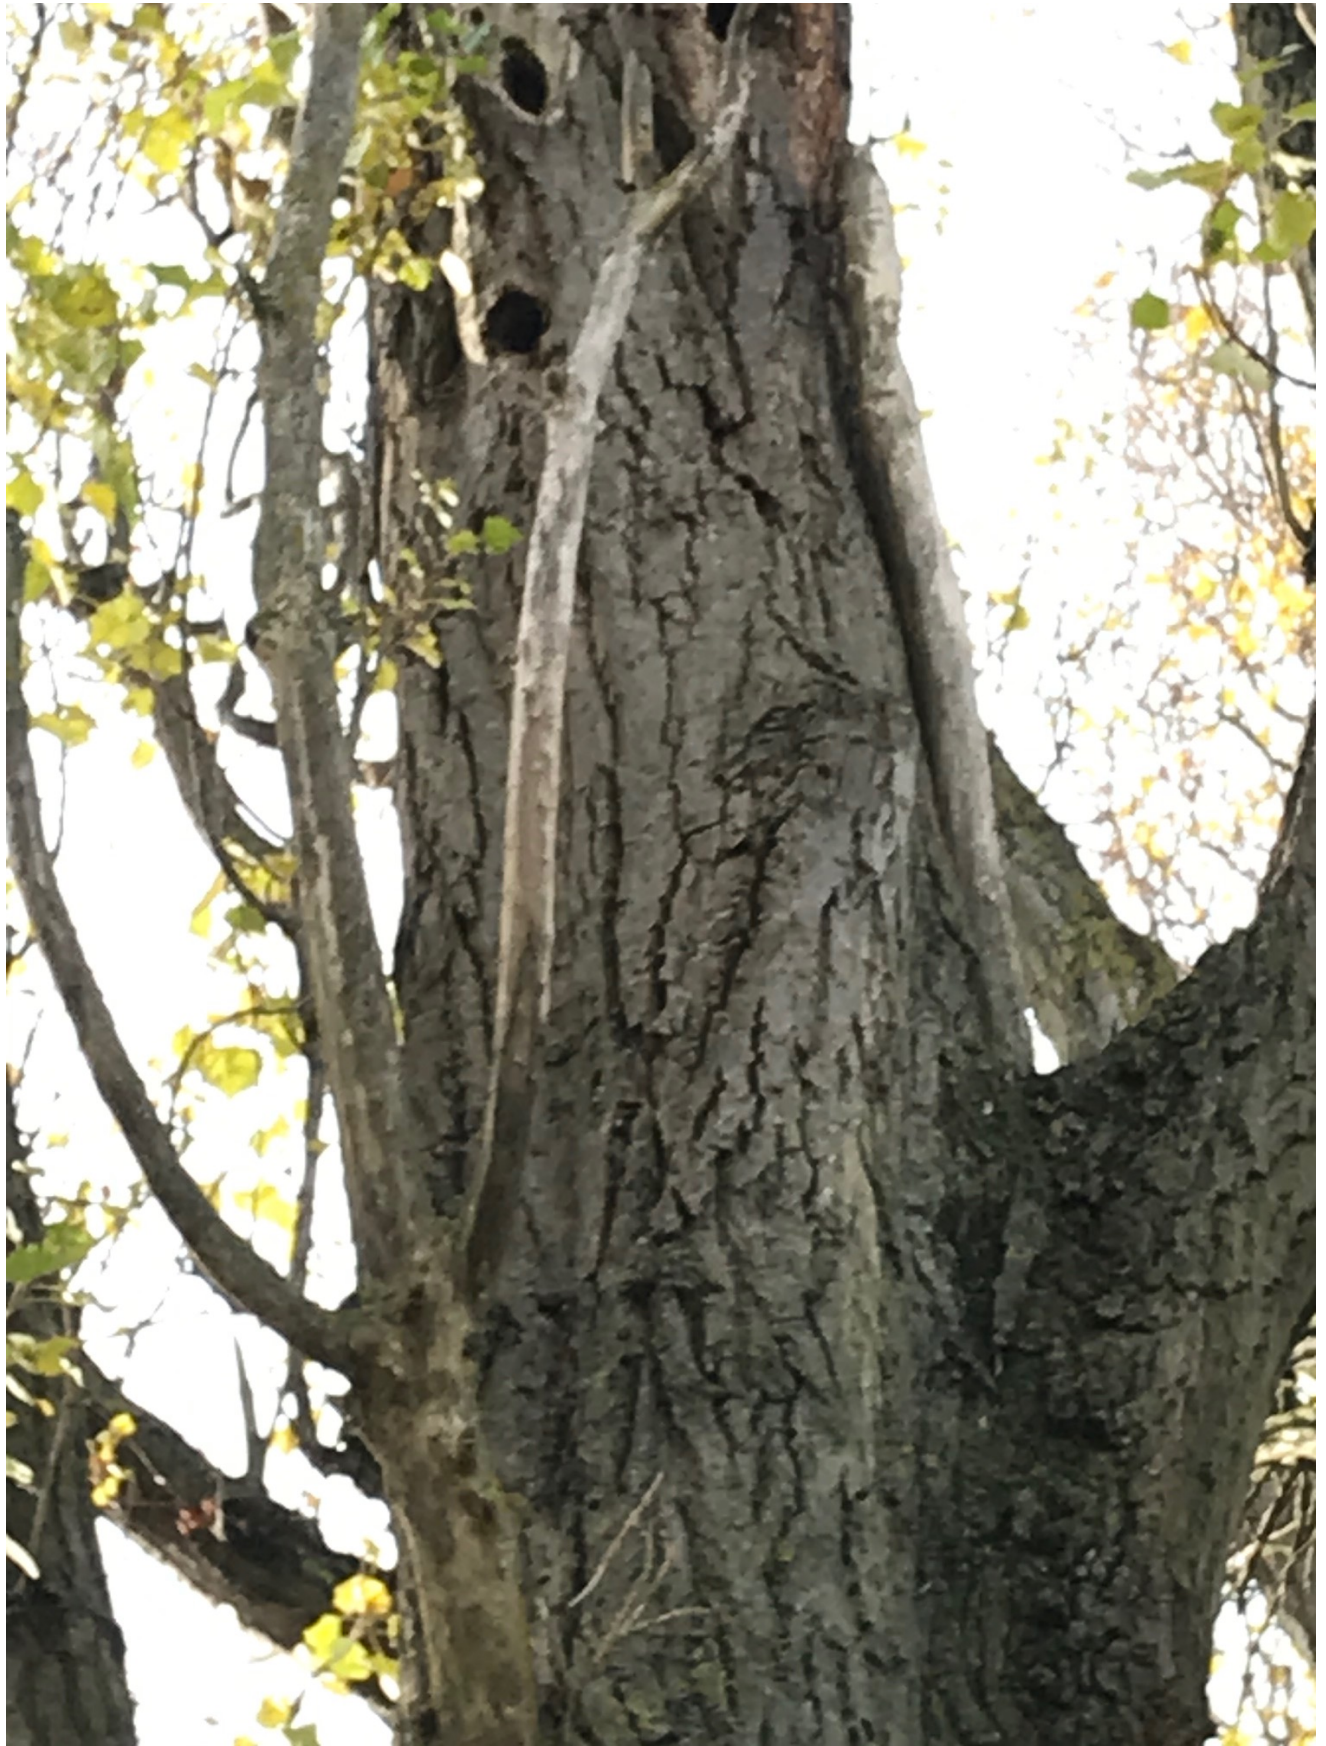
**Photo 6: Tree 4: Upper trunk x 3 woodpecker holes at 7-8 m from north**

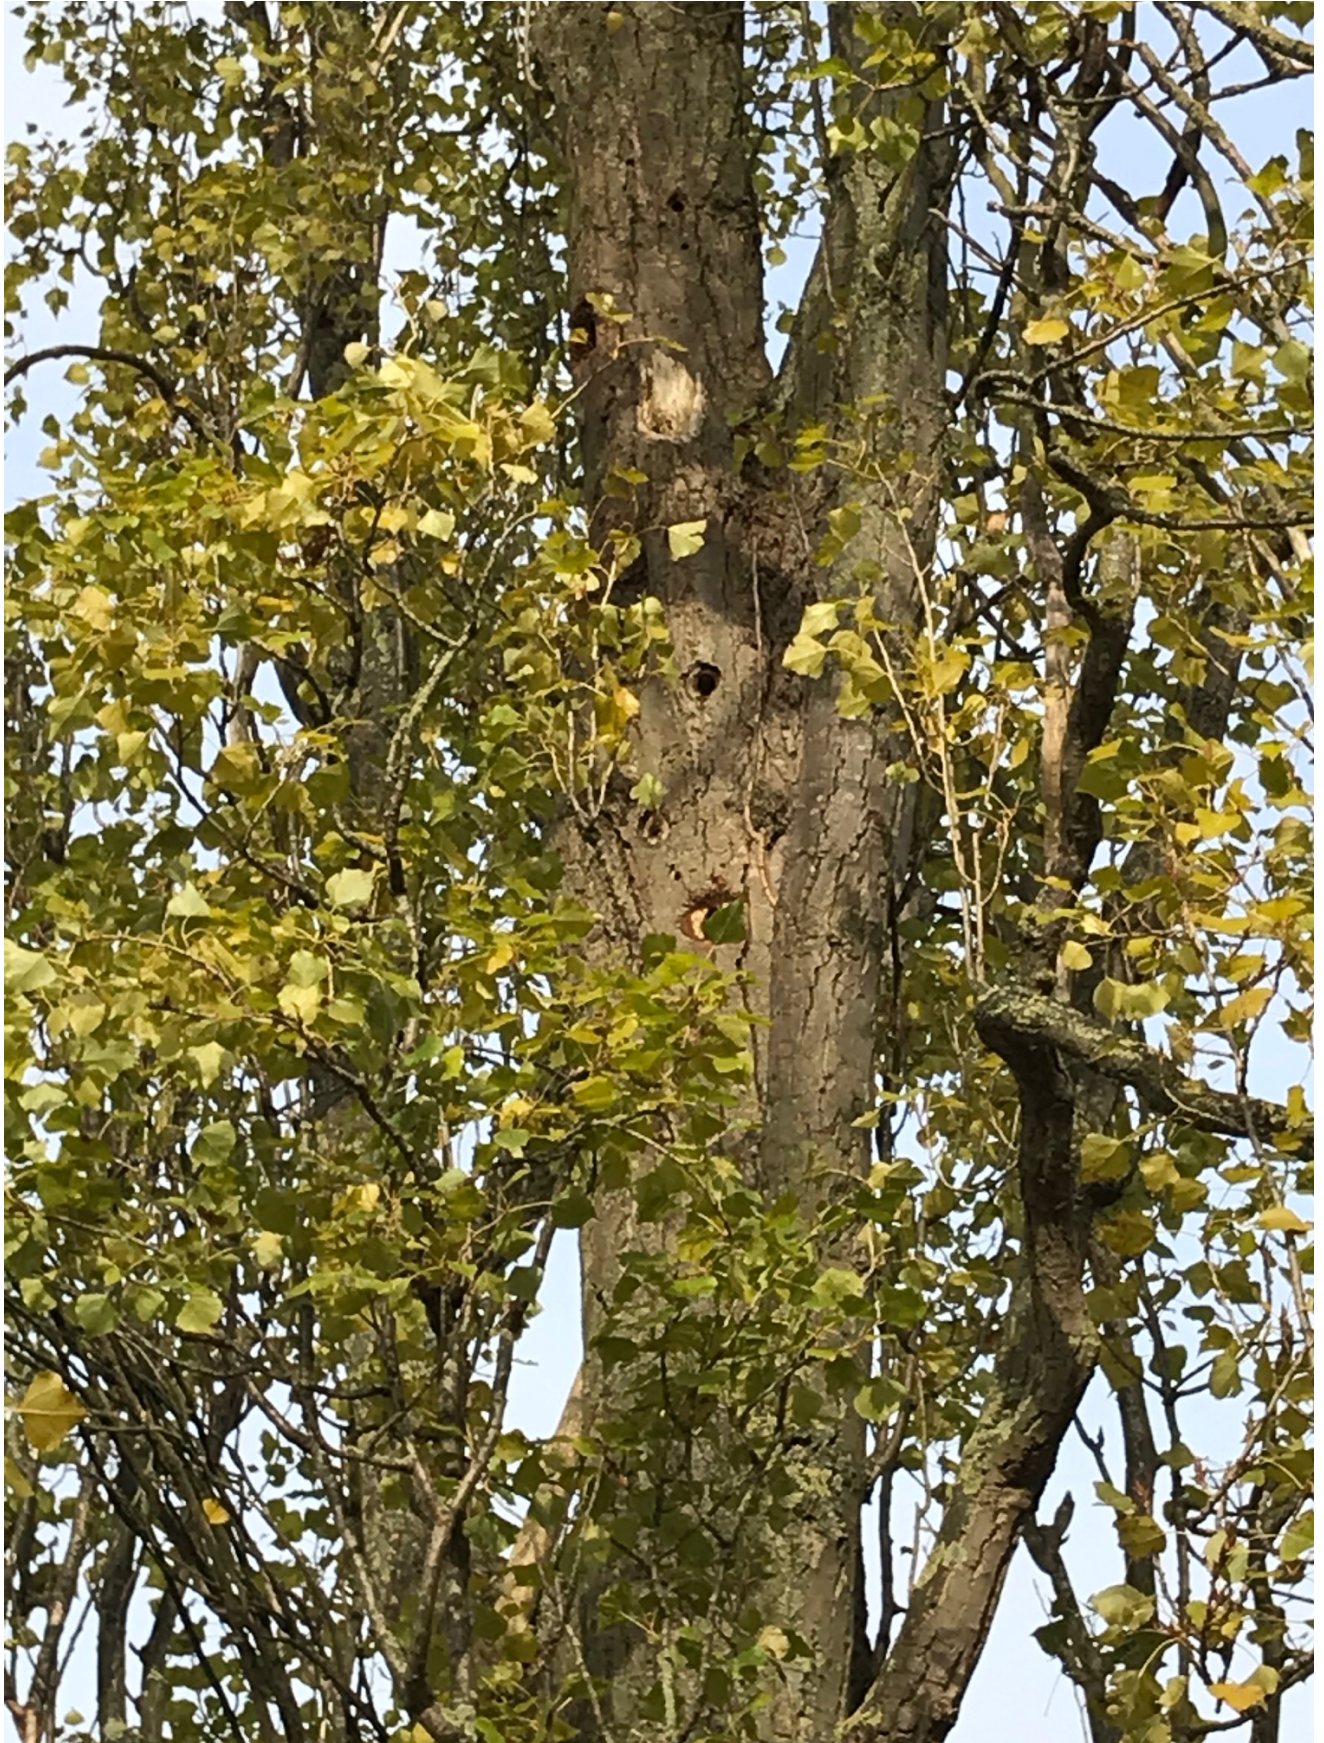
**Photo 7: Tree 5: Upper trunk x 3 woodpecker holes at 7-8 m from south**

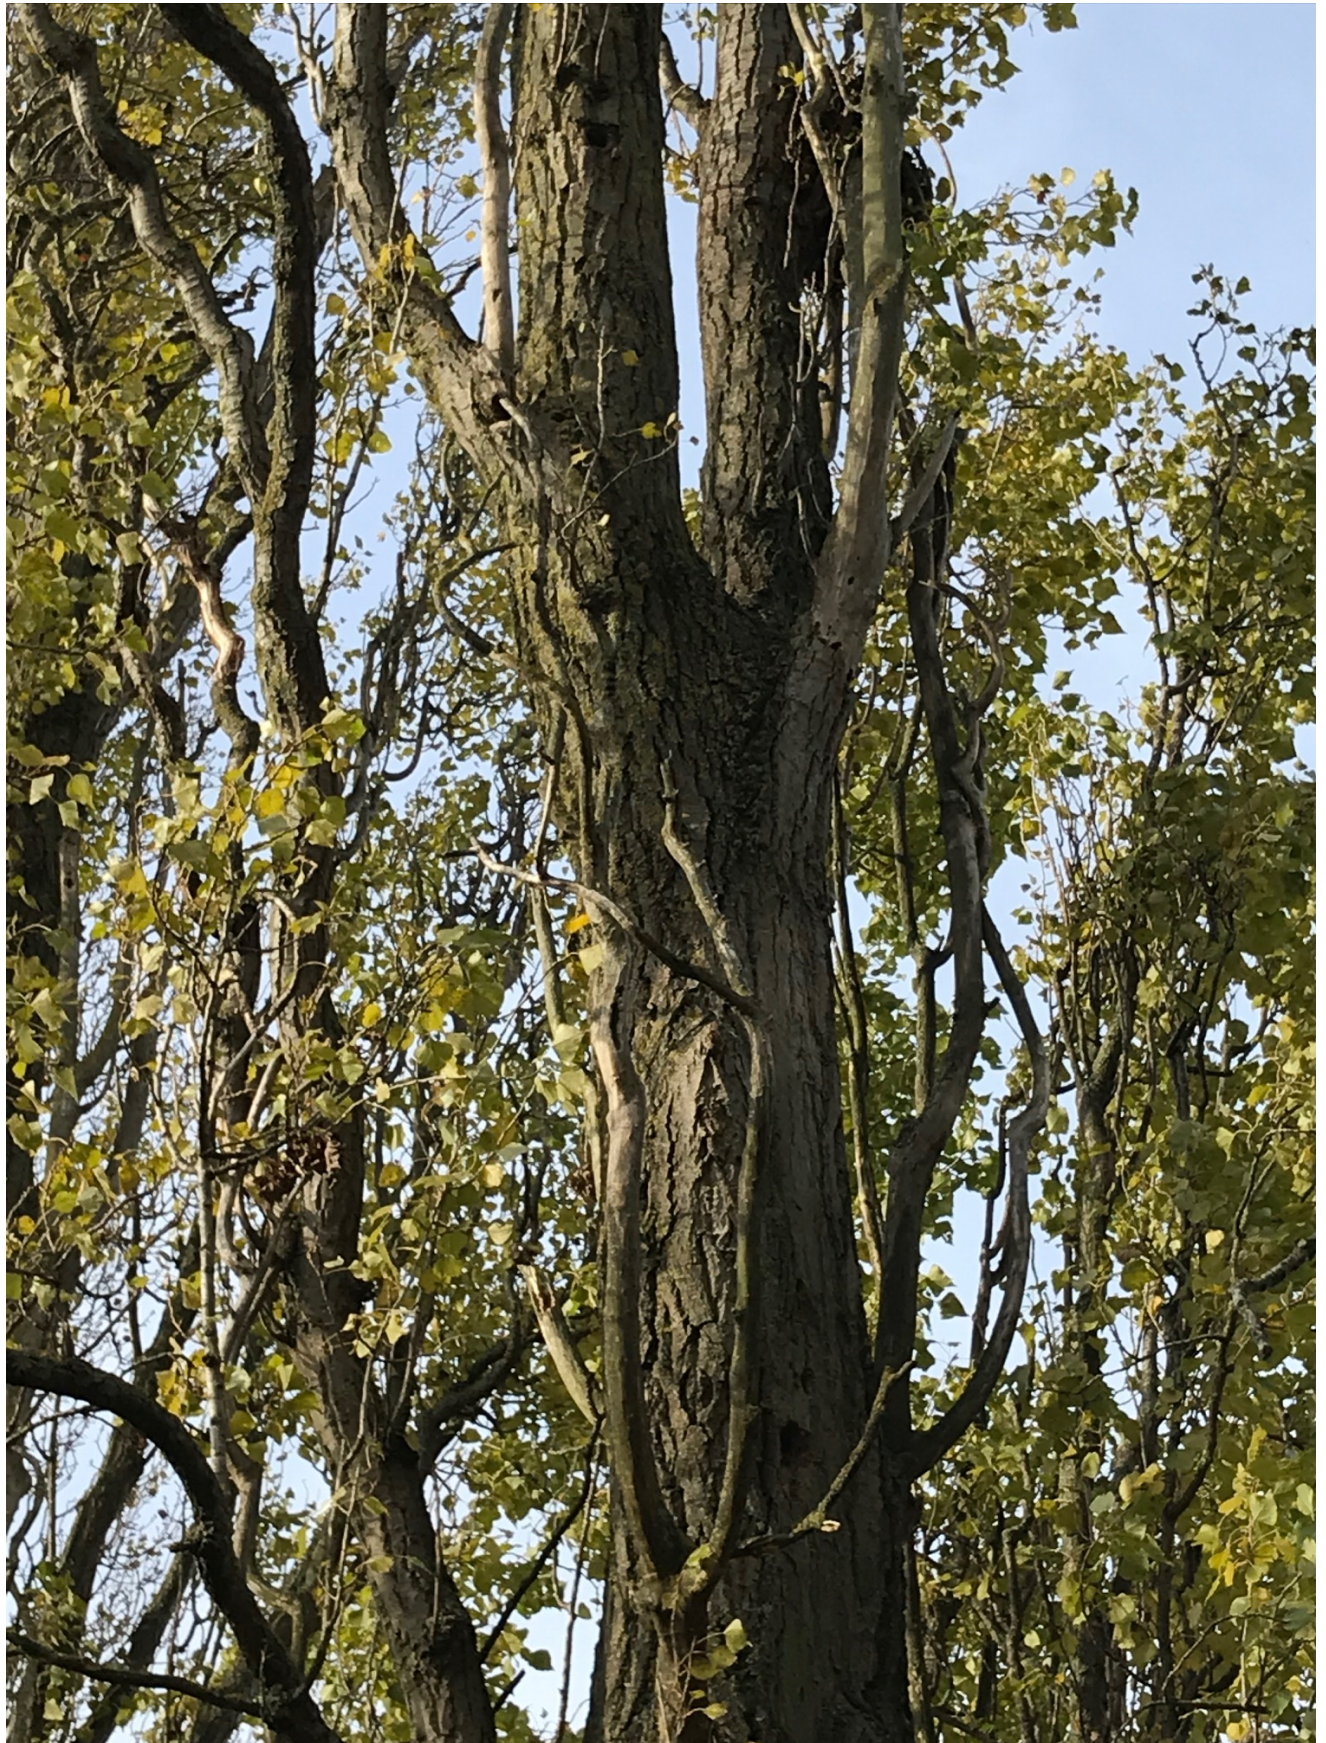
**Photo 8: Tree 5: Upper trunk x 2 woodpecker holes at 5 & 9 m from north**

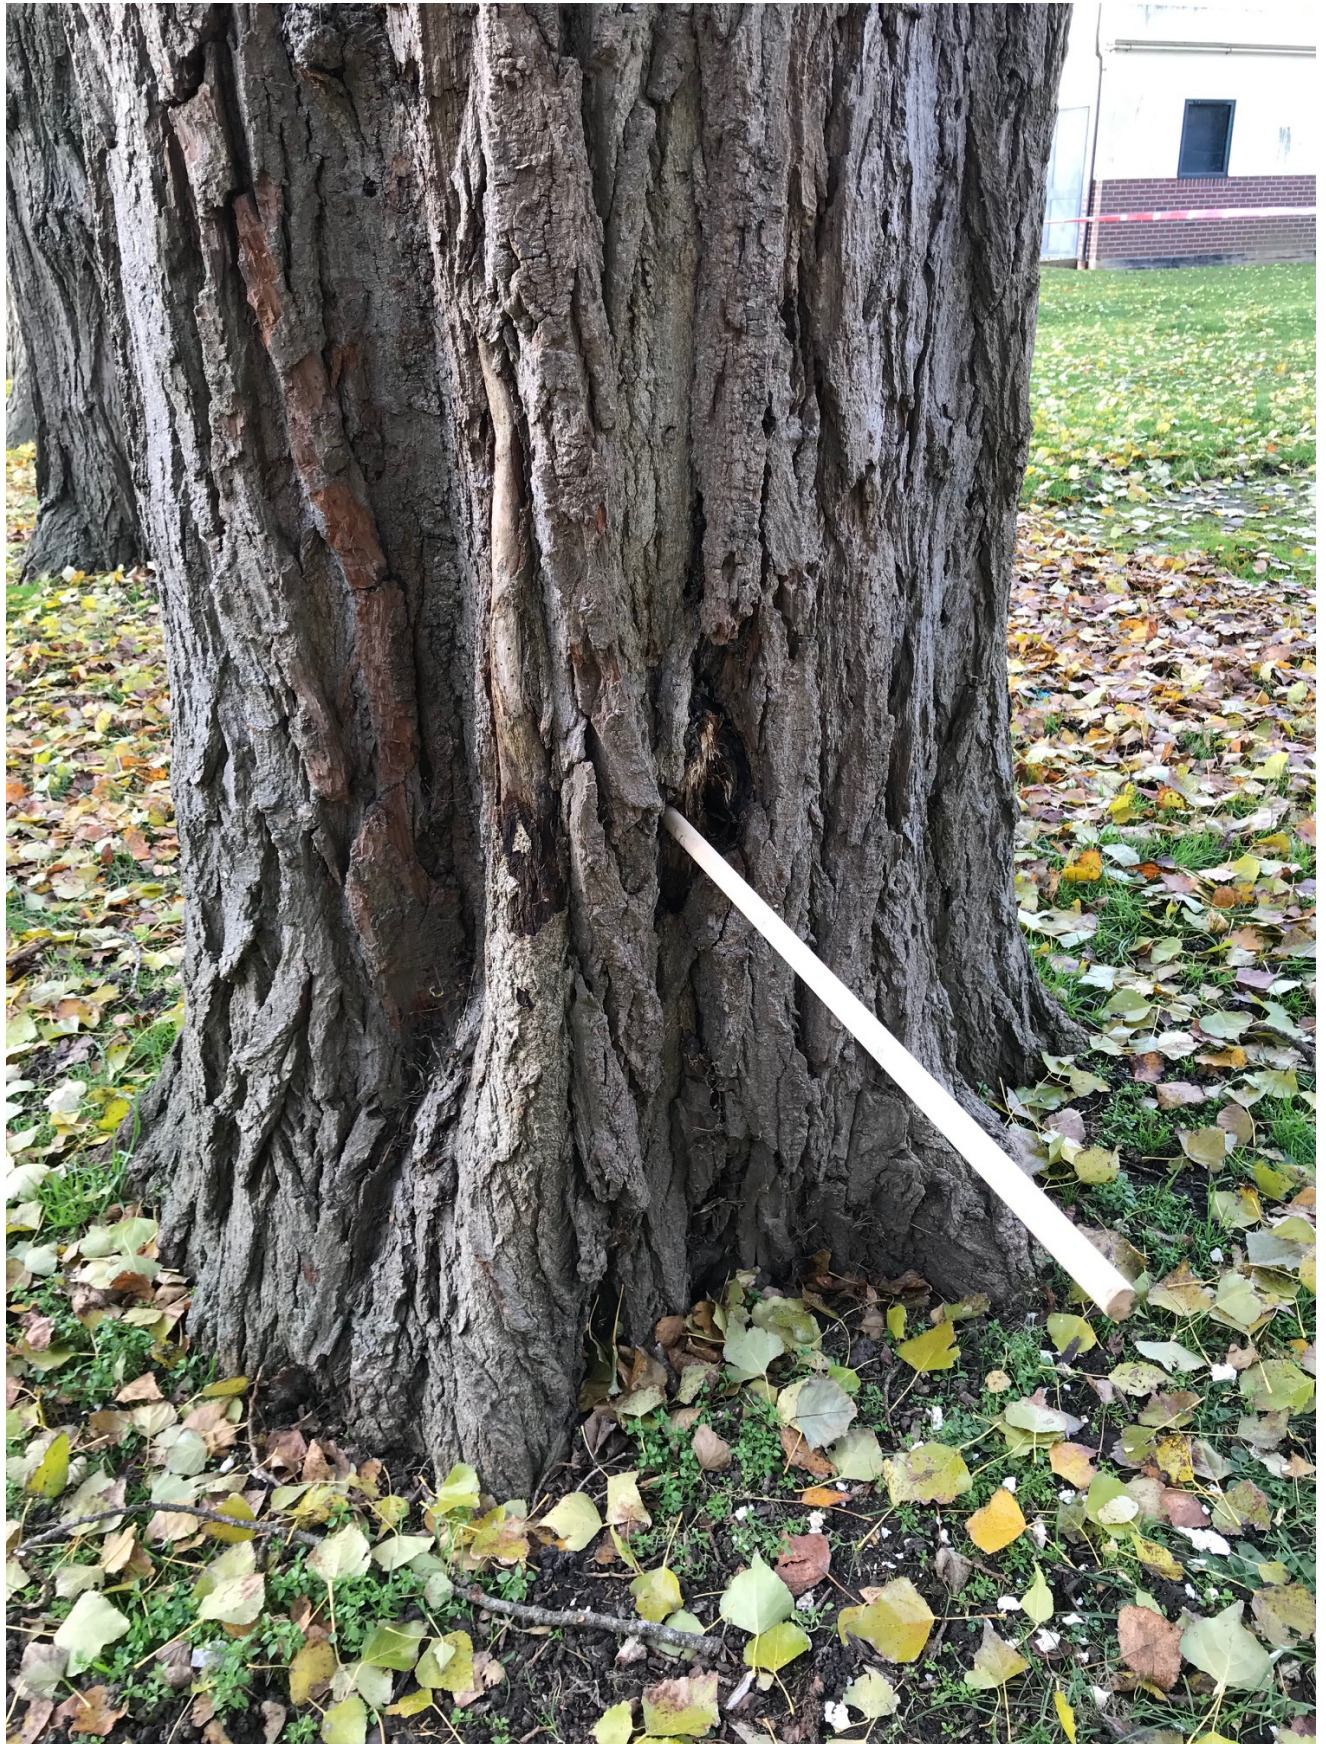
**Photo 9: Tree 6: Wooden probe inserted into trunk via wound to eastern flank**

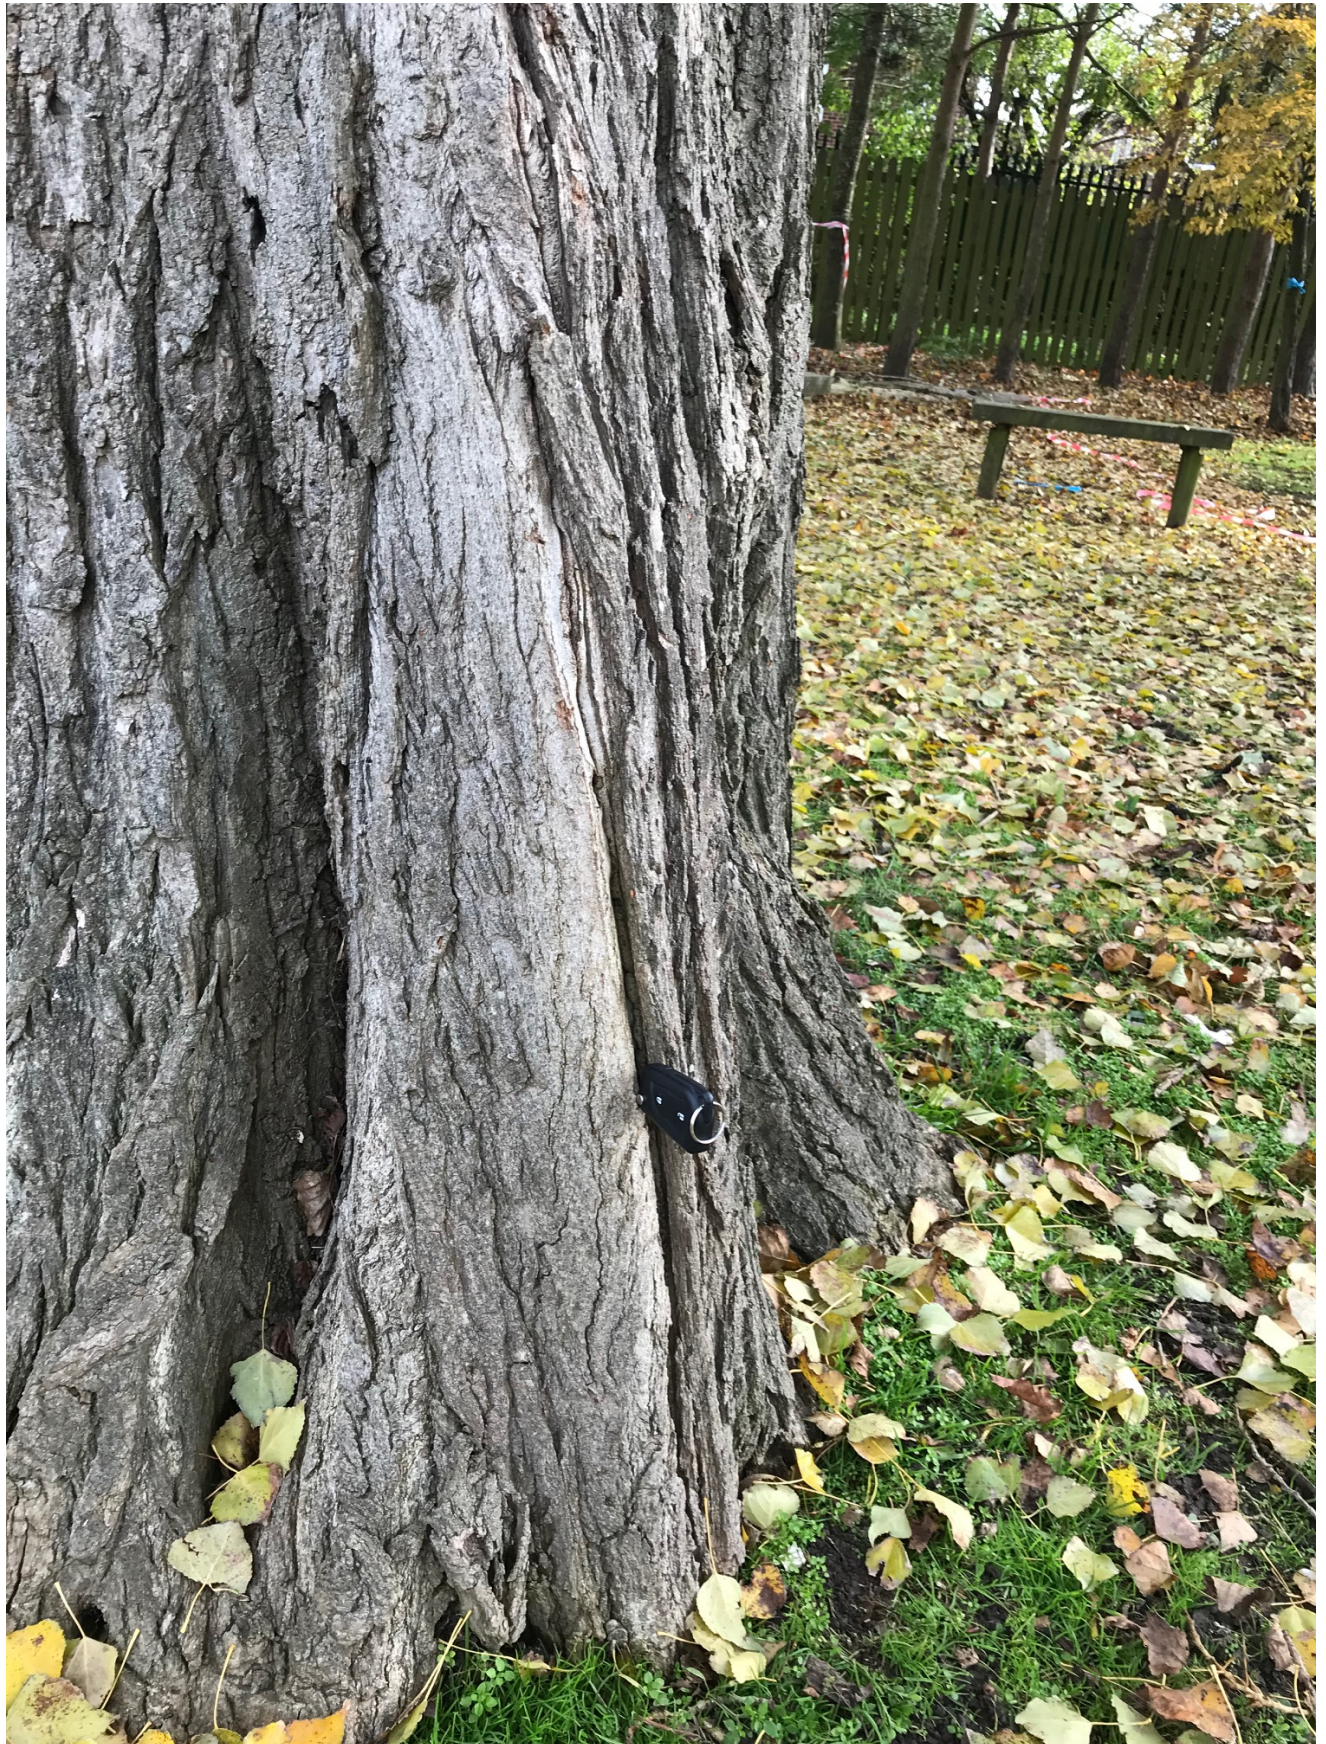
**Photo 10: Tree 6: Vertical crack to western flank.**

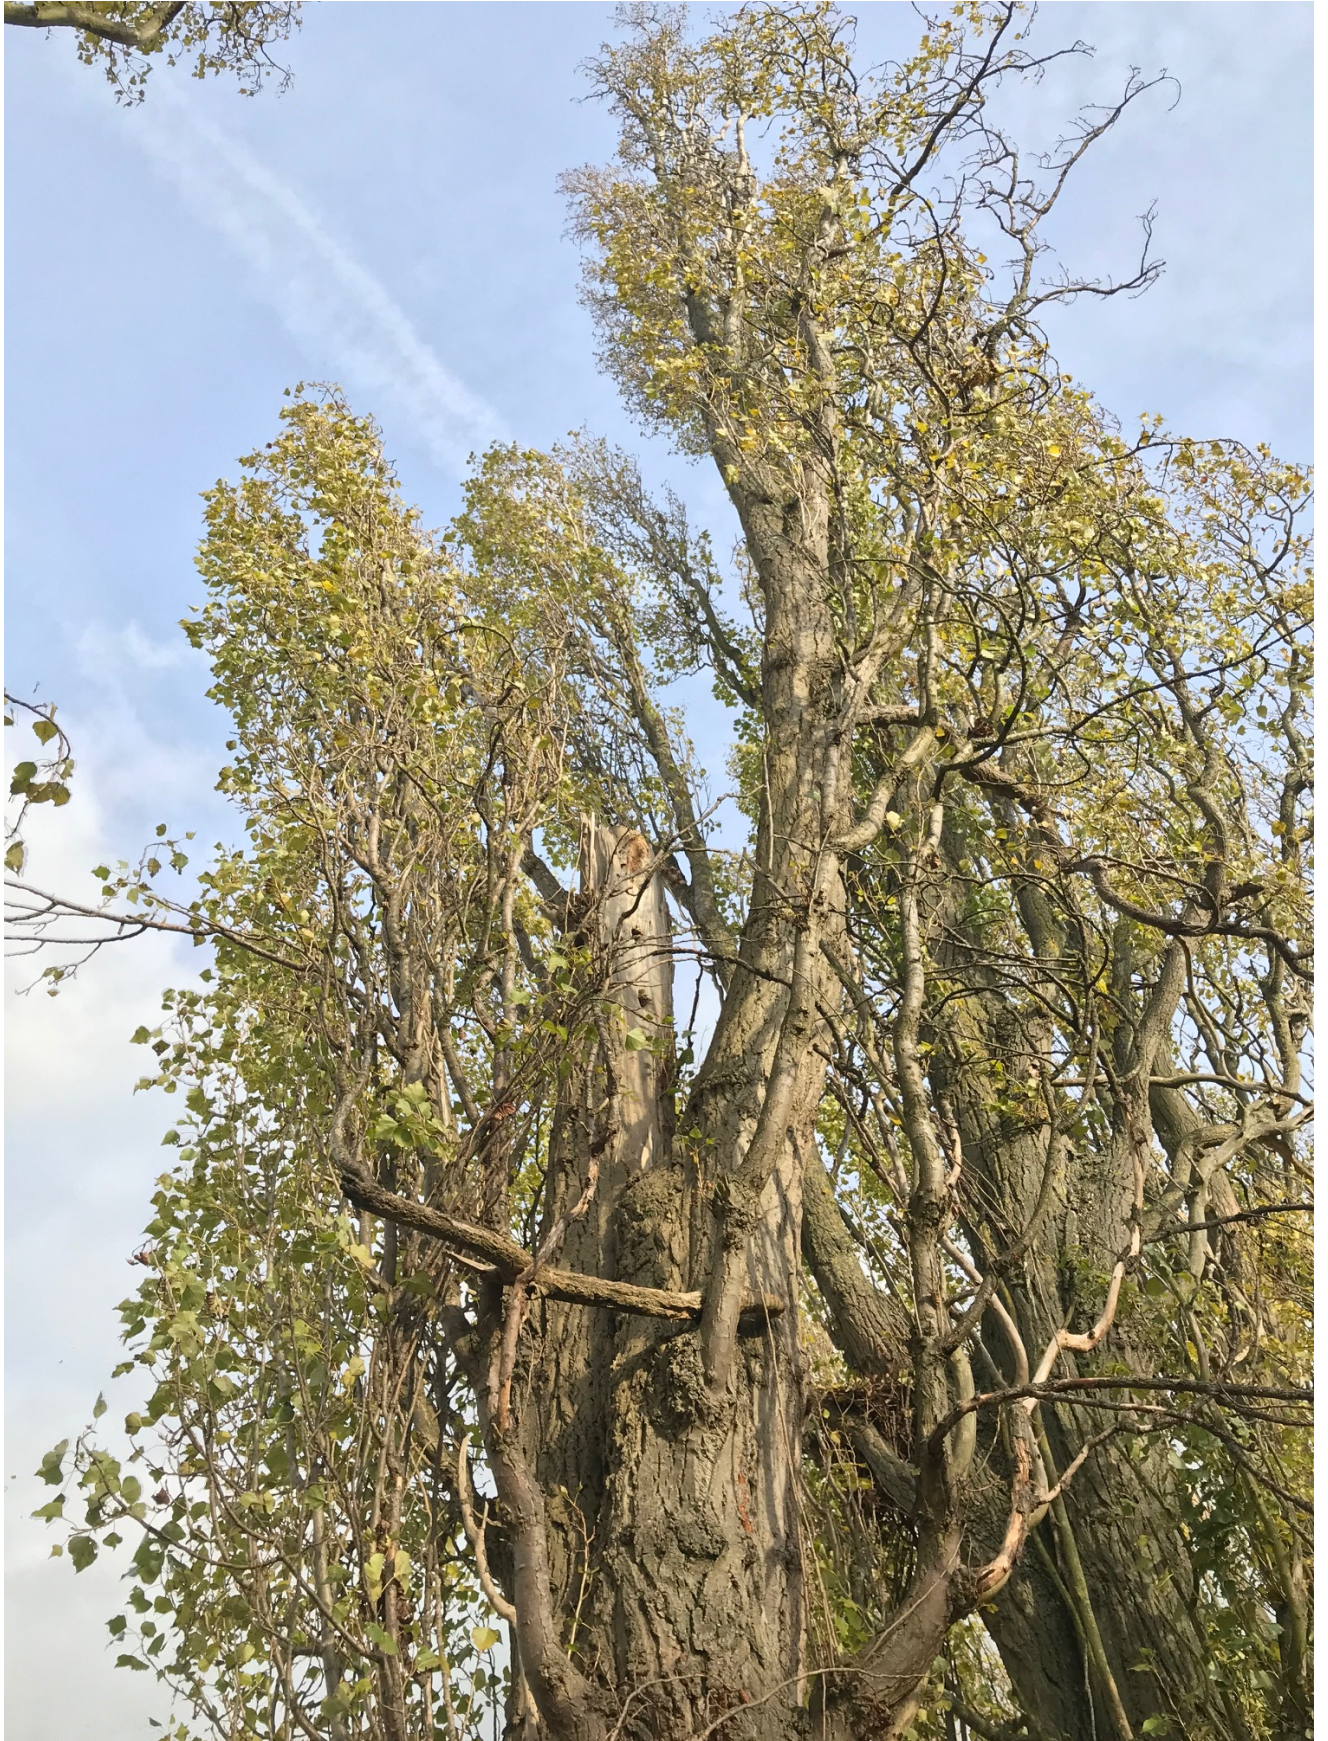
**Photo 11: Tree 6: Upper stem failure**
