*(tree inspection report by the tree agency)*

*(re: x 2 rows of lombardy poplar trees at hewens campus, hewens road, hayes, middlesex ub4 8jp)*

*(ref: dp/itc/1119/11/176.tir)*

*(date: 20<sup>th</sup> november 2019)*

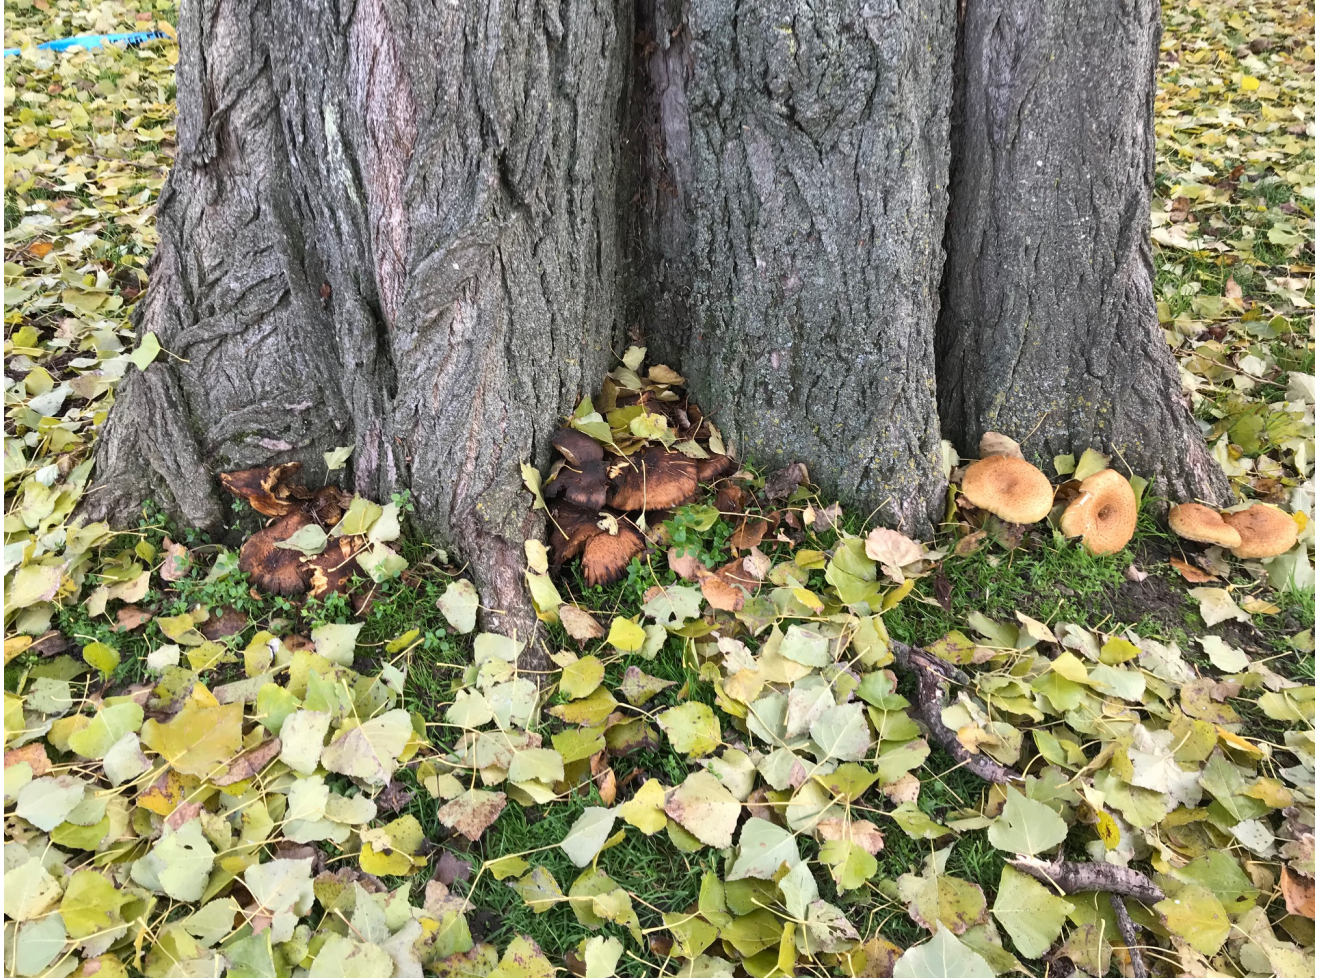
**Photo 12: Tree 7: Fungal growths to southern flank**

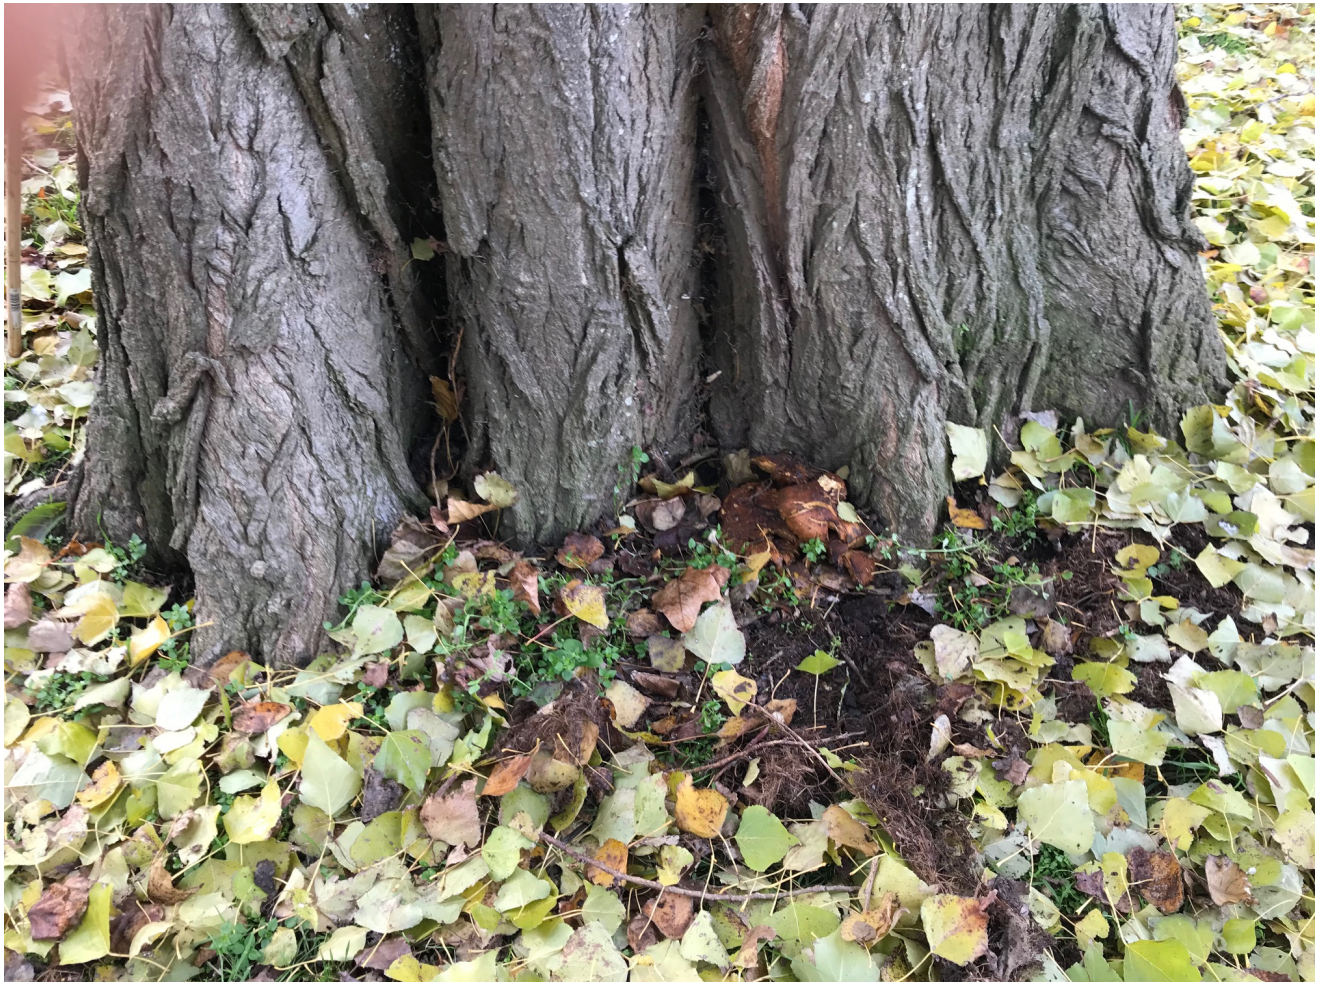
**Photo 13: Tree 7: Fungal growths to northern flank**

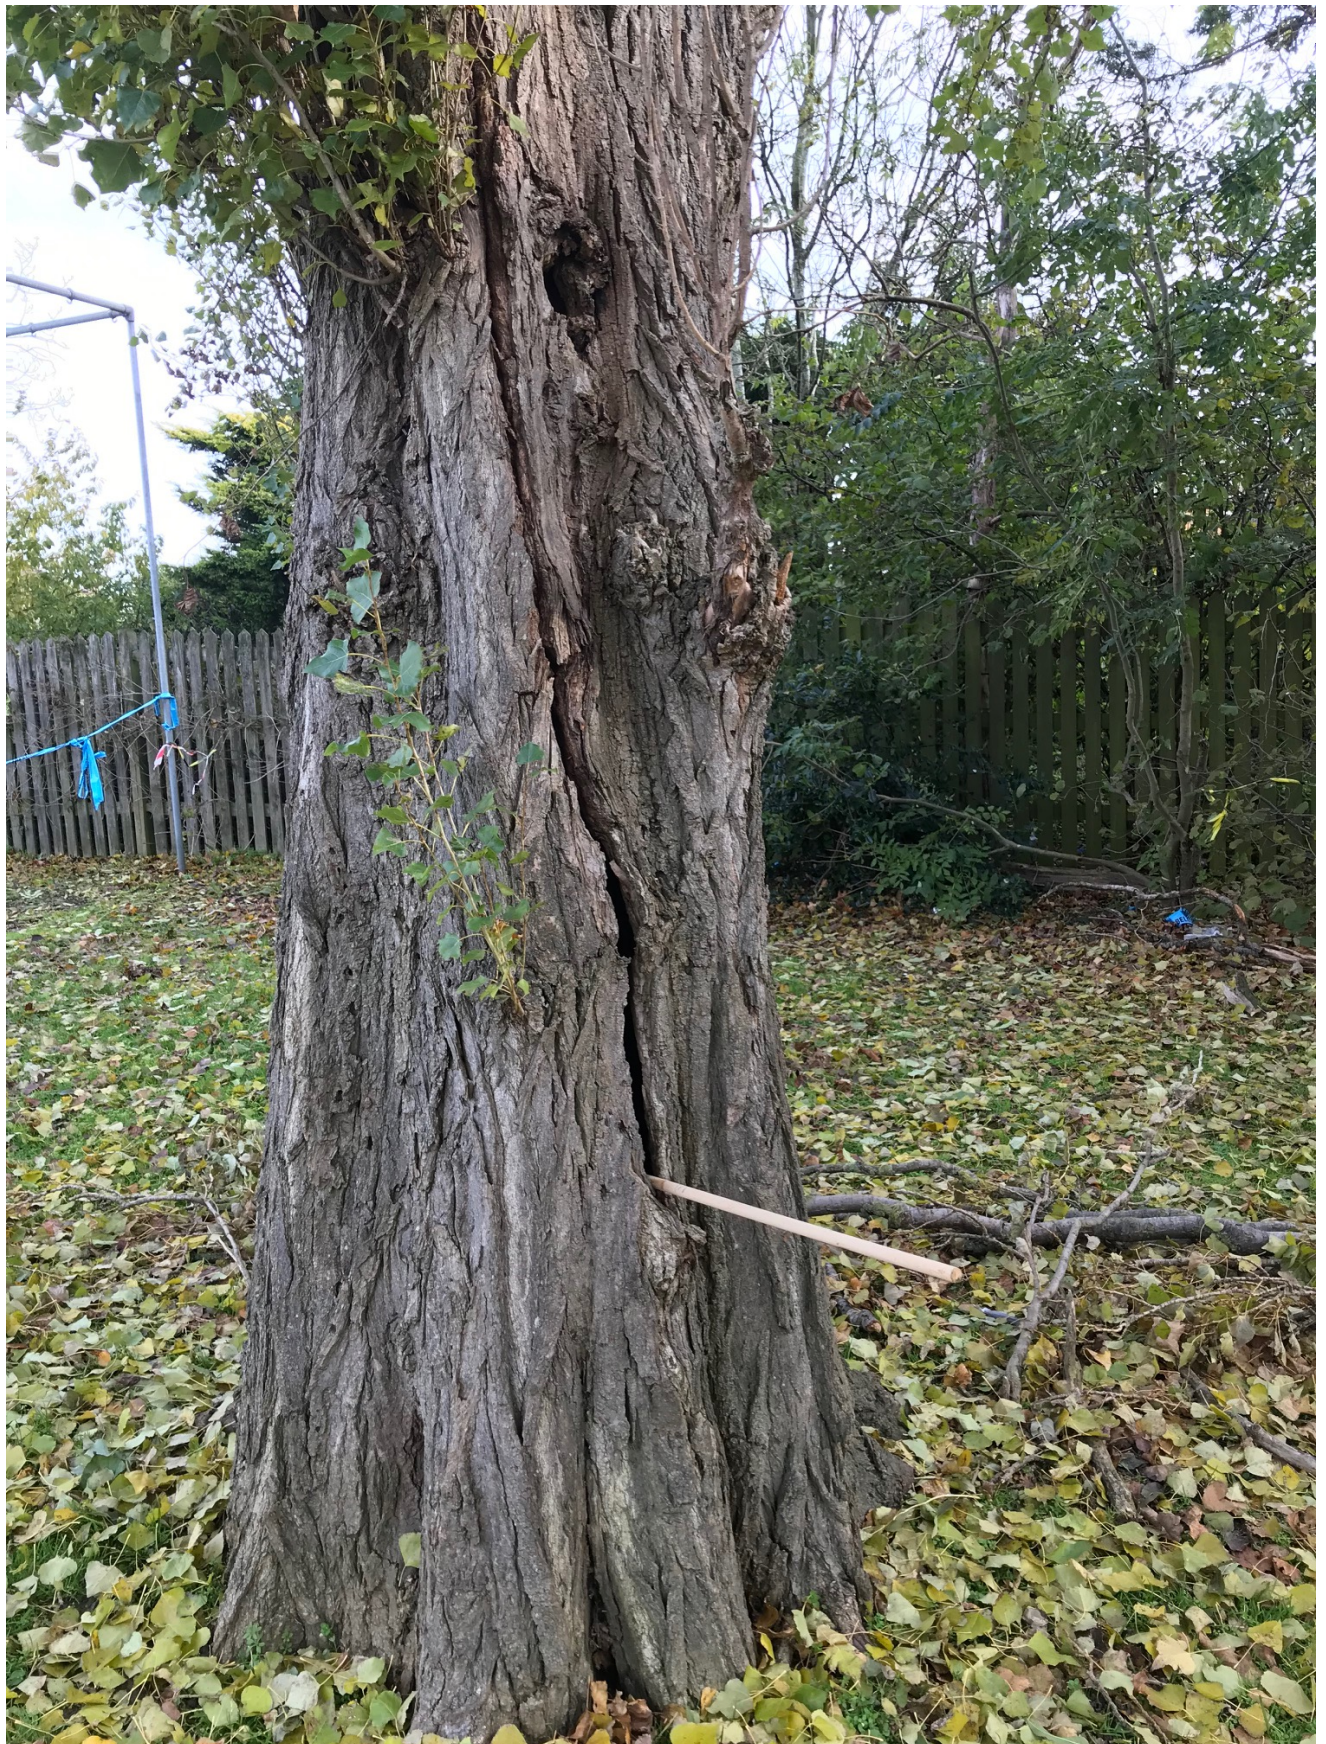
**Photo 14: Tree 8: Wooden probe inserted into vertical fracture**

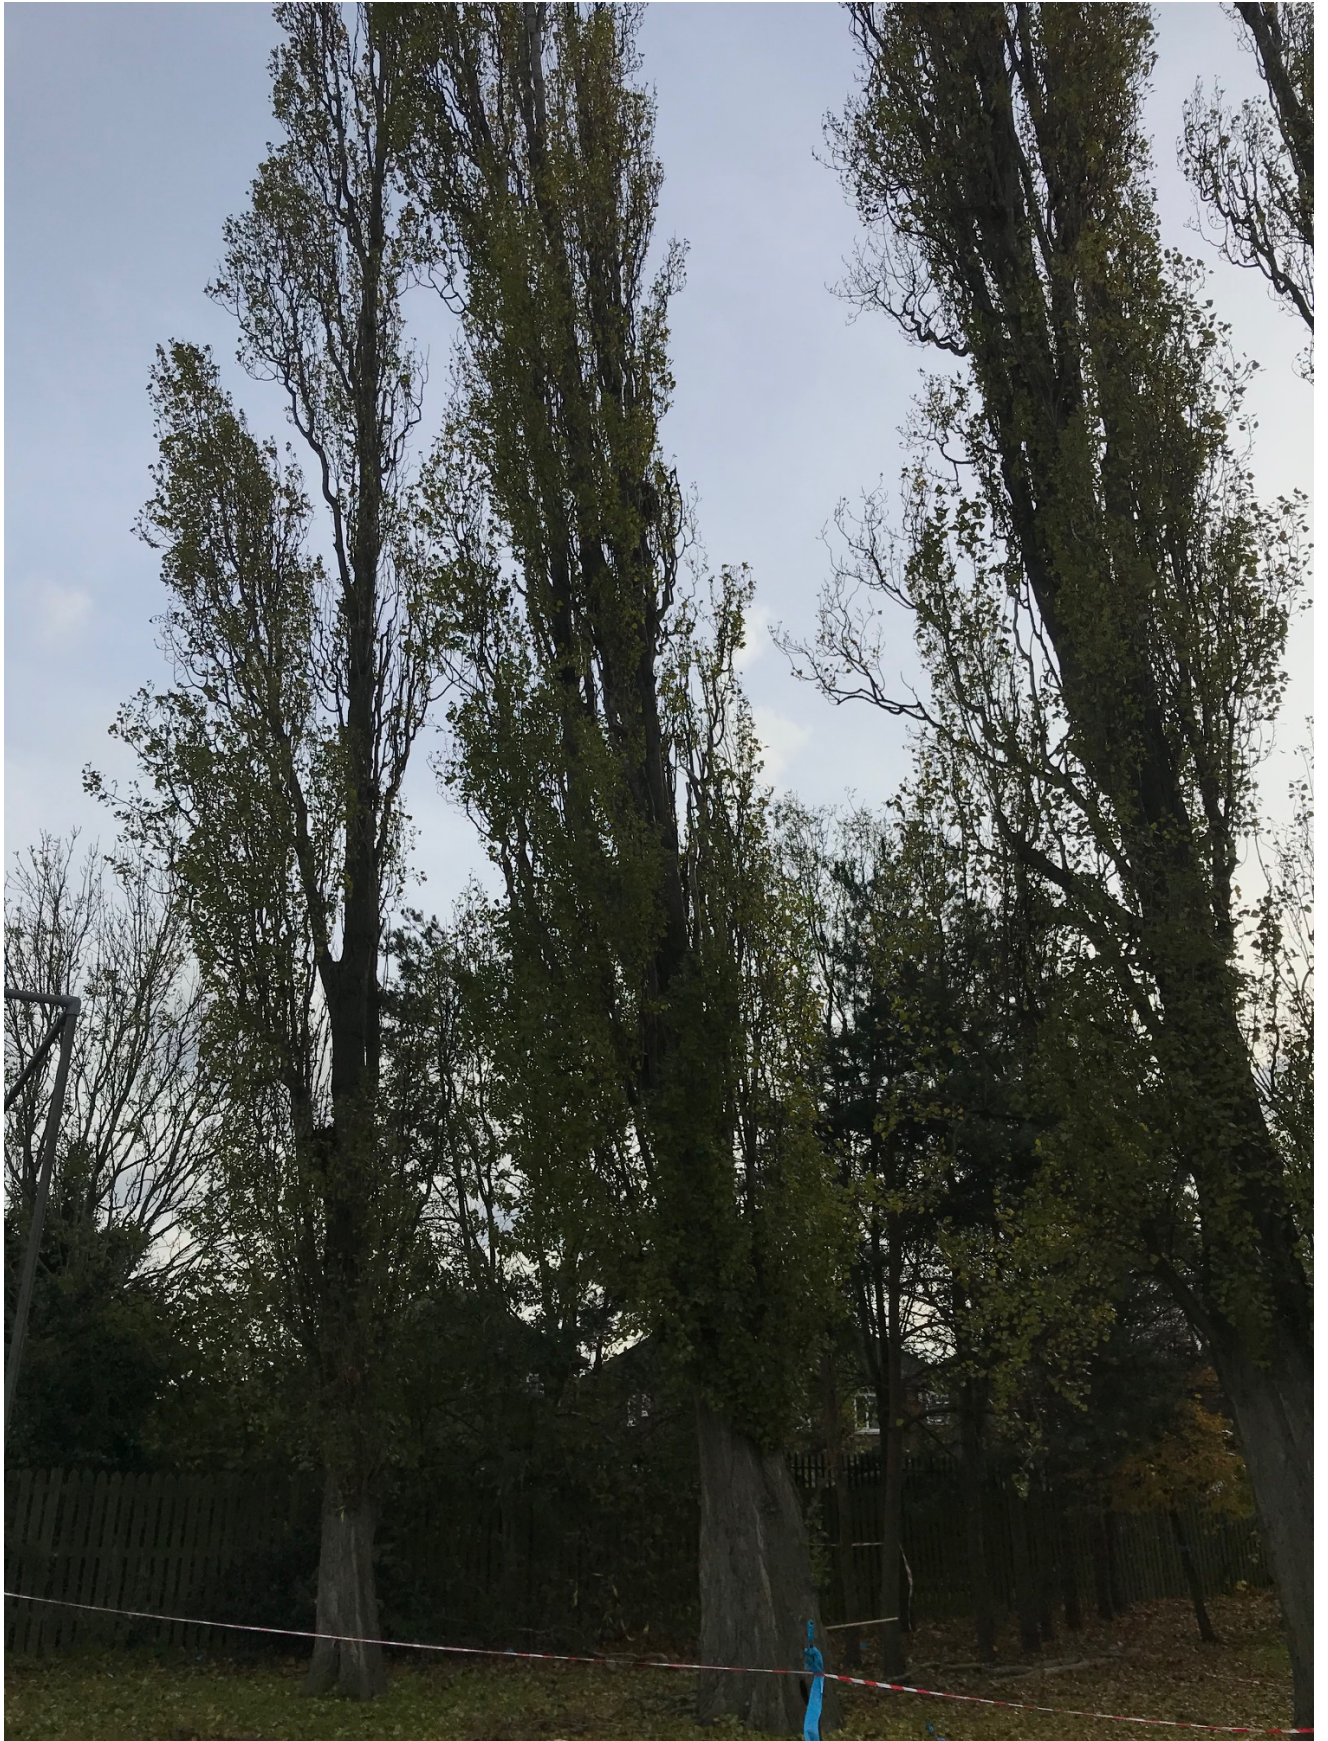
**Photo 15: Tree 8: Tree from west showing lean**

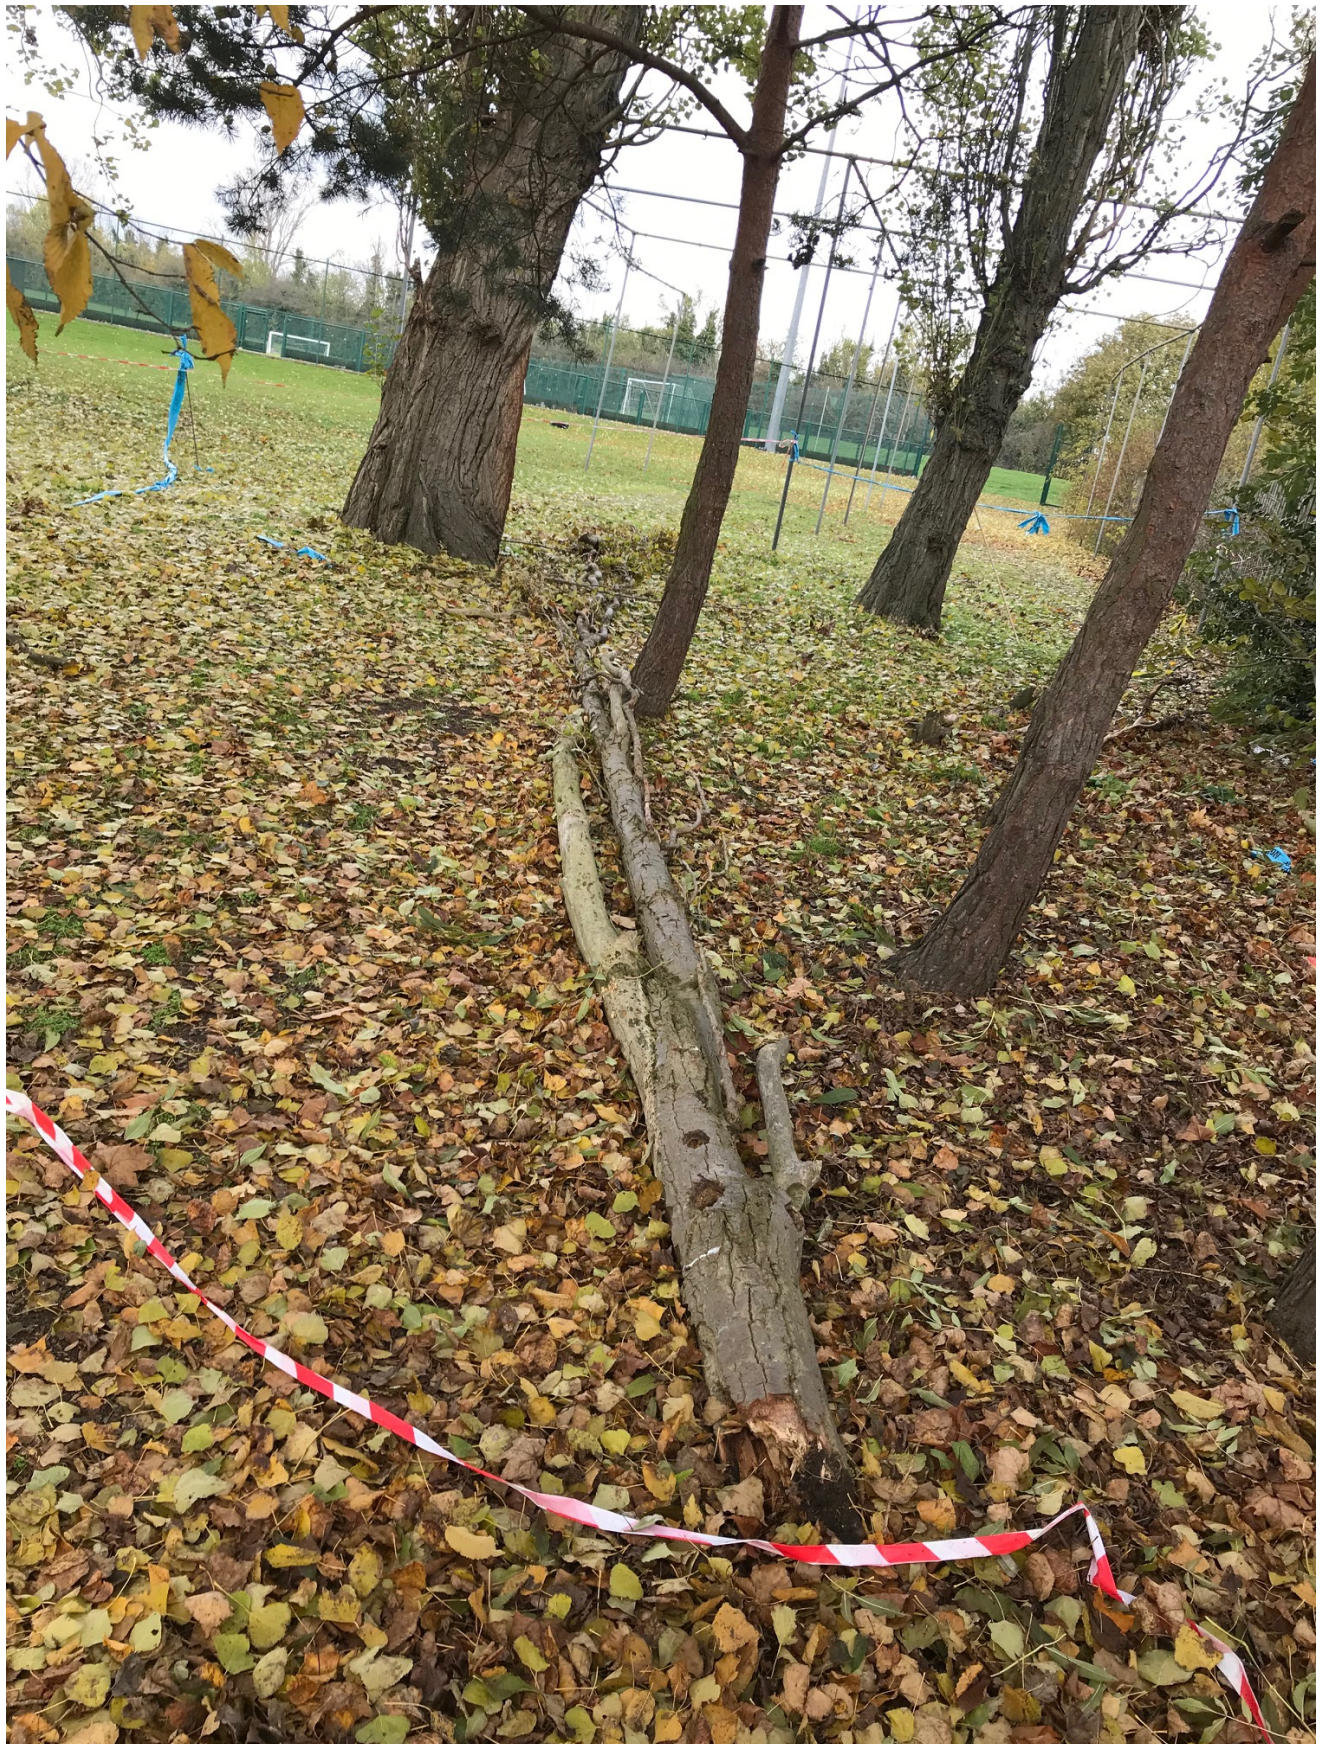
**Photo 16: Recent Fallen Limbs.**
