## APPENDIX B

*Engineers Logs*

Project Title: 113 Charville Lane

Client: Hillingdon Borough Council

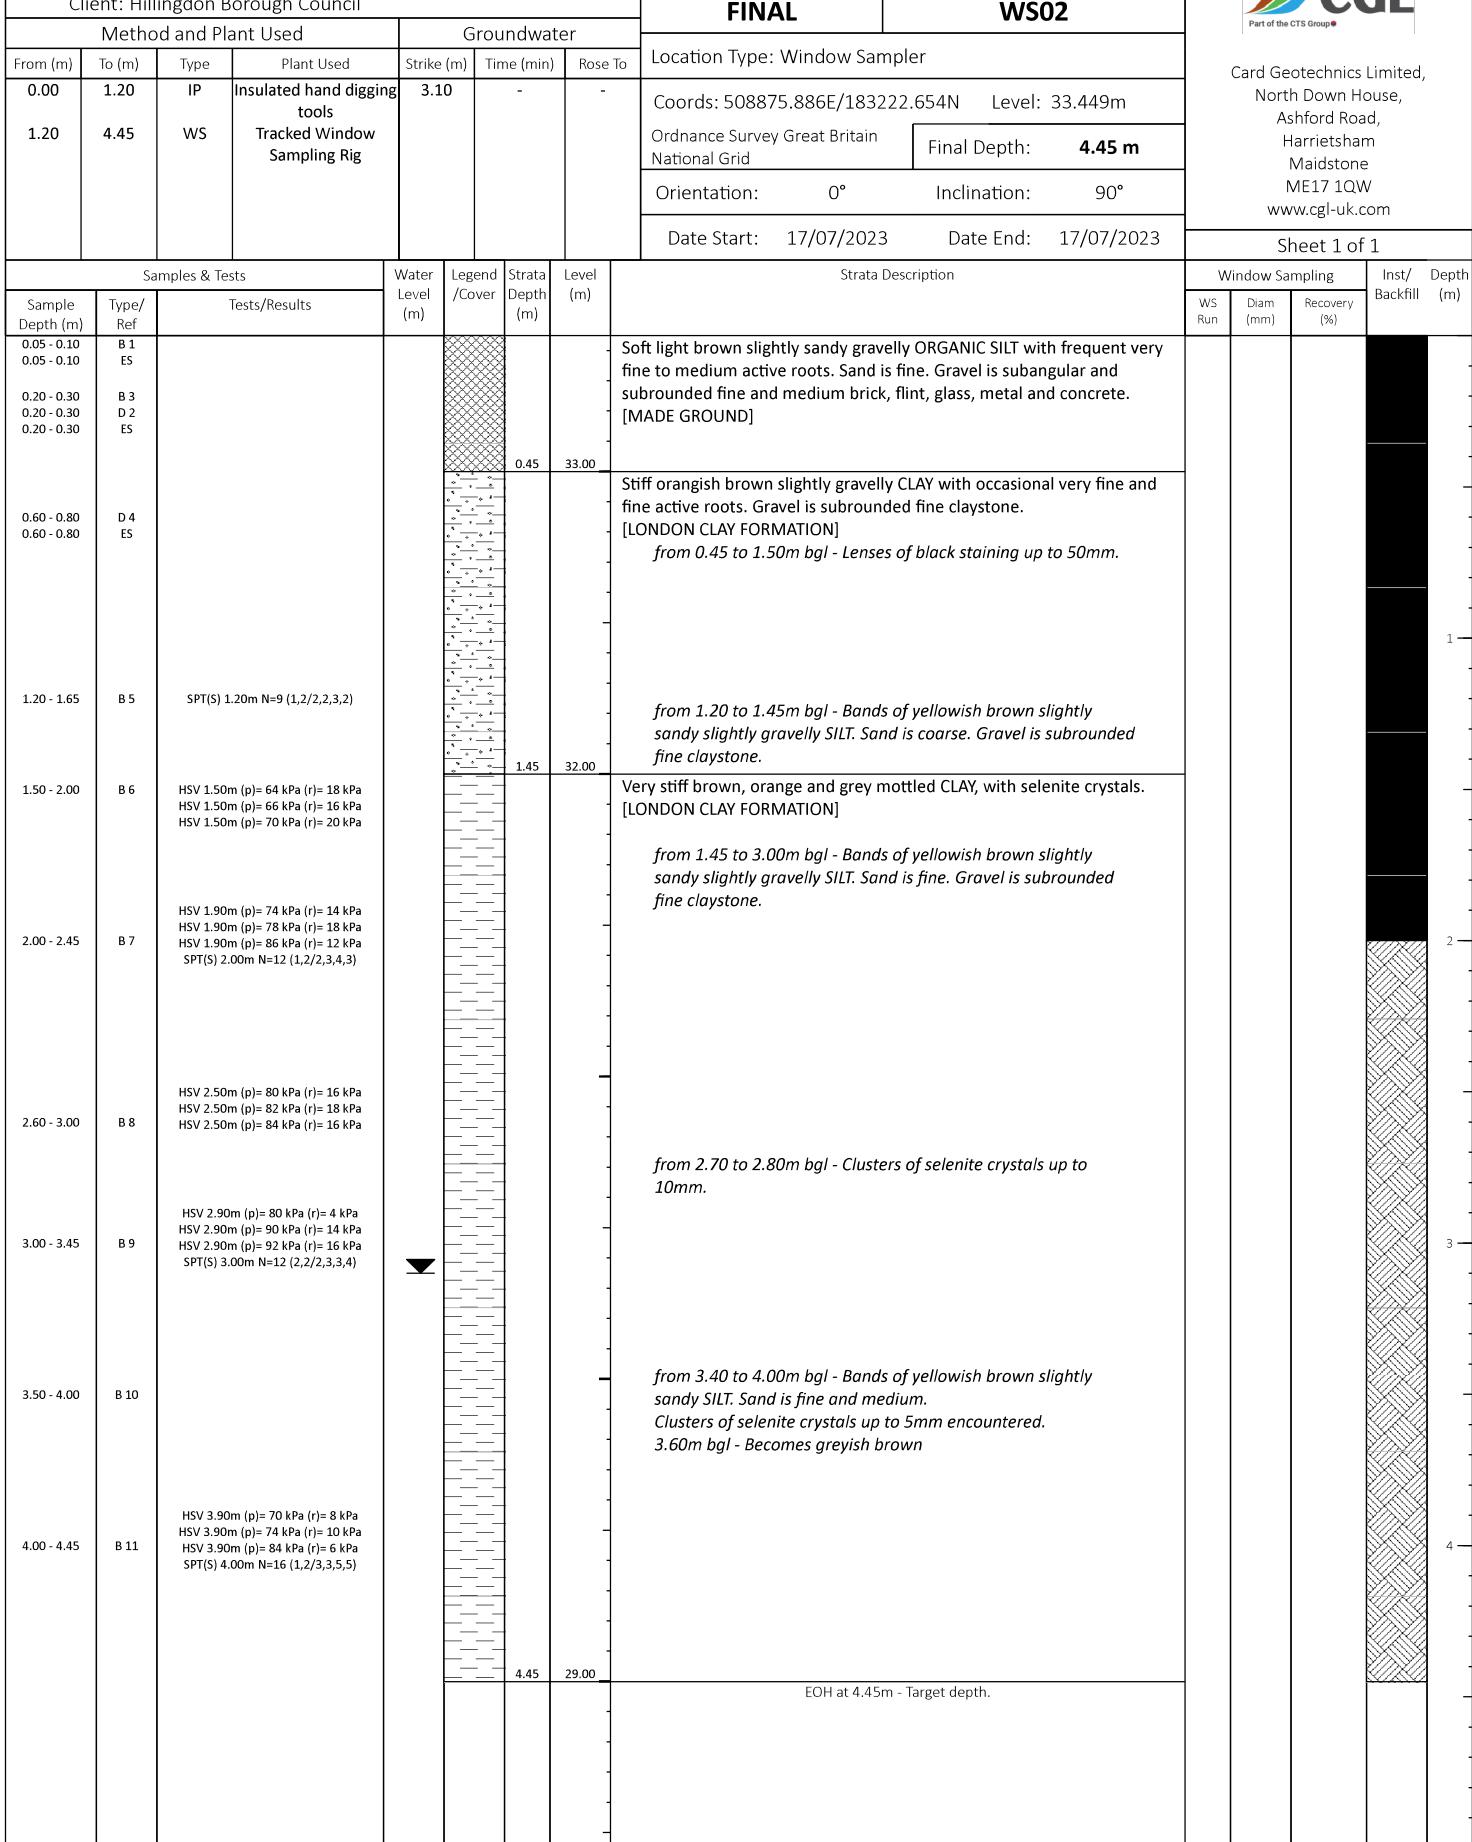
WS02

- Exploratory hole locations were surveyed by a Utilities Surveyor to clear the locations of underground services.
- Borehole was dry and stable upon completion.
- Groundwater seepage was recorded at 3.1m bgl.
- No visual or olfactory evidence of gross contamination was encountered.

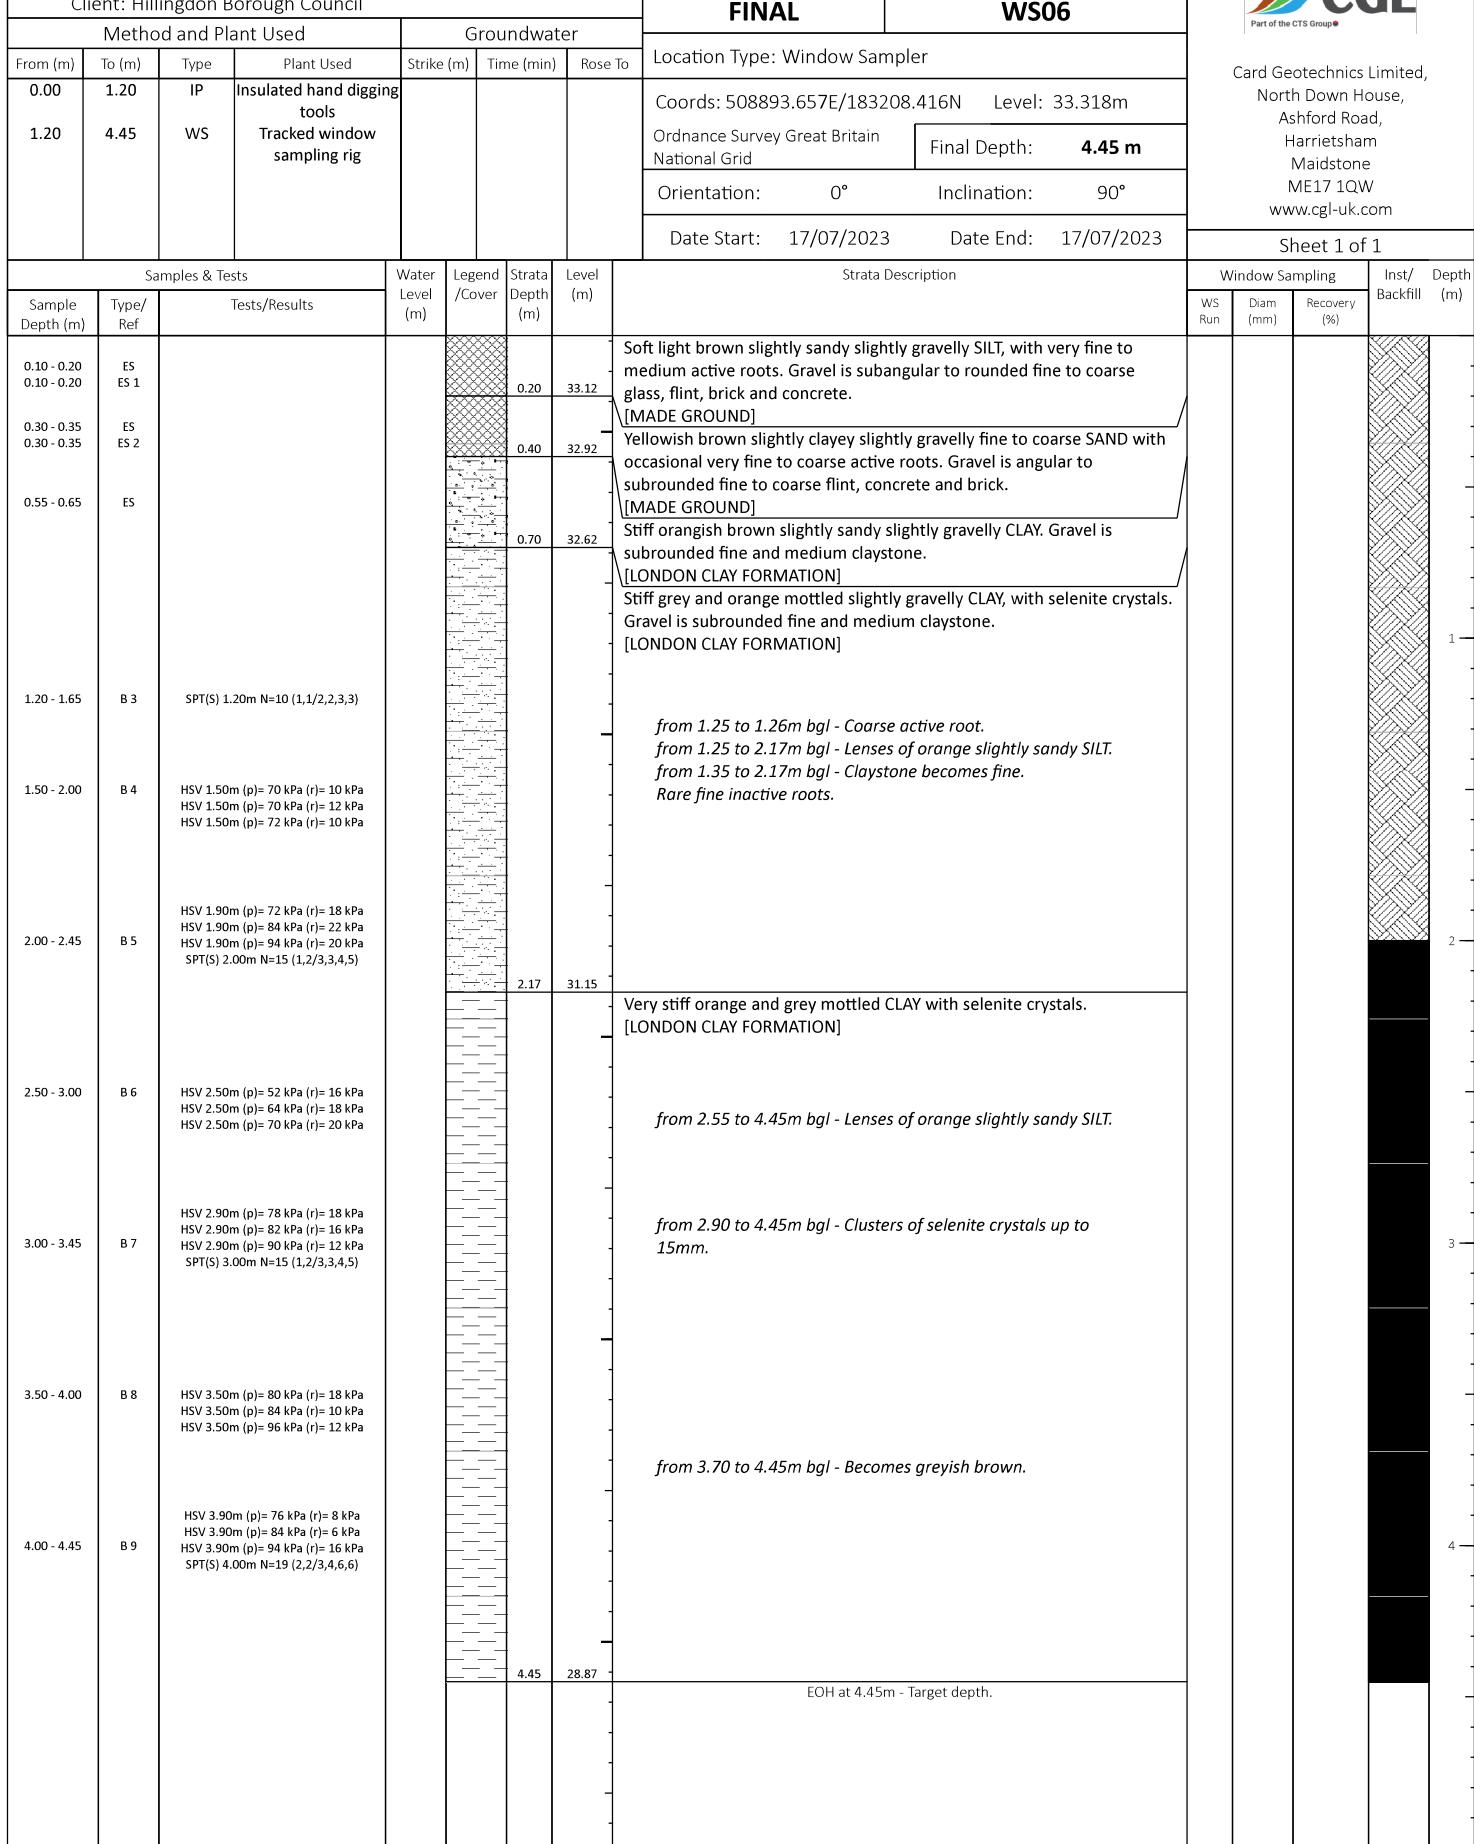
WS06

- Exploratory hole locations were surveyed by a Utilities Surveyor to clear the locations of underground services.
- Borehole was dry and stable upon completion.
- No groundwater was encountered.
- No visual or olfactory evidence of gross contamination was encountered.
- Location moved as coarse tree roots were encountered in first inspection pit.

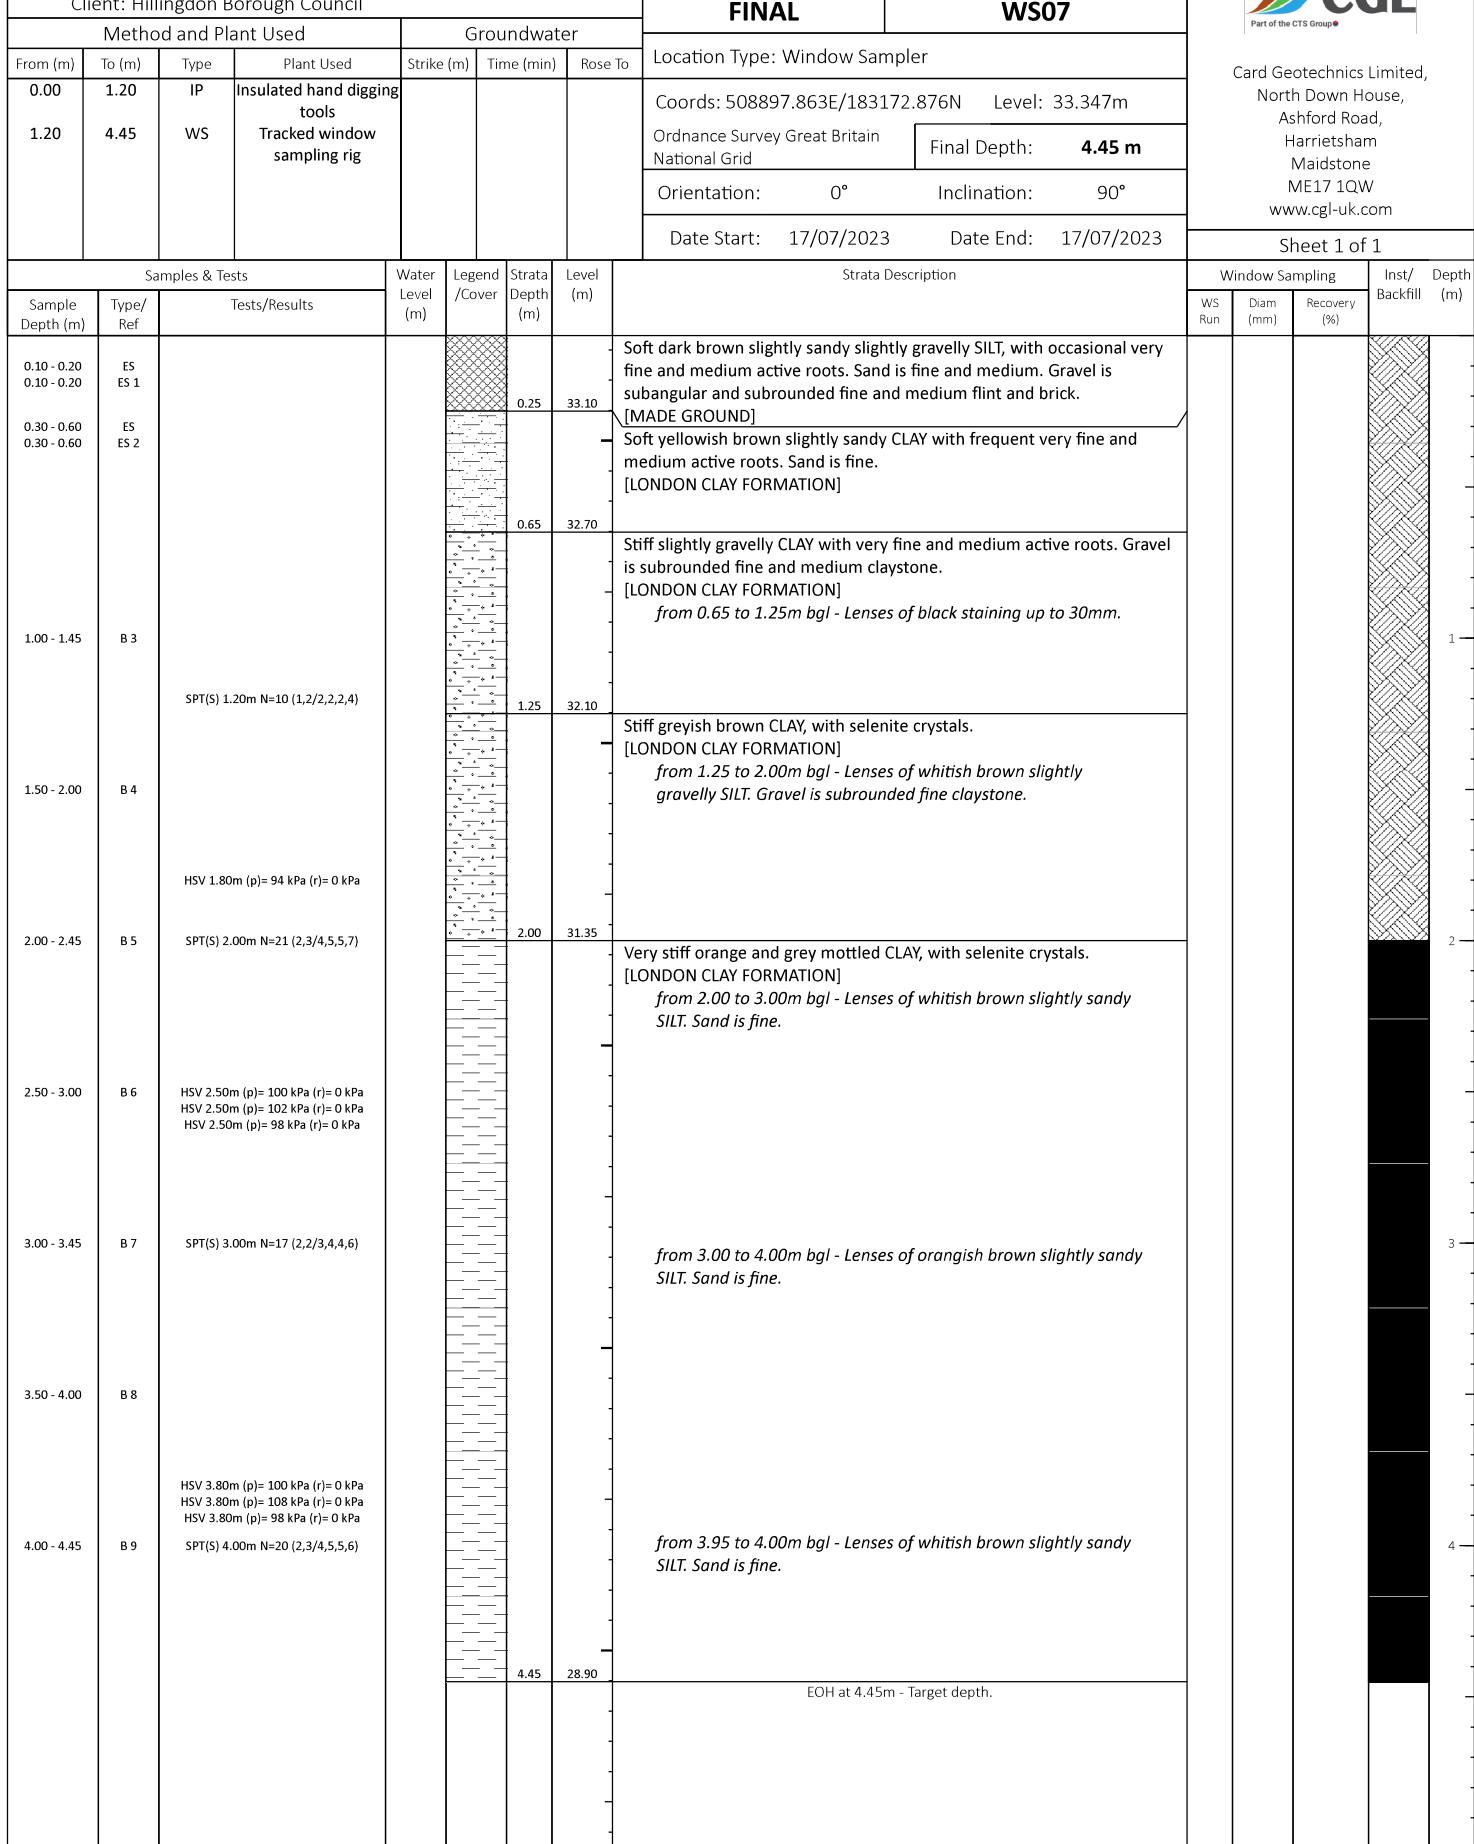
WS07

- Exploratory hole locations were surveyed by a Utilities Surveyor to clear the locations of underground services.
- Borehole was dry and stable upon completion.
- No groundwater was encountered.
- No visual or olfactory evidence of gross contamination was encountered.
- Shear vanes not undertaken in certain sections as the material was too desiccated.
