**DATE: October 2020**

**TREE CONDITION REPORT: 4 Warren Road, Uxbridge  
For Mr. Kishan Gohel**

**TREE CONDITION REPORT FOR OAK TREE AT 4 WARREN ROAD, UXBRIDGE. OCTOBER 2020**

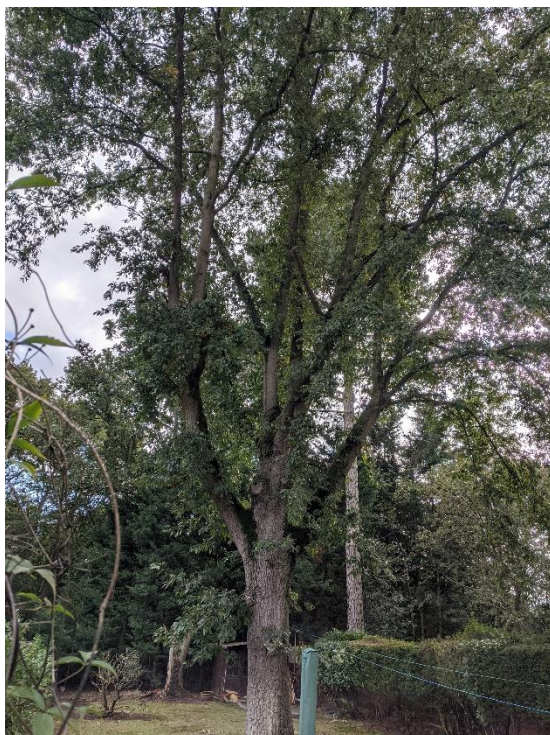
**IMAGE 1:** The tree viewed from the rear of the property.

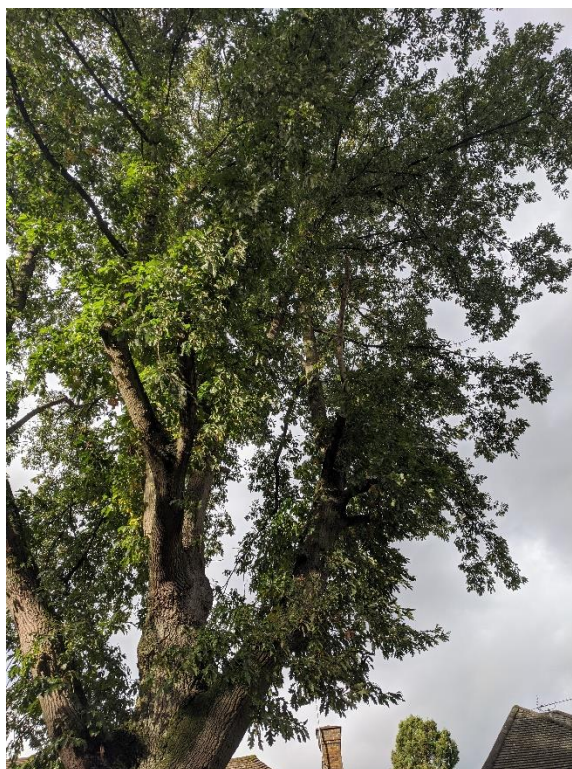
**IMAGE 2** The tree viewed from the south looking towards the house, looking in to the crown. Signs of epicormic growth are evident.

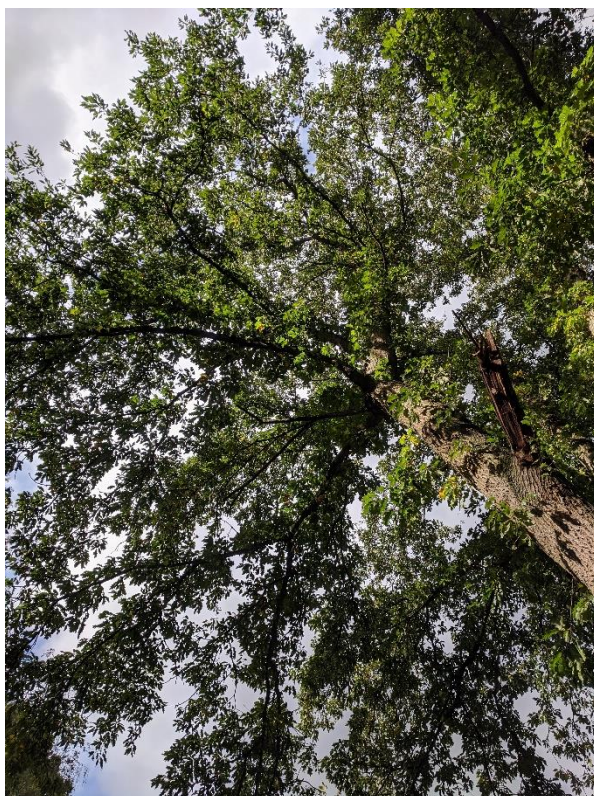
**The Tree:** The tree is a mature oak. It is showing signs of stress, with suckering and epicormic growth. There is a fungus at the base of the tree, most likely Ganoderma. There is dead wood within the crown and several large branches have broken from the crown recently.

**IMAGE 3** Looking up in to the crown of the tree. Notice stubs and dead wood present.

The preference is to replace the tree with a specimen that is young and vigorous. The suggestions include Silver Birch and Sweet Chestnut. The applicant is happy to plant a replacement in the rear garden, but recognises that one in the front garden would be more visible to the wider public.

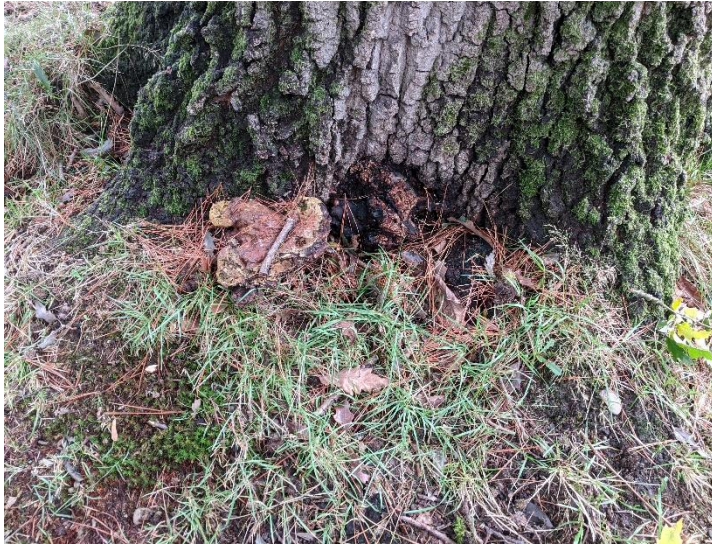
**IMAGE 5:** Fungus at the base of the tree.

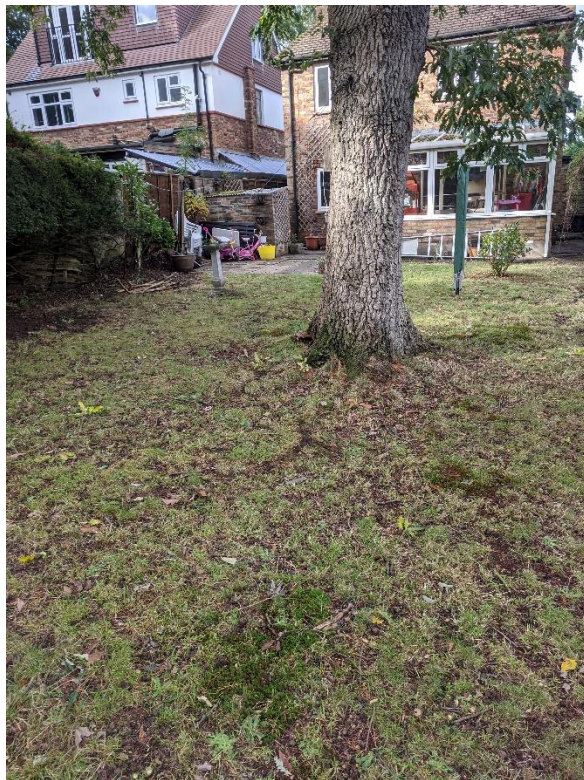
**IMAGE 6.** Ground around the tree.
