ADDENDUM ARBORICULTURAL REPORT

Crawford Reference: SU2206150

143 The Greenway

05 September 2023

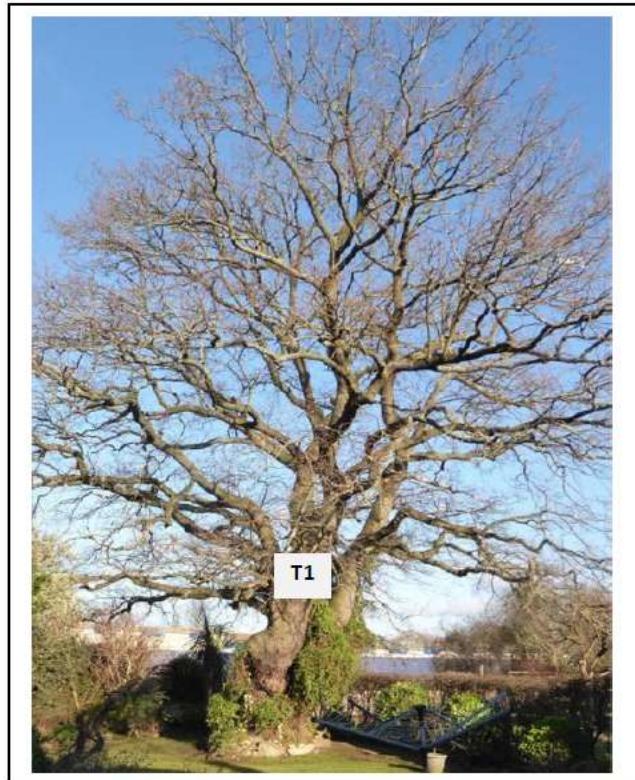
View of T1 Oak

The area of movement and damage is consistent with the locations of the subject Oak T1 and this is by far the most significant item of vegetation nearby that is likely to be causal.

The subject tree appears to pre-date the construction of the damaged structure therefore there is a theoretical risk of adverse soil heave occurring if the tree was to be removed entirely.

Oak T1 – Reduce height from 16.5m to circa 14m and reduce lateral spread from 20m to circa 8m, leaving a well-balanced crown (in accordance with BRE IP7/06 “Pruning trees to reduce water use” to mitigate root induced clay shrinkage subsidence. (subject to consent being granted under the TPO)
