Arboricultural Appraisal Report

Subsidence Damage Investigation at:

143 The Greenway
Ickenham
Uxbridge
UB10 8LT

CLIENT: Crawford & Company
CLIENT REF: SU2206150
MWA REF: SUB221129-11483
MWA CONSULTANT: Andy Clark
REPORT DATE: 12/04/2023

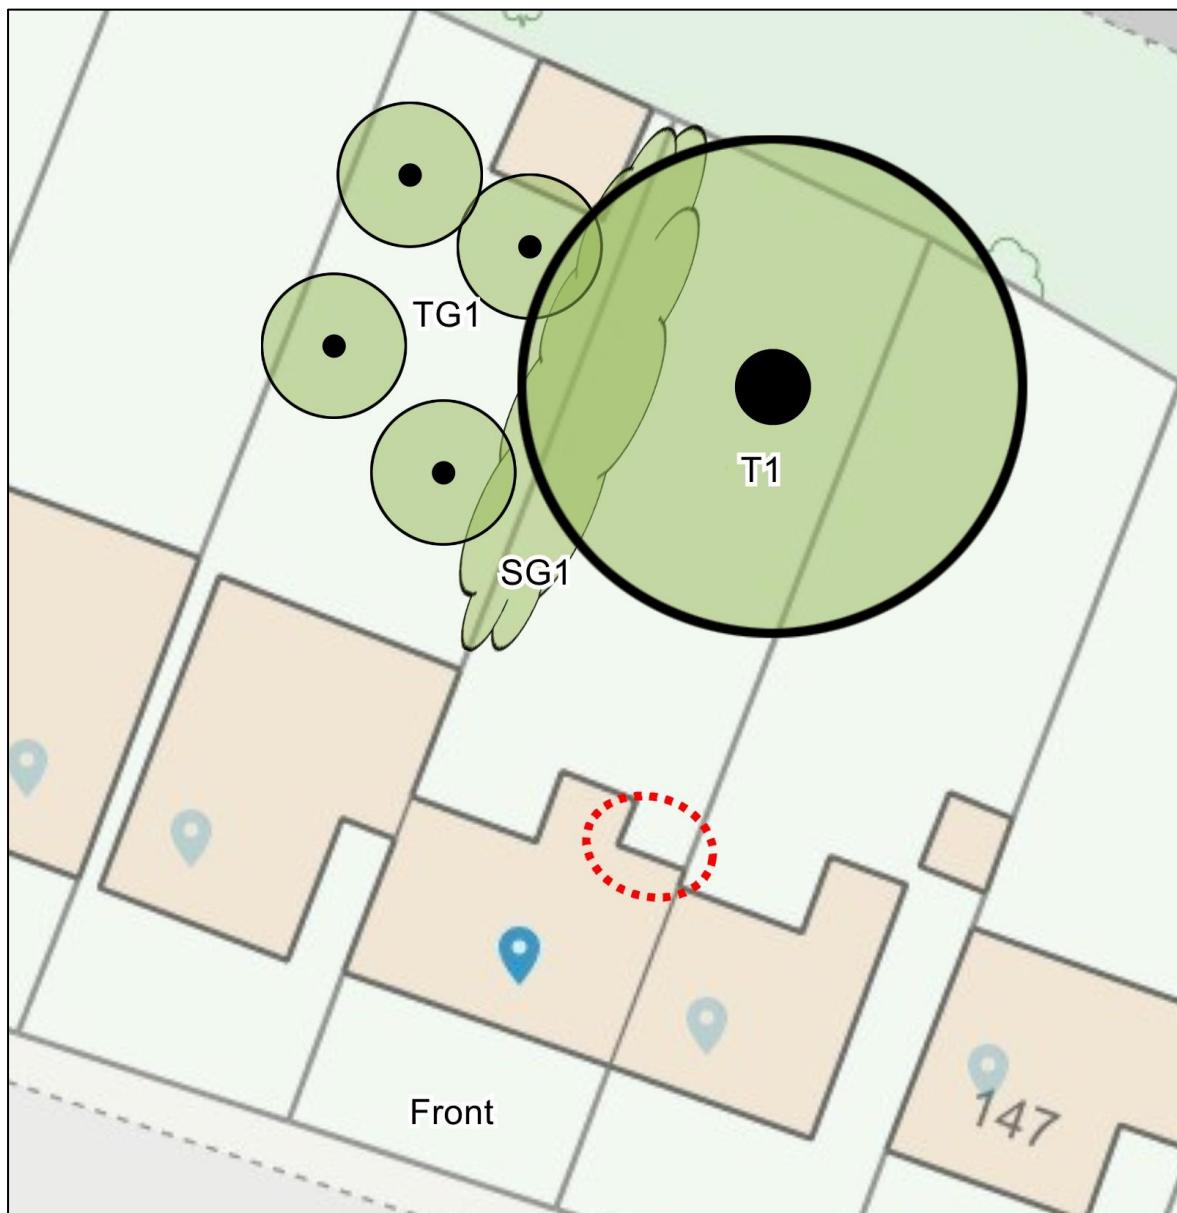
Site Plan

Approximate areas of damage

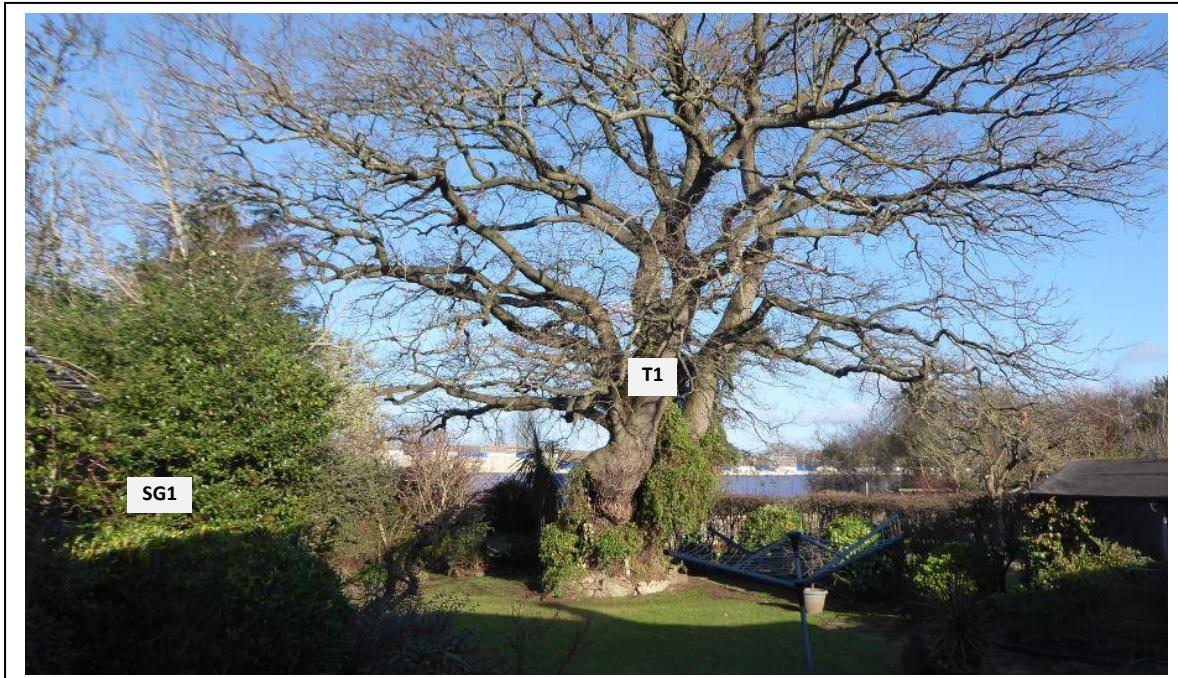
Our survey has identified vegetation within influencing distance of the building with a current potential to influence soil volumes below foundation level; the most significant of which in relation to the current damage is T1 Oak.

View of T1 Oak, with SG1 group to left of frame

If an arboricultural solution is to be implemented to mitigate the influence of the trees/shrubs considered to be responsible for the damage we recommend that T1 Oak is subject to significant crown reduction in order to reduce the trees moisture uptake.

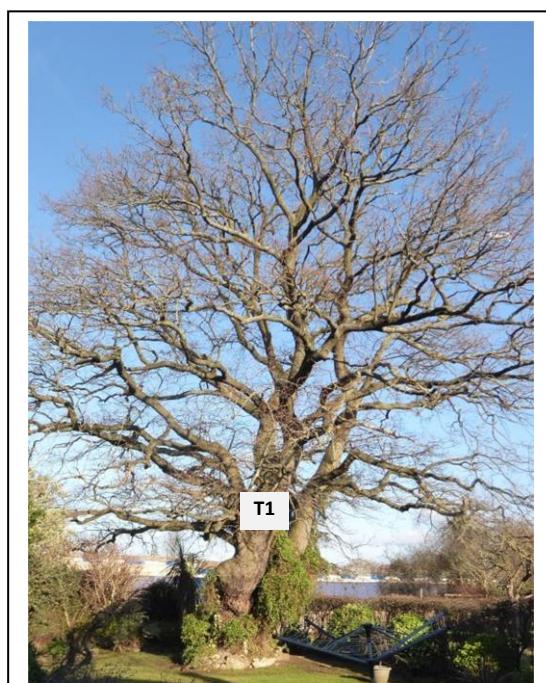
View of T1 Oak
