## ADDENDUM ARBORICULTURAL REPORT

Crawford Reference: 1786071 / SU2206150

**143 The Greenway**

29 July 2024

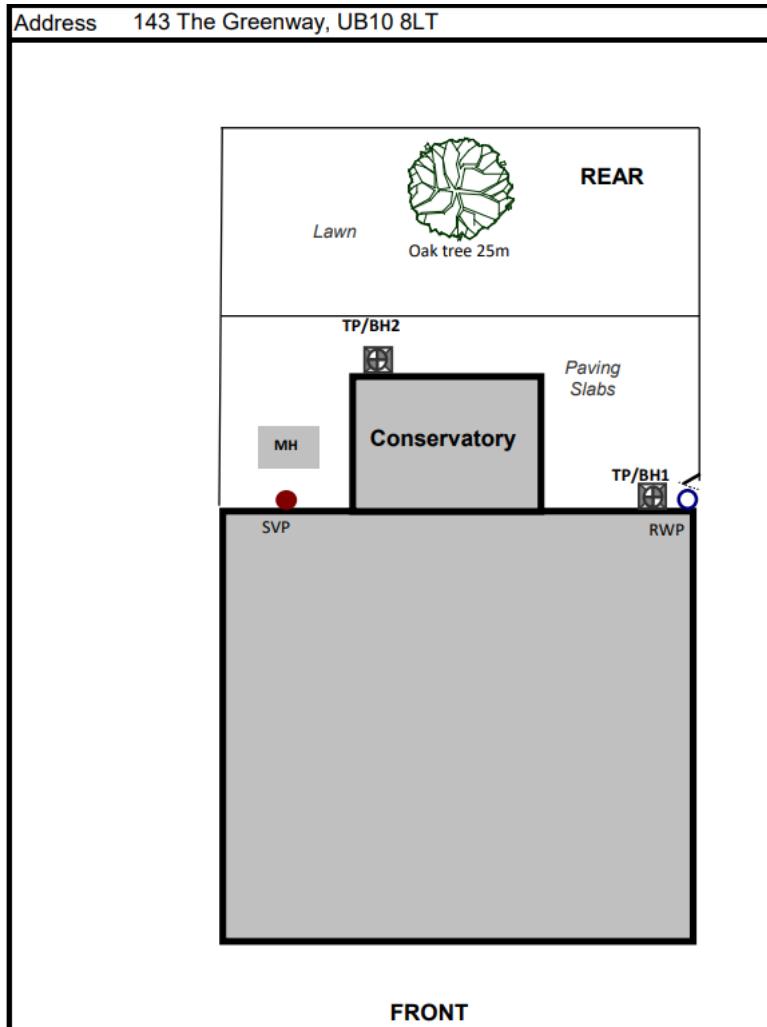
Site investigations undertaken during May 2024, which were not available at the time of the previous application, confirm 700mm deep foundations of the main house and rear conservatory, bearing on soil containing slightly sandy, slightly gravelly clay. The clay has medium to high plasticity meaning it can significantly shrink and swell seasonally due to fluctuations in moisture content.

In BH1 and BH2 the moisture content is less than 50% of the liquid limit and far closer to the plastic limit, indicating that there is the onset of desiccation. It is notable that the sampling was undertaken

during May, at a time of year when soil moisture deficits due to root activity would be at their lowest and we would expect significantly drier soil during summer months when roots are active.

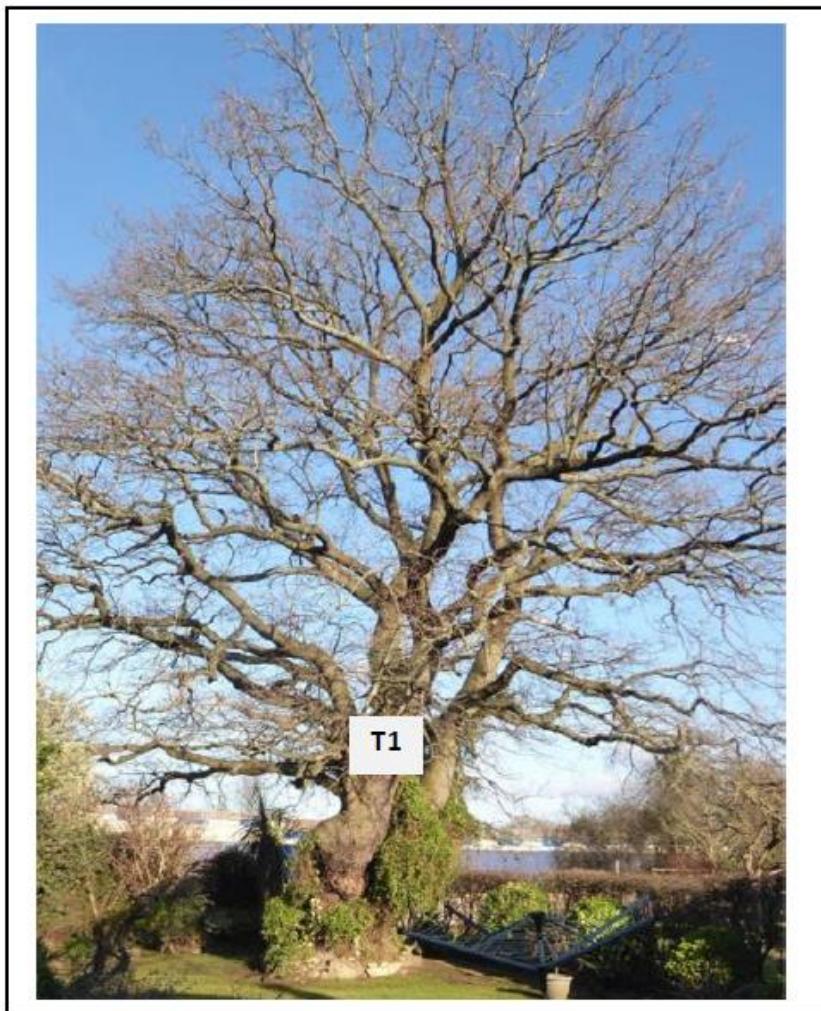
**View of T1 Oak**

According to the standard published work on the subject (Cutler, D.F. and I.B.K. Richardson, (1989) further confirmed by Mercer, Reeves & O'Callaghan (2011) in shrinkable clay soils, Oak species are capable of causing subsidence damage at distances up to 30m, with 75% of cases occurring where the tree was within 18m. The Oak T1, at only 14m, is therefore well within its species' potential rooting and influencing distance of the building and would be capable of causing seasonal soil drying beneath foundations.

The area of movement and damage is consistent with the locations of the subject Oak T1 and this is by far the most significant item of vegetation nearby that is likely to be causal.

**Oak T1** –Reduce height from 16.5m to circa 14m and Reduce lateral RADIUS to 8m which would leave a lateral SPREAD of 16m leaving balanced crown, leaving a well-balanced crown (in accordance with BRE IP7/06 “Pruning trees to reduce water use” to mitigate root induced clay shrinkage subsidence. (subject to TPO consent being granted).

**Statutory Controls** – The Oak T1 is covered by a Tree Preservation Order administered by the London Borough of Hillingdon, therefore an application is required and consent needs to be granted prior to any tree works occurring.

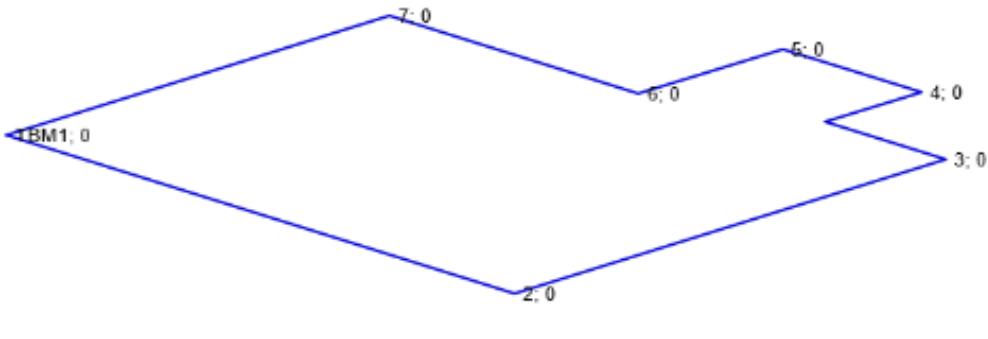
Monitoring shows 18mm of upward differential movement from Sept 23 to June 24. We anticipate that downward movement will again occur later during summer 2024. The degree of uplift/recovery indicates that there must have been significant downward movement during summer 2023, despite it being a much wetter summer than that of summer 2022 when damage occurred.
