Addendum Arboricultural Report

Subsidence Damage Investigation at:

143 The Greenway
Ickenham
Uxbridge
UB10 8LT

CLIENT: Crawford & Company
 CLIENT REF: SU2206150 / 1786071
 MWA REF: SUB221129-11483Rev01
 MWA CONSULTANT: Andy Clark
 REPORT DATE: 26/07/2024

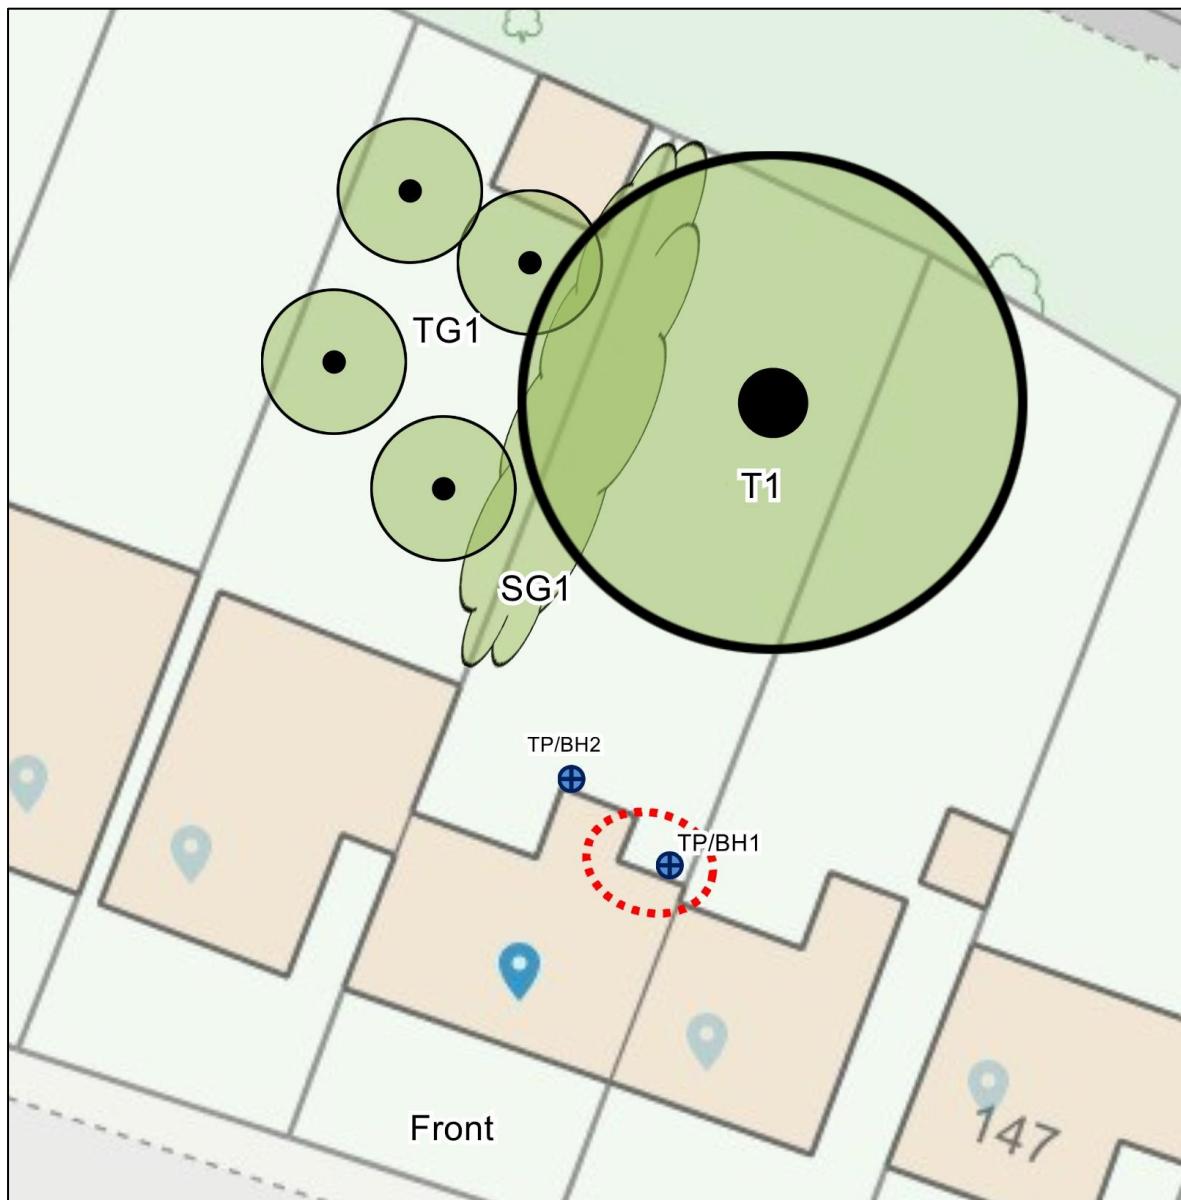
Site Plan

Approximate areas of damage

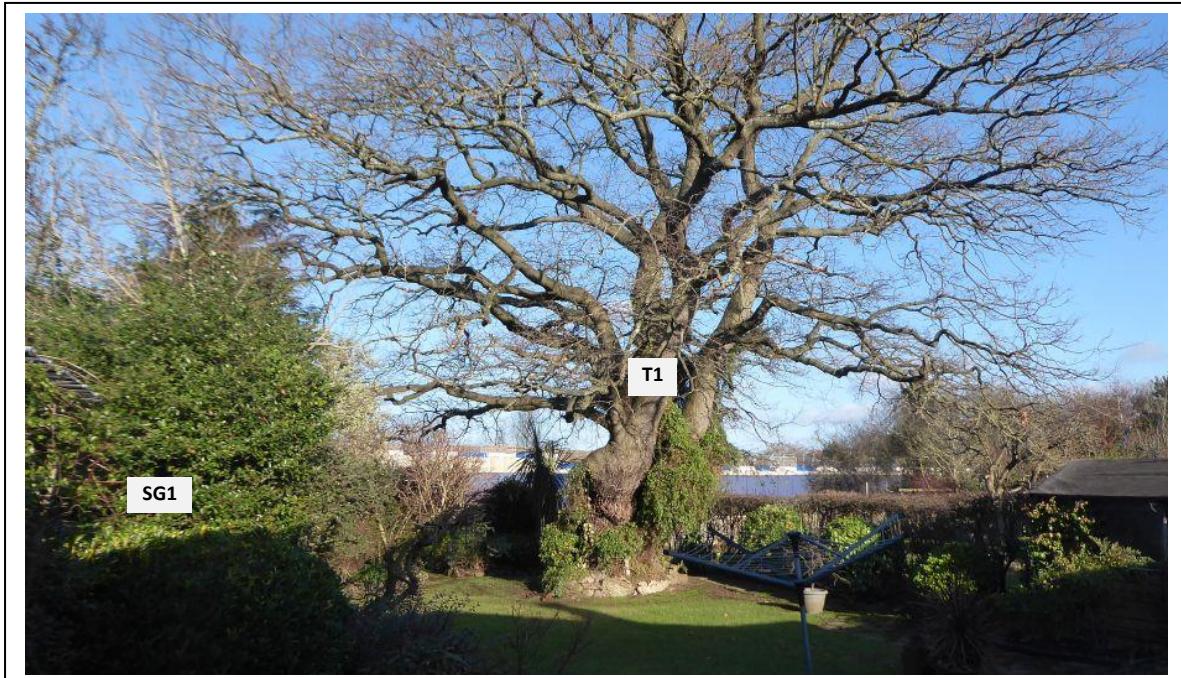
Roots were observed to 1.0m bgl in TP/BH1 and TP/BH2 and recovered samples have been positively identified (using anatomical analysis) as *Quercus* spp., *Pomoideae* gp. and *Clematis* spp., the most significant of which are the *Quercus* spp. roots confirming the influence of the Oak T1 on the soils below the property rear.

View of T1 Oak, with SG1 group to left of frame

If an arboricultural solution is to be implemented to mitigate the influence of the trees/shrubs considered to be responsible for the damage, we recommend that T1 Oak is subject to significant crown reduction in order to reduce the trees moisture uptake.

Tree No.	Species	Ht (m)	Dia (mm)	Crown Spread (m)	Dist. to building (m)	Age Classification	Ownership
T1	Oak	16.5	1600 *	20.0	14.0	Significantly older than property	Policy Holder
Management history		No significant past management noted.					
Recommendation		Reduce height to ~14.0m and crown radius to ~8.0m leaving balanced crown. Re-prune thereafter on a triennial cycle to maintain at broadly reduced dimensions.

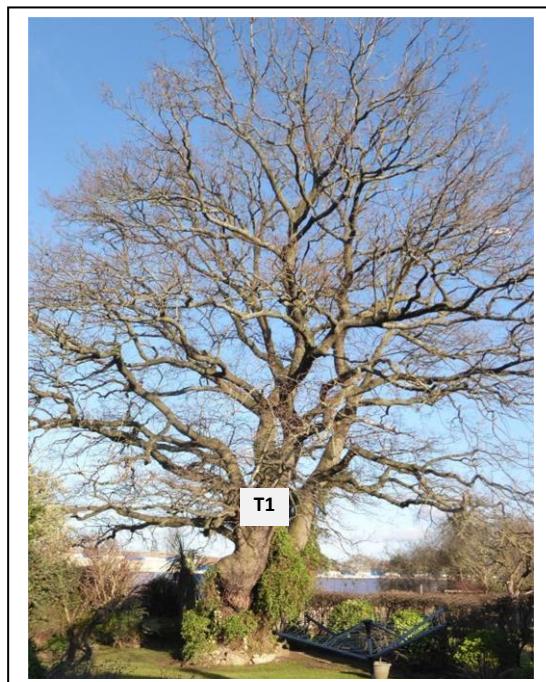
View of T1 Oak
