## 4 SURVEY RESULTS

### 4.1 Visual Inspections of Buildings

Figure 4  
Commuting and Foraging  
Bat Locations

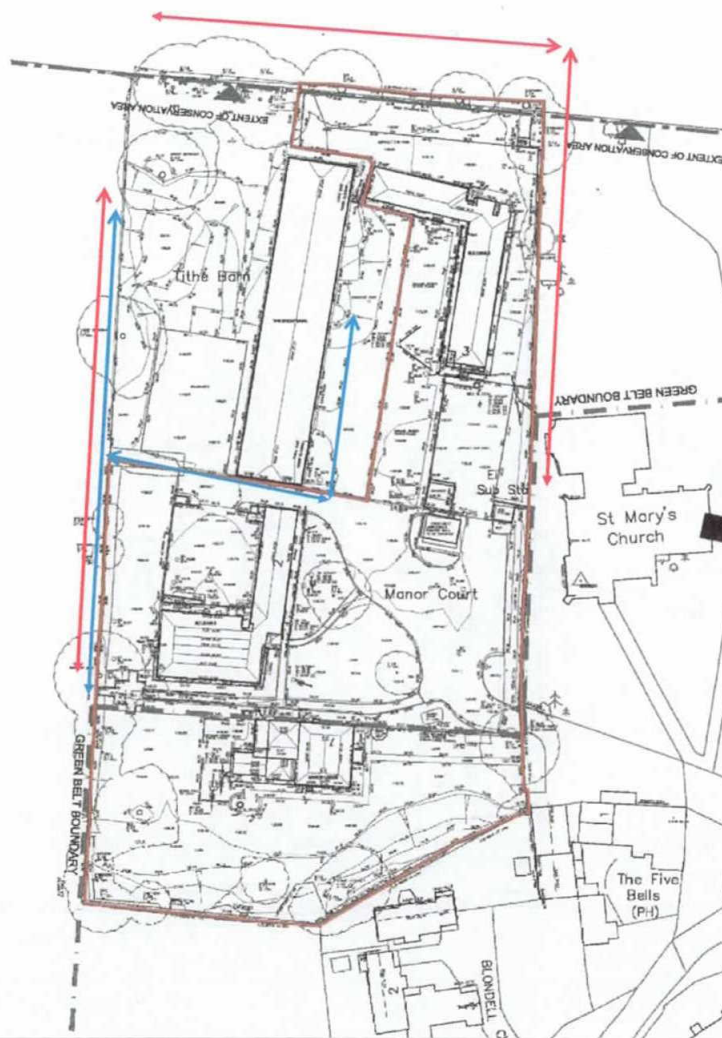
During all of the surveys carried out at the site no bats were observed emerging from the Stable Block or the Office Barn or investigating any of the suitable roosting locations within these buildings. In the early part of the season during May and June extensive use of the hedgerows to the east and west boundaries of the site was noted. It is clear that these dark areas are important for both species of bat recorded at the site. The surveys also confirmed the use of the English Heritage barn as still supporting small numbers of Soprano Pipistrelle and Brown Long-eared bats for roosting and additionally identified a new roost within the church to the east of site with a maternity roost of Soprano Pipistrelle bats.

The survey has shown that bats are reliant on the two hedgerows along the east and west sides of the site. These hedgerows are clearly important in allowing bats to disperse to the wider habitat that surrounds the site for foraging. These hedgerows are dark with no light directly illuminating them and should be retained as such after development.

Lighting at the site should be designed so that no artificial light illuminates the hedgerows on the east and west boundaries of the site so that the hedgerows used by bats as commuting routes and foraging areas remain uncompromised, and also that the Listed Barn is also kept dark. This is particularly important in the case of the Brown Long-eared bats present at the site which are extremely light averse and additional lighting on the hedges and on the barn are likely to deter bats from using these areas.

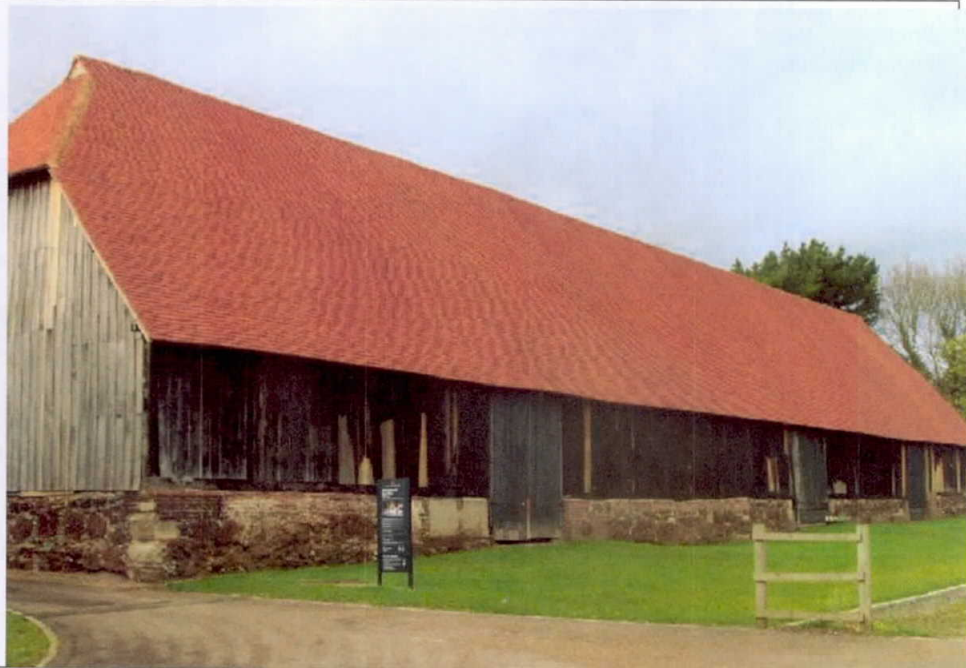
**Plate 1** – Grade 1 Listed Tithe Barn containing Soprano Pipistrelle and Brown Long-eared maternity roosts immediately adjacent to development site

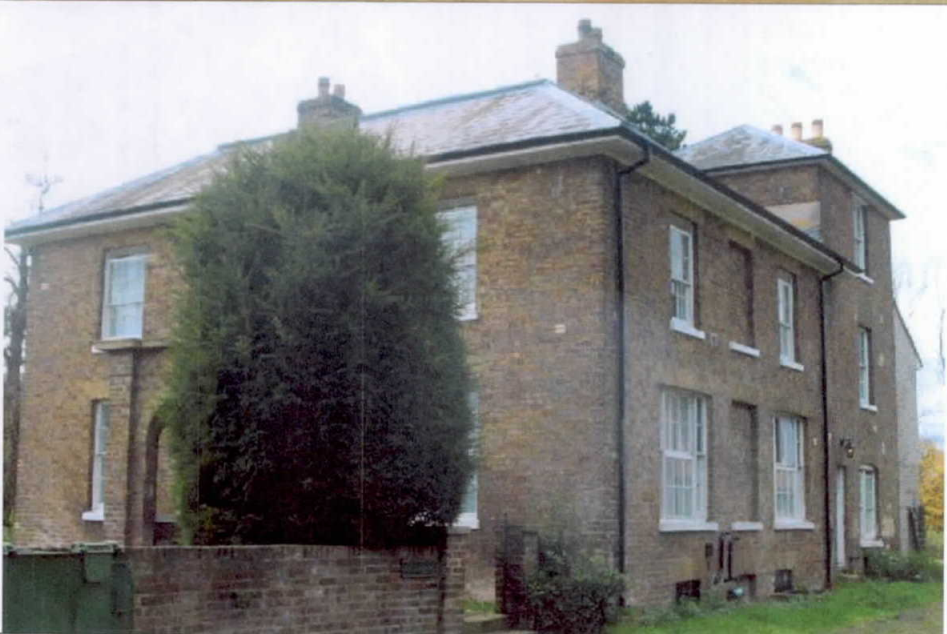
| Date | Species Observed | Roost Type | Structure Reference | Roost Location | Potential Access Points | Dimensions of existing roosts |
|---|---|---|---|---|---|---|
| <p><b>Notes and Observations:</b> The exterior of the building was examined using close focusing binoculars. The roof was in excellent condition with all of the slates on the roof being laid flat with no missing or broken slates that could allow bats into the interior voids of the building. All of the walls of the building were in good condition with no cracks or crevices that would be suitable for roosting bats. All of the soffits surrounding the roof line were all intact and had no gaps where access could be gained to the interior of either the soffit or the roof void,</p> <p>This building is classified as having NEGLIGIBLE potential as a bat roost as shown in Table 4, Section .</p> | | | | | | |

**Plate 2** – Building 1 – Manor Lodge – Building with no potential bat access

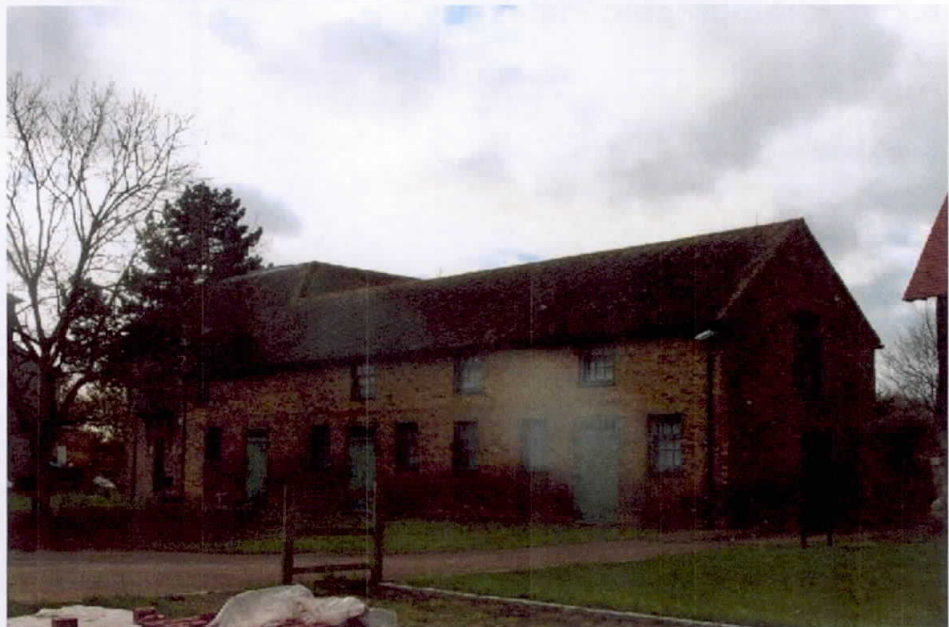
| Date | Species Observed | Roost Type | Structure Reference | Roost Location | Potential Access Points | Dimensions of existing roosts |
|---|---|---|---|---|---|---|
| <p><b>Notes and Observations:</b> This building is located on the west side of the site immediately north of Manor Lodge and just south of the end of the Tithe Barn. The exterior of the building was examined using close focusing binoculars. The roof was examined and a small number of tiles were found to be missing on various elevations. The rest of the roof tiles are handmade clay tiles and are uneven throughout. There are extensive gaps where the tiles do not lay flat potentially allowing bats to gain access to the small void between the roof covering and the internal ceilings of the building.</p> <p>The external walls are all in good condition with no suitable gaps or crevices suitable for bats. The soffits surrounding the roof line of the building are in fairly good condition, there are no cracks or splits in the wood that form the soffits and they are positioned close to the walls of the building with no gaps suitable for bats.</p> <p>This building is classified as having MODERATE potential as a bat roost as shown in Table 4, Section .</p> | | | | | | |

**Plate 3** –  
Building 2 –  
Former Stable  
Block west  
facing elevation

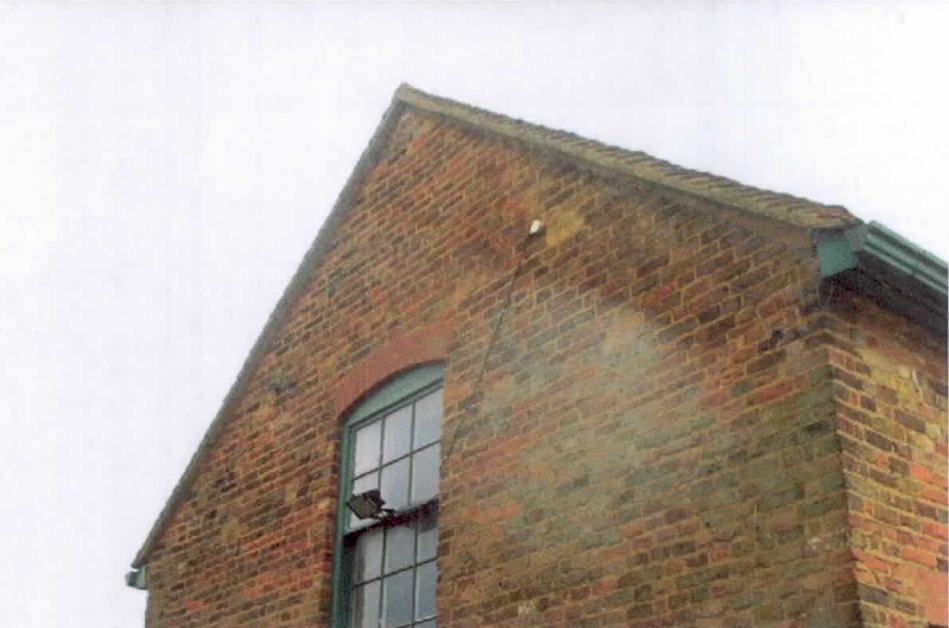
**Plate 4** –  
Building 2 –  
Former Stable  
Block – North  
facing Gable  
end showing  
condition of  
pointing.

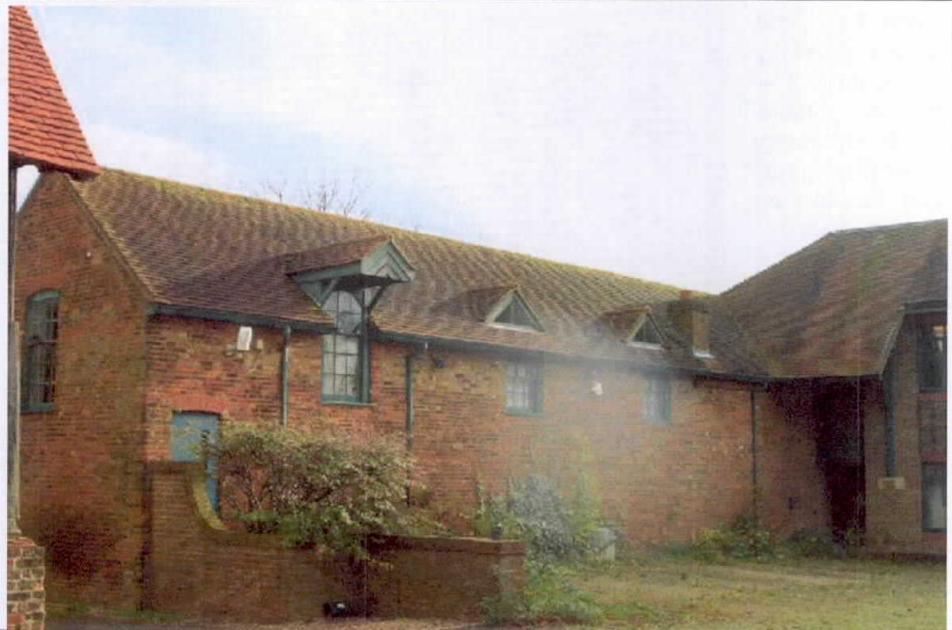
**Plate 5** – Rear elevation of Building 2 showing small dormers

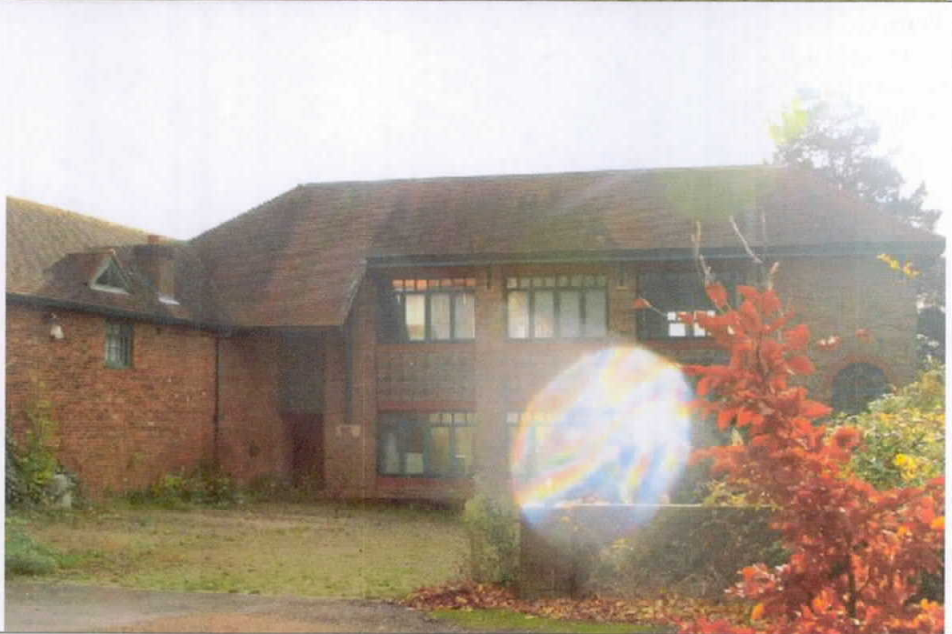
**Plate 6** – Extension of rear elevation of Building 2 – Former Stable Block

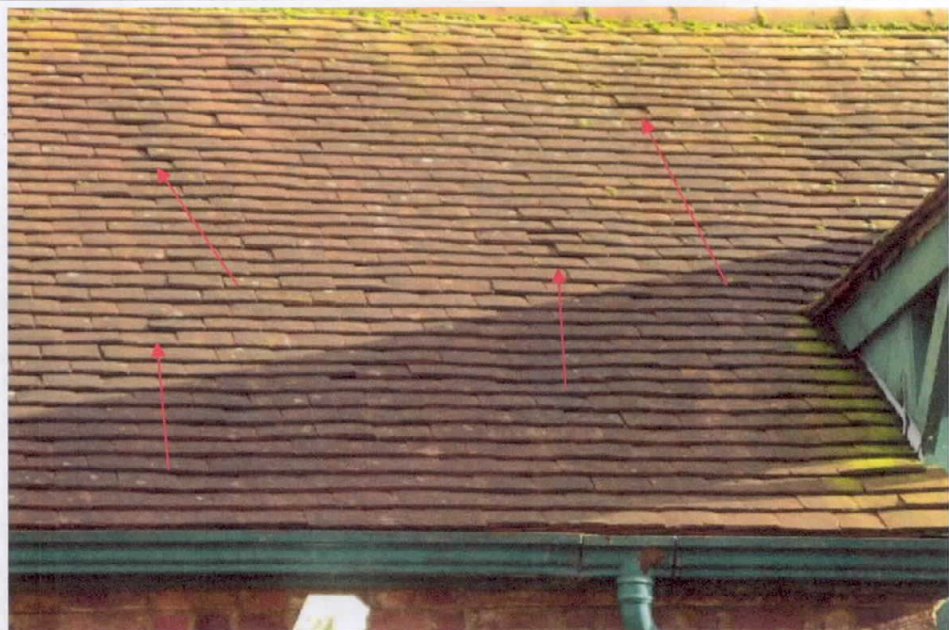
| Structure Reference | Species | Count/Estimate of number of individuals | Site Status assessment – roost types | Conservation Significance of Roost | Use and importance of the site throughout the year |
|---|---|---|---|---|---|
| Building 2 – Former Stable block | None Found | None | Potential for Summer Roosts of individual bats beneath roof tiles | Moderate Potential | There is no physical evidence of use of this building by bats. Emergence surveys confirmed that no bats were using the features of this building as a roost. |

**Plate 7** – View of roof covering of Building 2 – Former Stable Block showing extensive gaps that could be used by bats

It is important that development of the site also provides for the bats that are present within the Listed Barn. To enhance the site generally a single Schwegler 1 FQ bat box should be erected on the exterior of both the Stable Block and the office barn once these buildings have been converted. The boxes should be located on the southern elevation of each building at eaves level. This will provide additional quality roosting habitat for bats at the site.

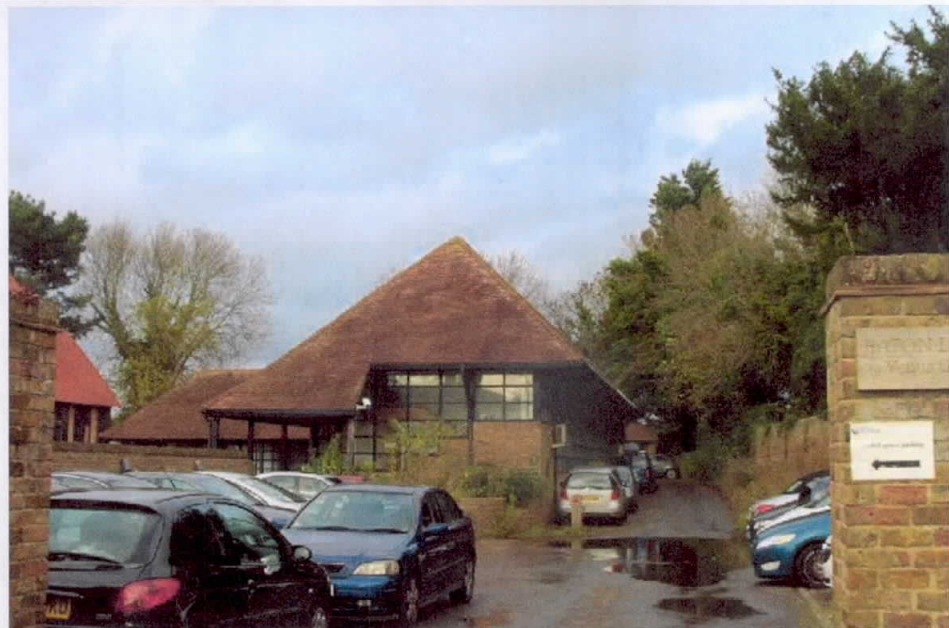
| Date | Species Observed | Roost Type | Structure Reference | Roost Location | Potential Access Points | Dimensions of existing roosts |
|---|---|---|---|---|---|---|
| <p><b>Notes and Observations:</b> This building is located on the east side of the site. The exterior of the building was examined using close focusing binoculars. The roof was examined and a small number of tiles were found to be missing on various elevations. The rest of the roof tiles are handmade clay tiles and are uneven throughout. There are extensive gaps where the tiles do not lay flat potentially allowing bats to gain access to the small void between the roof covering and the internal ceilings of the building.</p> <p>The external walls are all in good condition with no suitable gaps or crevices suitable for bats. The soffits surrounding the roof line of the building are in fairly good condition, there are no cracks or splits in the wood that form the soffits and they are positioned close to the walls of the building with no gaps suitable for bats.</p> <p>All gable ends were inspected and all found to have intact pointing preventing any access at these locations.</p> <p>This building has a small void on the first floor at its north-east corner. The interior was examined and no evidence of bats was found i.e. no droppings or feeding remains. The small void between the roof covering and the internal ceilings on the first floor of the building was inaccessible but could provide roosting opportunities for bats beneath the roof covering.</p> | | | | | | |

| This building is classified as having <b>MODERATE</b> potential as a bat roost as shown in Table 4, Section | | | | | | |

**Plate 8** –  
Building 3 –  
Office Barn –  
South Elevation

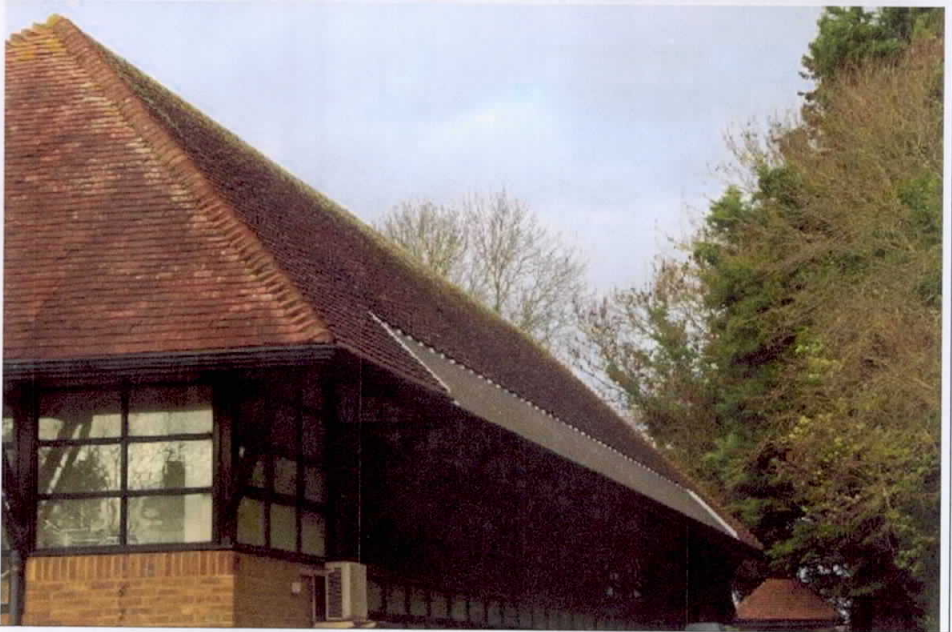
**Plate 9** – Office Barn View of East elevation showing corrugated panels along bottom of roof slope

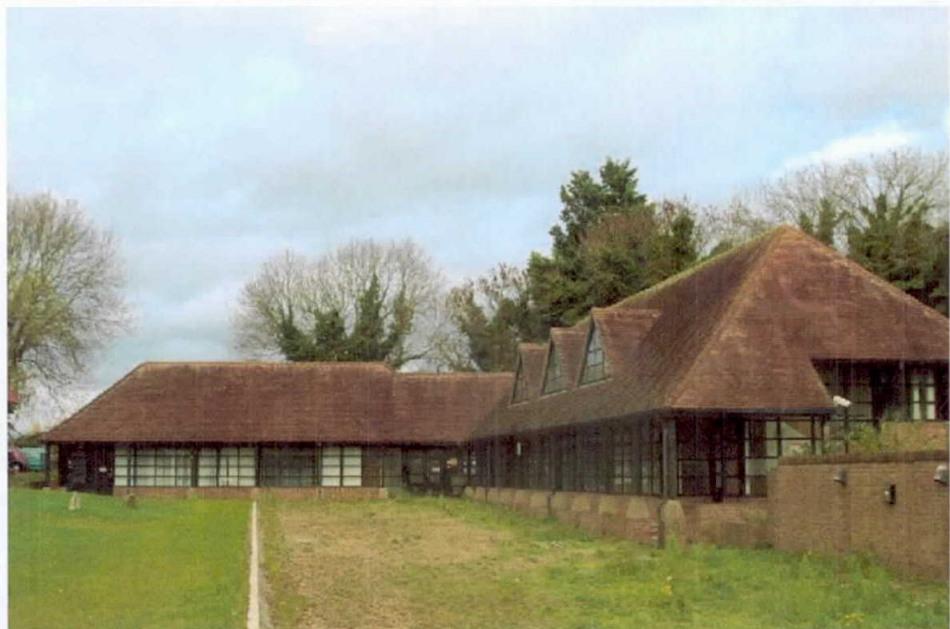
**Plate 10** –  
Building 3  
Office Barn  
west and south  
elevations

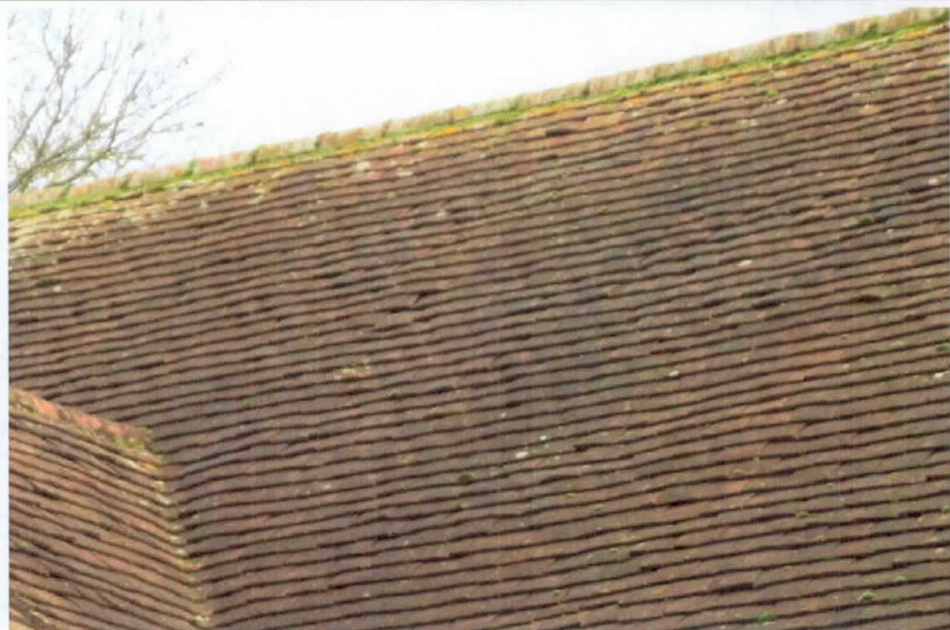
| Structure Reference | Species | Count/Estimate of number of individuals | Site Status assessment – roost types | Conservation Significance of Roost | Use and importance of the site throughout the year |
|---|---|---|---|---|---|
| Building 3 – Office Barn | None Found | None | Potential for Summer Roosts of individual bats beneath roof tiles | Moderate Potential | There is no physical evidence of use of this building by bats. Emergence surveys confirmed that no bats were using the features of this building as a roost. |

**Plate 11** –  
Building 3  
Office Barn  
View of roof  
(general)  
showing  
extensive gaps  
under tiles
