MAYFORDS
Chartered Surveyors

BUILDING SURVEY REPORT

6 Lawrence Drive, Ickenham, UB10 8RN

On: 31st October 2019

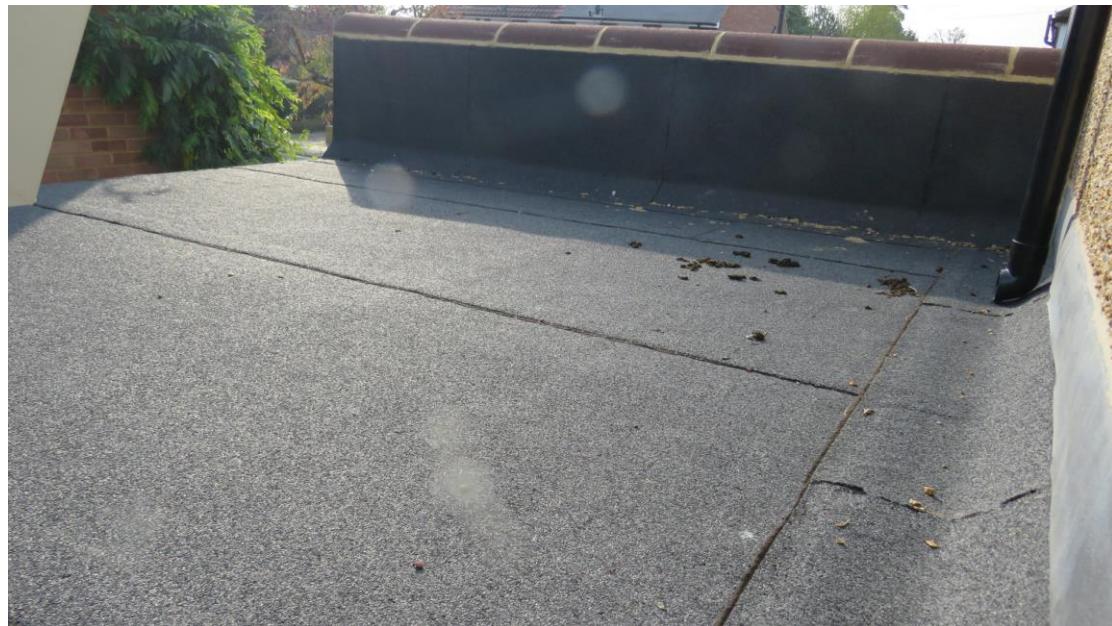
We found no obvious signs of any significant distortion or deflection to the pitched roofs to suggest any structural failures within the roof frame. We would stress to you, however, that the condition of the roof coverings are likely to continue to deteriorate in the longer term and the question of their condition may well arise again upon the future re-sale of the house.

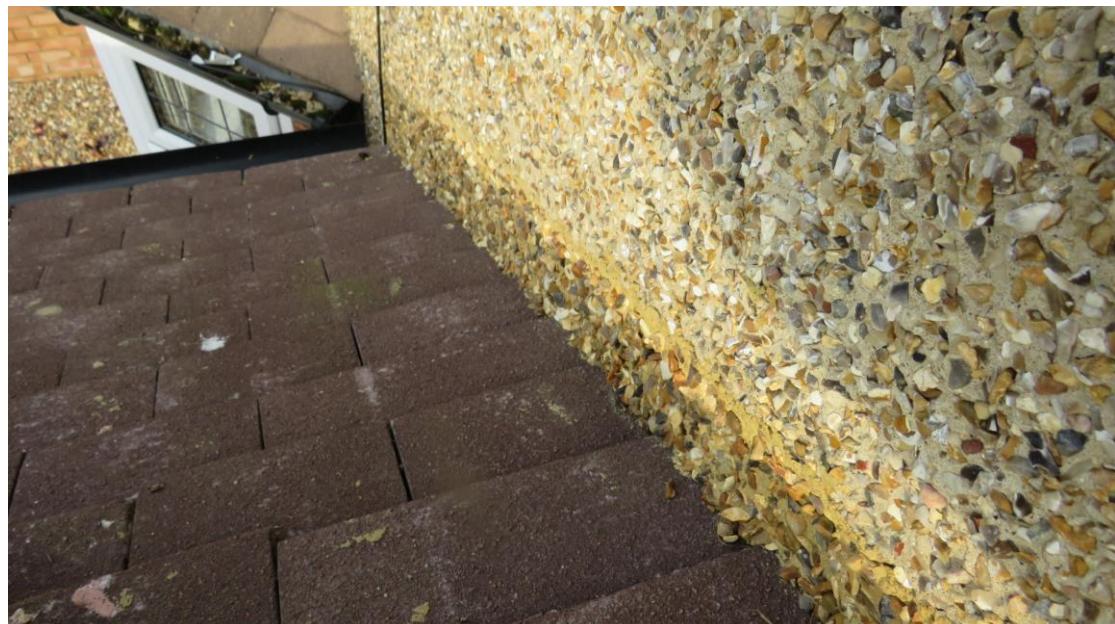
We note in your initial enquiry you have questions as to why lead flashings have not been installed to the front single storey projections, the developer / builder advised that they have been installed, however these have been cloaked behind the pebbledashing. There is evidence of new pebbledashing around the junction where the porch meets the main house, where the cement work has a darker consistency and appears to be newer with similar new pebbledash at the junction where the sloping roof to the front right hand side extension. Whilst this is not an uncommon detail the problem with dressing over metal or lead flashings, differential expansion and contraction can occur resulting in cracking and the render falling away. There is evidence of local hairline cracks starting to appear above the porch roof.

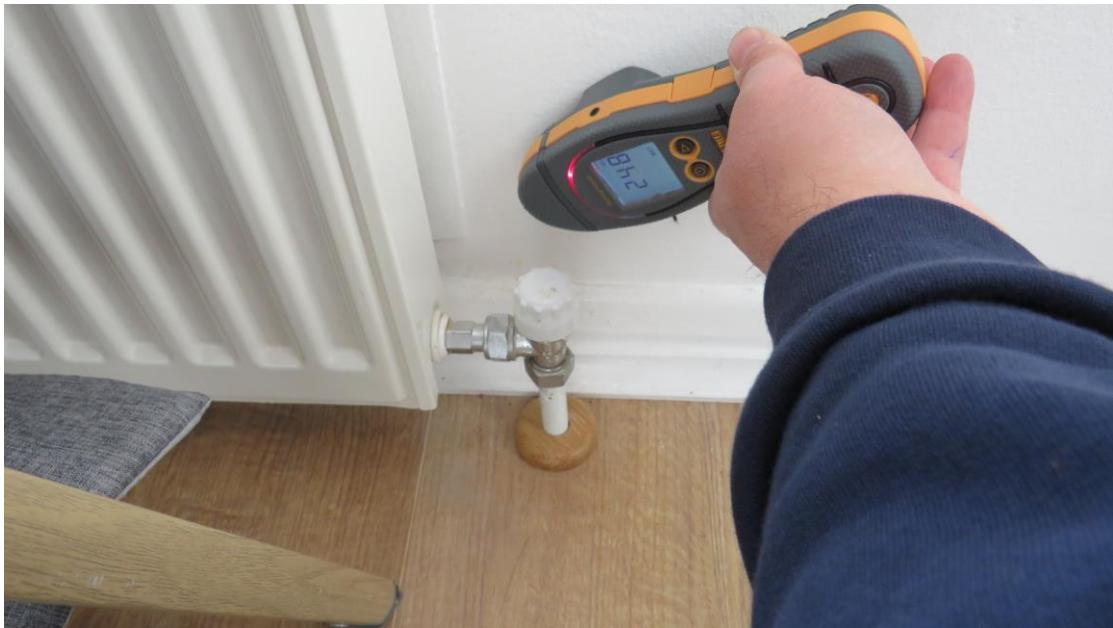
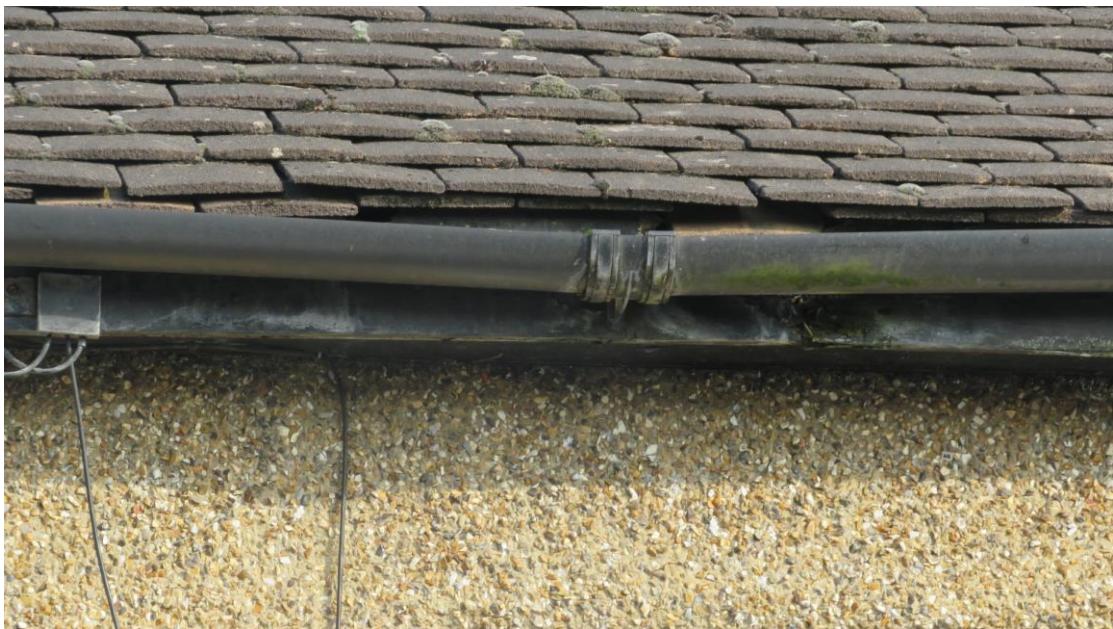
Internally within bedroom three adjacent to this area there is high moisture meter readings / evidence of dampness and we note that the gutter above appears to be leaking and appears to have deflected at this position. These areas require urgent further investigation and repair. Ideally the cement render / pebbledashing should be stopped higher than the lead flashing, otherwise this will be prone to cracking.

Furthermore metal / lead flashings would be preferred as these are more tolerant to differential movement which are common at such parts of the structure, where an addition / extension meets the main building.

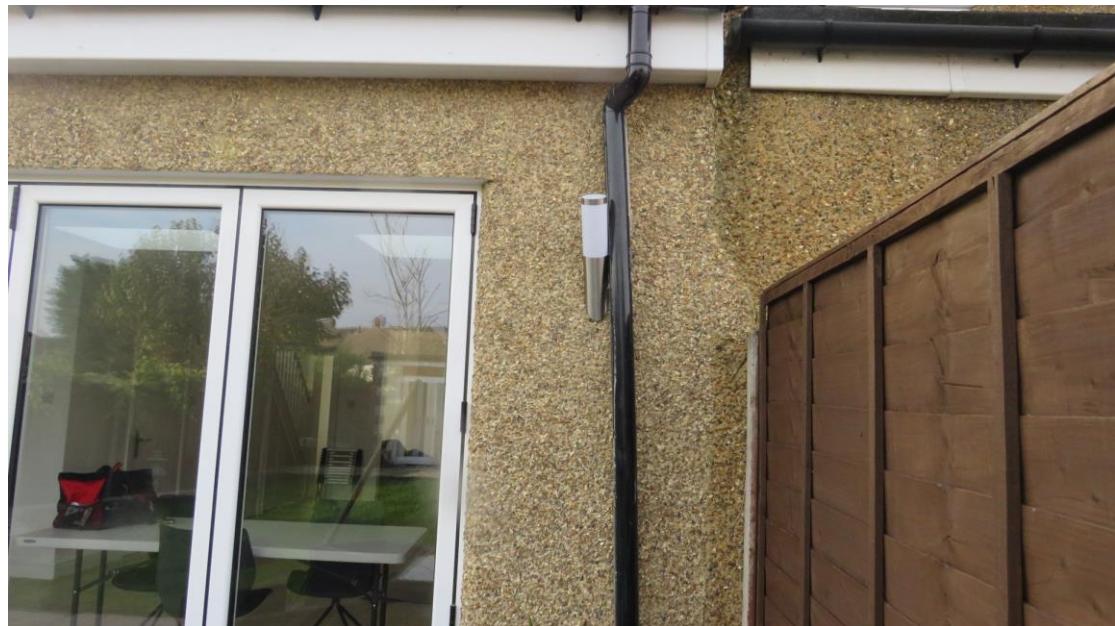
The downpipe to the first floor front right hand side corner and rear left hand corner at ground floor level requires some adjustment. There are minimal wall fixings to the right hand side downpipe and the downpipe to the rear left hand sided needs to be repositioned to avoid conflicting with the external light.

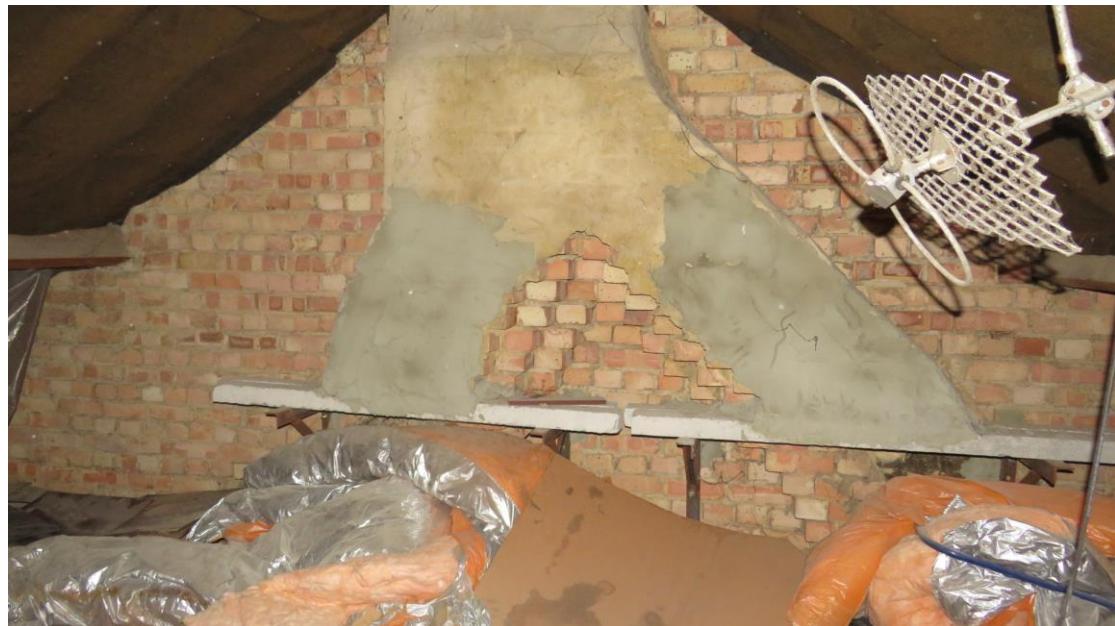
The underside of the rafters / main roof was obscured from view as felt has been fixed to the underside of the rafters. This felt conceals the roof structure, we would note the absence of ventilation between the felt and underside of the roof can reduce

the life expectancy of the tiles, without examination of the tiles we are unable to confirm the condition or level of ventilation that has been provided.

There is signs of staining on the boarding, however this appears to be old, nevertheless with the presence of the felt we are unable to analyse the condition of the timber or roof structure and ideally this should be removed for further inspection and possible repair.
