Survey House, 24 Northfield Avenue, London W13 9RL

**Re: Tarnwood – Garage Inspection Report**

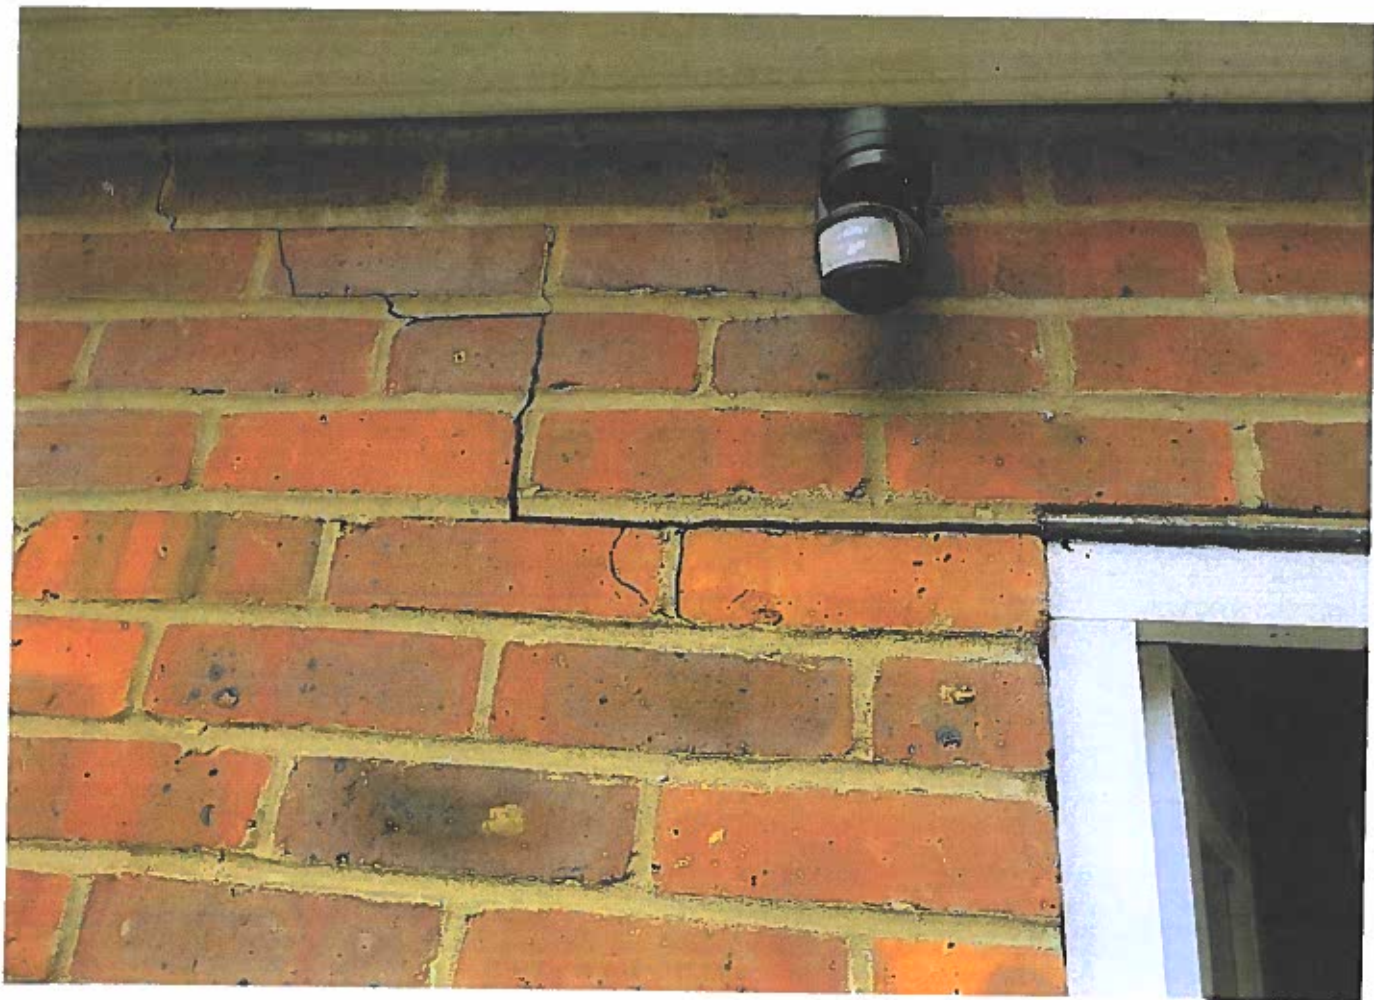
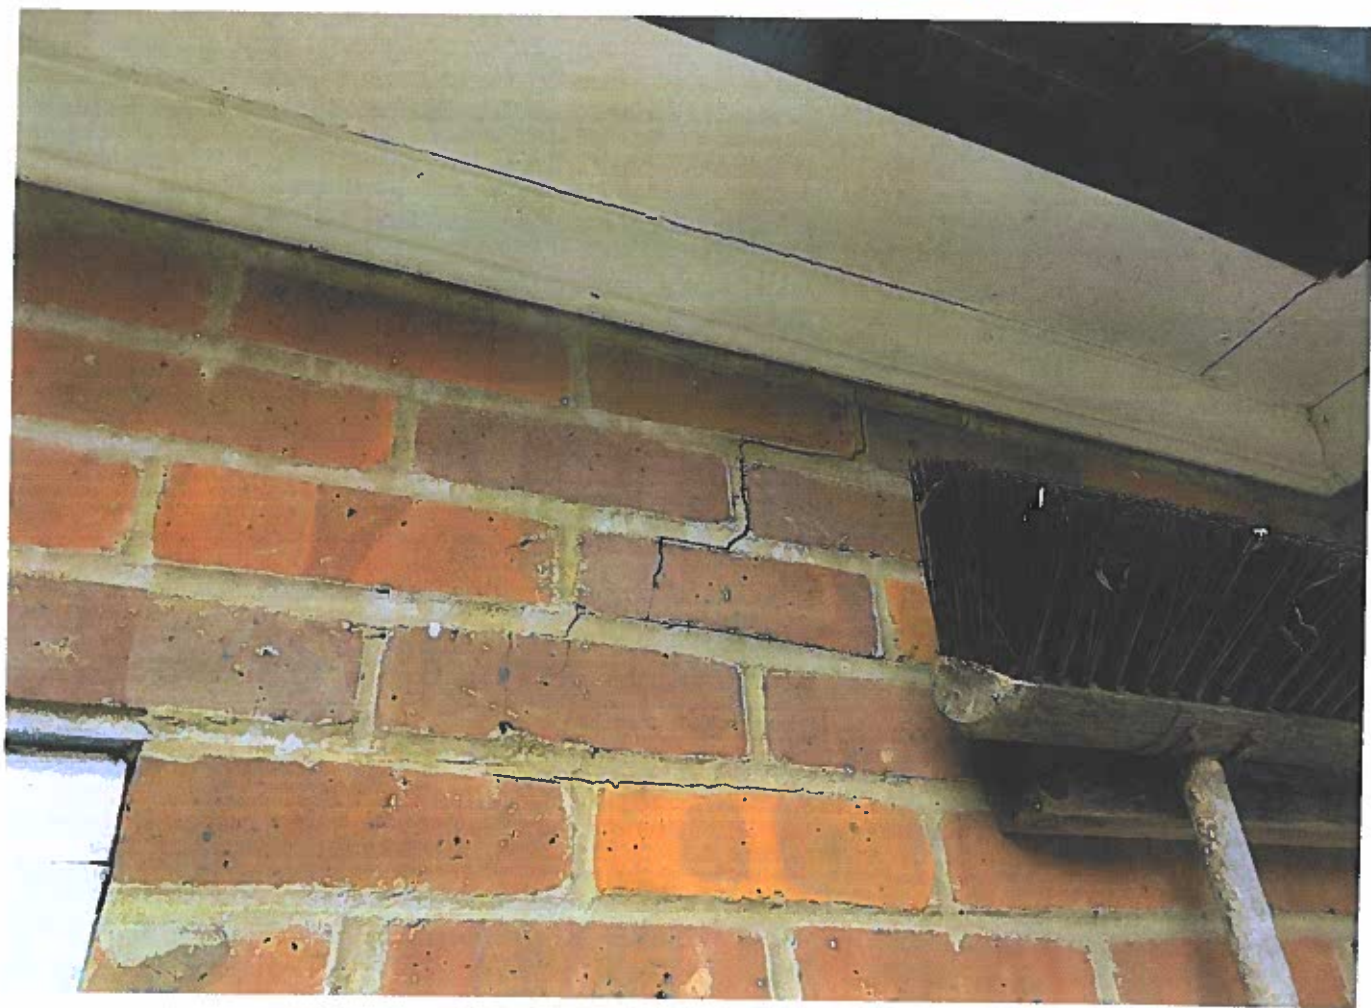
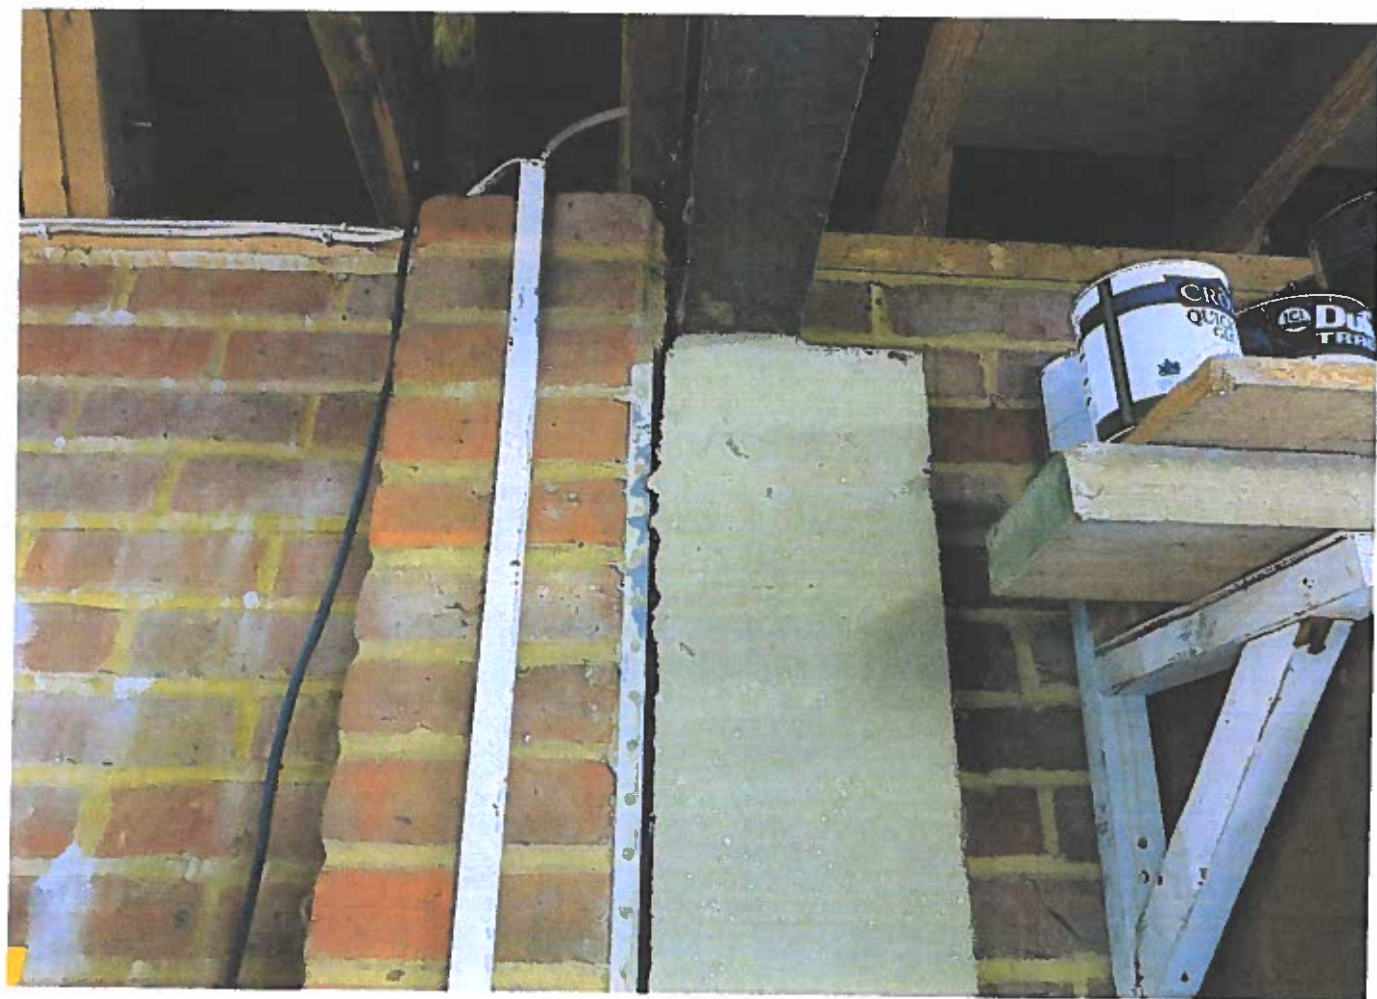
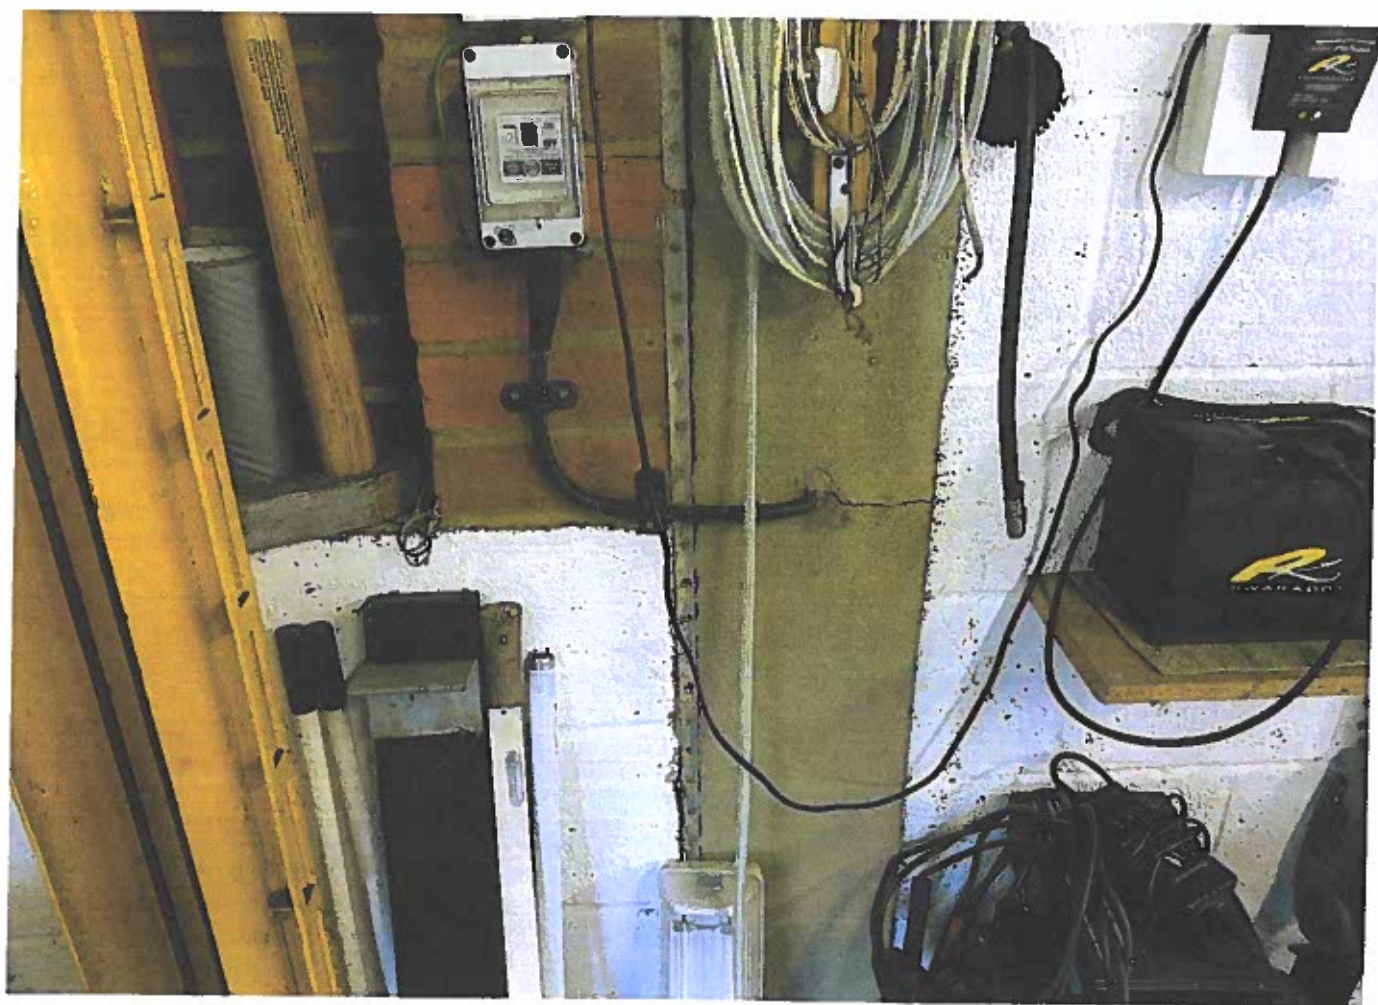
- Above the head of the door opening referred to we record a visible diagonal stepped fracture extending downwards from roof level where it has a maximum width of approximately 3-5mm falling through one brick course and then running diagonally as a hairline crack to a second and just into a third brick course falling towards the front right-hand head of that door opening

- Above the rear left-hand head of the door opening is a further fracture running horizontally from the door head for approximately one and a half bricks and a maximum thickness of approximately 10mm reducing in size as it vertically/diagonally upwards again to the underside of the roof structure

- Within the garage we record sympathetic areas of cracking above the head of the door opening as referred above
- To the right-hand party wall line we record that the original tightly butted 'joint' has now opened at its head to a maximum width of approximately 15mm reducing to a negligible thickness towards floor level
- There is no evidence of any cracking visible to any other areas of the building nor indeed to the flooring

It is our view that the proximity of the tree to the rear, allied with the excessively hot dry weather recently experienced has probably caused abnormal shrinkage of the subsoils more specifically in this area resulting in an issue of 'differential movement' beginning to affect the garage extension.

This movement has effectively been 'controlled' by the movement joint on the right-hand flank wall line but has become more noticeable by the lack of similar to the left-hand flank wall line and the nature of the movement is exhibited in the cracks which have developed across the head of the door opening.

The nature and extent of the movement which has so far occurred is not contributing to any structural instability and it would be our view that during the colder wetter winter/spring months that the subsoil conditions will recover and you may find that the cracks gradually close.

- Excavate a trial hole towards the rear/flank of the garage extension
- Identify any roots which may be found within the trial hole
- Monitor the building for a further period.

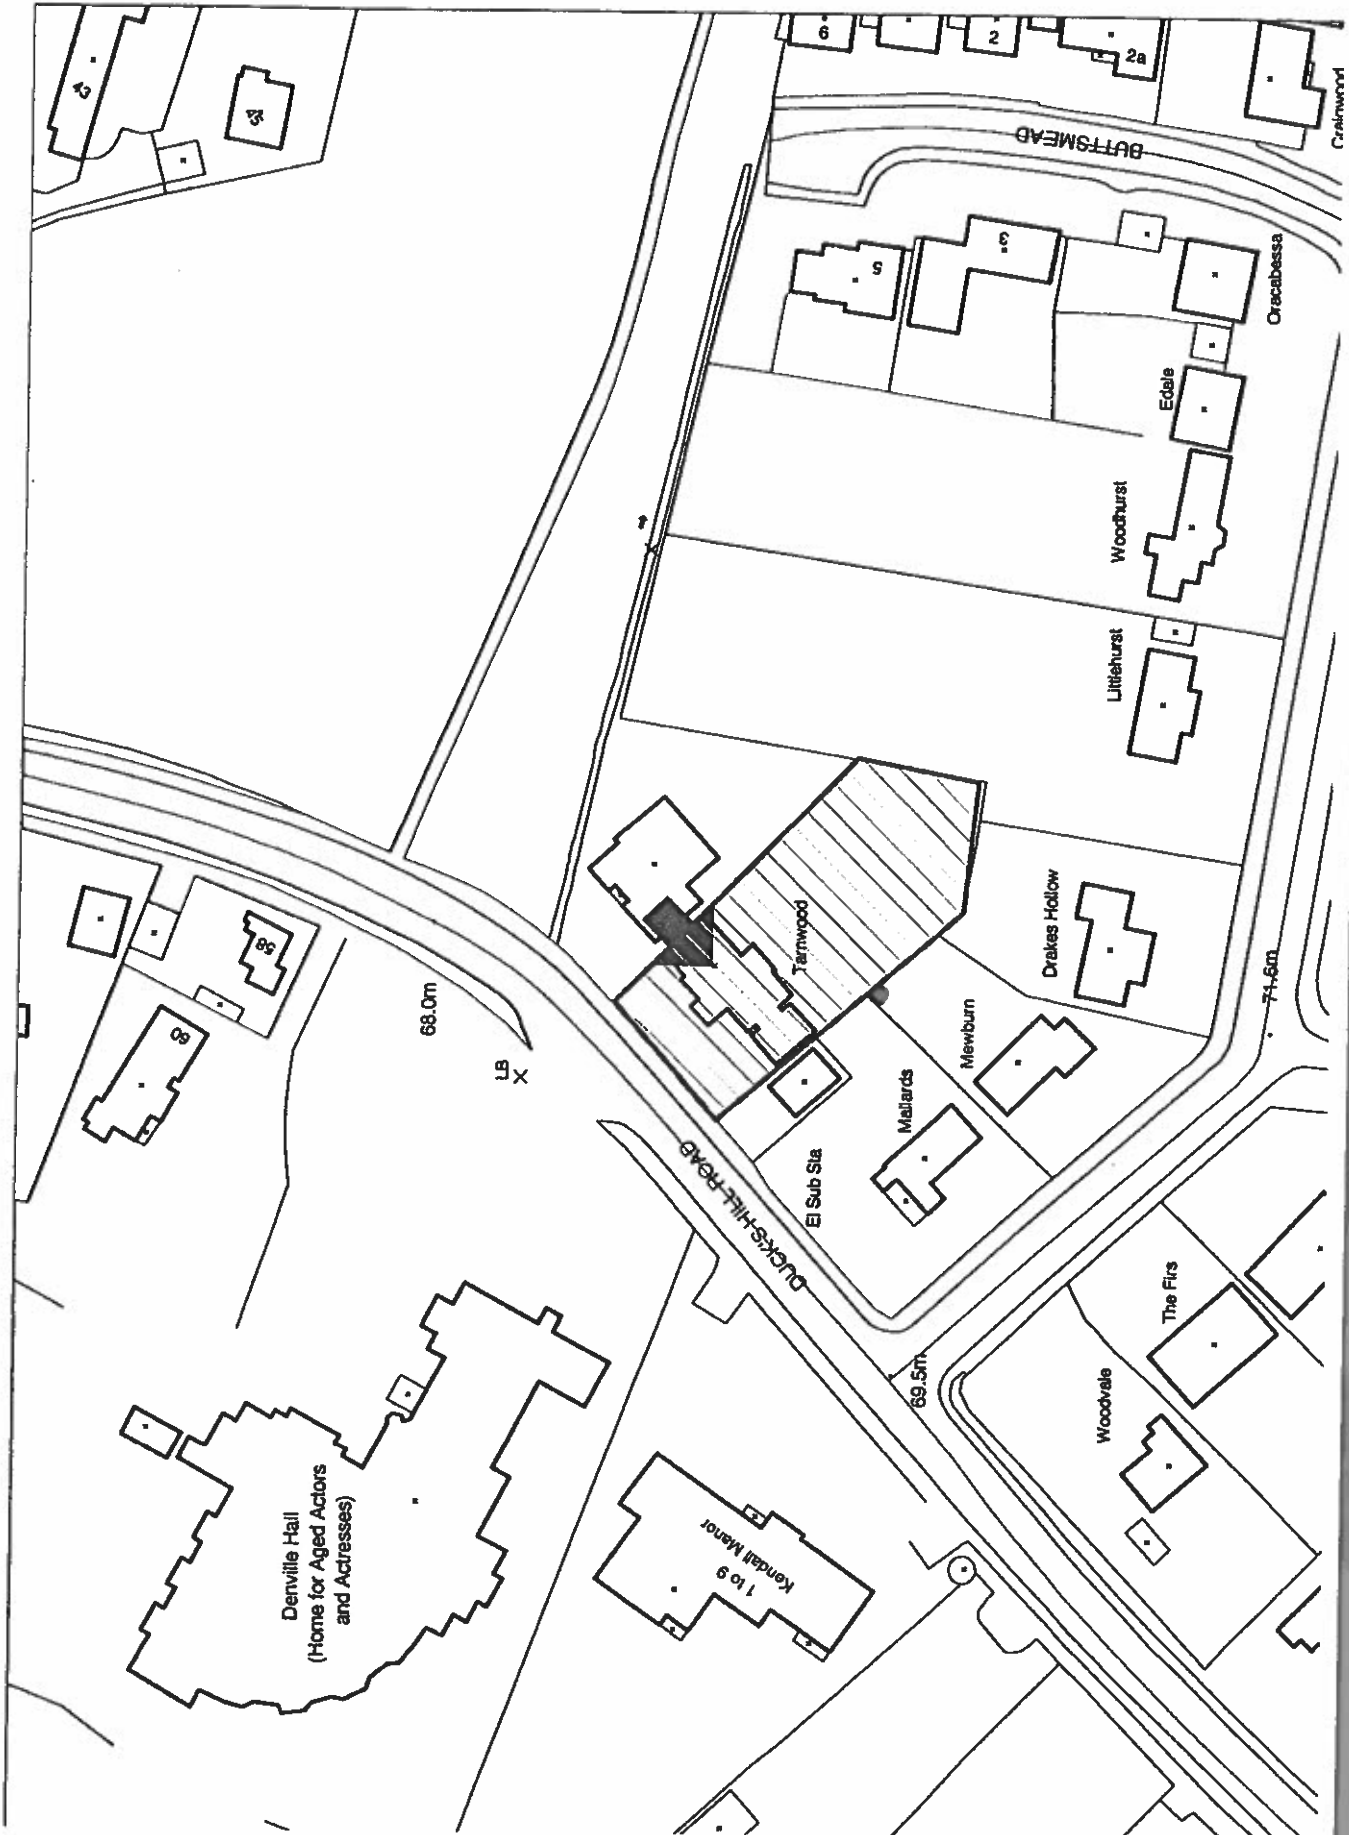
## TREE LOCATION

- The presence of a substantial mature ash tree lying within the curtilage of the adjoining site. This tree is approximately 5m distant from the rear wall of the garage extension and in our opinion this tree lies within 'influencing distance' of the garage even as unextended.
- As the tree predates the garage extension (and indeed construction of the original house) the foundations would have been designed to accommodate the presence of the tree at that time and on the basis of assumed normal weather conditions.

● ASH TREE

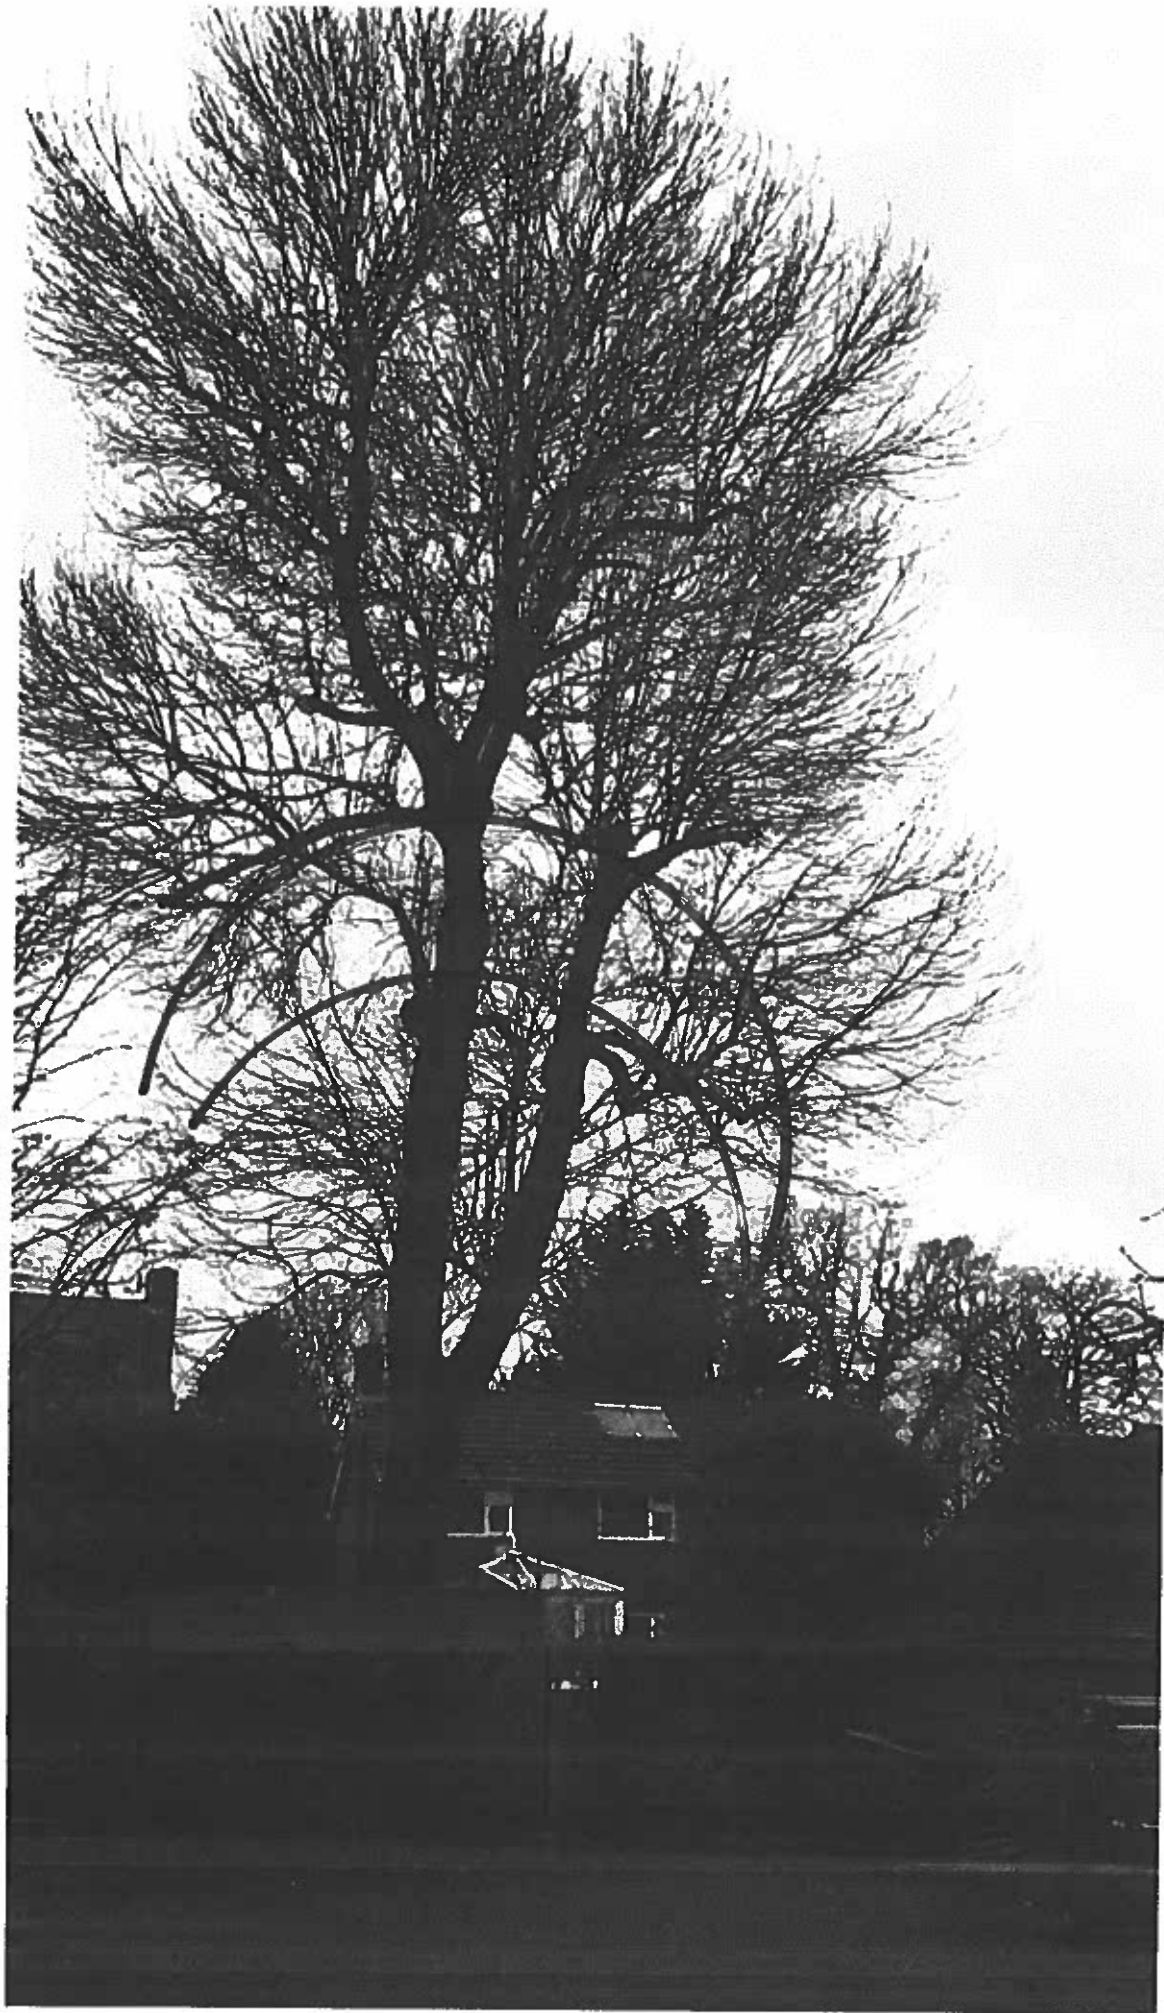
POLLARD TO THIS HEIGHT
