**RE: Trees at 19 Moor Park Road. Northwood. HA6 2DL**

Thank you for your instruction to undertake an assessment of the recently constructed outbuilding and patio area at the above site, in order to assess any impact on nearby trees. I duly visited the site on the 10<sup>th</sup> April 2025 and can now advise as follows.

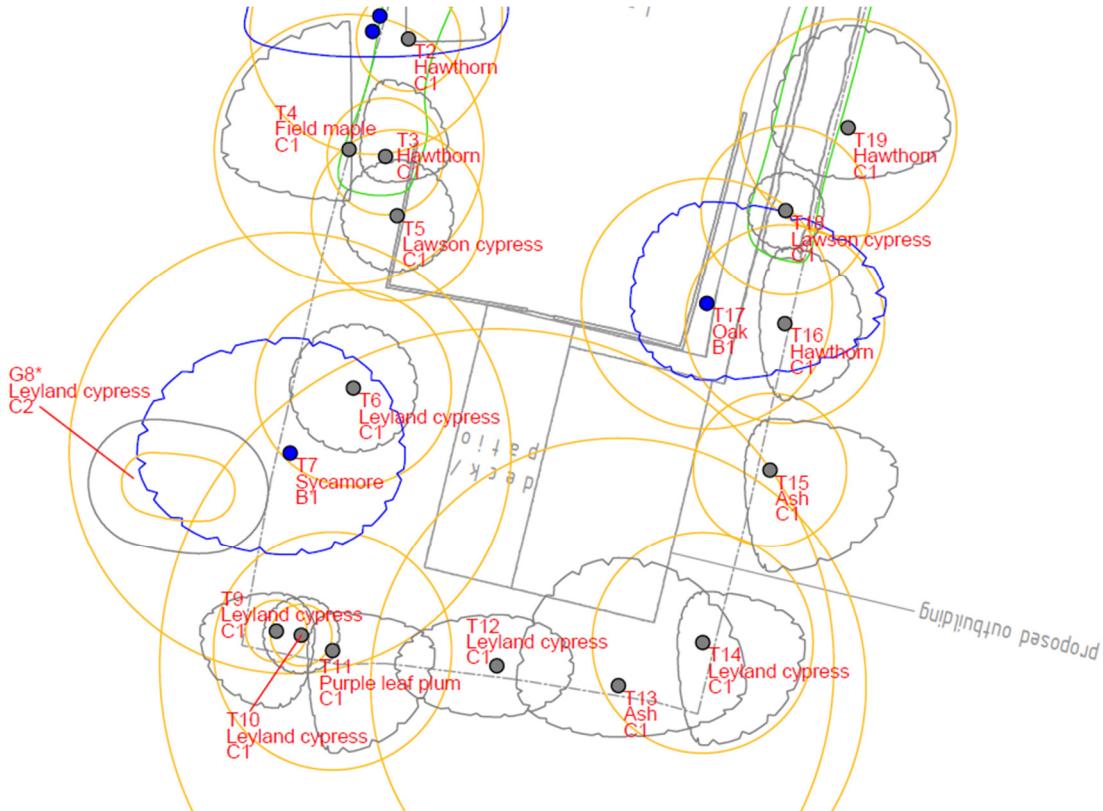
The outbuilding and patio area in relation to the nearby trees can be seen on the appended plan an excerpt from which is shown below. **Please note T14 has been removed since the original survey from 2024.**

*Below: plan excerpt showing trees in relation to new outbuilding and patio*

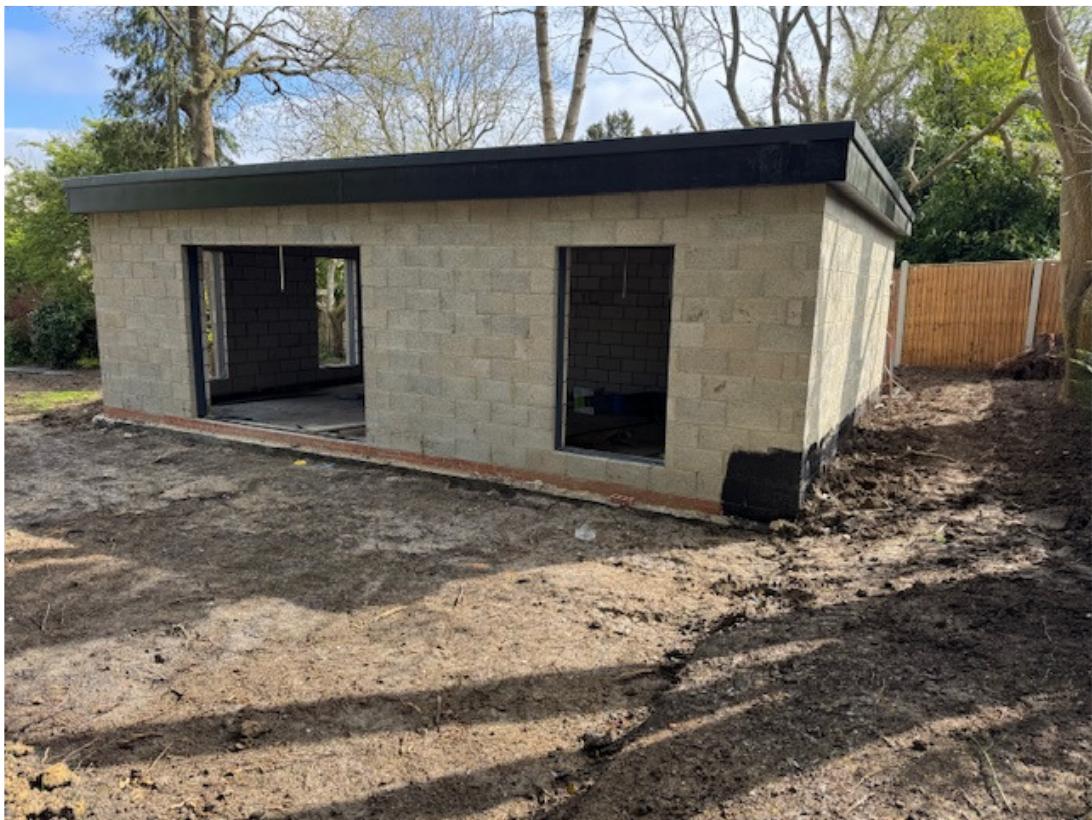
*Below: new outbuilding and patio area*

The outbuilding encroaches into the Root Protection Areas (RPAs) of T12, T13, T14, T16 and T17. The patio encroaches into the RPAs of T7, T12 and T13.

It is clear that a small amount of level reduction has been undertaken to install these structures and I estimate this to be around 200mm for the outbuilding and 100mm for the patio.

Of the impacted trees, T12, T13, T14 and T16 are C category trees (in accordance with BS 5837: 2012 – Table 1) and should therefore not act as a limitation on the effective use of the site, or impose any constraints on the layout. These trees are still in situ and are not showing any signs of dieback in response to the works. However, tree damage can take several years to manifest after root damage and given this work is quite recent, I would recommend these trees are inspected in Autumn 2025 and again in Spring 2026 to assess for damage at these junctures. If any damage is present, we must take appropriate action and where necessary replace any defective trees. If there is no damage showing in spring 2026, we would need to schedule further annual inspections.

T7 and T17 are B category; however, these RPA encroachments are much less and assessed to be within acceptable levels. These are both healthy trees which will tolerate this small amount of root loss and recover quickly, especially when considering no other part of the RPAs are affected and there are large areas of open ground to the other side of the RPA for compensatory root growth to develop.

In the meantime, I would suggest some soil improvement works to improve soil conditions in the areas of RPA outside the new structures in order to reduce compaction and maximise the potential for compensatory root growth in these areas. The decompaction work will be

undertaken using an air-spade which will use compressed air to break up the soils structure whilst adding organic matter at the same time. A layer of suitable organic matter will be laid over the area in question, and then the air-spade will be used to incorporate this into the soil whilst also breaking down any areas of heavily compacted soil. Ruskins are a company that GHA Trees have worked with in the past to complete such work:
