GROUND FLOOR PLAN

ORCHARD ASSOCIATES
32 WHITEHALL ROAD
HARROW ON THE HILL
MIDDLESEX

OLD WORKHOUSE
BREAKSPEAR ROAD NORTH
HAREFIELD
MIDDLESEX

PROPOSED PLAN

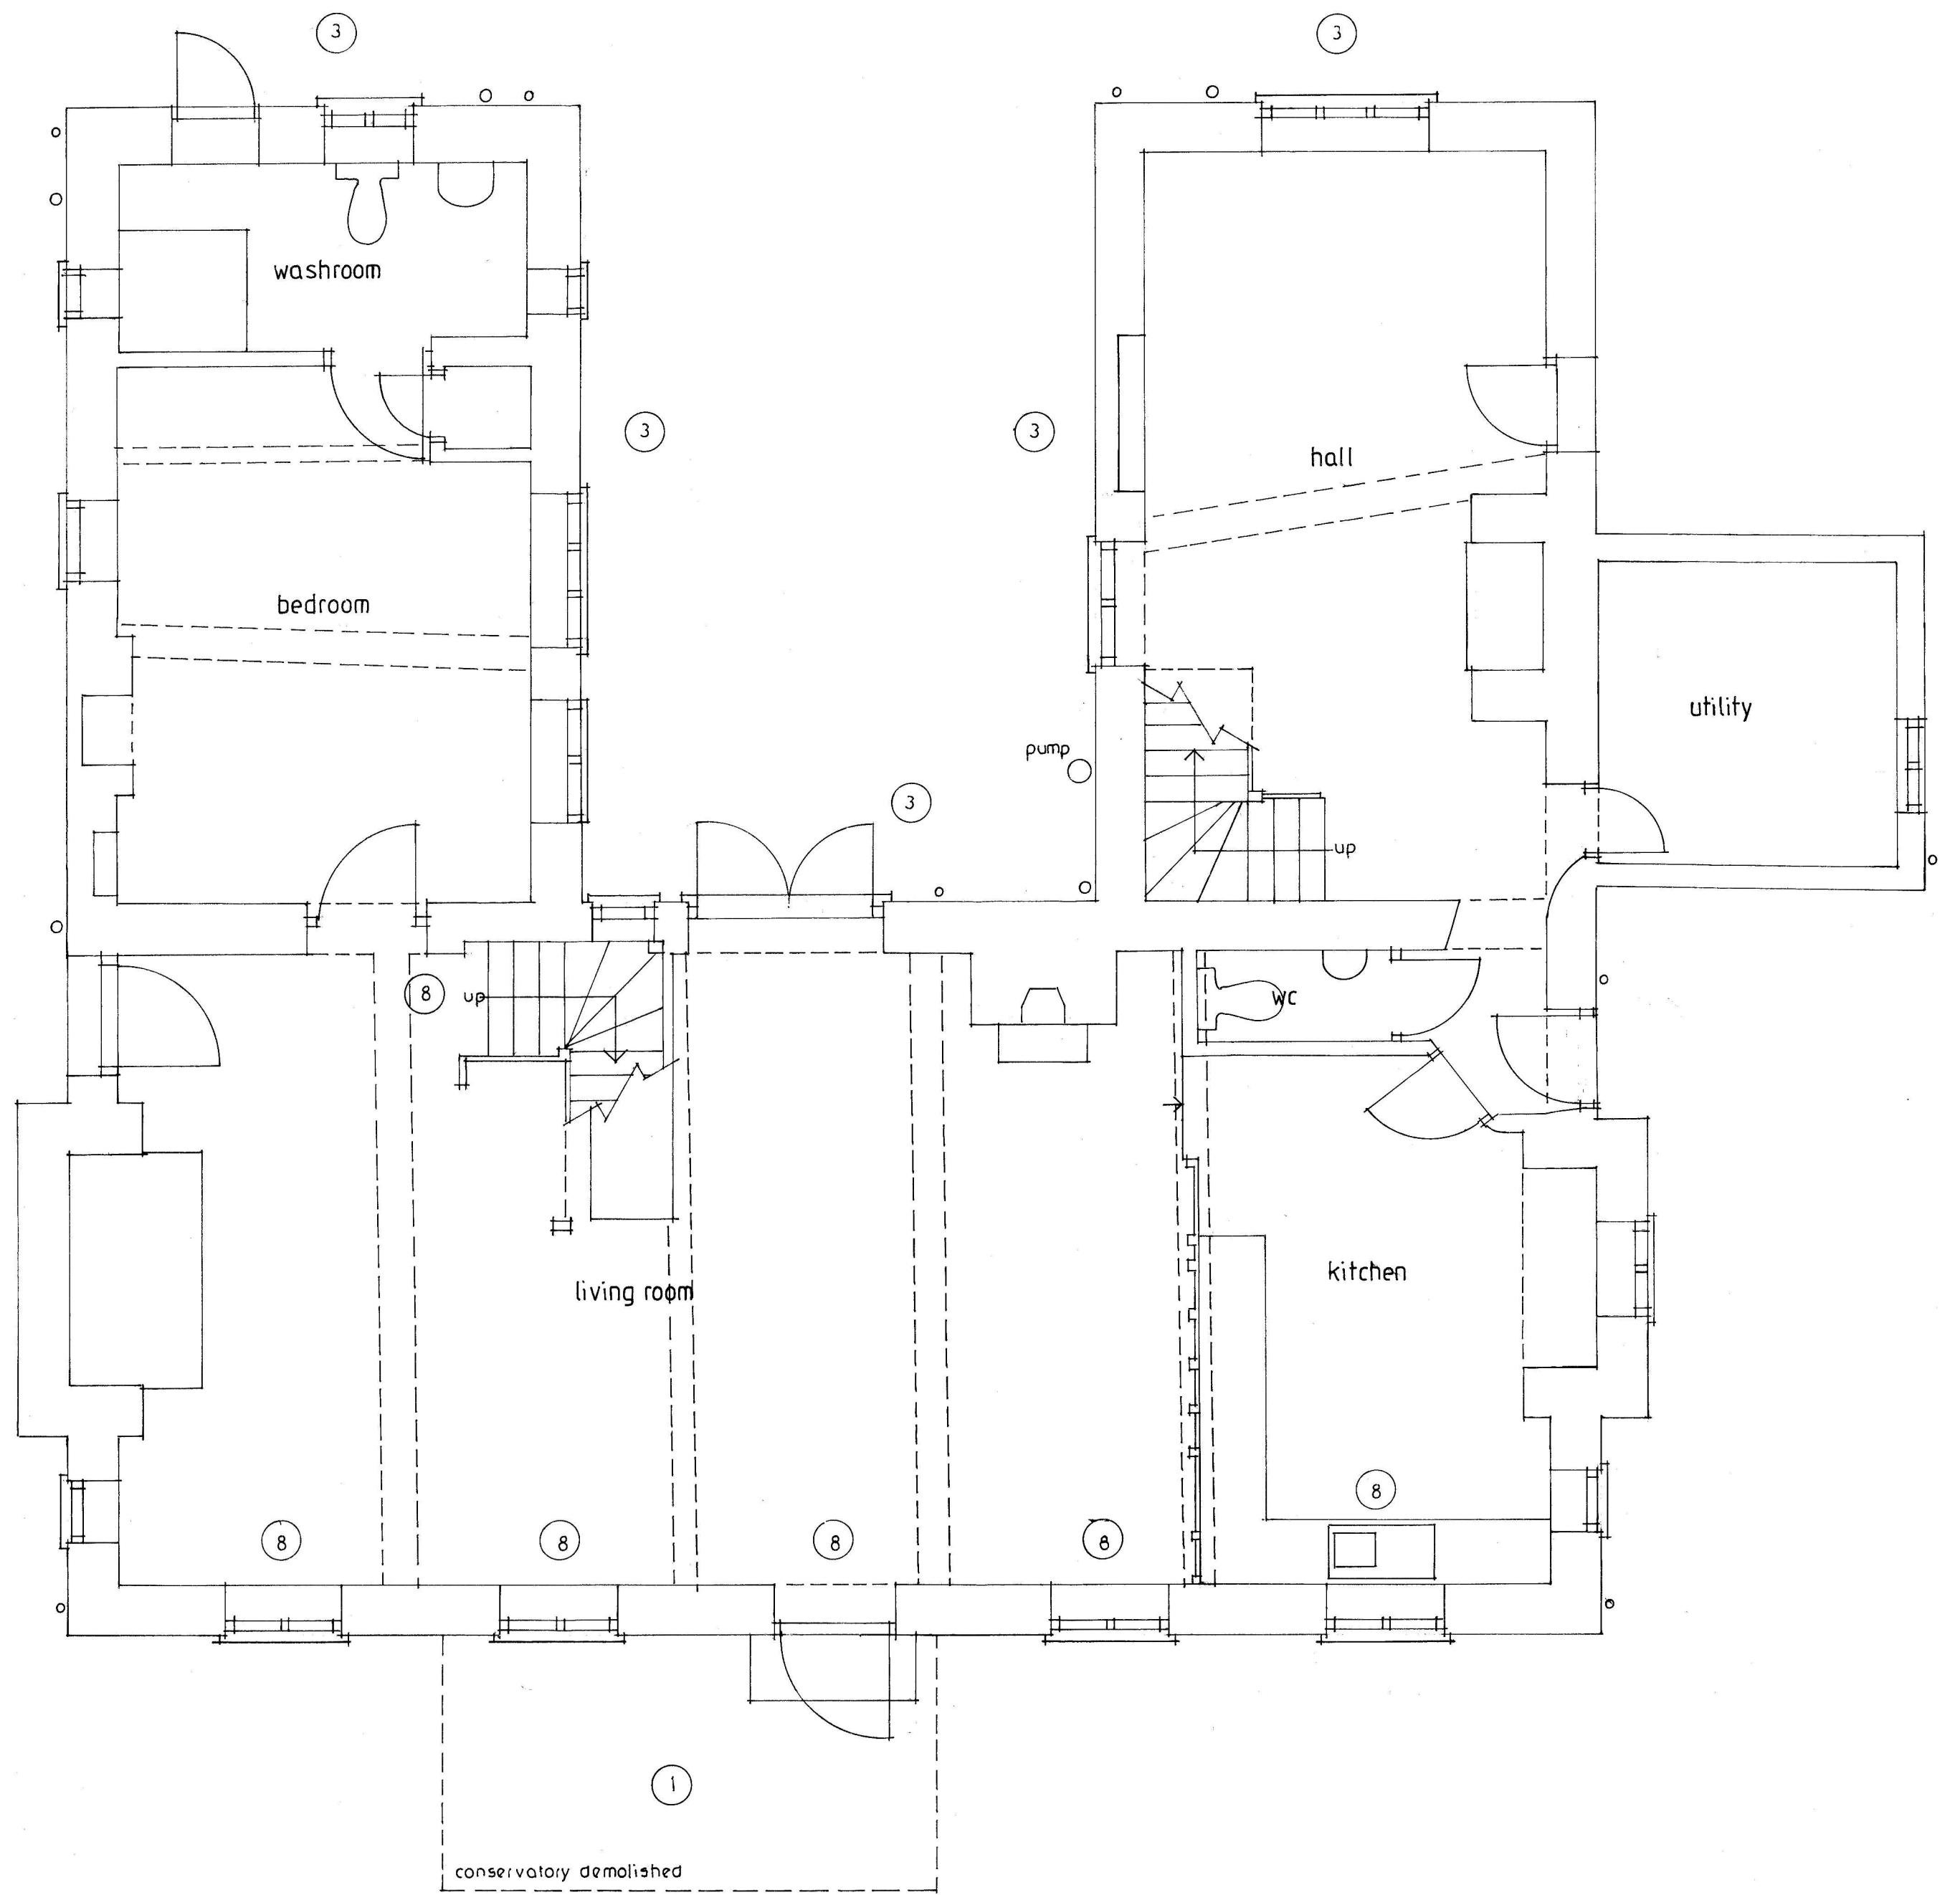
8. Structural Engineer to investigate beam bearing and vertical crack adjacent to door opening from living into rear bedroom and lintels over windows to front elevation.

1. Contractor to carefully take down and dispose of dilapidated, lean-to timber conservatory from front elevation including bolted timber trimmer plates, fixings and flashings into masonry walling. Following removal of conservatory floor tiling re-instate yorkstone external paving and install yorkstone step.

2. Cracked deteriorated soft bricks and inappropriate coloured and engineering bricks to external walls and chimney breasts to be cut out and replaced with reclaimed brick and pointing to match existing. Where possible cut out soft bricks, turn, clean and re-bed in lime mortar.

3. Remove modern, unsympathetic paint coatings from courtyard and rear elevation brick walls with Thermatech system (combined with alcohol-based chemical softener if required) and apply Kein mineral-based paint system providing breathability and permeability.

4. Where there is hard cement mortar on the brickwork, particularly poor cement pointing to brick arches and previously patched masonry cracks, then carefully rake out and re-point in lime mortar to match existing.

5. Cut out any rotten sections of timber joinery to windows and doors and fit hardwood pieces with Timbecare resin to conservation joints to jambs, mullions, transoms and glazing bars.

6. External joinery to be rubbed down, re-primed where necessary and re-painted with undercoat and white gloss finish.
7. All upvc above ground waste and soil and vent pipes to be replaced in cast-iron with black paint finish.
