## SITE PHOTOGRAPHS

THE OLD WORKHOUSE  
BREAKSPEAR ROAD NORTH  
HAREFIELD  
MIDDLESEX

FEBRUARY 2024

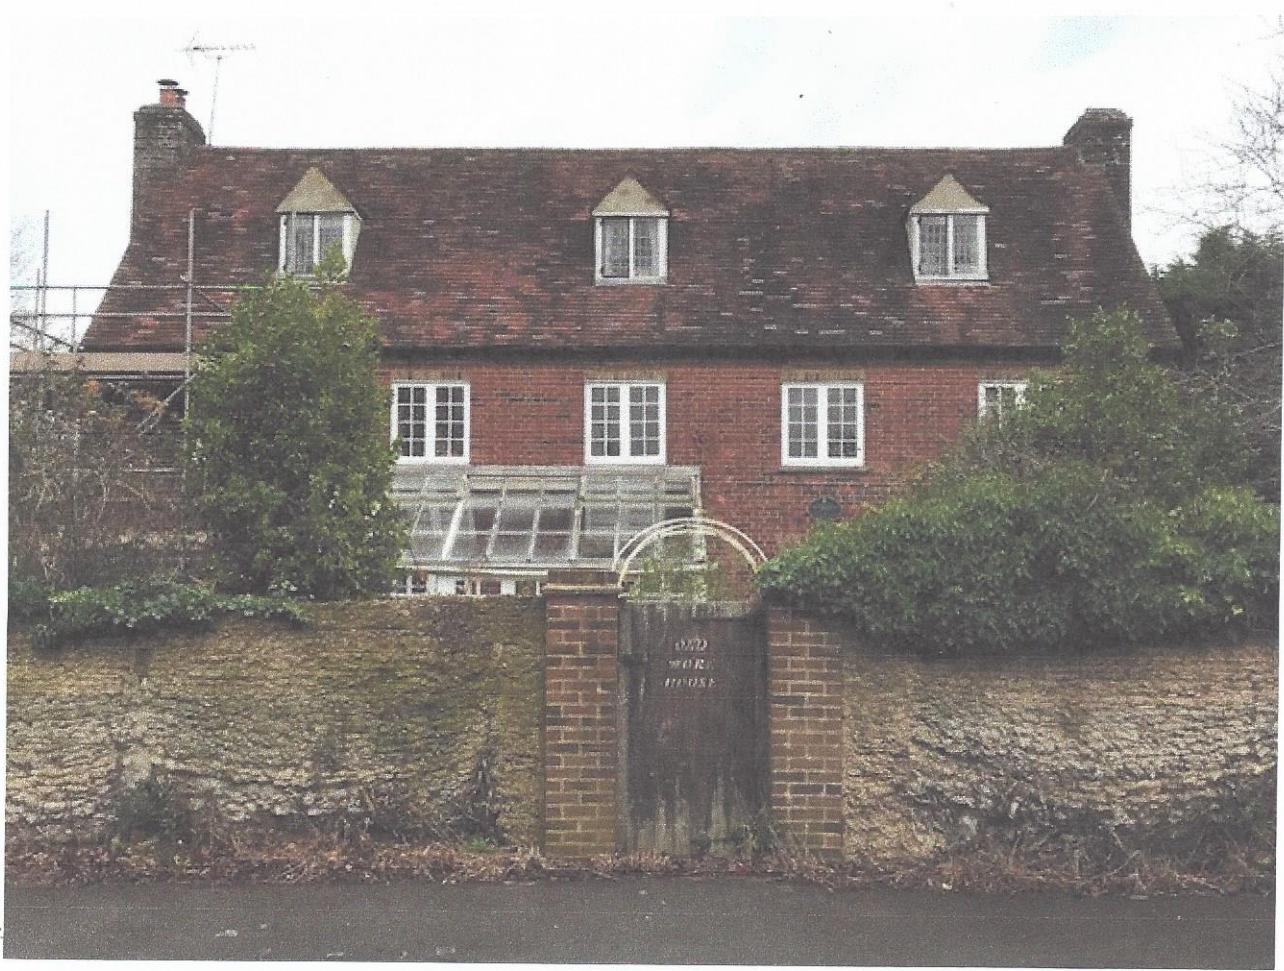
ROAD VIEW OF THE OLD WORKHOUSE.

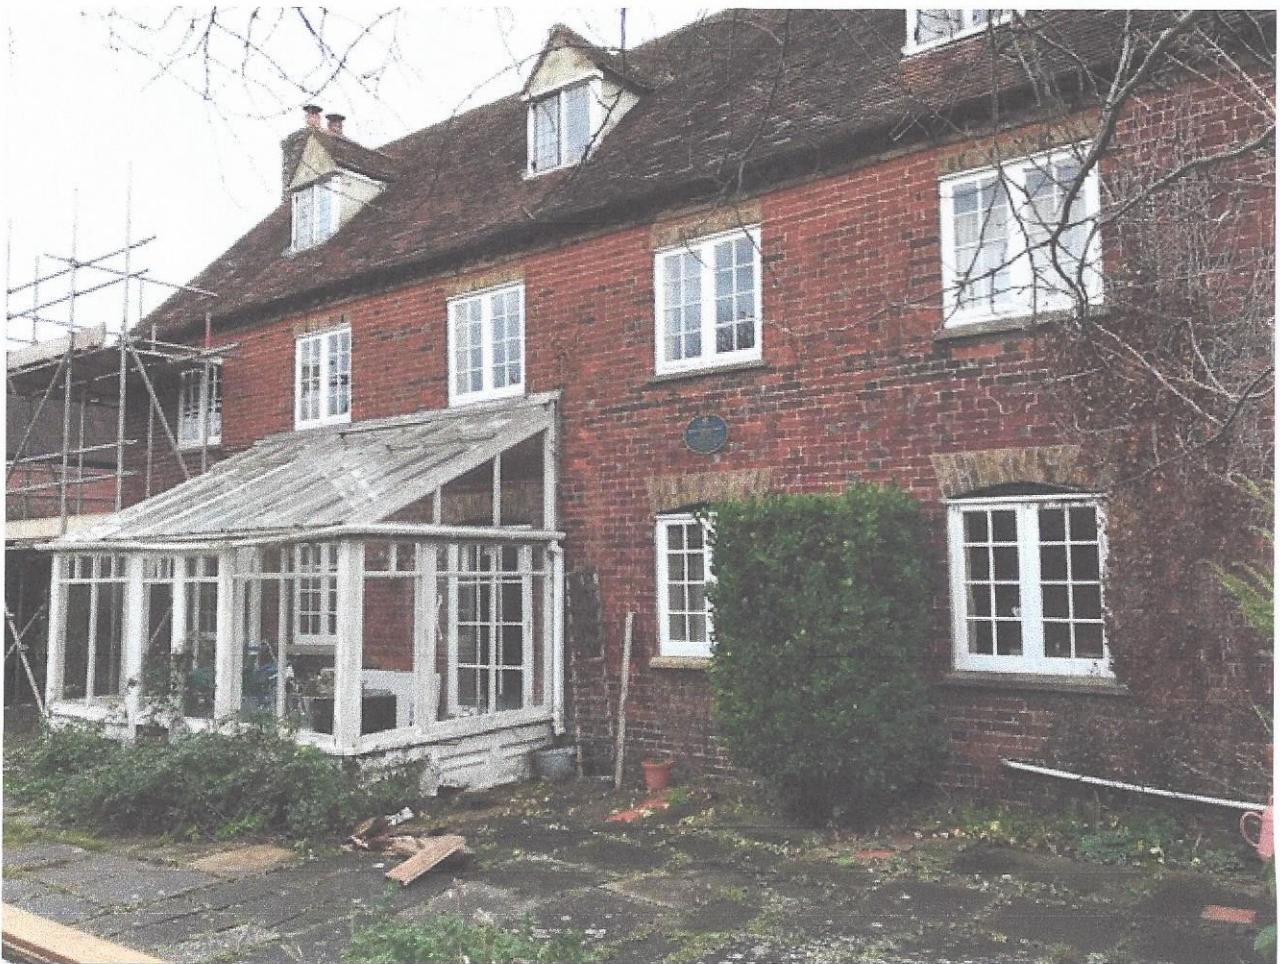
FRONT VIEW OF HOUSE WITH DILAPIDATED TIMBER CONSERVATORY.

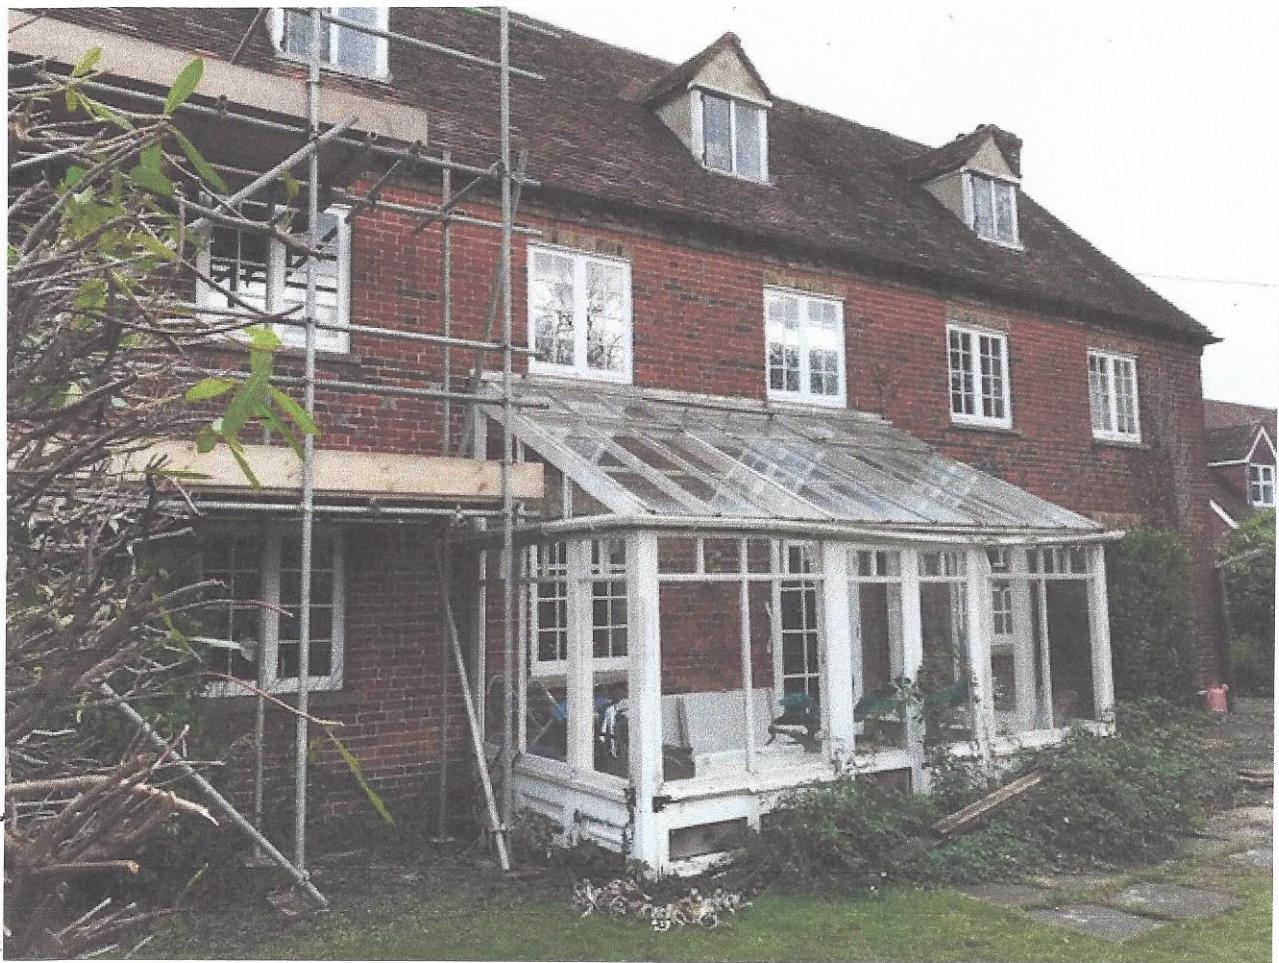
FRONT VIEW OF HOUSE WITH DILAPIDATED TIMBER CONSERVATORY.

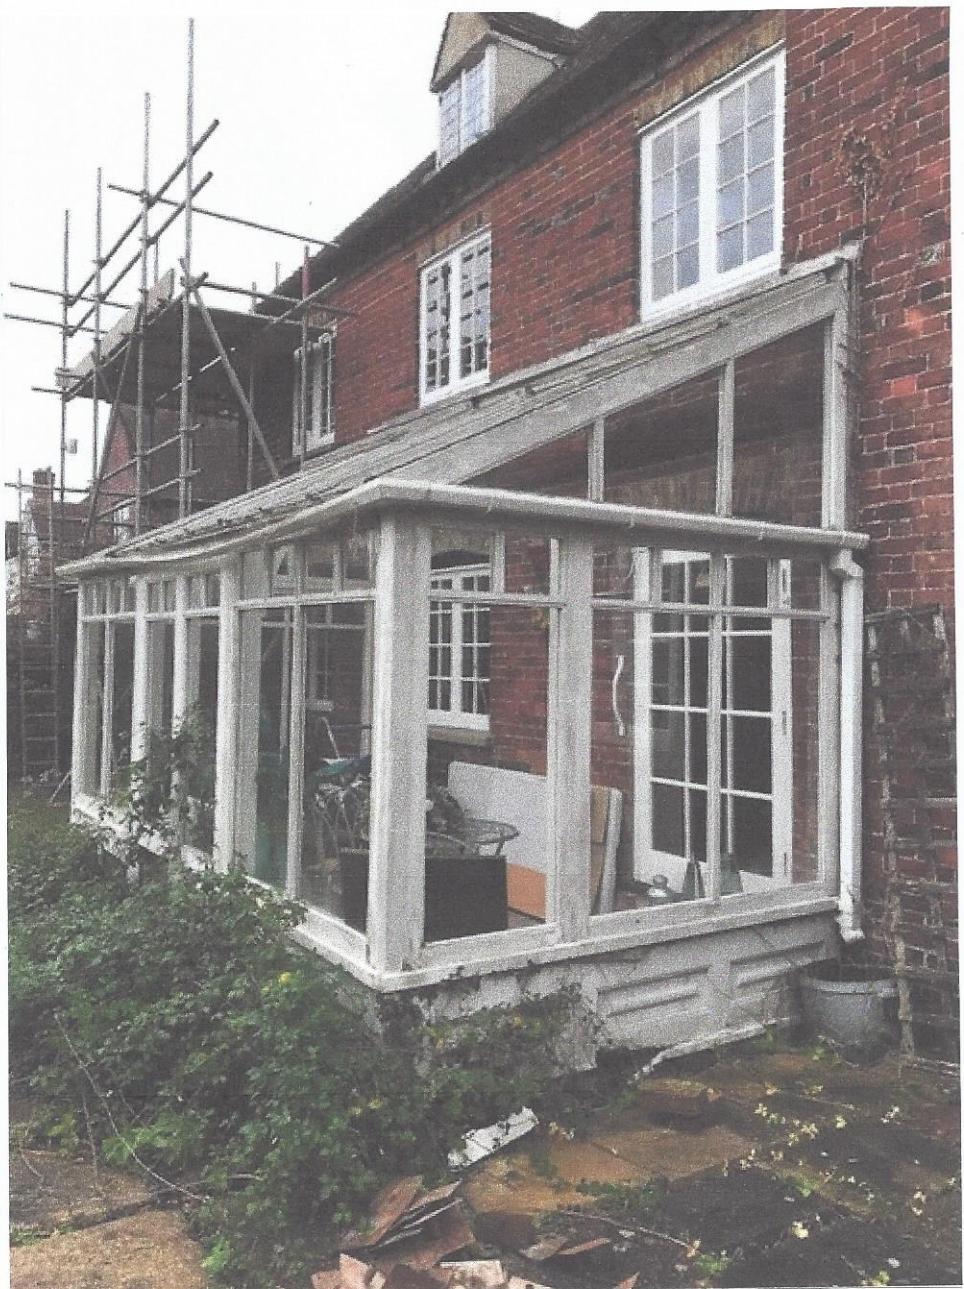
DILAPIDATED TIMBER CONSERVATORY TO FRONT OF HOUSE.

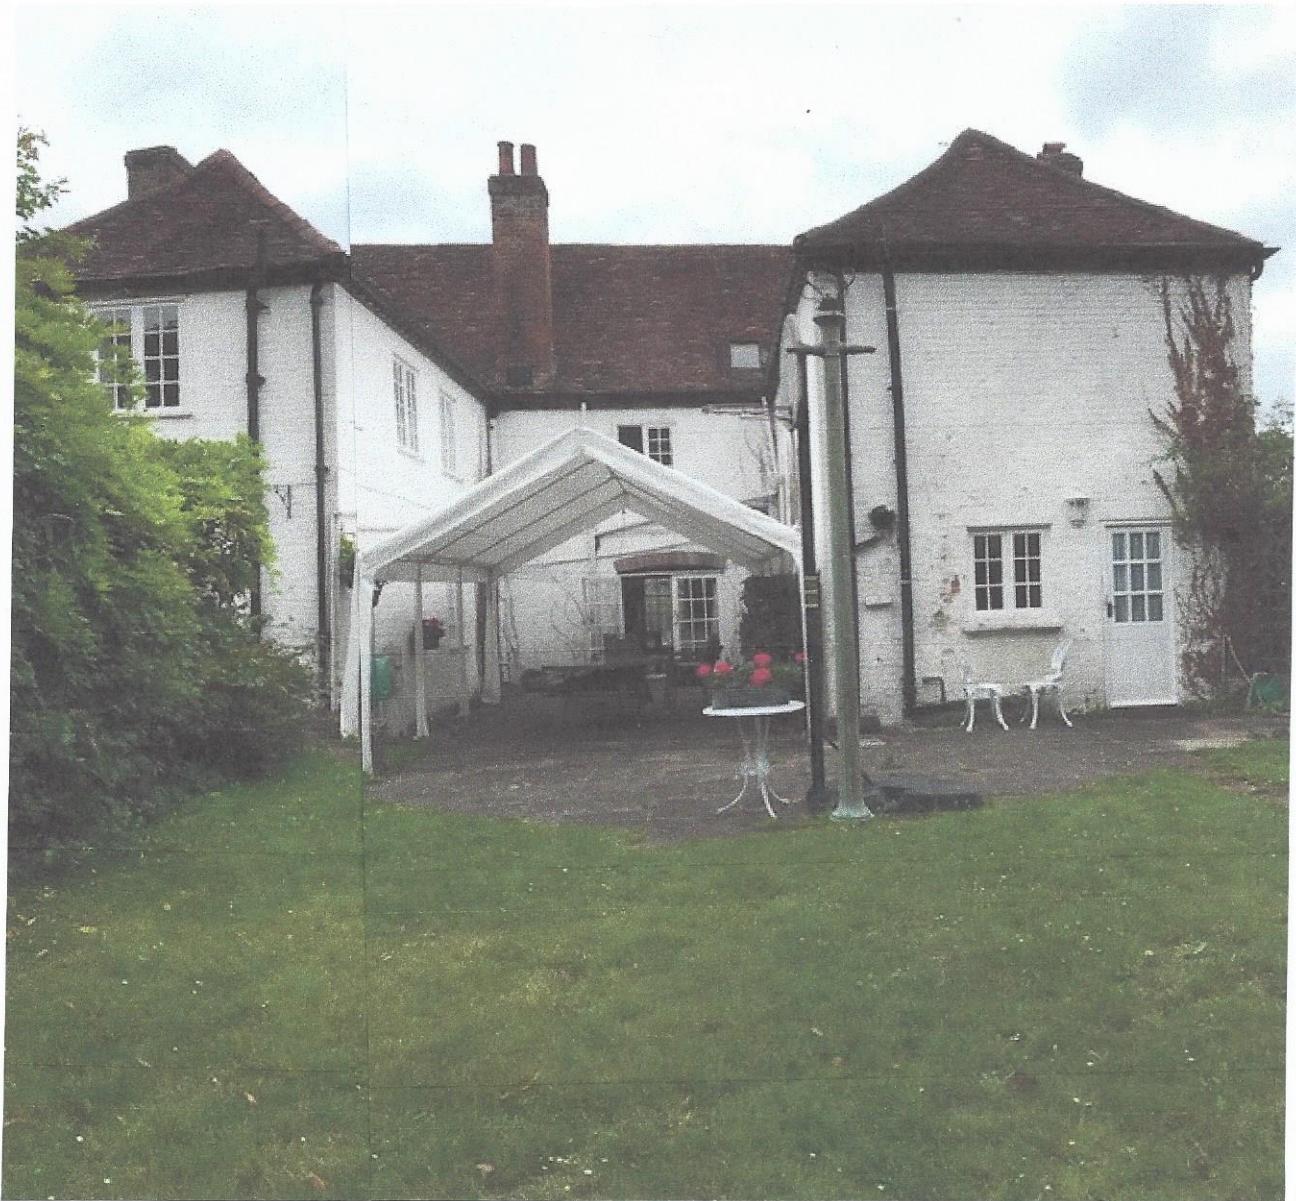
PAINTED BRICKWORK TO REAR AND COURTYARD ELEVATIONS.

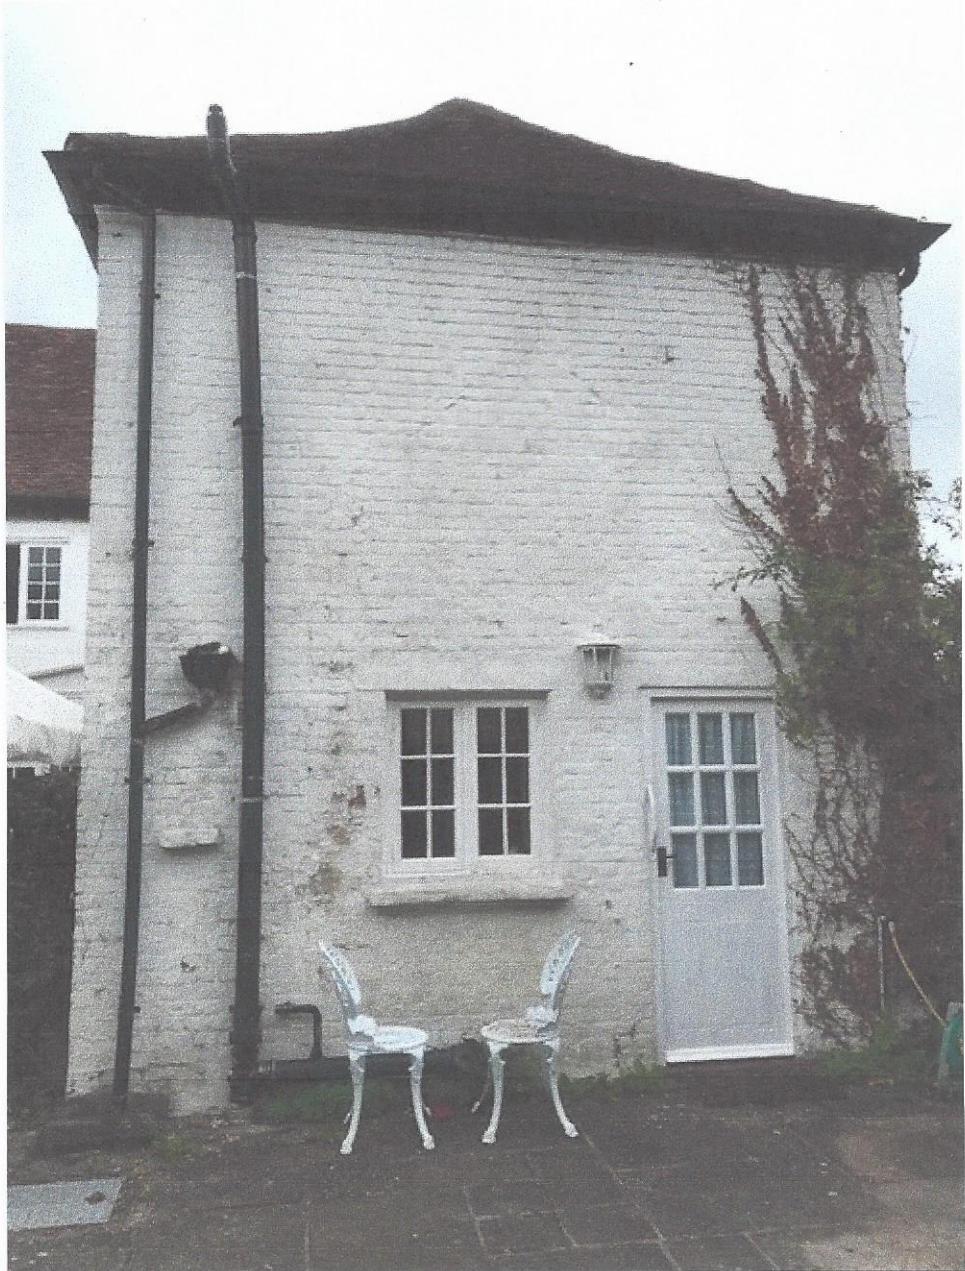
PAINTED SOFT, ERODED BRICKWORK TO REAR COURTYARD WING.

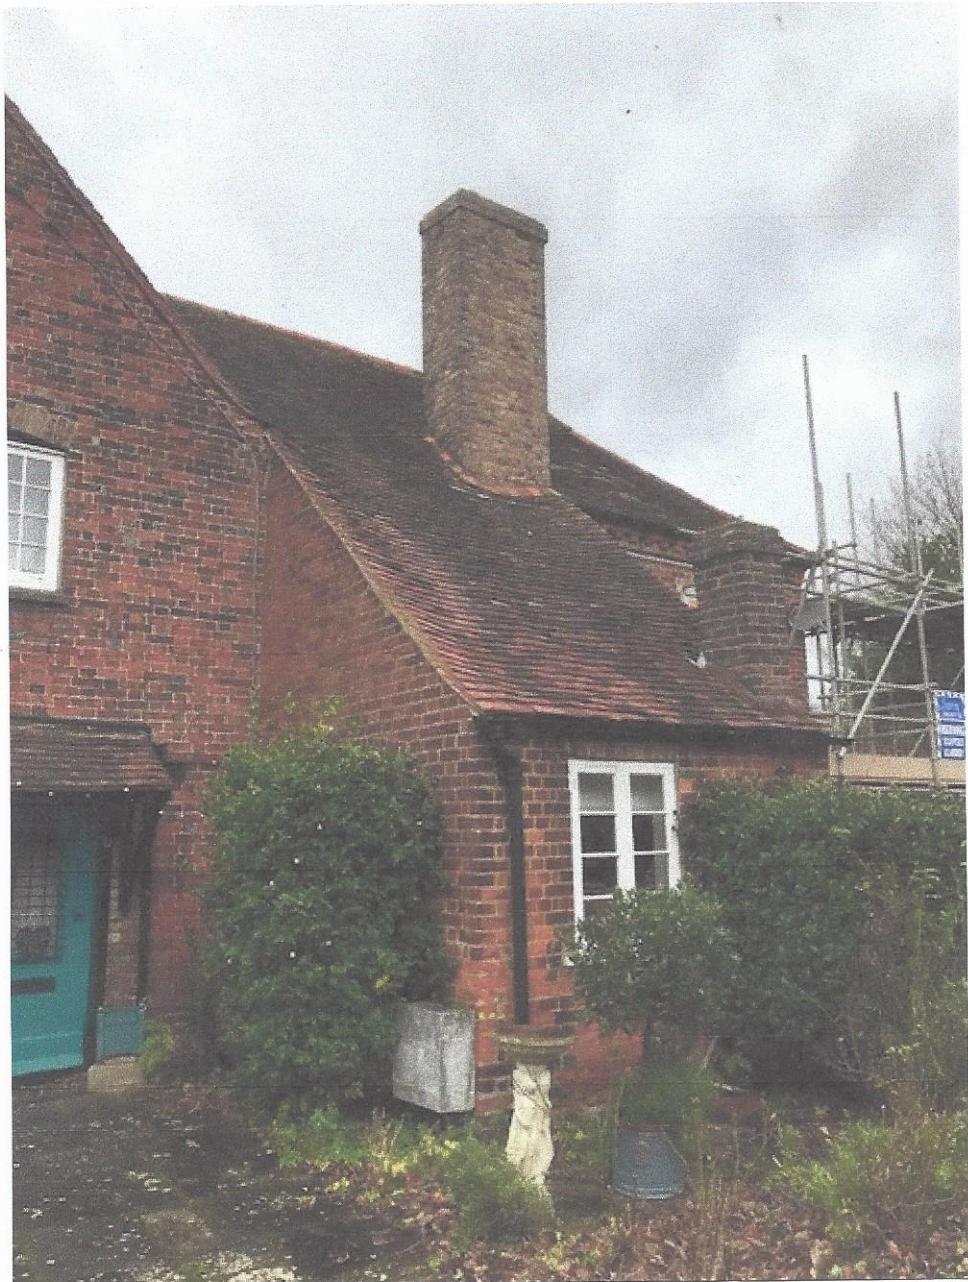
CAT-SLIDE ADDITION WITH LEANING CHIMNEY STACK ON EAST SIDE OF HOUSE.

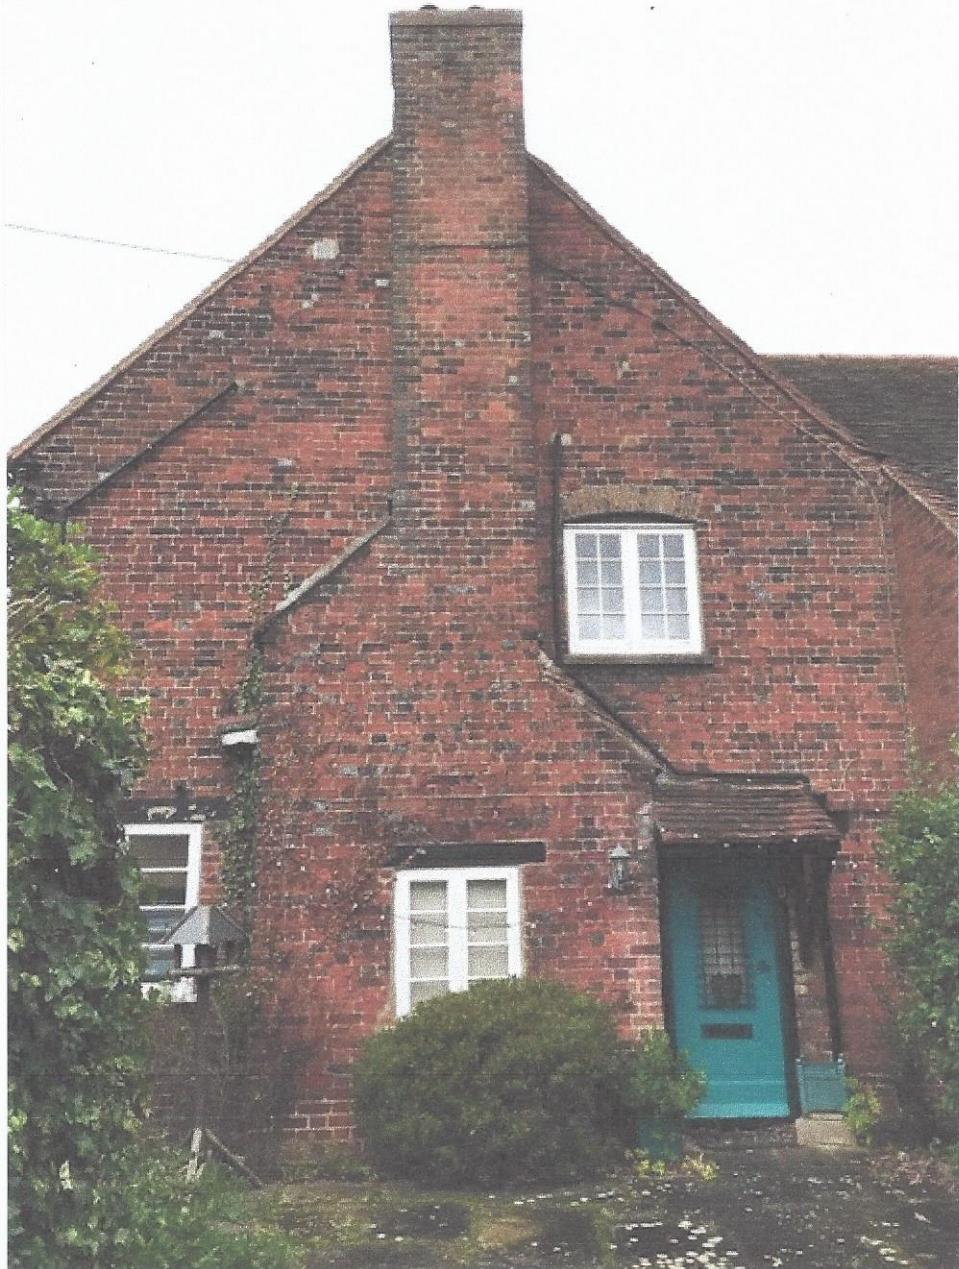
INAPPROPRIATE ENGINEERING BRICKS INSTALLED IN STACK, POOR CEMENT TILE ABUTMENT AND POINTING ON EAST SIDE OF HOUSE.

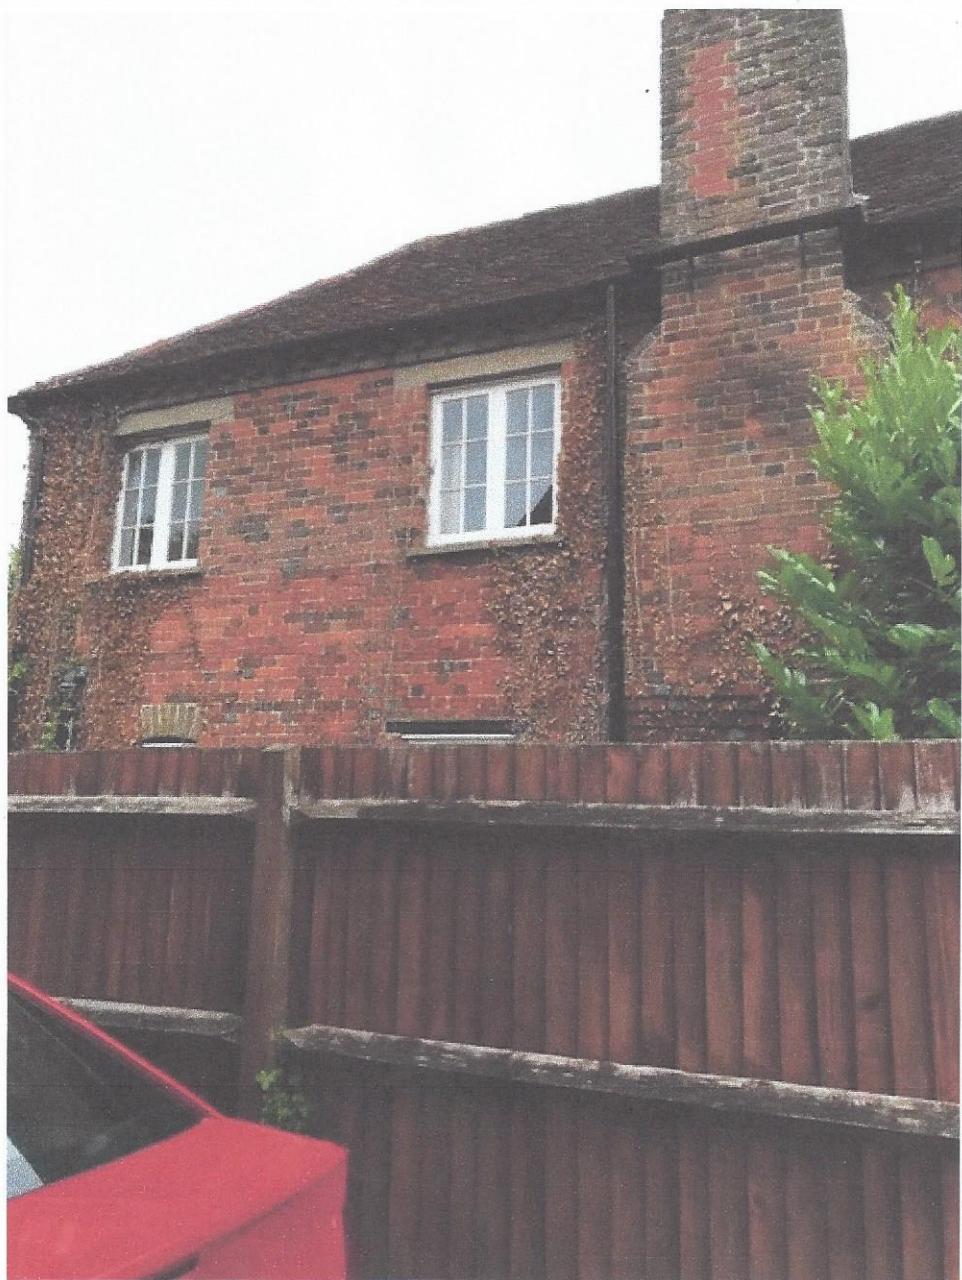
INAPPROPRIATE ENGINEERING BRICKS INSTALLED IN CHIMNEY STACK ON WEST SIDE OF HOUSE.

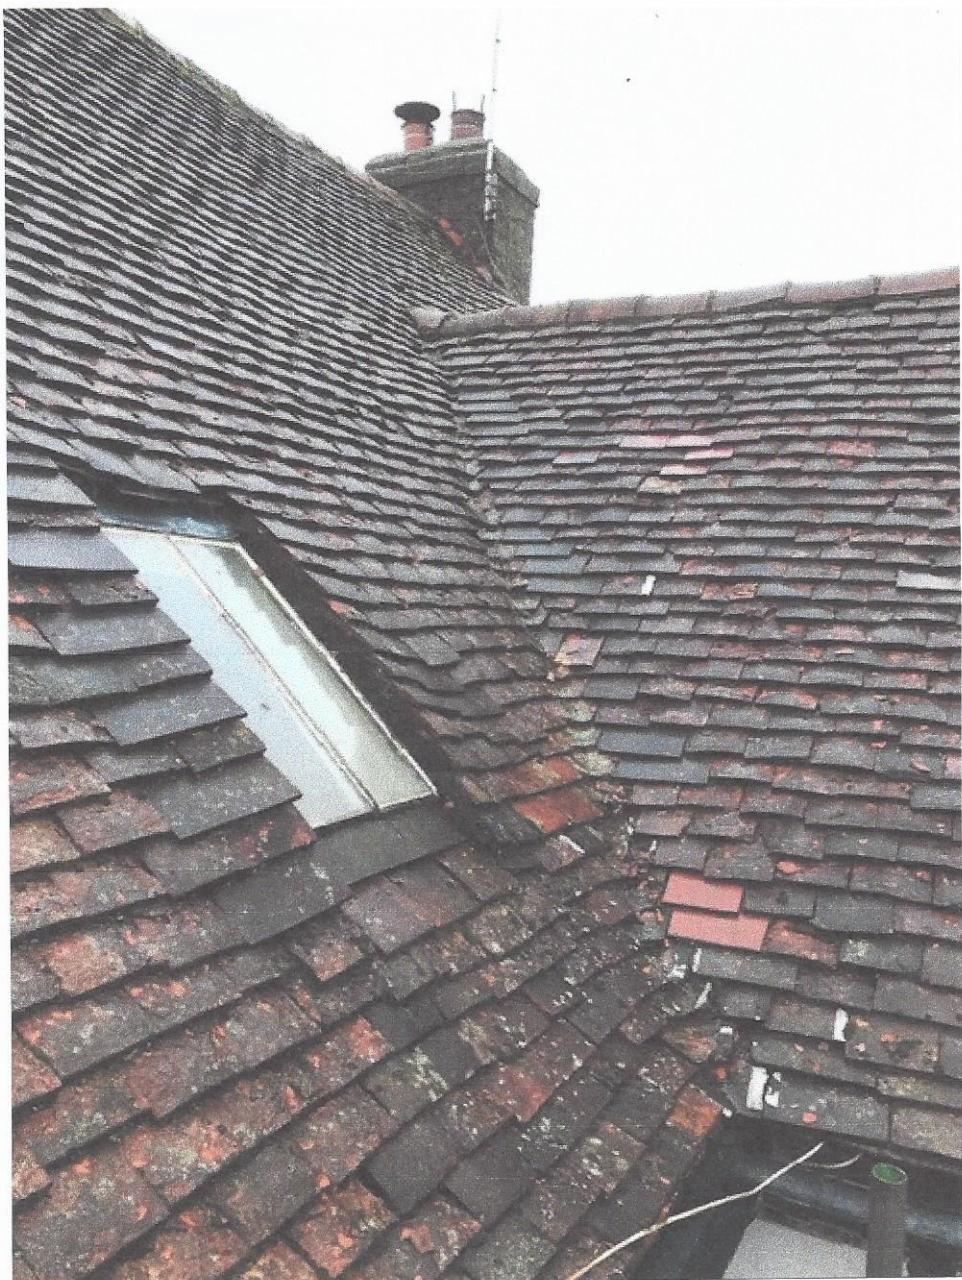
COURTYARD VALLEY AND ROOFLIGHT.

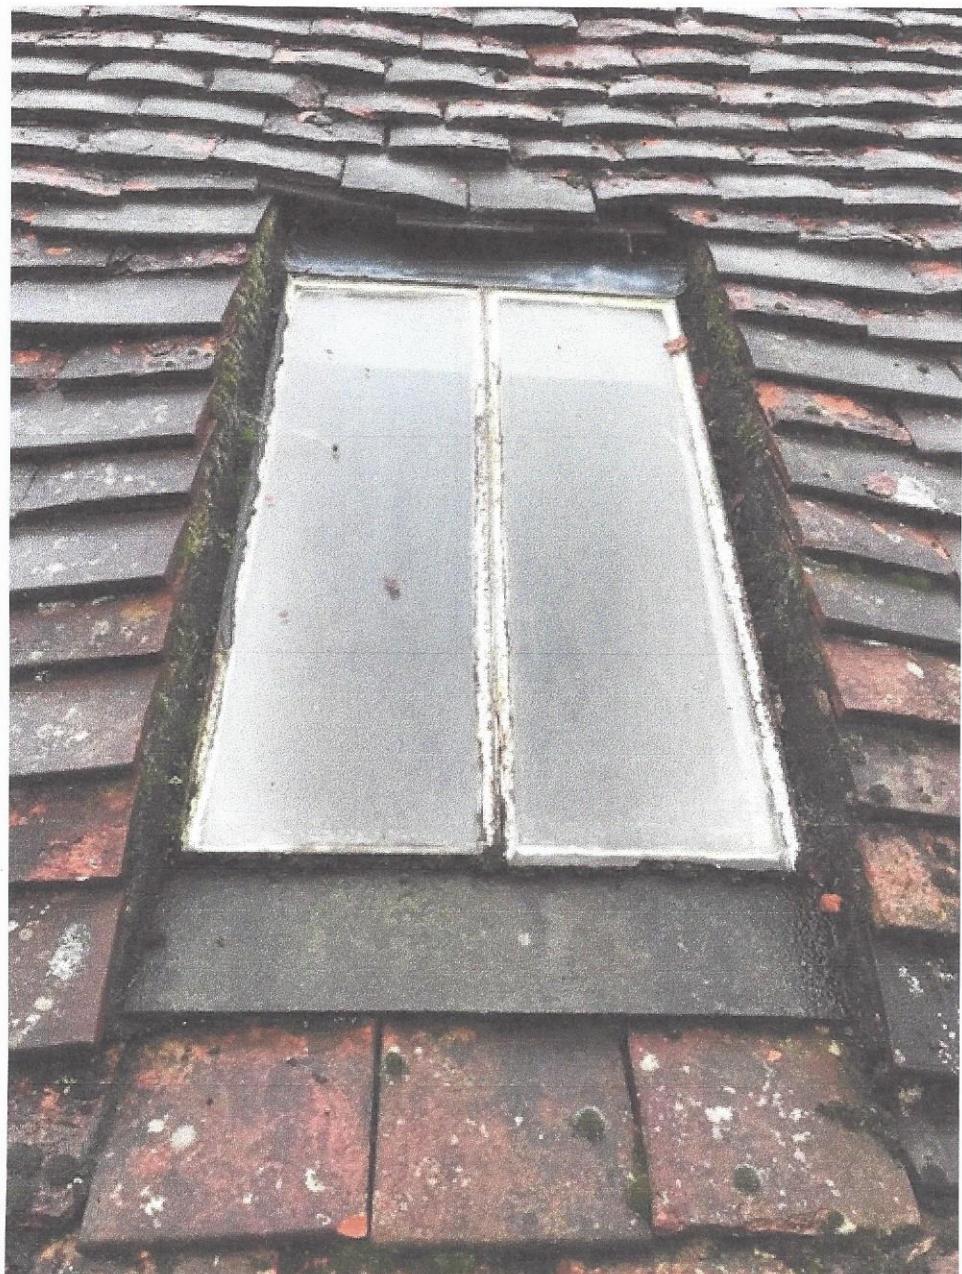
COURTYARD ROOFLIGHT.

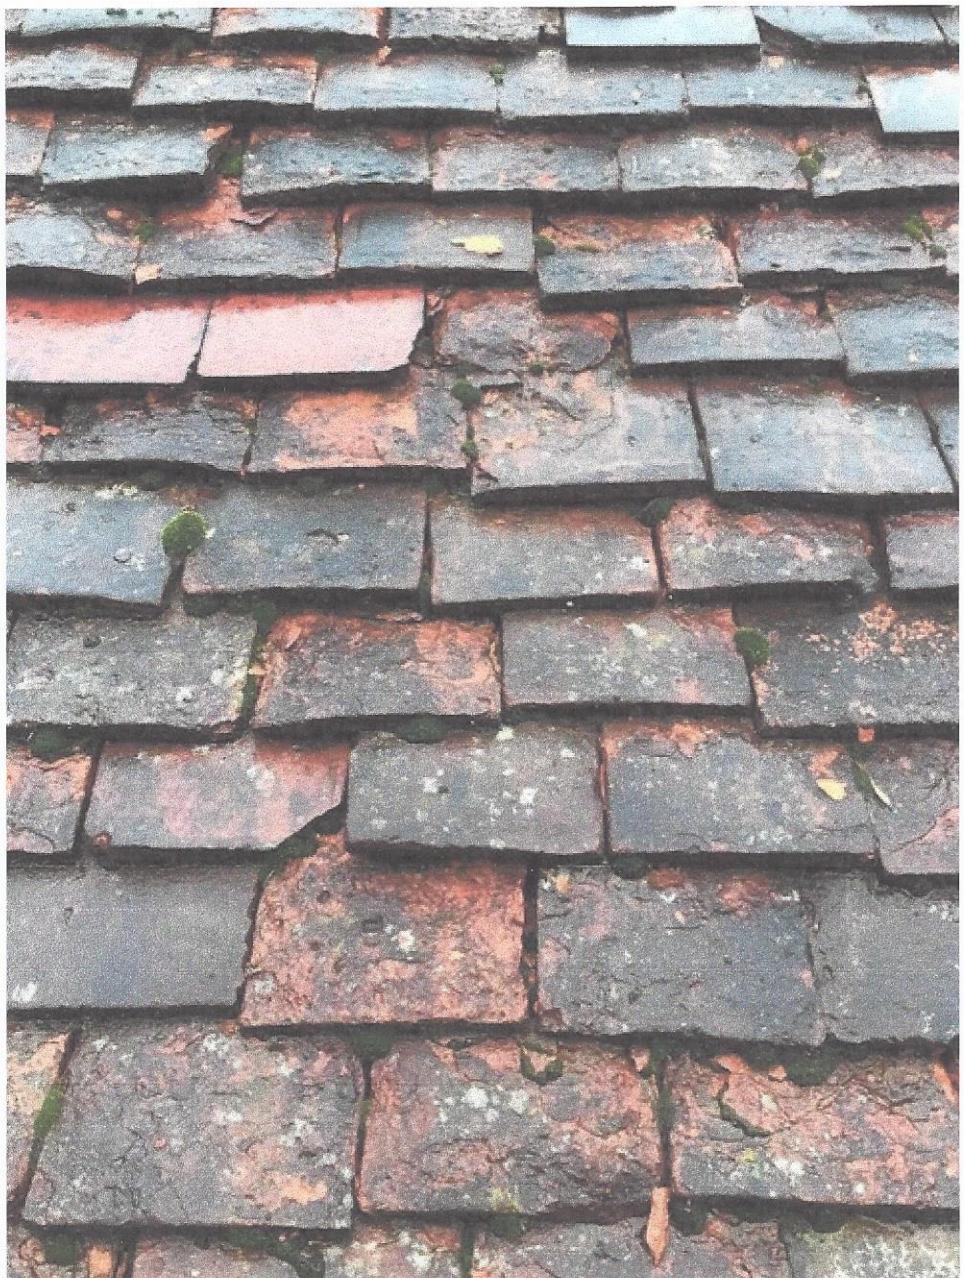
LAMINATED AND ERODED TILING TO COURTYARD ROOF SLOPES.

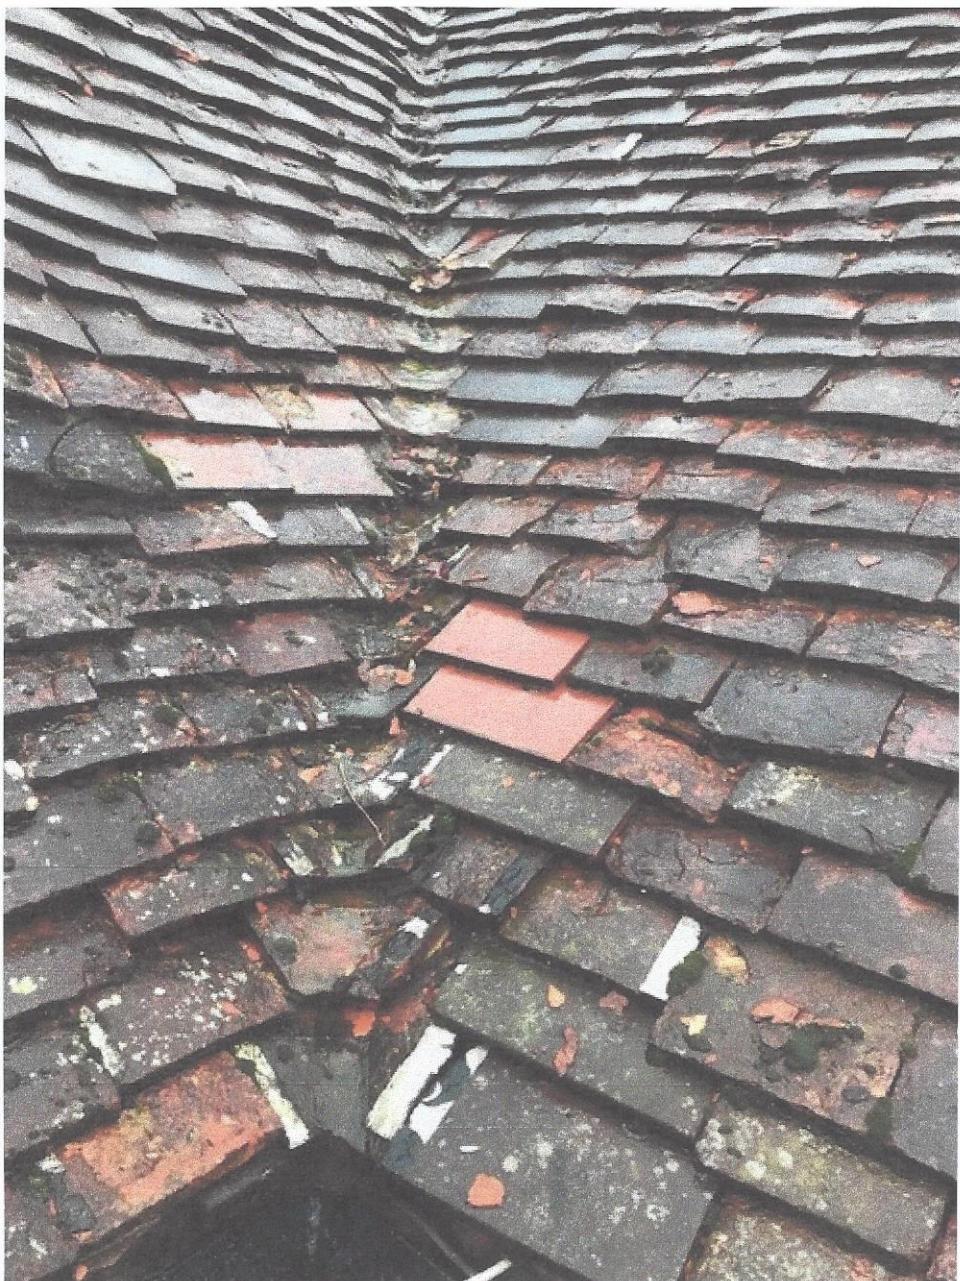
COURTYARD VALLEY AND ADJACENT TILING.

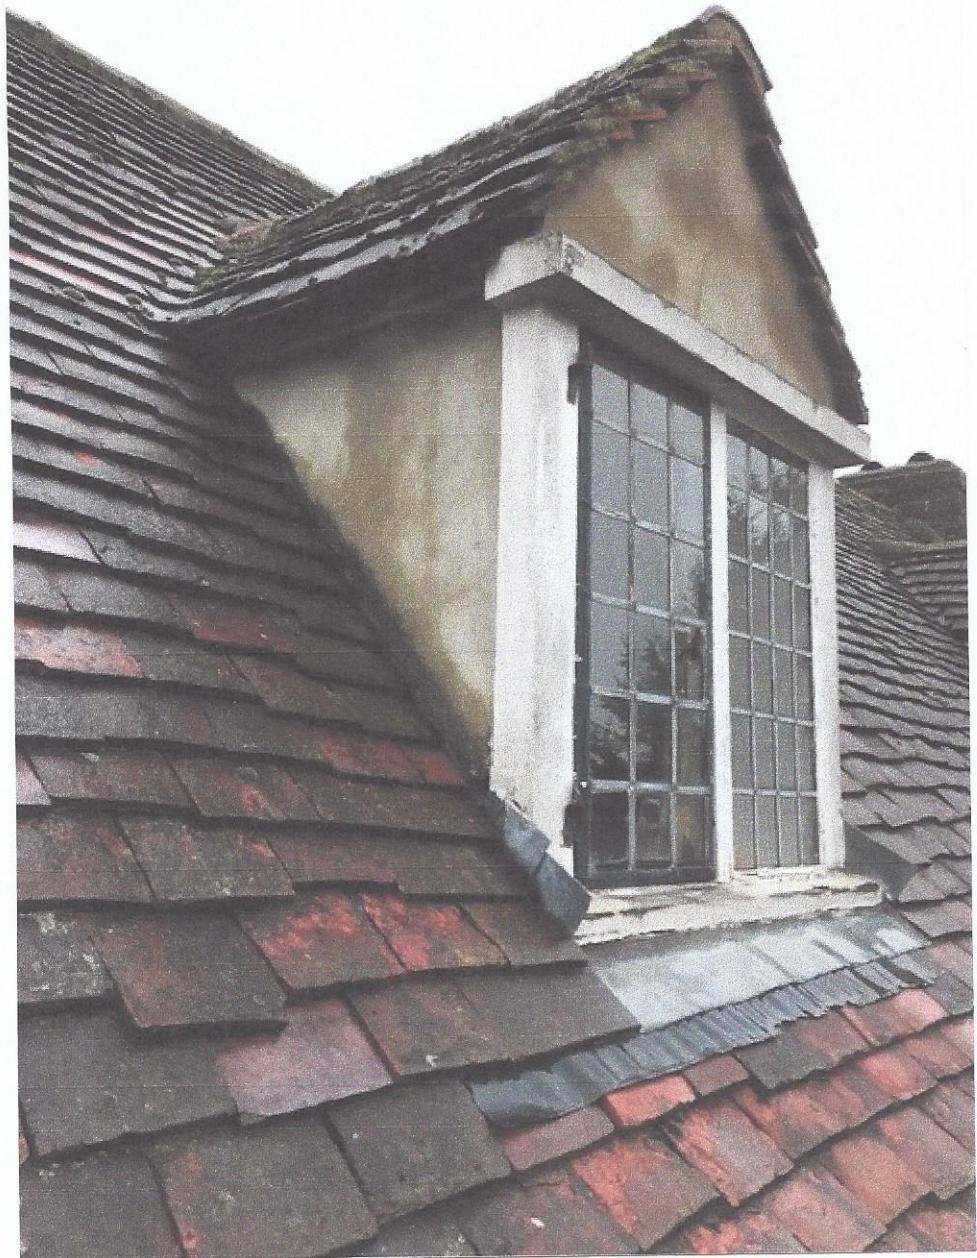
DORMER WITH CRACKED RENDER AND WINDOW REQUIRING OVERHAULING, NEW GLAZED CASEMENT WINDOW AND REDECORATION .

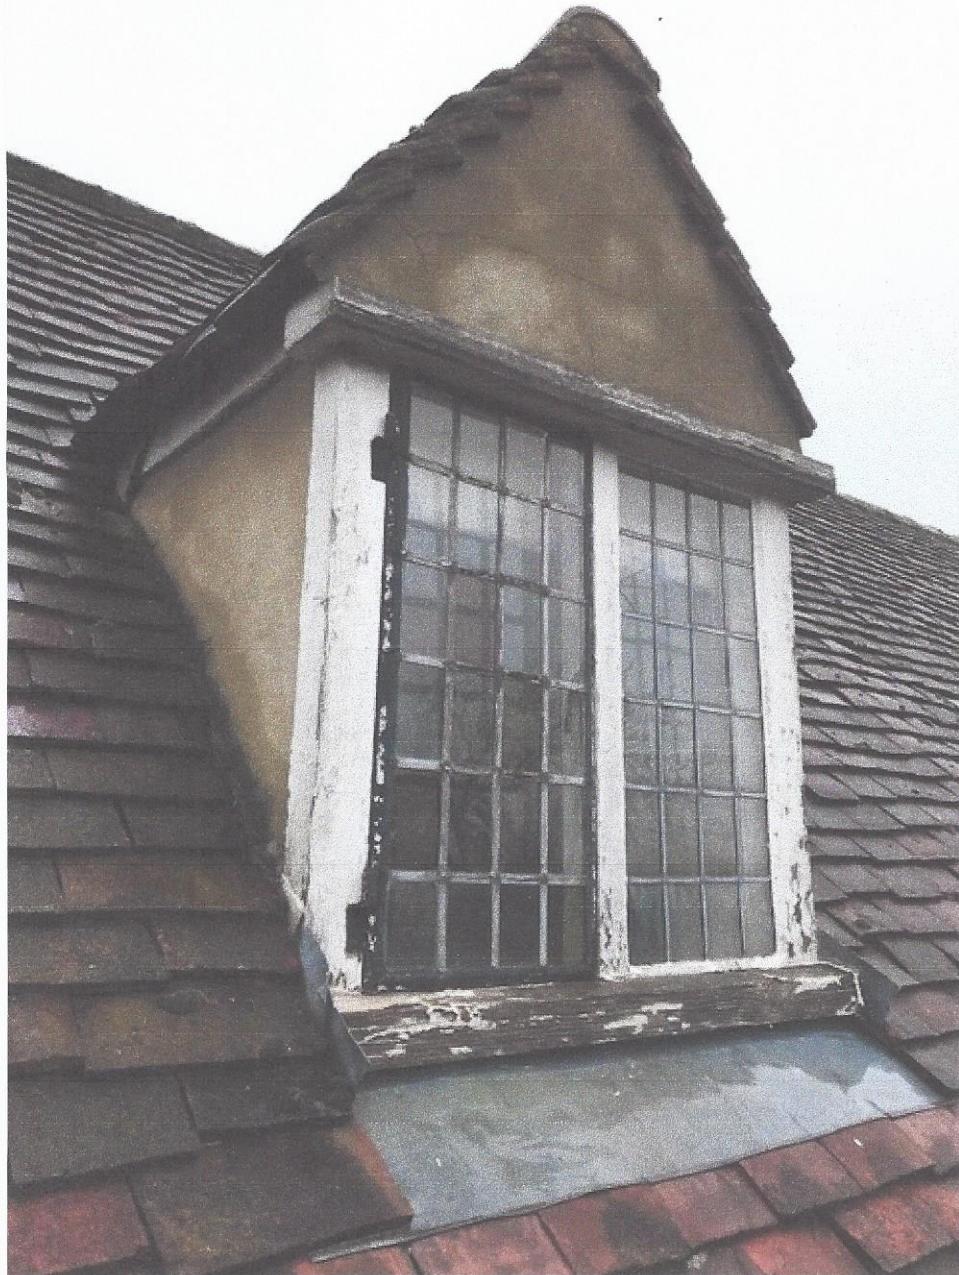
DORMER WITH CRACKED RENDER AND WINDOW REQUIRING OVERHAULING AND REDECORATION.

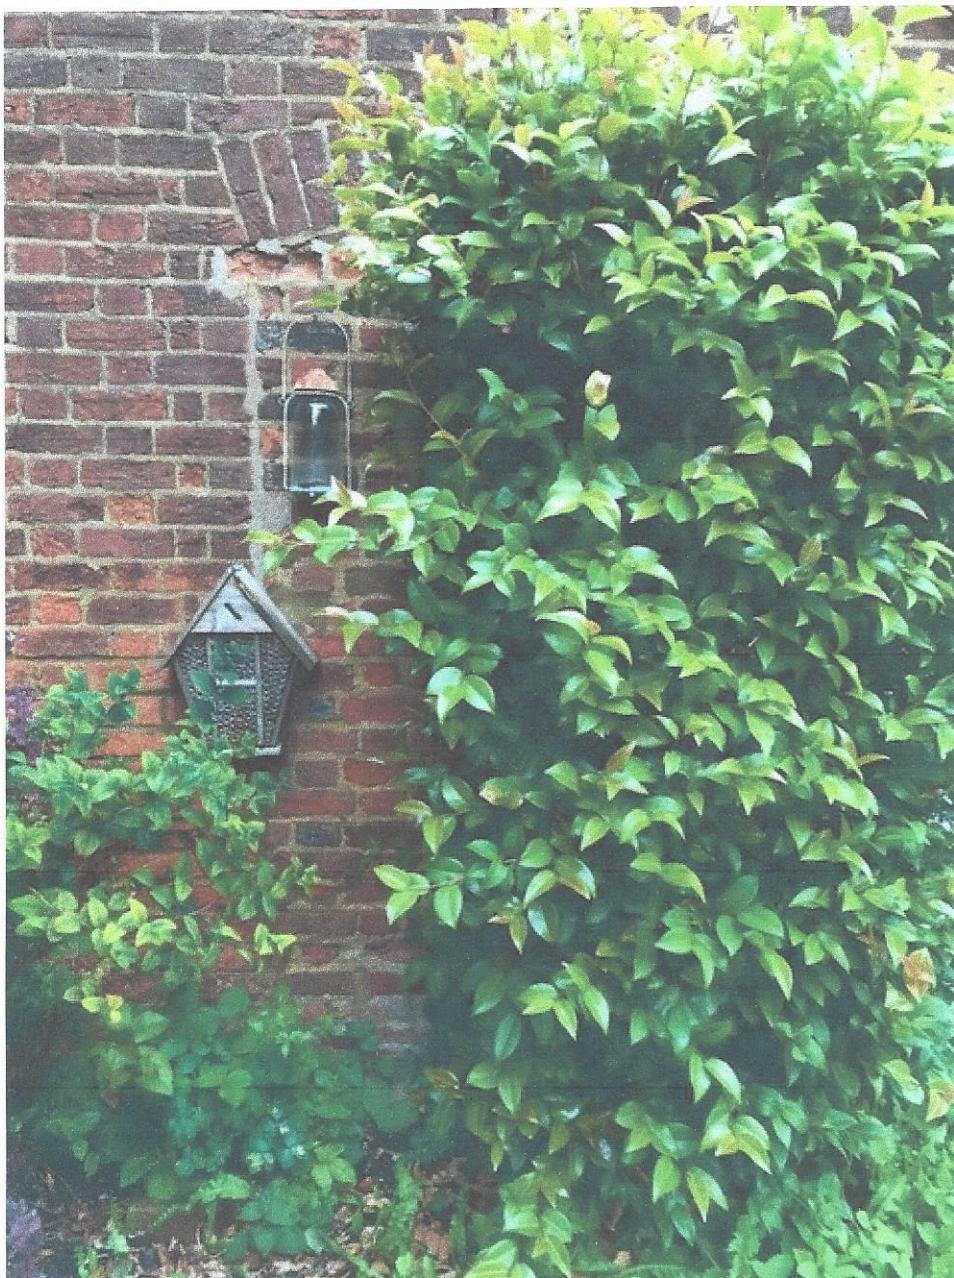
POOR CEMENT POINTING AND ERODED BRICKWORK TO INFILLED WINDOW OPENING ON EAST SIDE OF HOUSE.
