## Drainage Investigation Report

### For Subsidence Management Services

**Risk Address:** 9a Rofant Road, North Wood, HA6 3BD

**Our Reference:** C42528 D17911

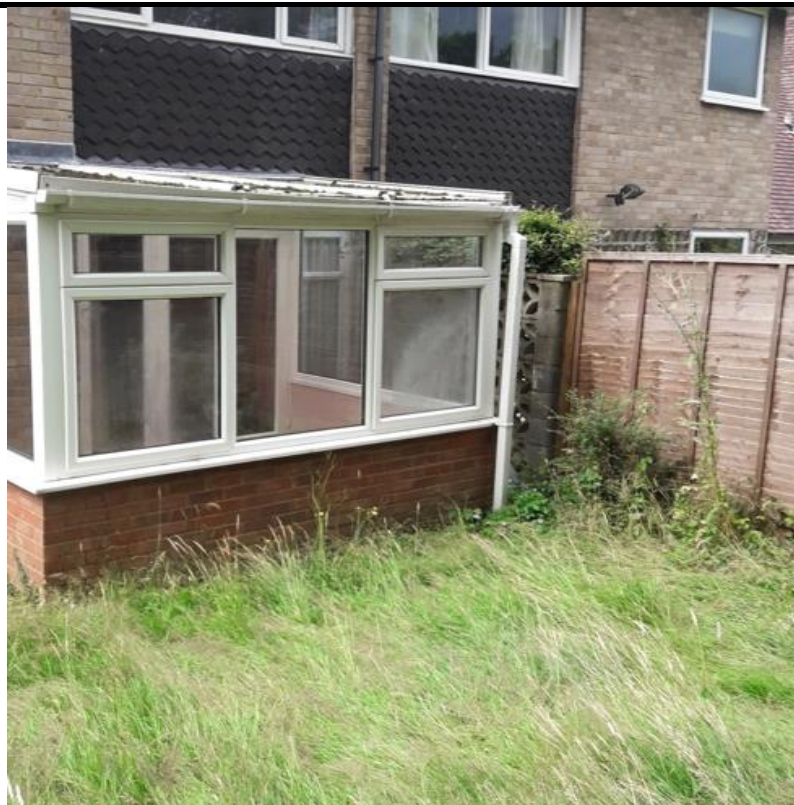
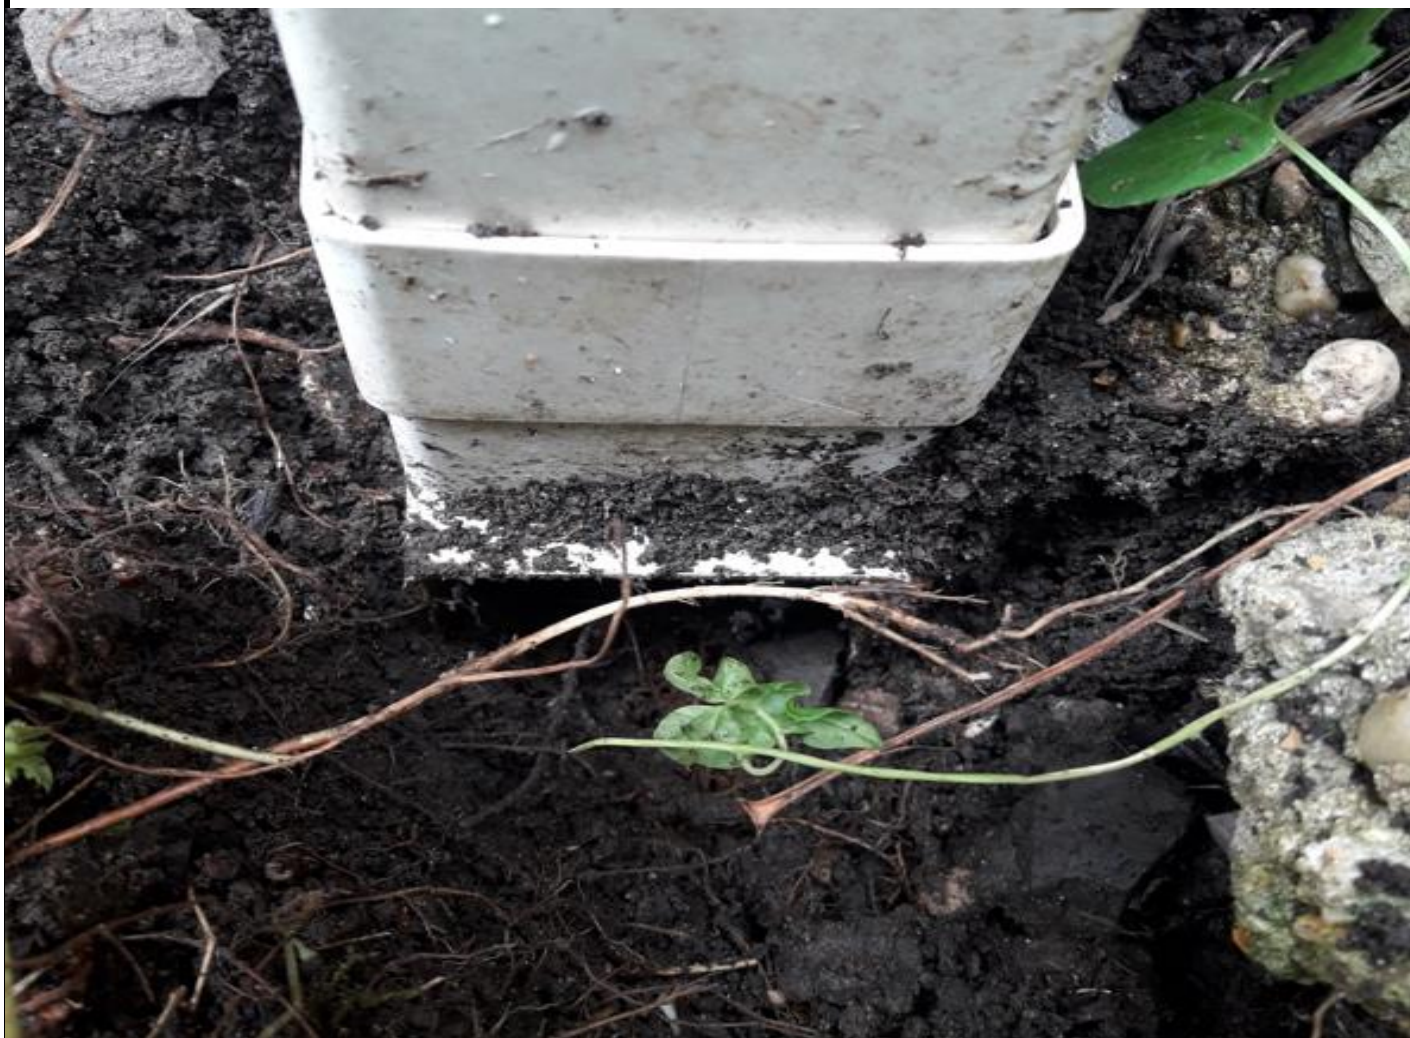
We have exposed the base of RWP1 and found this is discharging water to ground adjacent to the conservatory. See Photos
