Tree Condition Survey Report (VTA)

Site: Clare House Care Home, 176 Harefield Road, Uxbridge
UB8 1PP

Client: Bupa

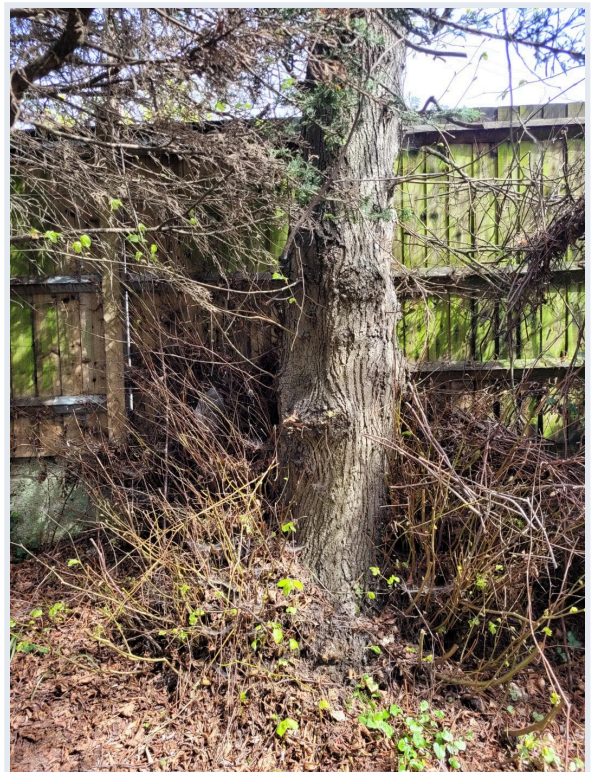
Common lime Tree ID #10

Physiological
Condition: Good

Structural Condition: Fair

Tree / Group ID	Common Name	Work Task	Work Priority	Description	Tag No
10	Common lime	Remove Basal and Epicormic Growth up to 2.5m	Within 12 Months	Remove basal epicormic to facilitate proper inspection of the base.	757
