Arboricultural Consultancy for Lloyds Bank

Insured	Mr & Mrs Saidam	Address	165 Swakeleys Road, Ickenham, Uxbridge, UB10 8DN		
Client	Subsidence Management Services	Contact	Peter Hughes	Claim No.	IFS-LBG-SUB-22-0101692
ES Ref	SA-250409	Consultant	Kirk Thompson	Contact No.	0330 380 1036
Report Date	06/10/2022

GEOTECHNICAL

165 Swakeleys Road, Ickenham, Uxbridge, UB10 8DN

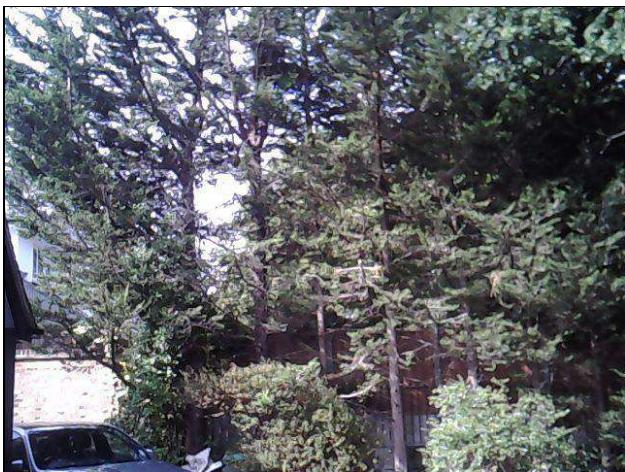
TG1 - Cypress

With due regards to species profile, size and proximity, TG1 (Cypress), T1 (Oak), T2 (Oak) and T5 (Cypress) are considered the dominant features proximate to the focal areas of movement and accordingly, where vegetation is confirmed as being causal, we have identified them as the primary cause of the current subsidence damage.

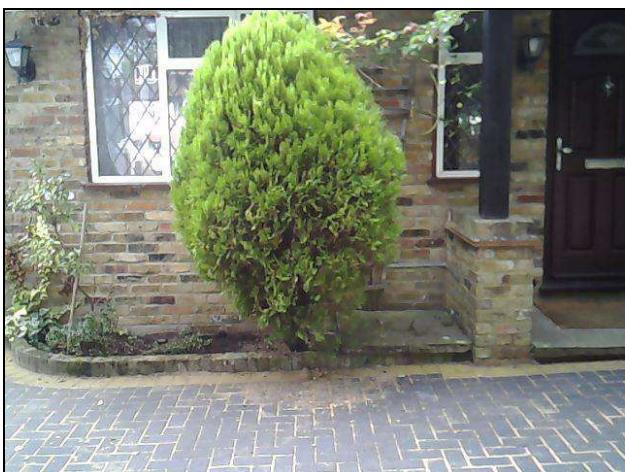
T7 - Cypress

T7 (Cypress) is also considered to retain a contributory influence, albeit in a secondary capacity when compared to the above.

Consequently, we have advocated the complete removal of T1 (Oak), T2 (Oak), T5 (Cypress) and T7 (Cypress) in conjunction with management, to include partial removal of a section of TG1 (as detailed)) as it will offer the most certain arboricultural solution likely to restore long-term stability.

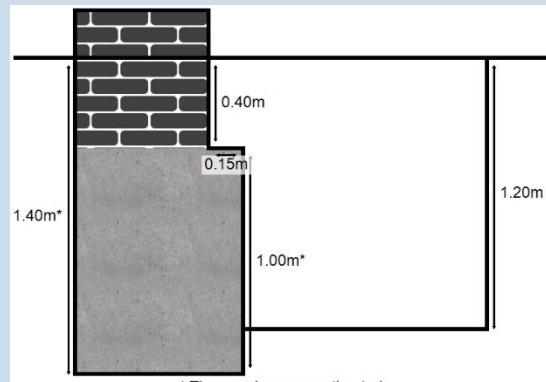
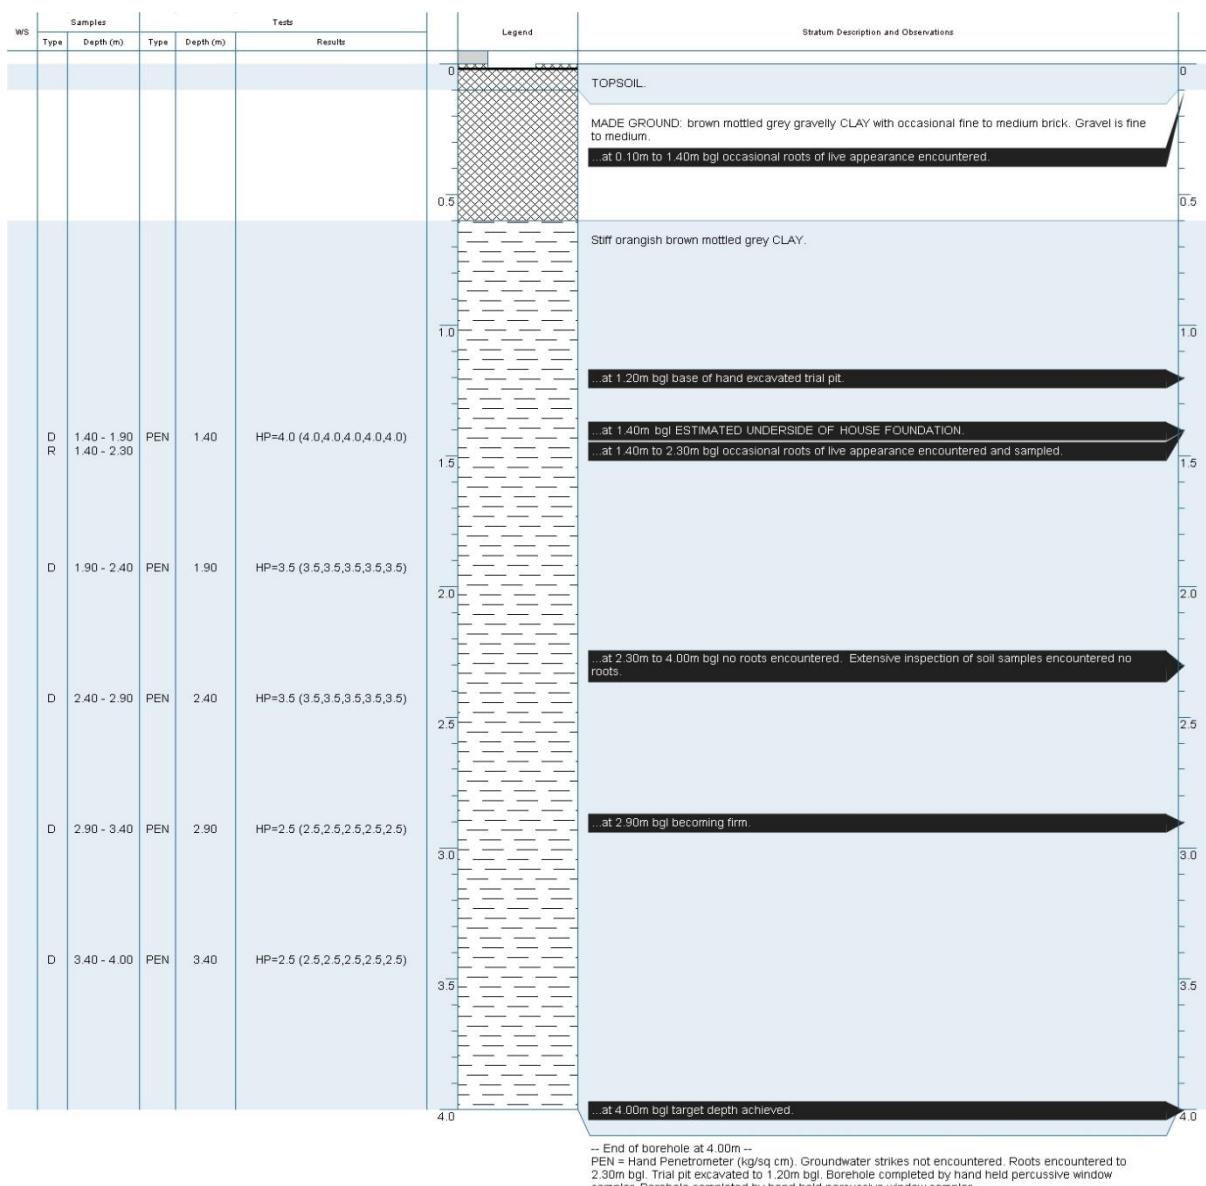
TP/BH1 Foundation Detail and Borehole Log

House foundation comprised of brick wall to 400mm bgl, bearing on concrete to an estimated depth of 1400mm bgl, with a total projection of 150mm from the elevation. Underside of foundation (USF) was estimated by pushing a probe, approximately 50mm back from the face of the foundation, at an angle with no apparent contact with the face of the foundation beyond the estimated depth.

At 1.40m bgl ESTIMATED UNDERSIDE OF HOUSE FOUNDATION in TP/BH1.

At 0.10m to 1.40m bgl occasional roots of live appearance encountered in TP/BH1.

At 1.40m to 2.30m bgl occasional roots of live appearance encountered and sampled in TP/BH1.

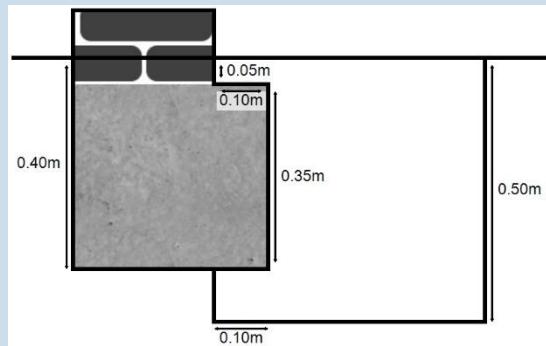
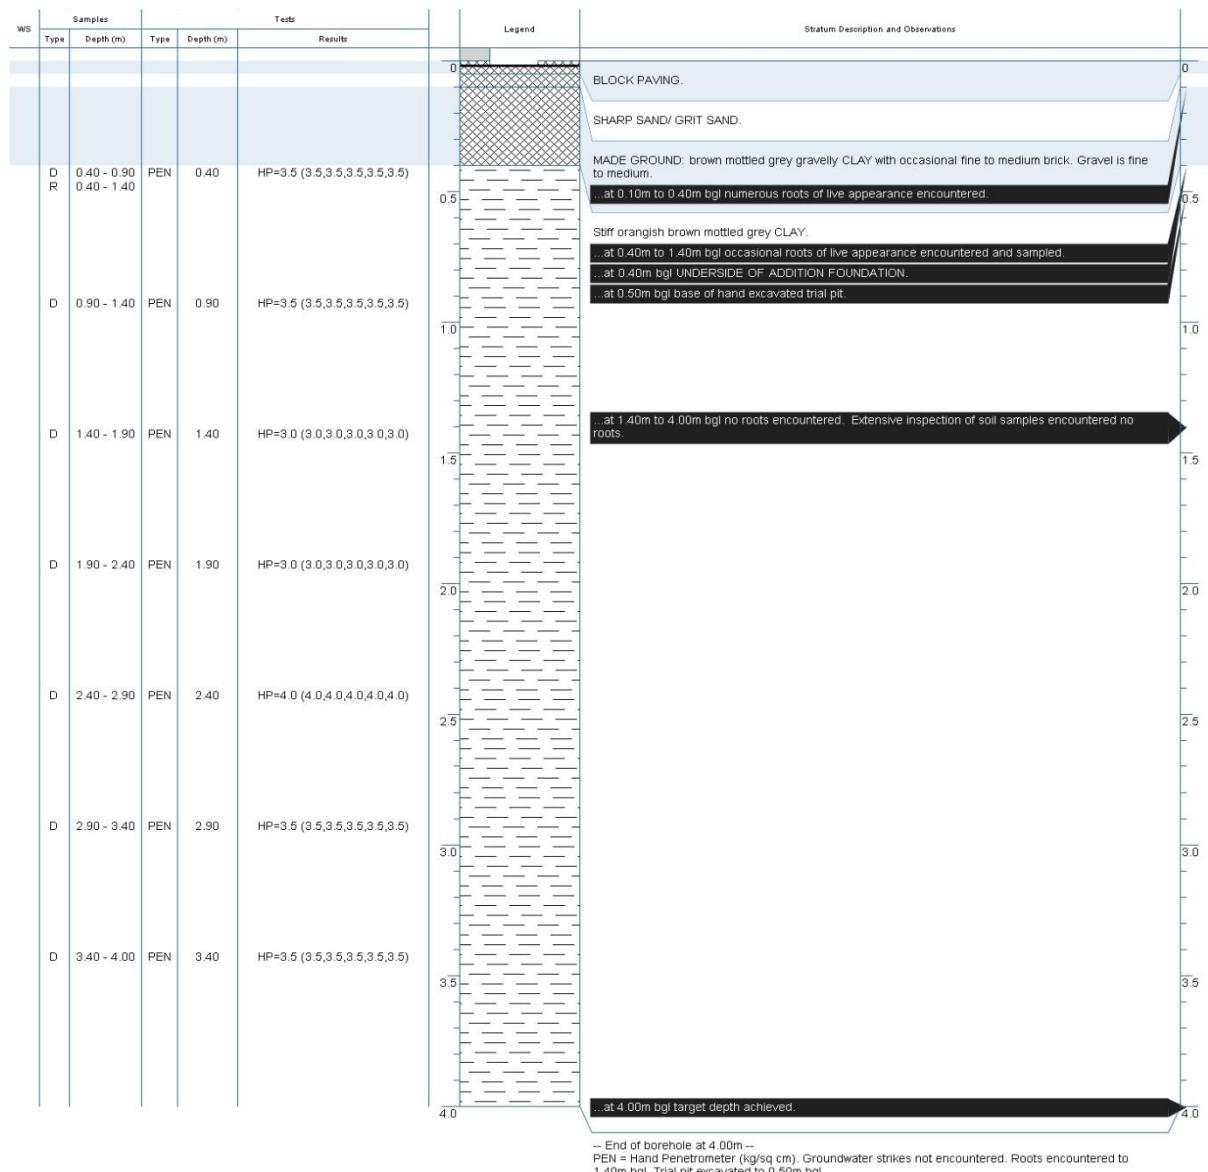
TP/BH2 Foundation Detail and Borehole Log

Addition foundation comprised of brick wall to 50mm bgl, bearing on concrete to 400mm bgl with a total projection of 100mm from the elevation. Underside of foundation (USF) was exposed to 100mm back from the face of the foundation and probed 400mm back from the face of the foundation.

At 0.40m bgl UNDERSIDE OF ADDITION FOUNDATION in TP/BH2.

At 0.10m to 0.40m bgl numerous roots of live appearance encountered in TP/BH2.

At 0.40m to 1.40m bgl occasional roots of live appearance encountered and sampled in TP/BH2.
