STRUCTURAL INSPECTION REPORT

**Woodland View
Old Mill Lane
Cowley
UB8 2JH**

Job No: 10420

Date: October 2024

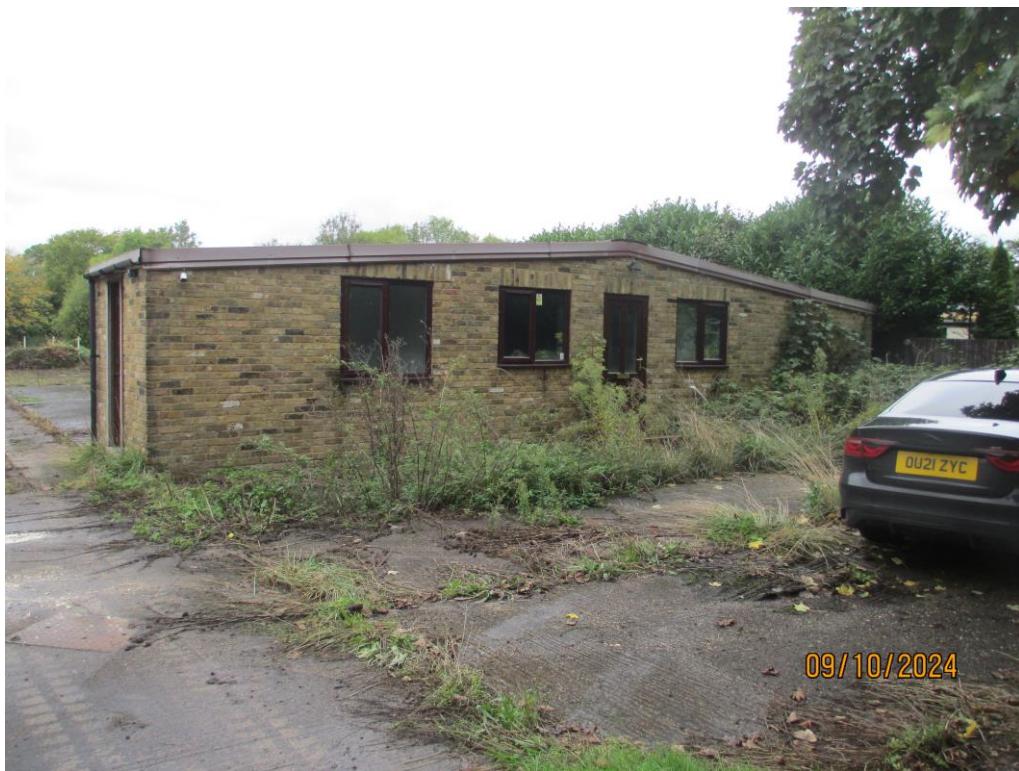
Photograph 1 Front Elevation.

An external inspection of the walls showed them to be in a very good condition. There was some minor cracking above two of the lintels in the front elevation. There were some small hairline cracks in the rear elevation adjacent to the steel purlins that have been built into the wall. There were no other cracks visible.

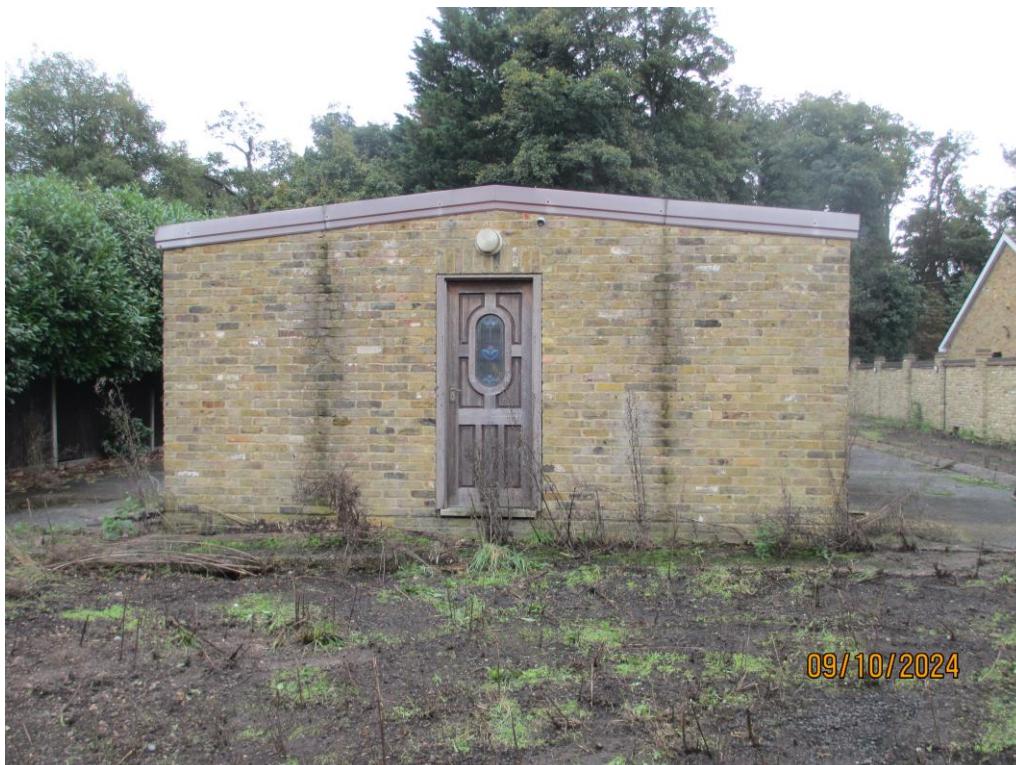
Photograph 4 Rear Elevation.

There was a vertical expansion joint both sides of the long wall at the rear of the building.

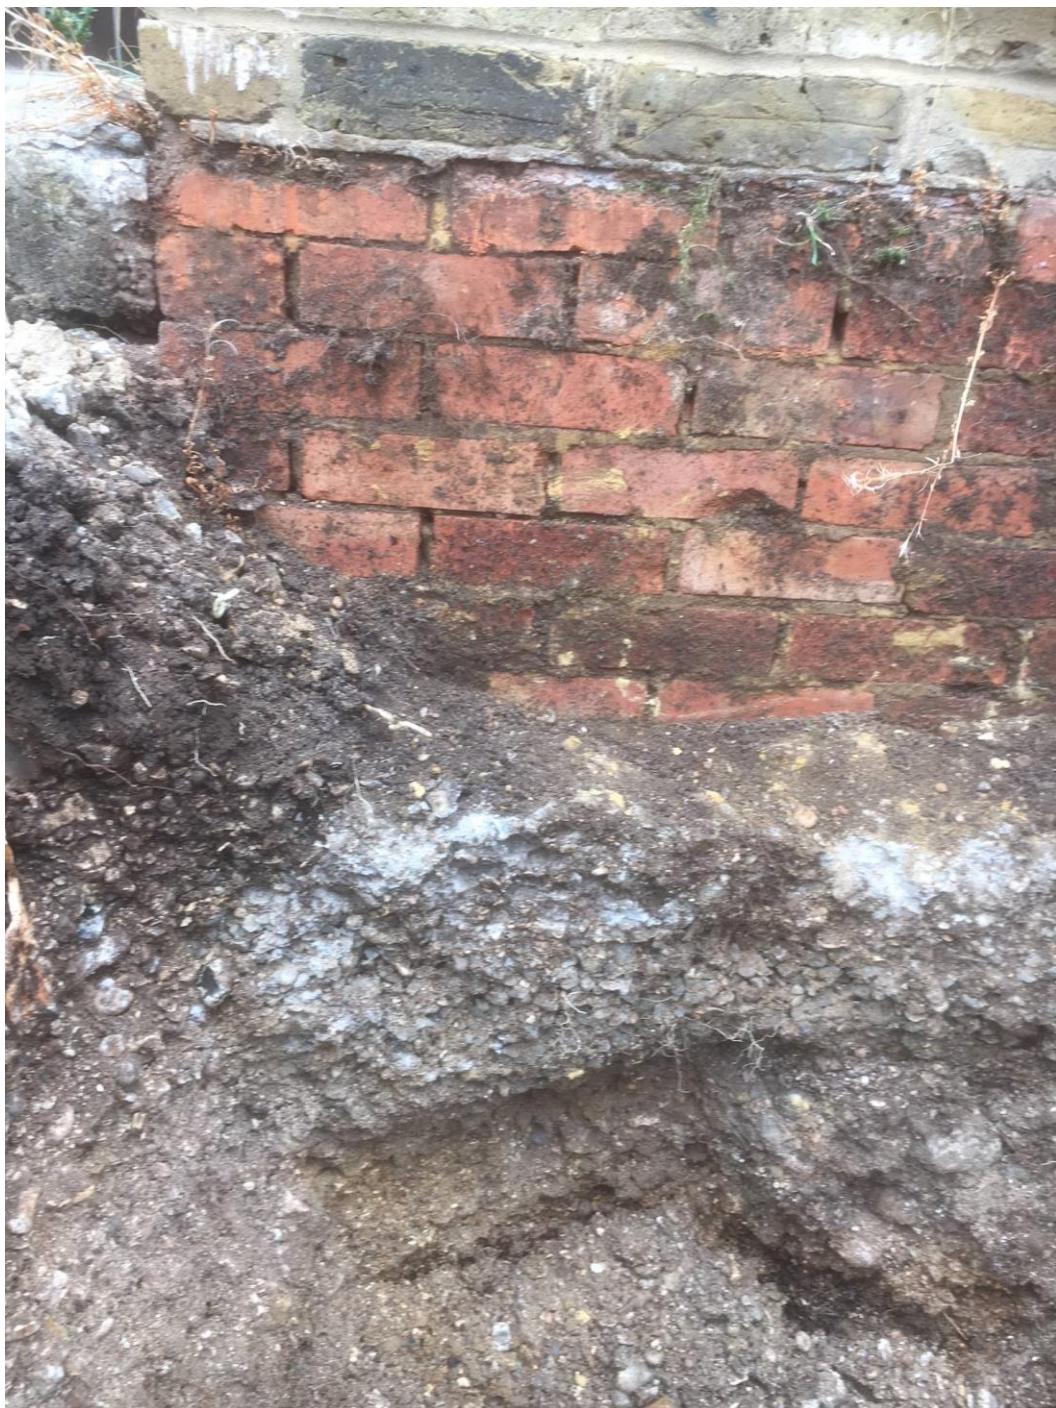
Photograph 7 Foundation detail.

A trial hole had been excavated at the rear of the building in 2018. A sketch, SK-1, is attached in Appendix A. The perimeter wall is supported on 300mm deep concrete strip footing. The footing is founded approximately 800mm below ground level on a sandy gravelly subsoil.

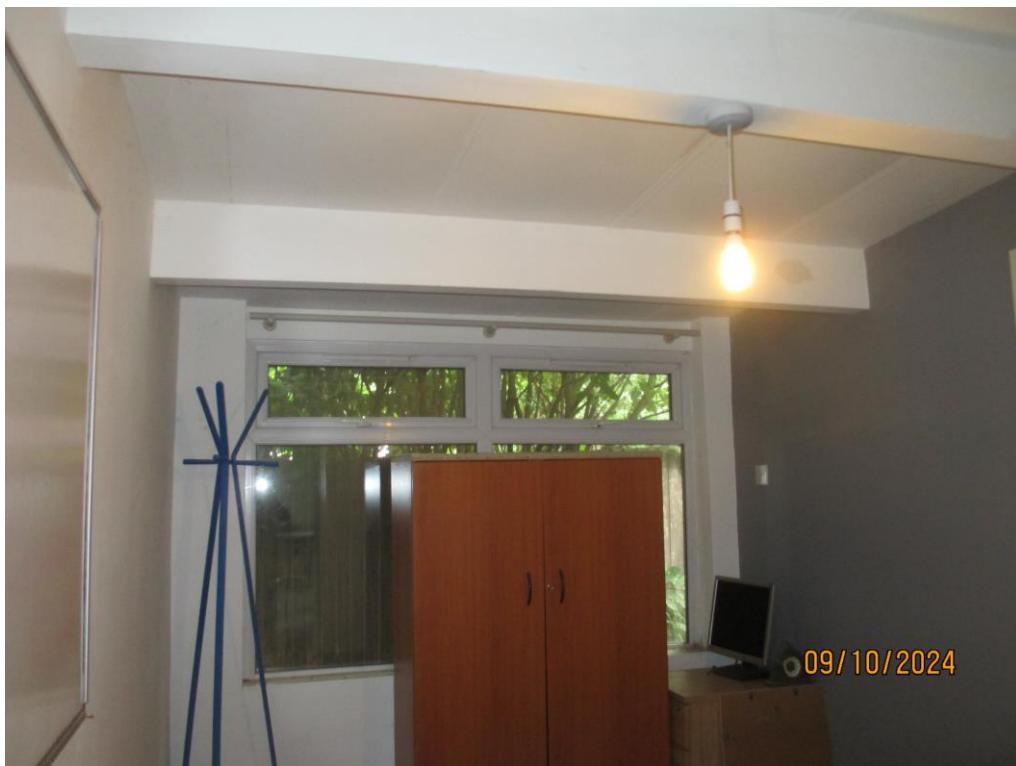
Photograph 8 Internal view of bedroom roof.

The roof in the bedroom and the toilet/shower room comprised of timber purlins supporting the metal insulated sheeting. There were some small hairline cracks at the junction of the walls and ceiling. There was a damp patch in the ceiling of the bathroom.

The hairline cracking evident inside the building has been caused by thermal movements.

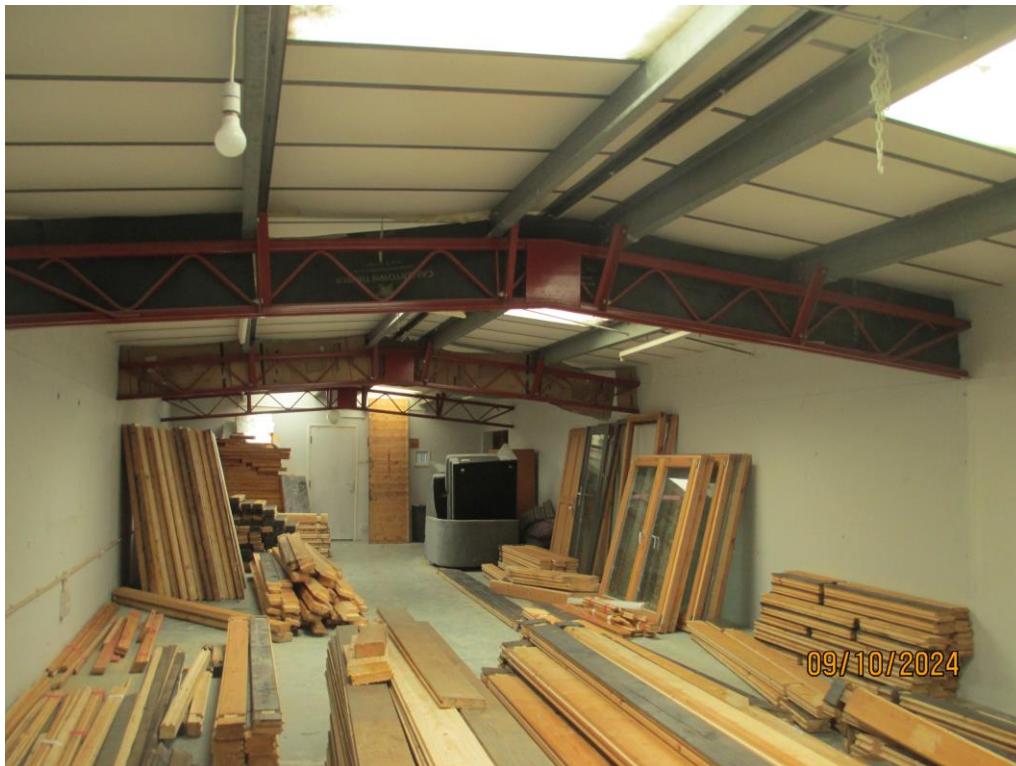
Photograph 9 Internal view of rear room.

The walls to the large room were plastered and painted. There was no evidence of any movement in these walls.

There was a concrete ground bearing slab with no evidence of any movement or settlement. I would expect the concrete slab to be constructed on a damp proof membrane and sand blinded hardcore.

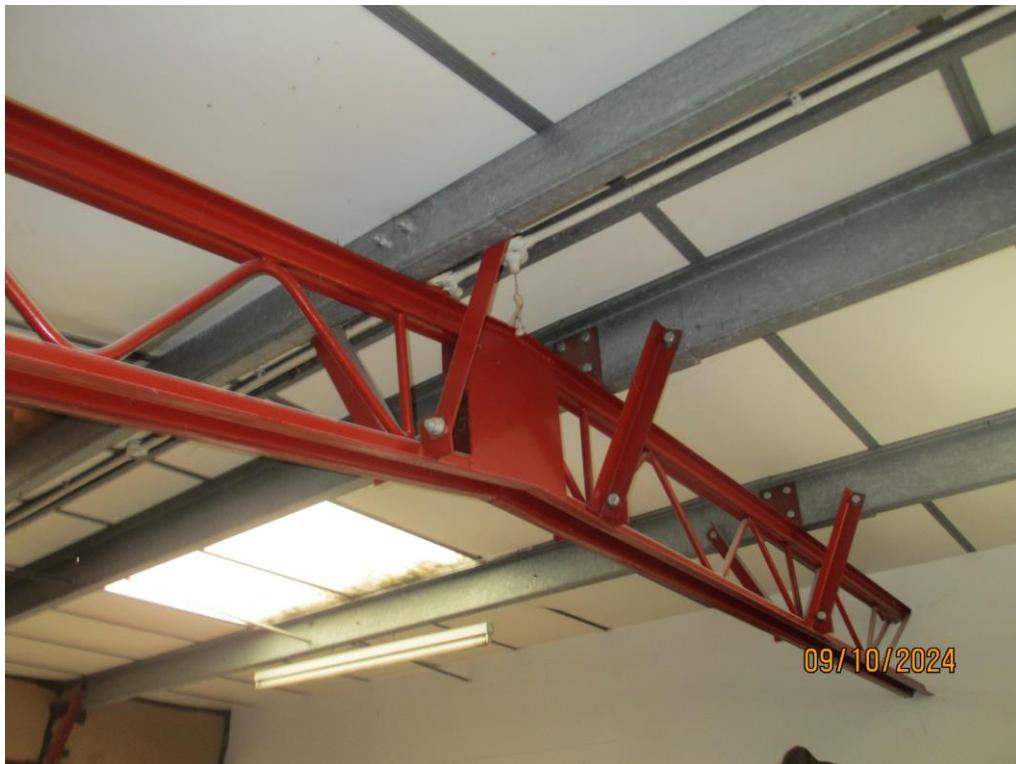
Photograph 10 Internal view of metal truss and purlins.

An internal inspection of the rear part of the building showed a single large room with three metal trusses 355mm deep spanning across the building supporting 170mm deep metal purlins. The insulated roof was supported by the purlins.

The metal trusses and purlins were in very good condition with no evidence of rust or movement on them. Bracing was evident from the purlin to the bottom flange of the trusses.

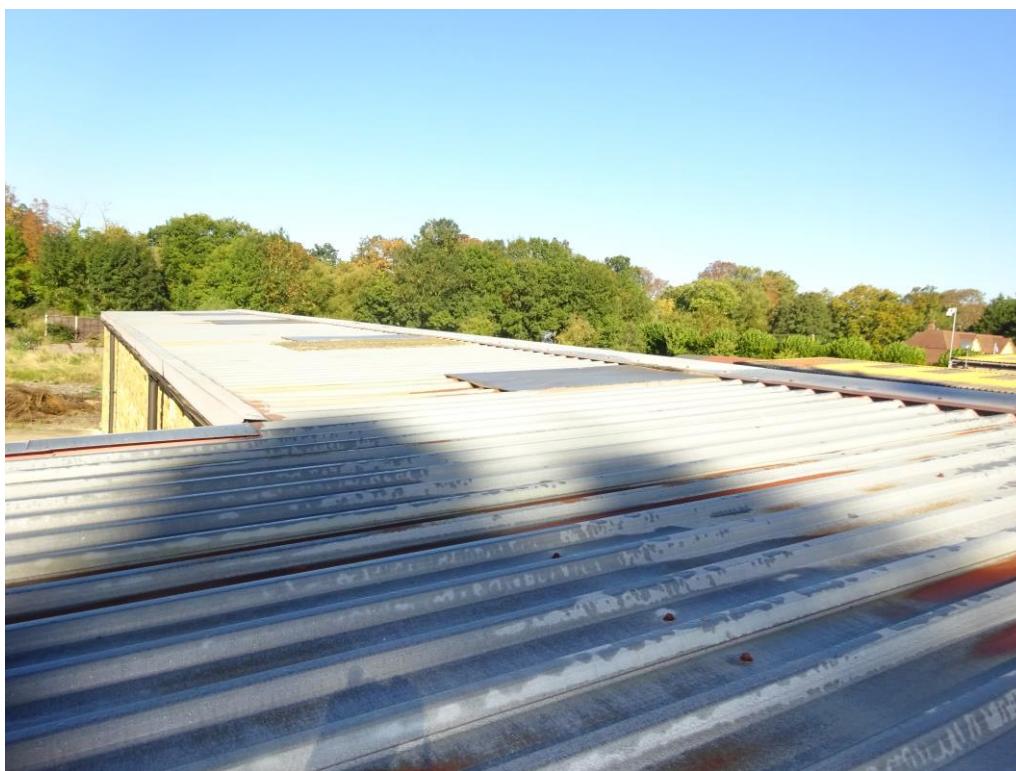
Photograph 11 View on roof covering.

The roof was a shallow pitched roof with steel cladding and translucent rooflights. It was in good condition with no evidence of any leaking. The ridge line was level.
