Arboricultural Consultancy for Aviva

Insured	Mr Alan Hutchinson	Address	4 Theodora Way, Pinner, HA5 2RA		
Client	Subsidence Management Services	Contact	Ian Domigan	Claim No.	IFS-AVI-SUB-22-0102007
ES Ref	SA-250583	Consultant	Kirk Thompson	Contact No.	0330 380 1036
Report Date	13/10/2022

Scope of Report: To survey the property and determine significant vegetation contributing to subsidence damage, make recommendation for remedial action and assess initial mitigation and recovery prospects. The survey does not make an assessment for decay or hazard evaluation.

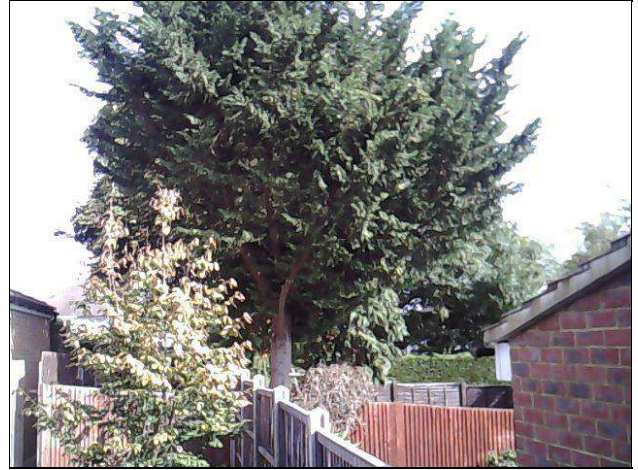
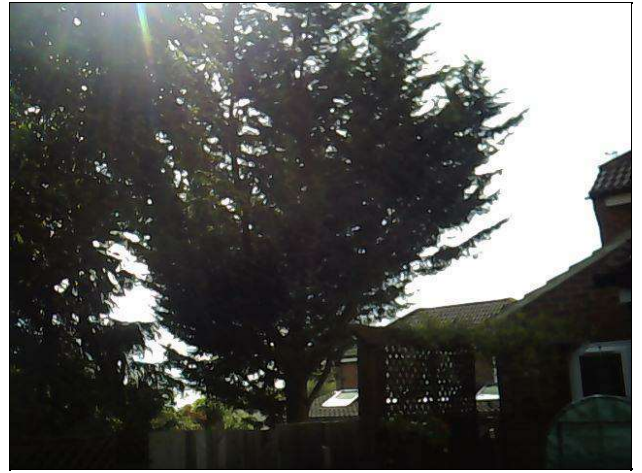
With due regards to species profile, size and proximity, T1 (Horse Chestnut) and T4 (Cypress (Leyland)) are considered the dominant features proximate to the focal area(s) of movement and accordingly, where vegetation is confirmed as being causal, we have identified them as the primary cause of the current subsidence damage.

T4 - Cypress (Leyland)

Consequently, we have advocated the complete removal of T1 (Horse Chestnut) and T4 (Cypress (Leyland)) as it will offer the most certain arboricultural solution likely to restore long-term stability.

Tree No.	Species	Age Cat	Approx. Height (m)	Distance to Building (m) *	Ownership	Action	Requirement
T1	Horse Chestnut	3	16.5	10	A - Third Party	Remove	Remove close to ground level and treat stump to inhibit regrowth.
T4	Cypress (Leyland)	3	12	5.5	A - Third Party	Remove	Remove close to ground level.

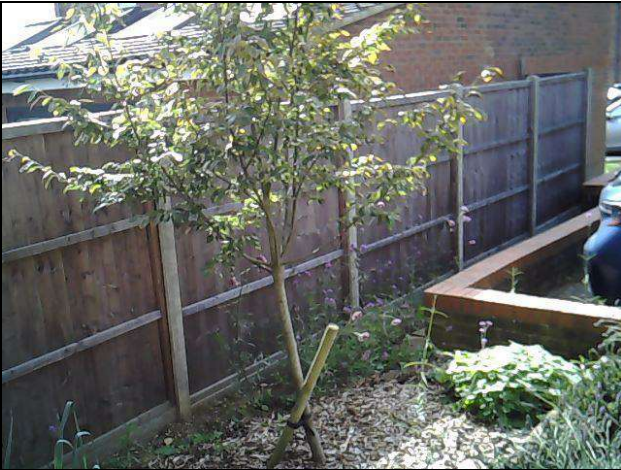
T5 - Prunus

Tree No.	Species	Age Cat	Approx. Height (m)	Distance to Building (m) *	Ownership	Action	Requirement
H1	Cypress	1	2.5	4	A - Third Party	Action to avoid future risk	Maintain at broadly current dimensions by way of regular pruning.
H2	Cypress (Lawson)	1	6	5.8	A - Third Party	Action to avoid future risk	Do not allow to exceed current dimensions by way of regular pruning.
SG1	Mixed species shrubs	1	3	5	C - Insured	Action to avoid future risk	Maintain at broadly current dimensions by way of regular pruning.
T2	Ash	3	16	18	A - Third Party	Action to avoid future risk	Maintain at broadly current dimensions by way of regular pruning.
T3	Oak	3	18	23	A - Third Party	Action to avoid future risk	Maintain at broadly current dimensions by way of regular pruning.
T5	Prunus	1	3	3.5	C - Insured	No action	No works.

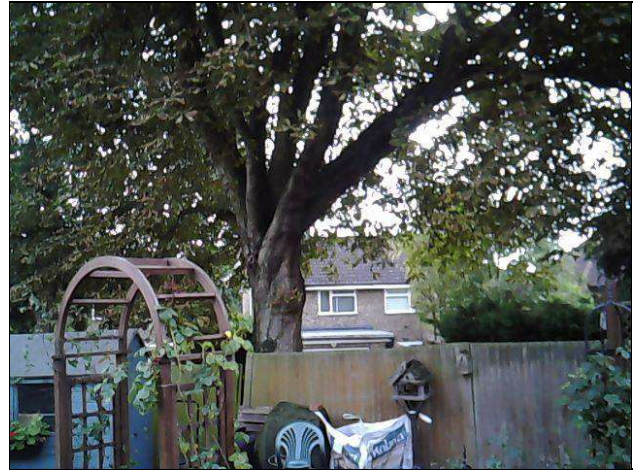
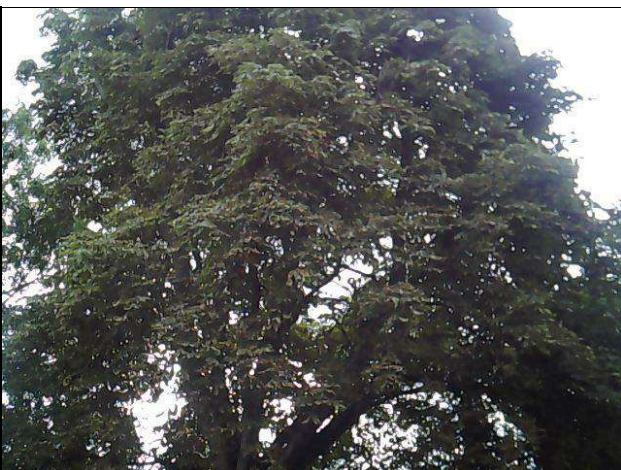
T1 - Horse Chestnut

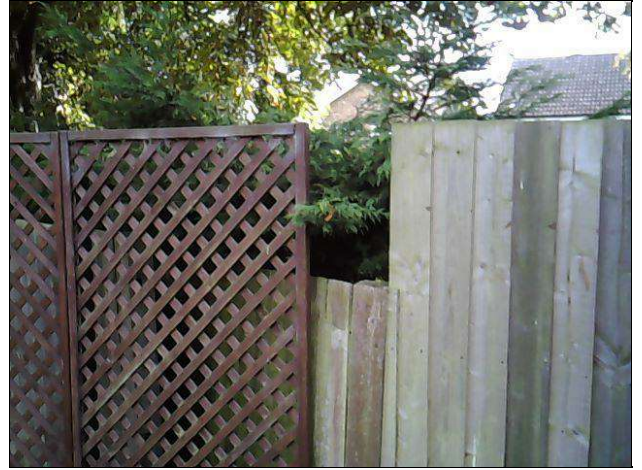
H1 - Cypress

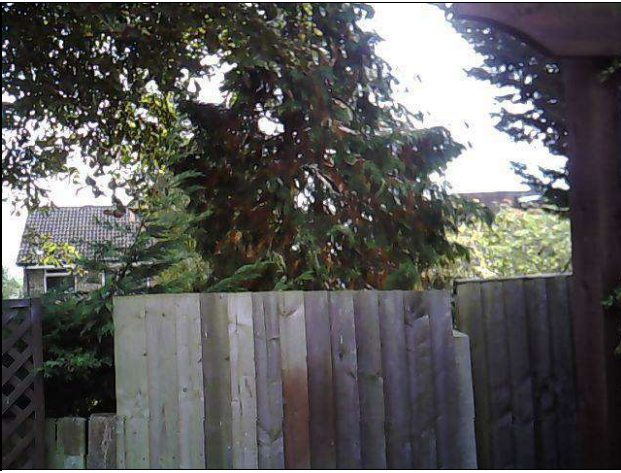
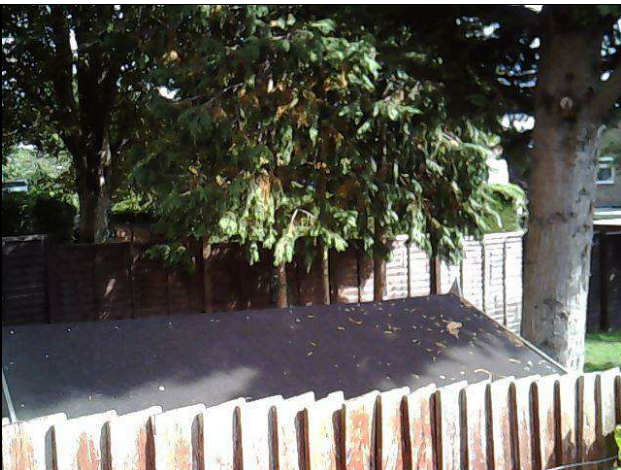
H2 - Cypress (Lawson)
