TREE SURVEY - HEALTH & SAFETY

Proj. No 11132	9 Ravenscourt Close, Ruislip, Middlesex, HA4 7PP	
Client:	Daniel Sparrowhawk	
Date of Report:	21/08/2024

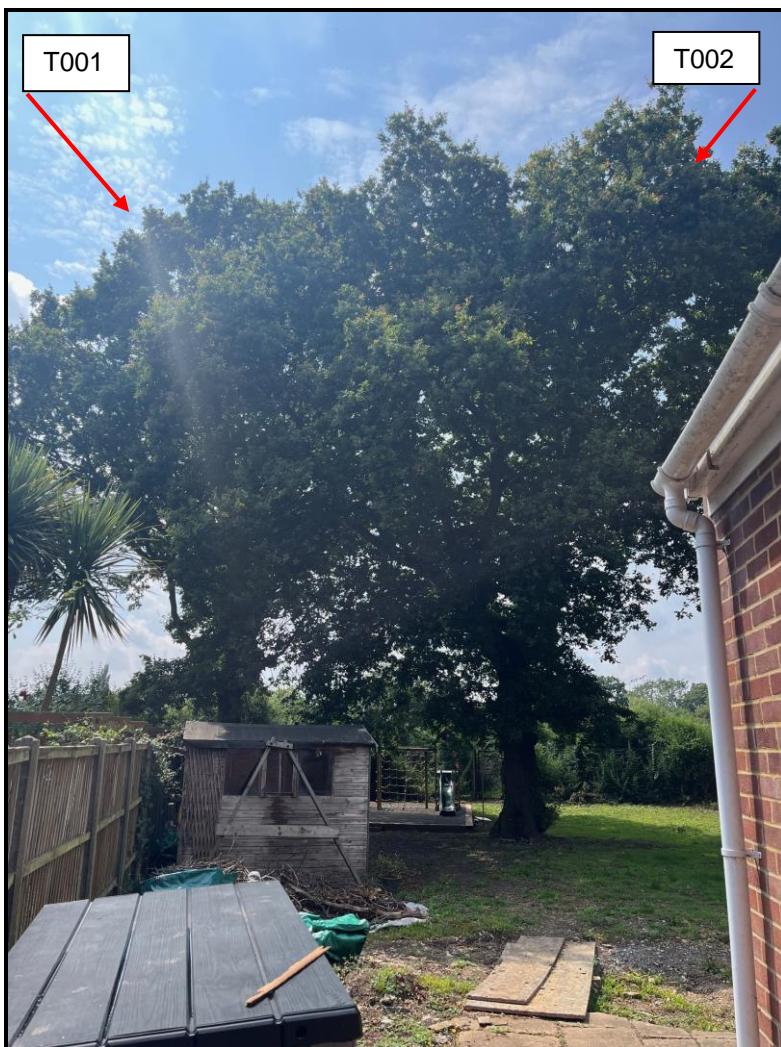
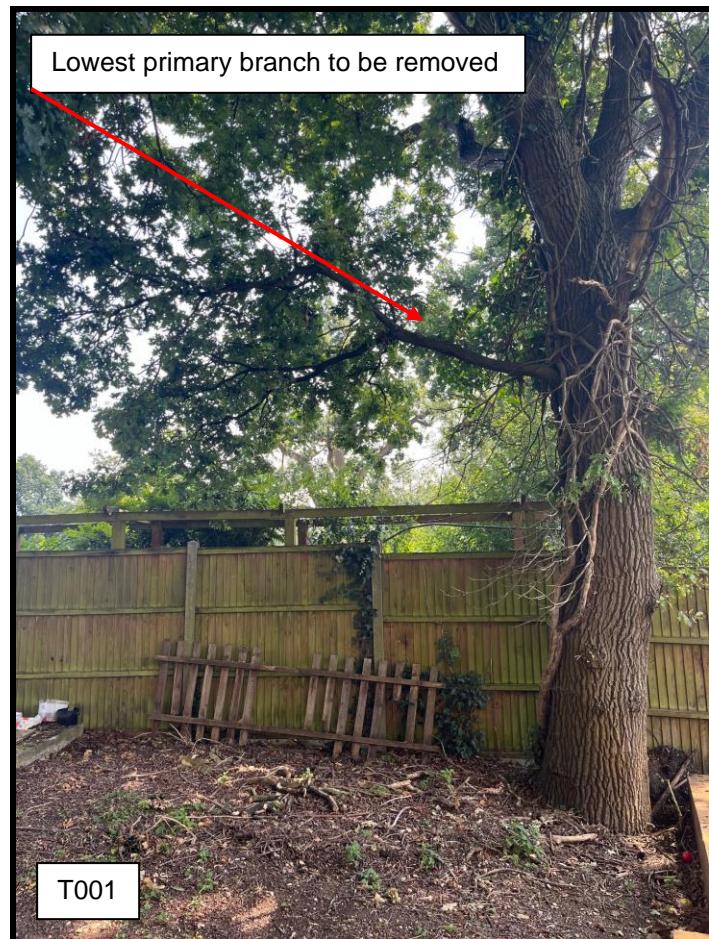
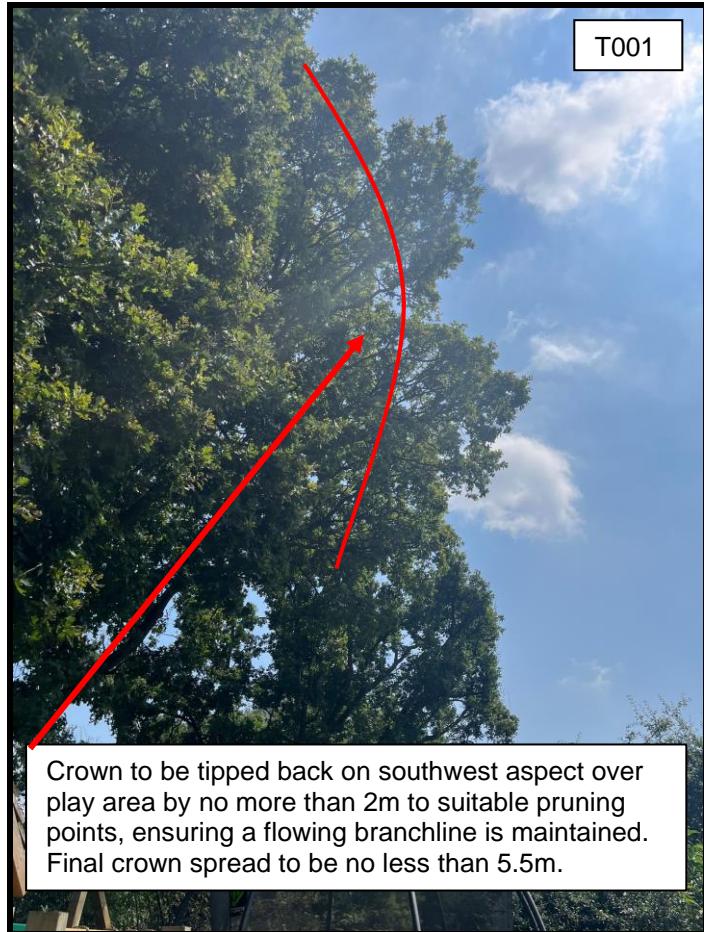
3.7 **Oak (T001)**

3.7.2 A children's play area has been constructed beneath the south / south west aspect of its crown. This has been constructed above ground and has a porous, rubber surface (i.e. tiger mulch). No visual evidence of any fungal pathogens were observed around the base or on the lower stem and tapping the lower stem up to a height of 2m above ground level (agl) with a sounding hammer did not reveal the presence of any notable decay. Barbed wire from a historic fence is encased in the stem's north aspect at circa. 0.2m agl and this should be carefully removed where present and not encased in the stem. A dead primary branch extends to the north west at circa. 4m agl, above the tree displays multi-stemmed form. Dead Ivy partially impeded a detailed inspection of all the unions, but those that were visible appear stable. Ivy also impeded a detailed inspection of the dominant stem extending north between 4.5 and 7m agl. Dense foliage partially impeded a detailed inspection of the crown, however in the sections observed no notable defects that gave cause for concern were identified. Moderate deadwood is present throughout the crown but this is to be expected. Overall the tree displays normal, healthy vigour.

3.7.3 Given the above, whilst (T001) is not considered to pose an imminent risk, it is recommended that the deadwood and Ivy is removed and tree reinspected during the winter months. It is also considered that the proposed works to remove the lowest primary branch extending to the northwest (circa. 100mm in diameter), raise its crown to 5m agl by the removal of secondary and tertiary branches and tip back its crown over the play area to the southwest by no more than 2m will have a negligible impact on both its amenity value and longevity. Below are photographs of (T001) and the proposed works.

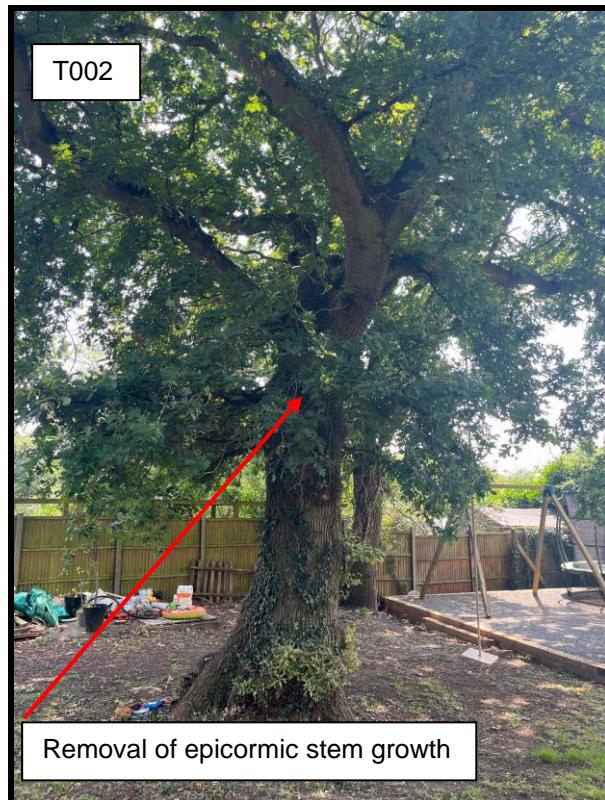
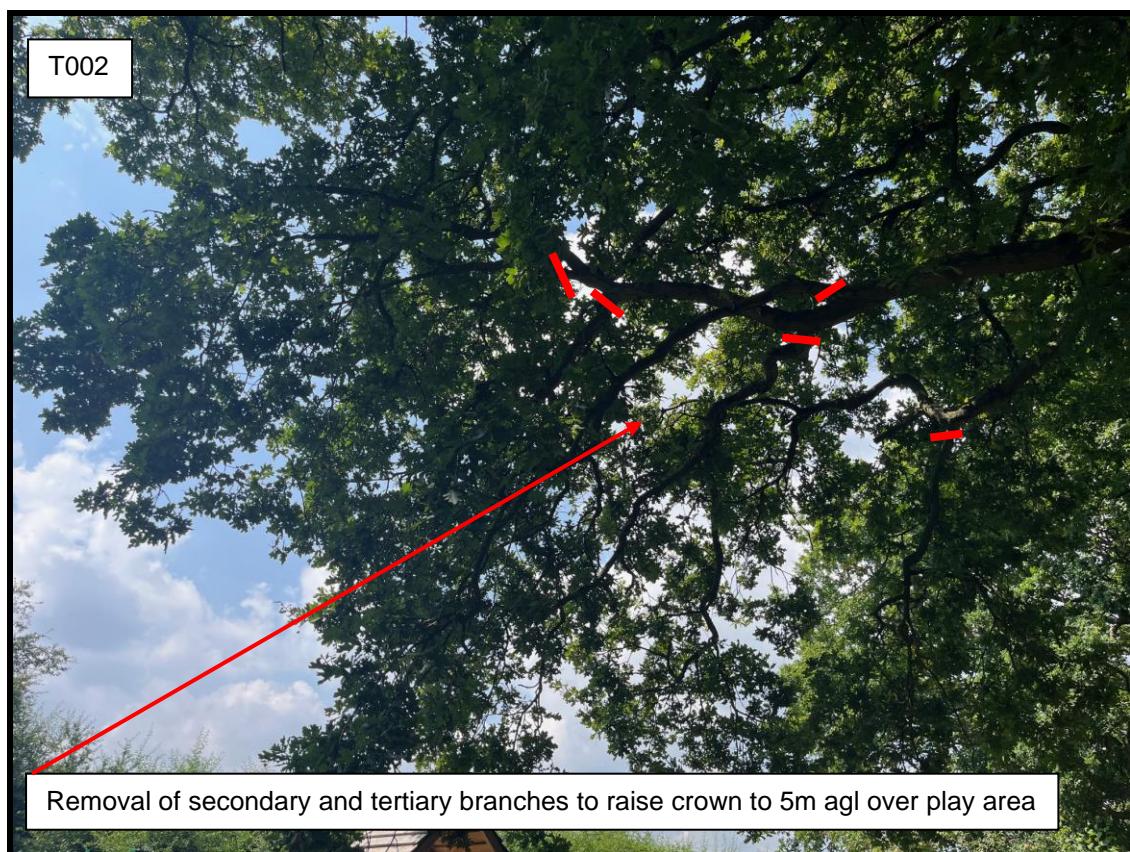
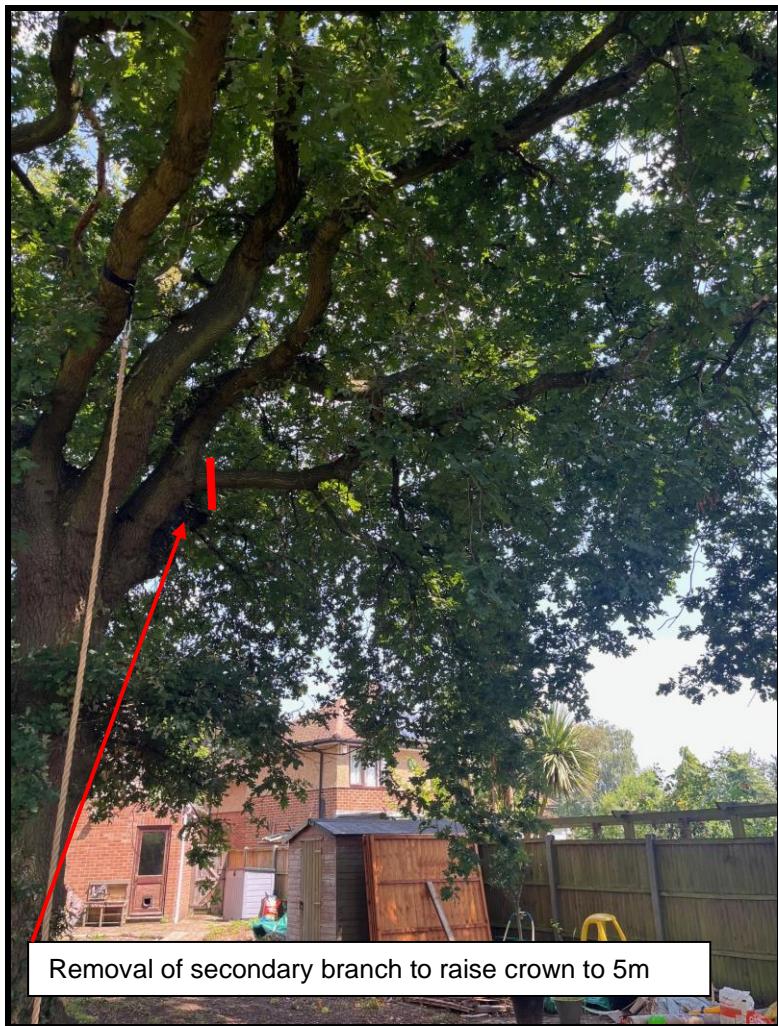
3.8 Oak (T002)

3.8.2 No visual evidence of any fungal pathogens were observed around the base or on the lower stem and tapping the lower stem up to a height of 2m above ground level (agl) with a sounding hammer did not reveal the presence of any notable decay. On the northeast aspect of the stem, at circa. 0.4m agl between two buttress roots, is a small cavity that measures circa. 0.15m in depth before solid wood is encountered. This small cavity is localised and not considered to be of any concern. Old pruning wounds on the stem display good occlusion and dense epicormic growth emanates from many of the historic wounds. The tree displays multi-stemmed form at circa. 3.5m agl and the unions appear stable. Slight fibre buckling is present at the base of the southern extending stem but this is also not of concern. The northern aspect of the crown has historically been reduced and the regrowth is circa. 2m in length. The crown is low on its southern aspect and overhangs the play area. Dense foliage partially impeded a detailed survey of the entire crown, but in the sections observed no notable defects that gave cause for concern were identified. Moderate deadwood is present throughout the crown but this is to be expected. Overall the tree displays normal, healthy vigour.

3.8.3 Given the above, whilst (T002) is not considered to pose an imminent risk, it is recommended that the deadwood is removed. It is also considered that the proposed works to raise its crown to 5m agl by the removal of epicormic stem growth and secondary and tertiary branches will have a negligible impact on both its amenity value and longevity. Below are photographs of (T002) and the proposed works.

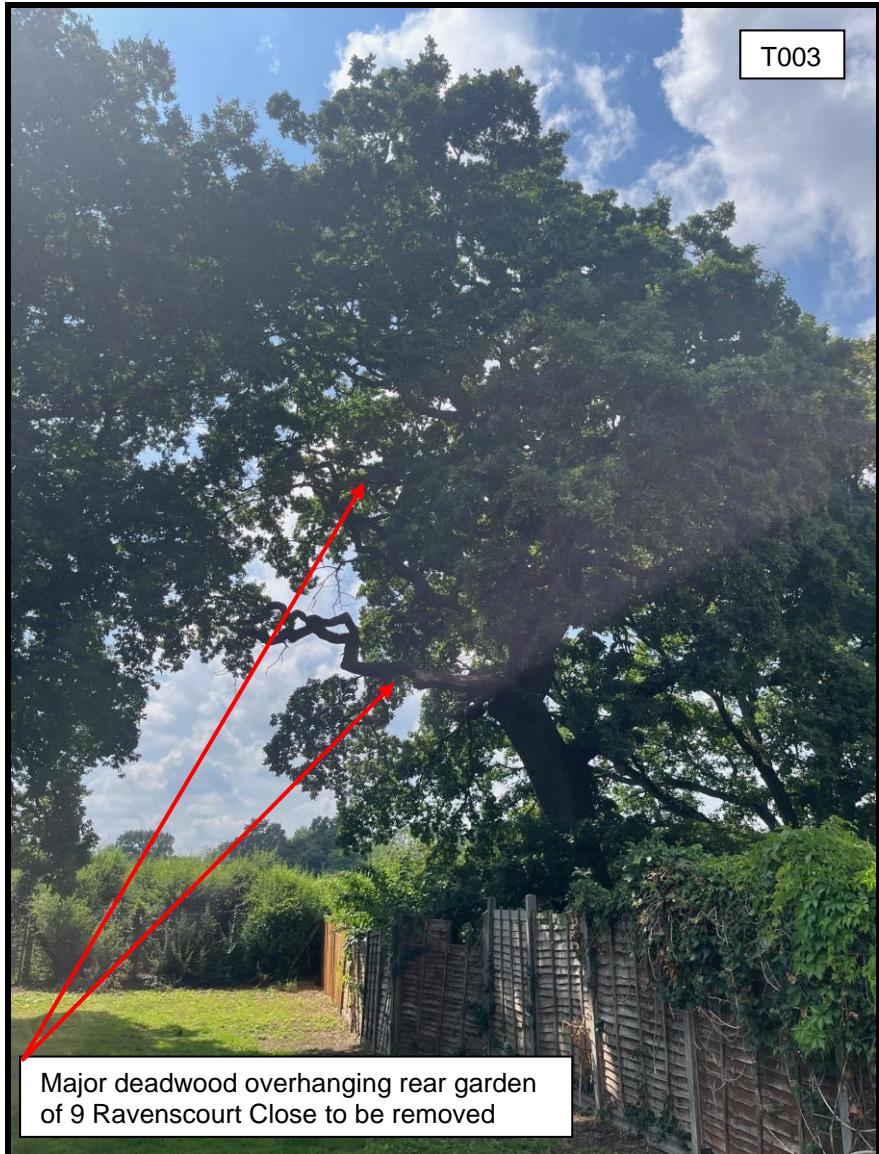
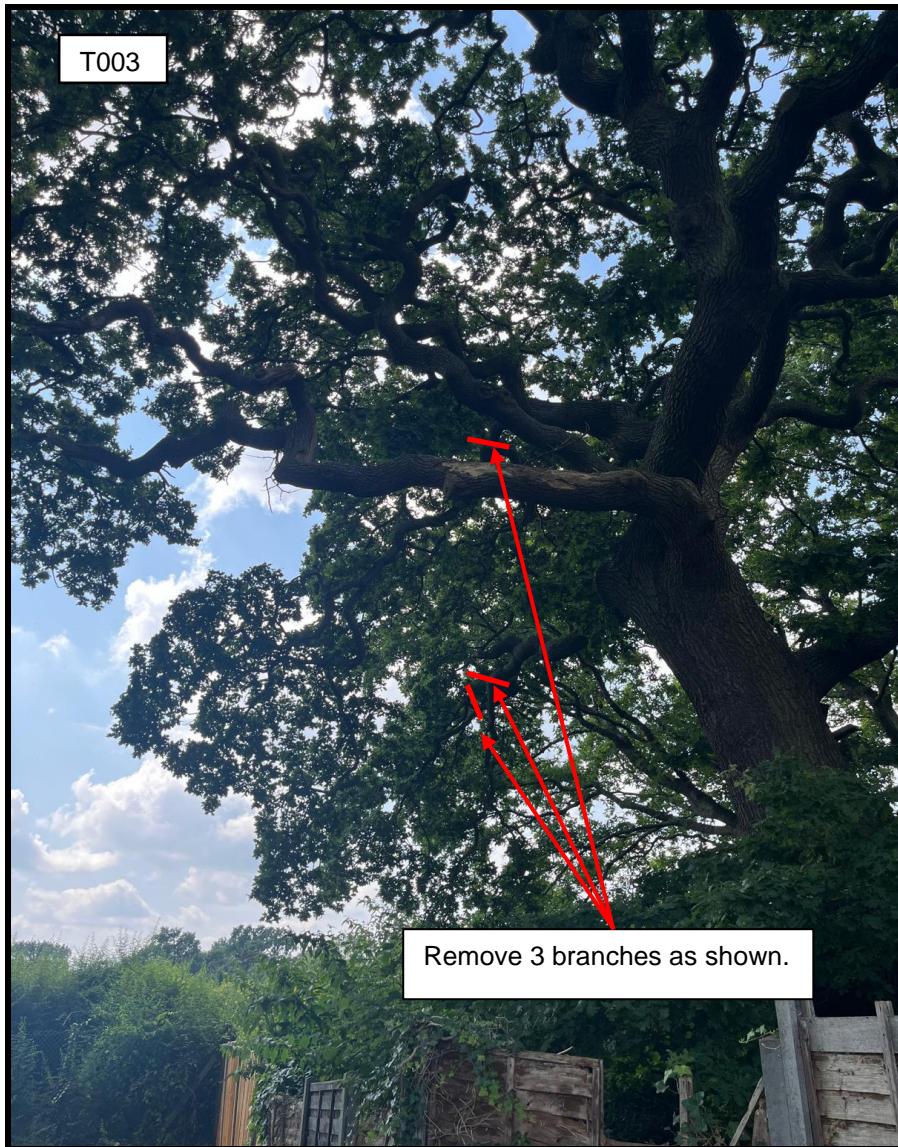
3.9 Oak (T003)

3.9.2 Restricted access into the neighbouring rear garden at the time of the visit impeded a detailed inspection of the tree being undertaken. However, whilst major deadwood was present throughout its crown, overall the crown displayed normal, healthy vigour.

3.9.3 Although restricted access impeded a detailed inspection, it is considered the removal of deadwood and proposed secondary and tertiary branches from the south western extending branches will have a negligible impact on both its amenity value and longevity. Below are photographs of (T003) and the proposed works.
