# **Willow Tree Depot, Ditchfield Road**

**Verification Report**

| ISSUE RECORD | | | | | |
|---|---|---|---|---|---|
| Report Reference: 2001015.001.01 | | | | | |

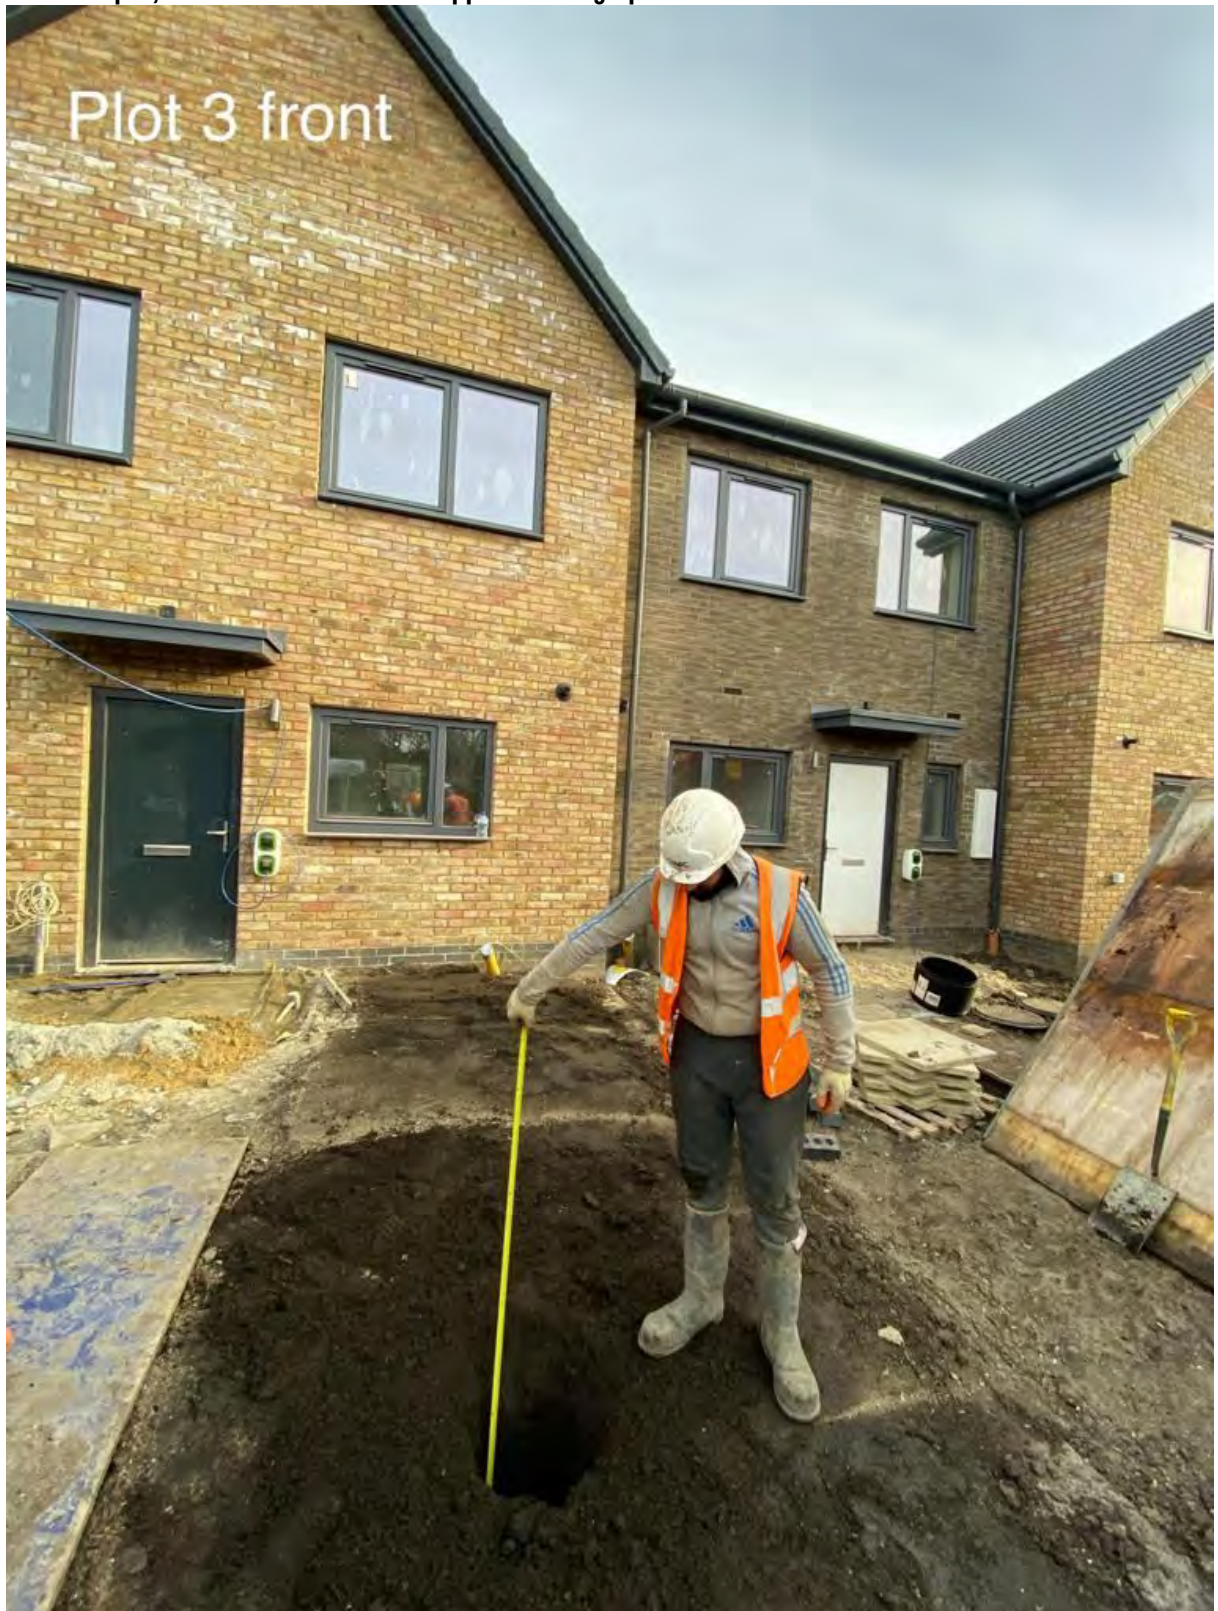
Photograph 9: Verification pit advanced within front garden of Plot 3.

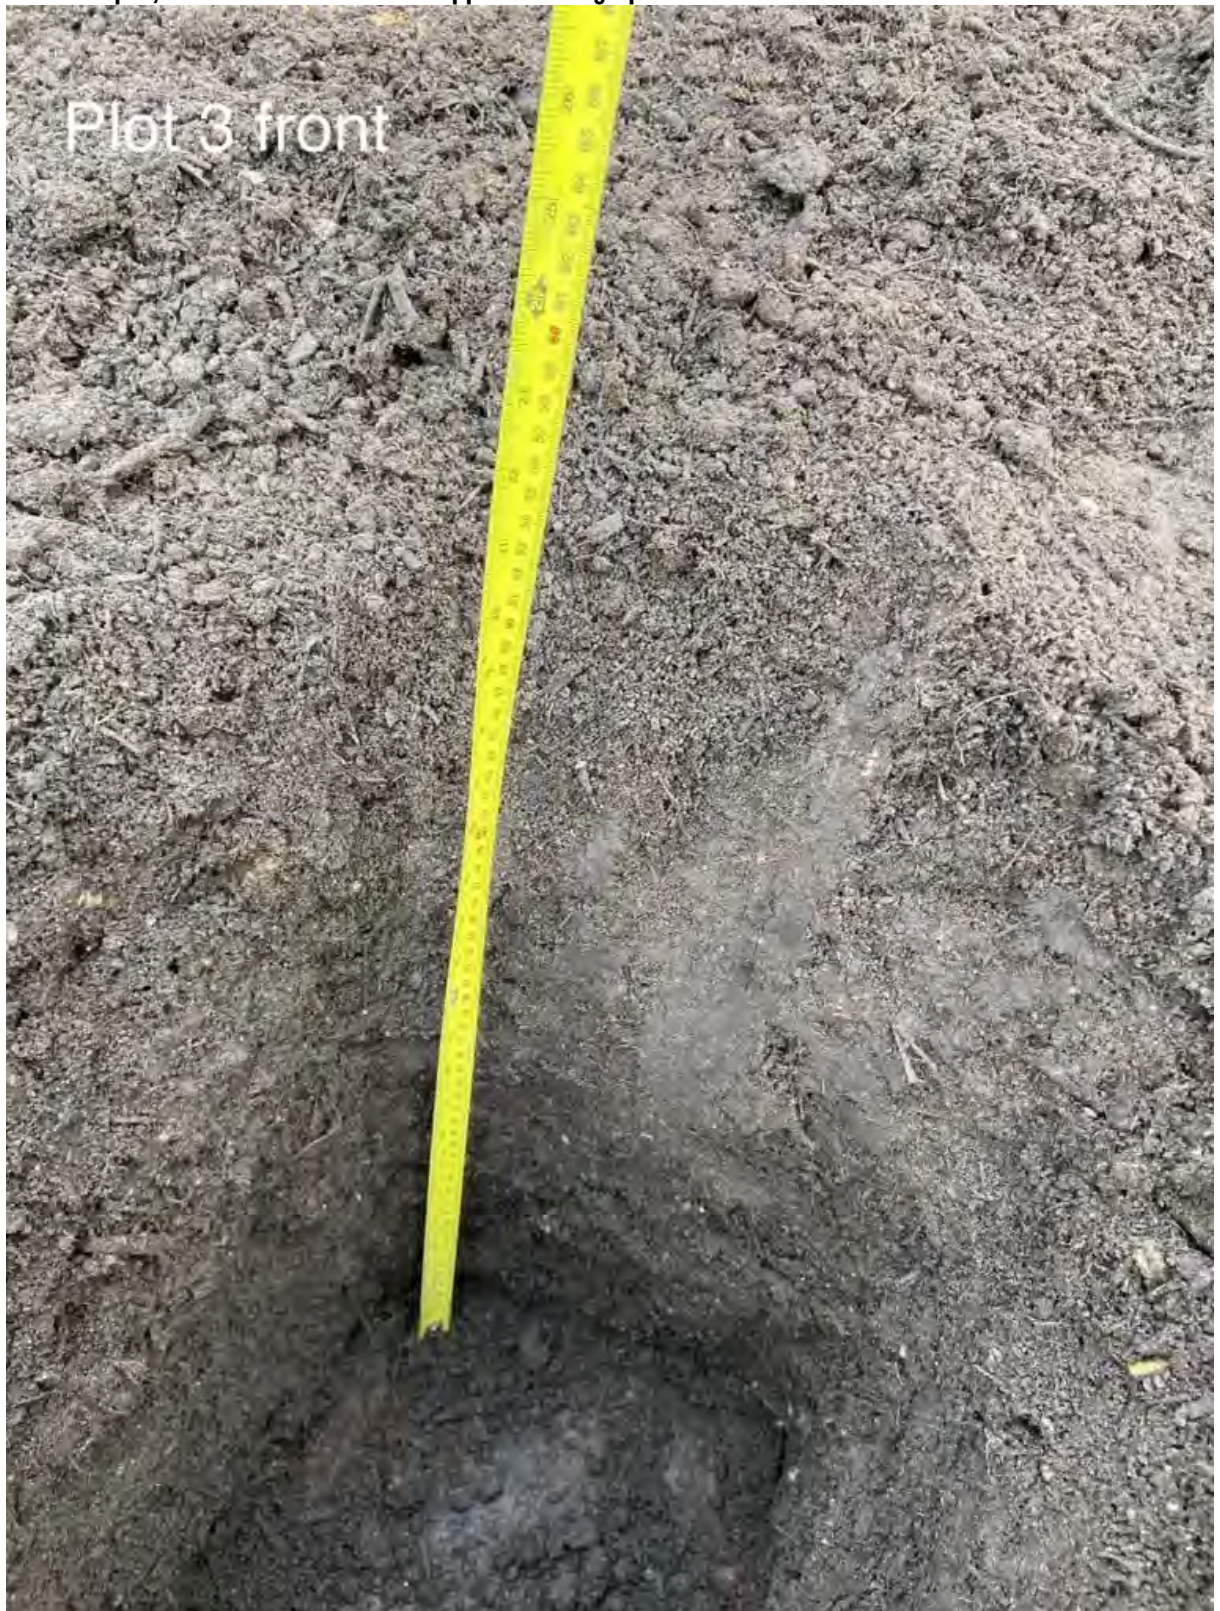
Photograph 10: Verification pit advanced within front garden of Plot 3.

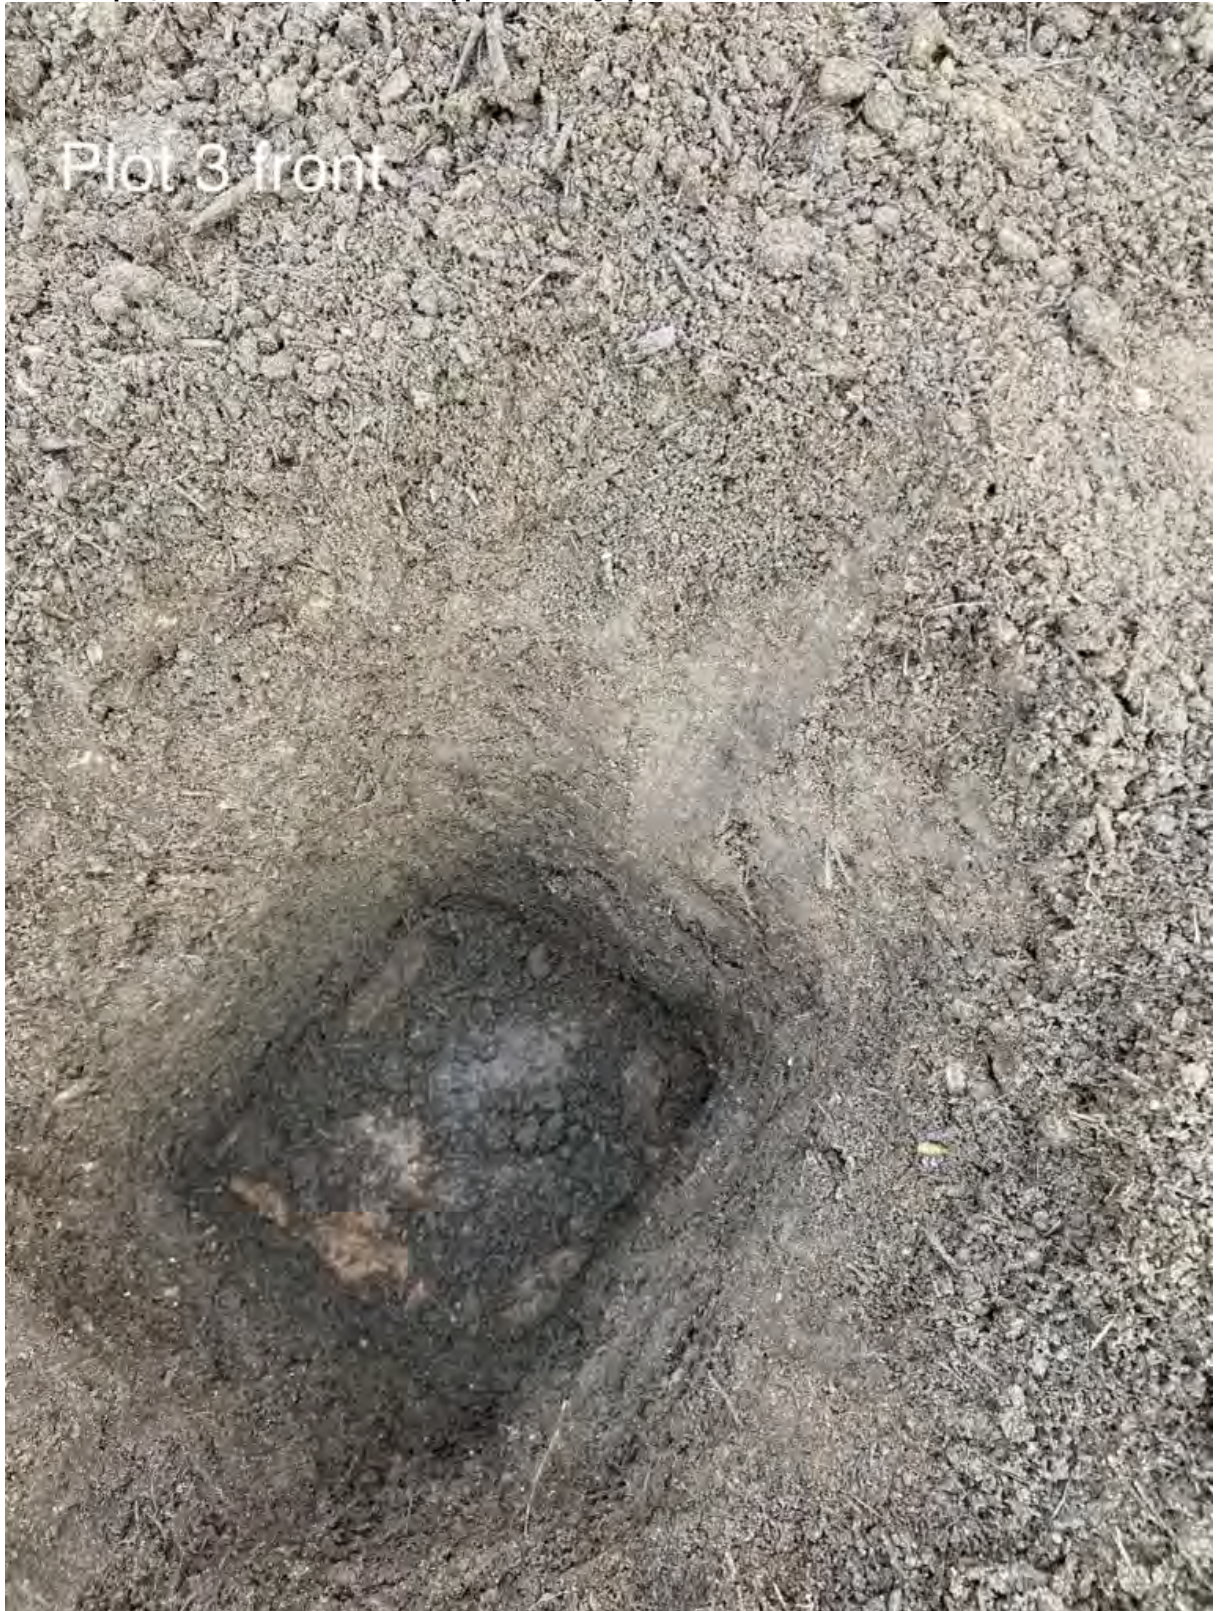
Photograph 11: Verification pit advanced within front garden of Plot 3.

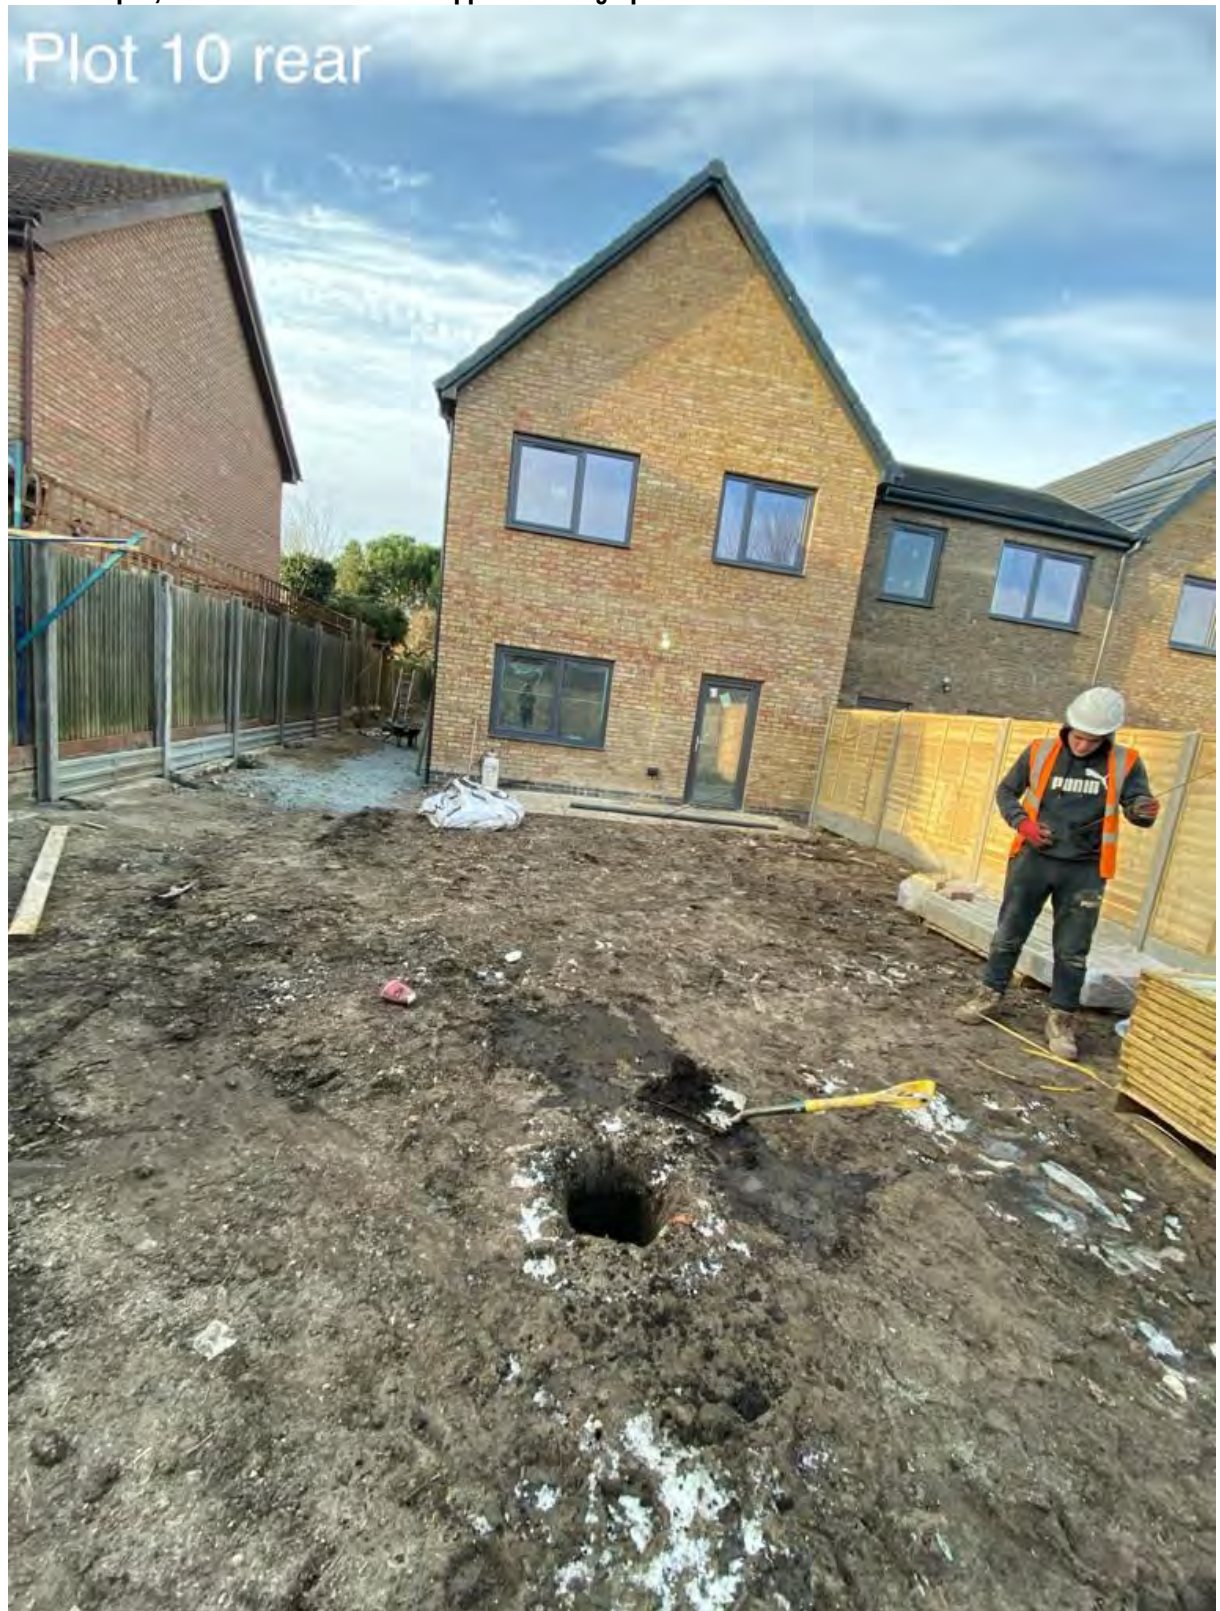
Photograph 12: Verification pit advanced within rear garden of Plot 10.

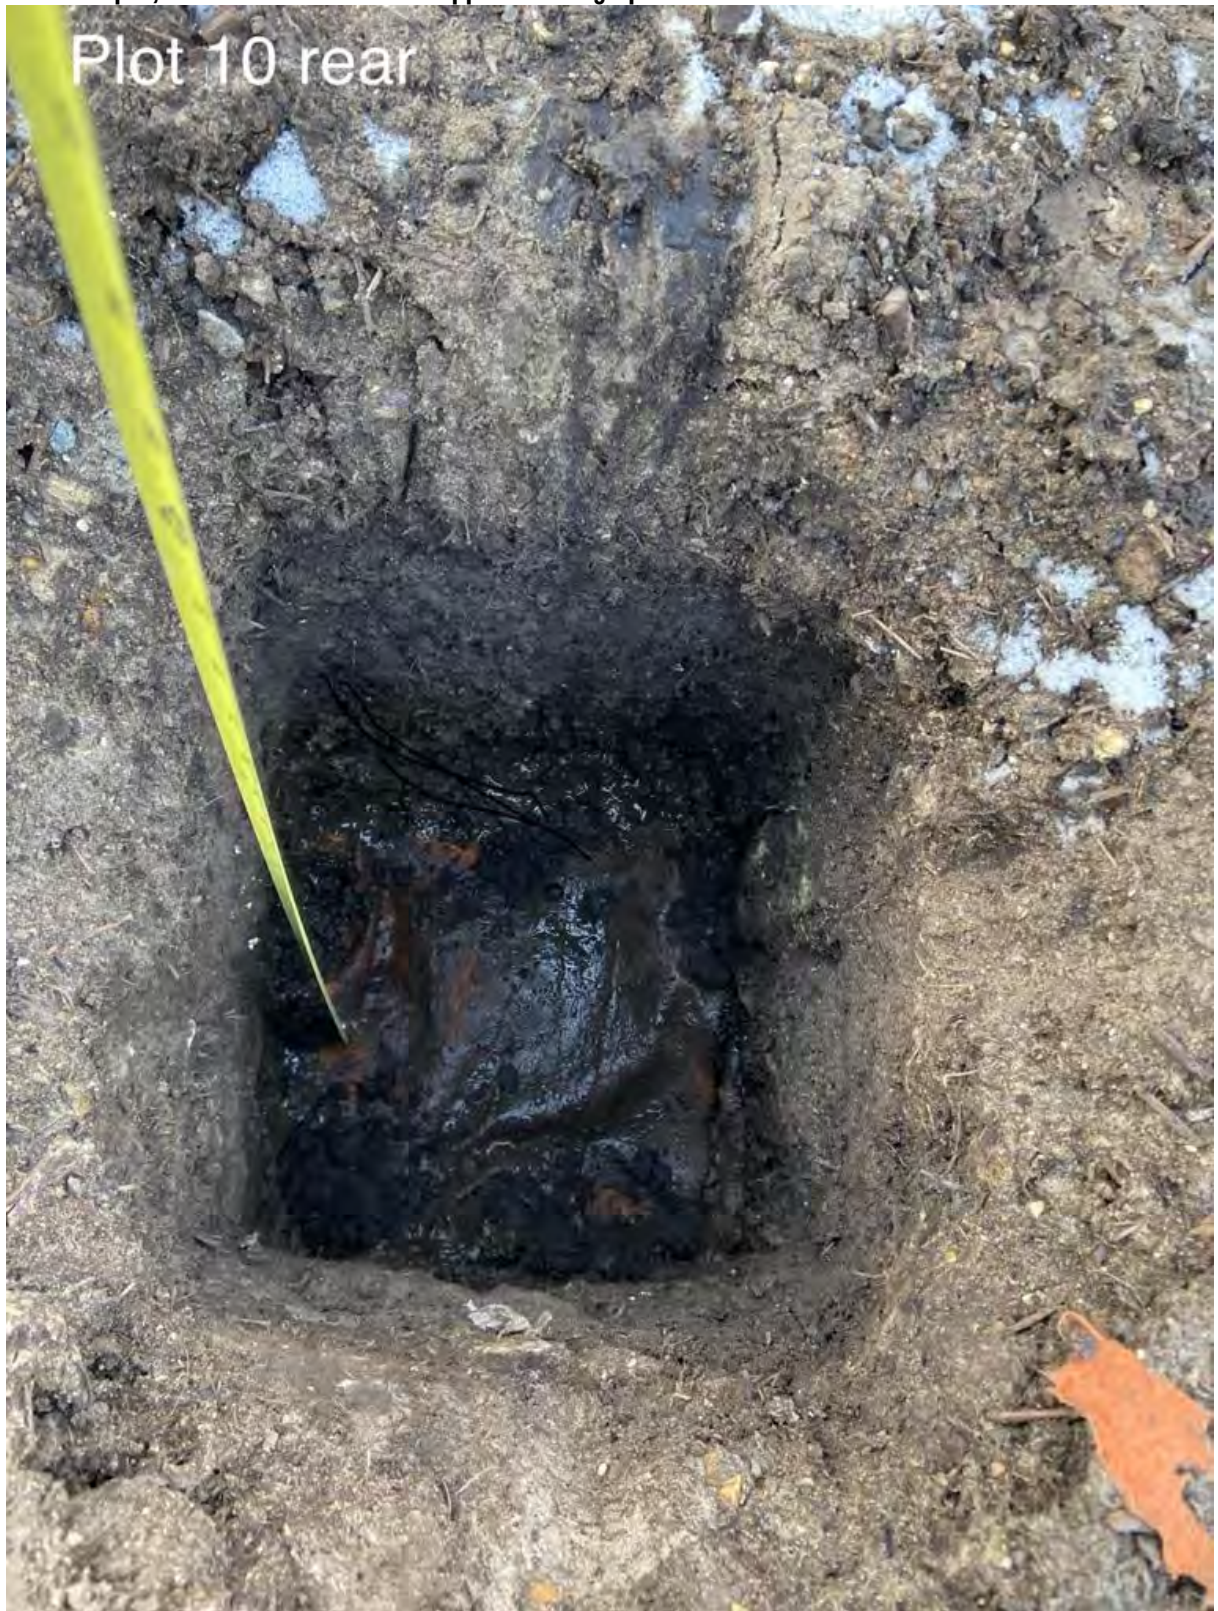
Photograph 13: Verification pit advanced within rear garden of Plot 10.

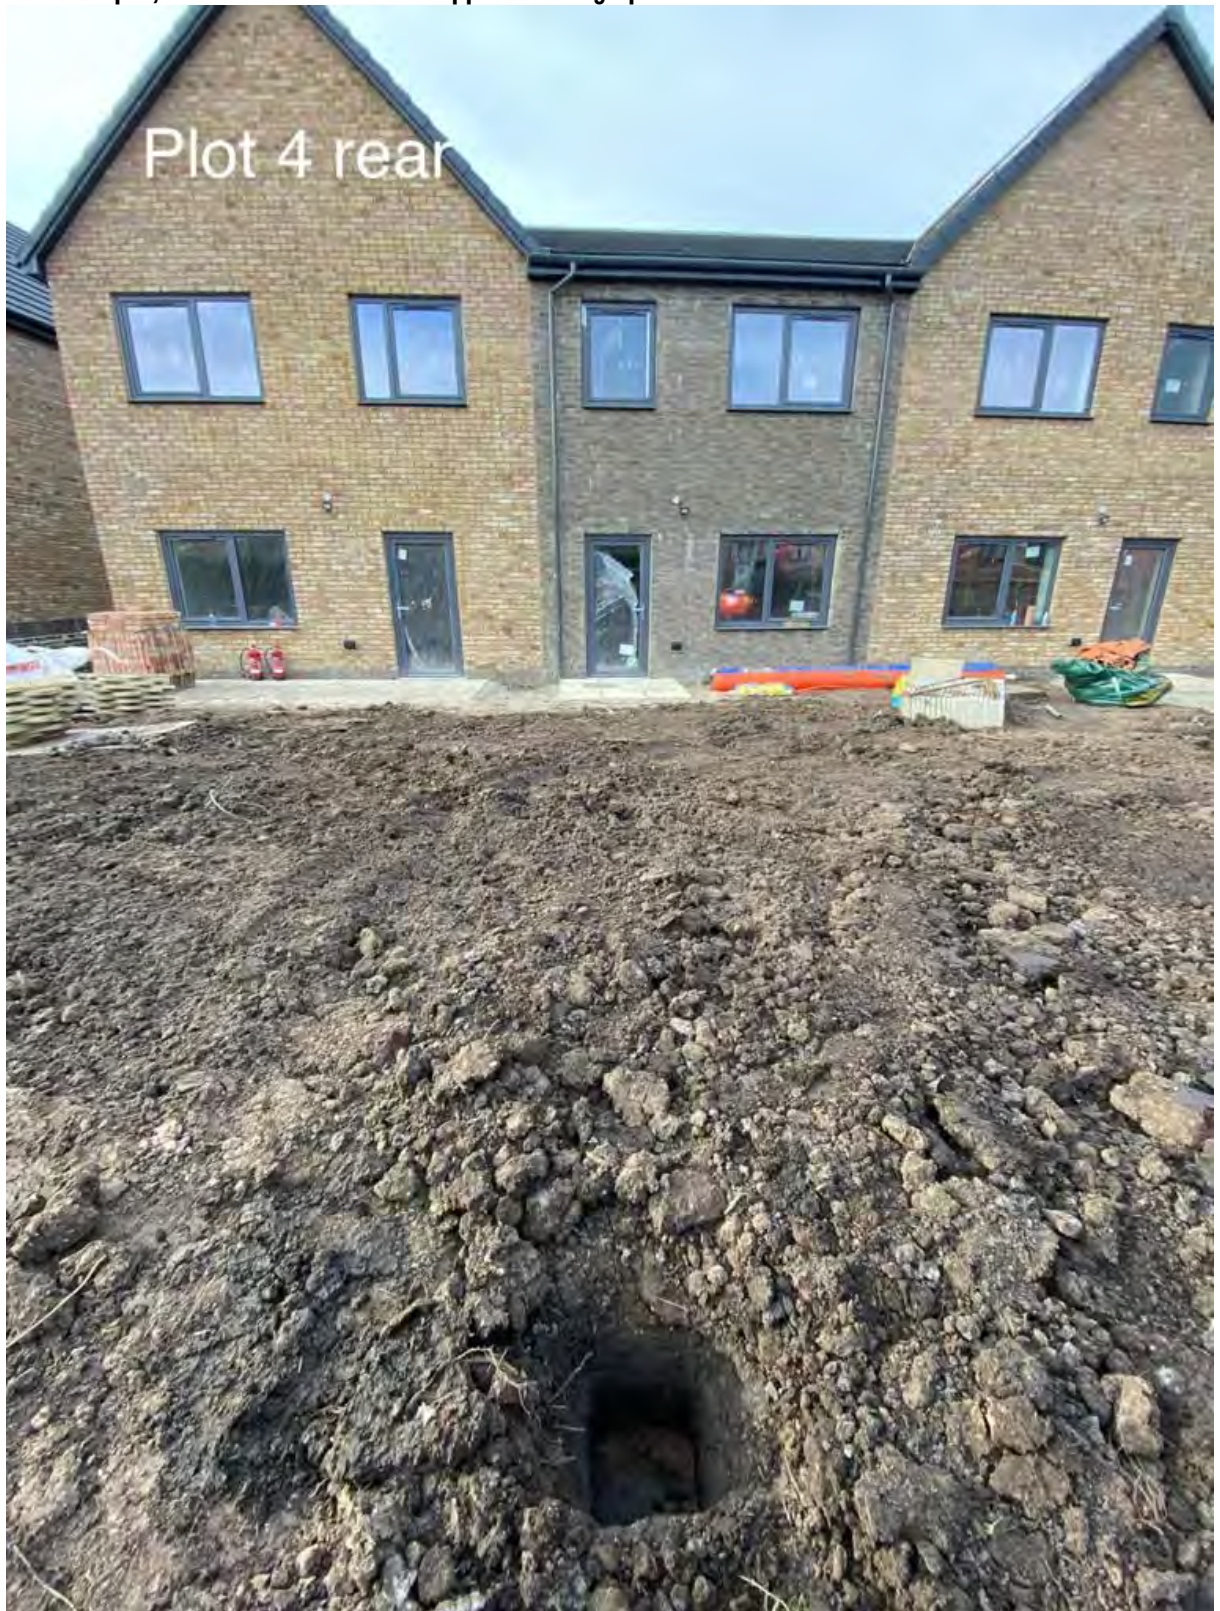
Photograph 14: Verification pit advanced within rear garden of Plot 4.

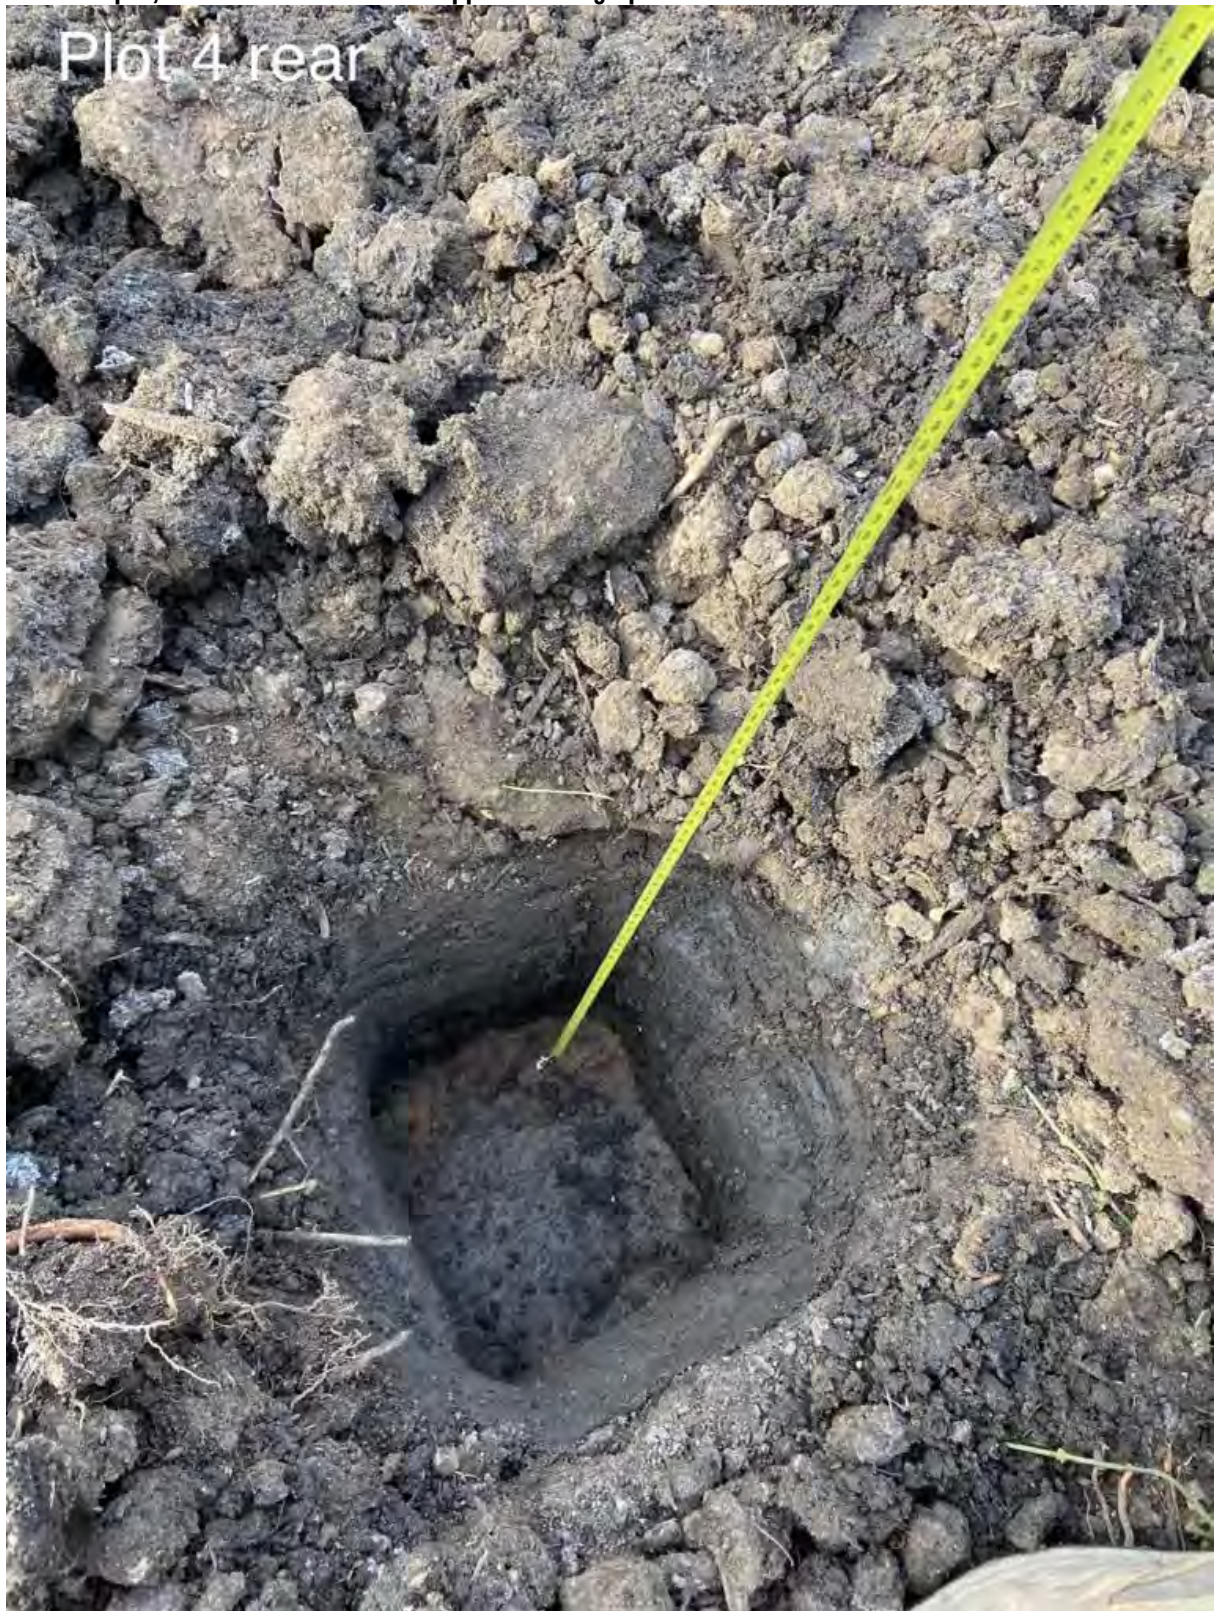
Photograph 15: Verification pit advanced within rear garden of Plot 4.

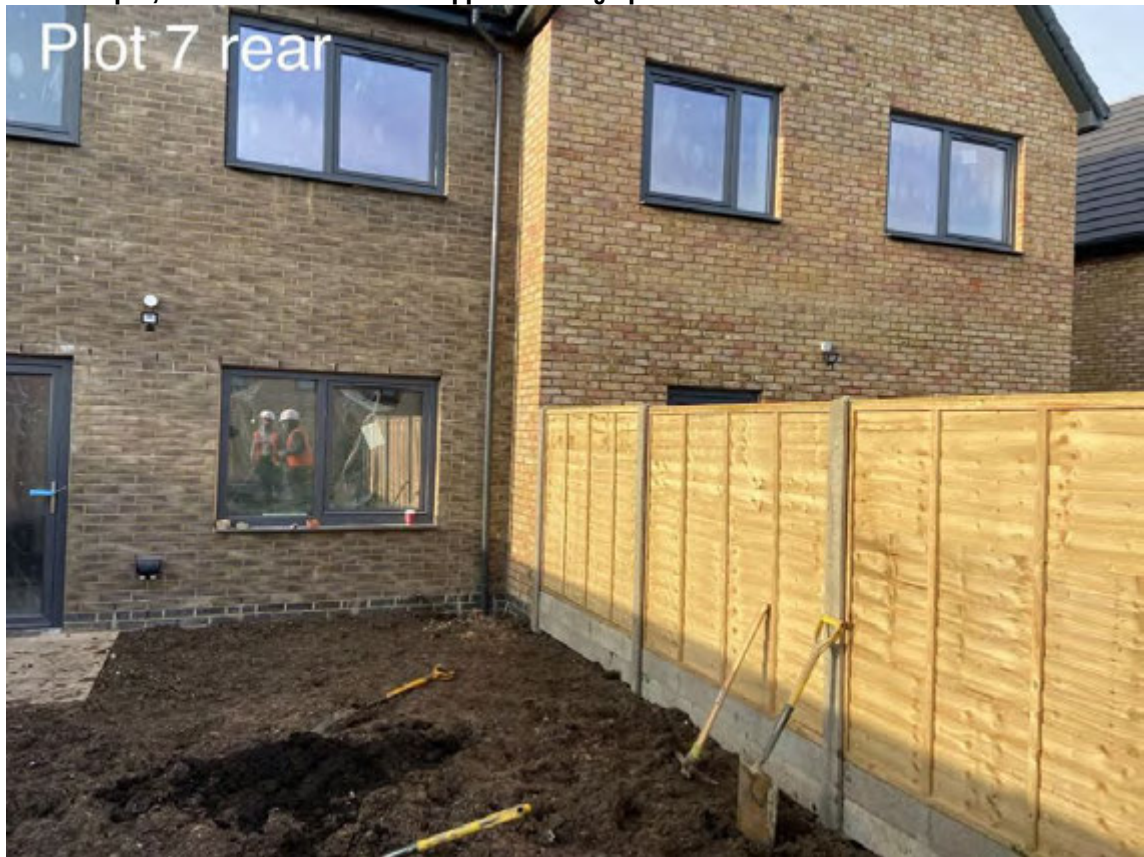
Photograph 16: Verification pit advanced within rear garden of Plot 7.

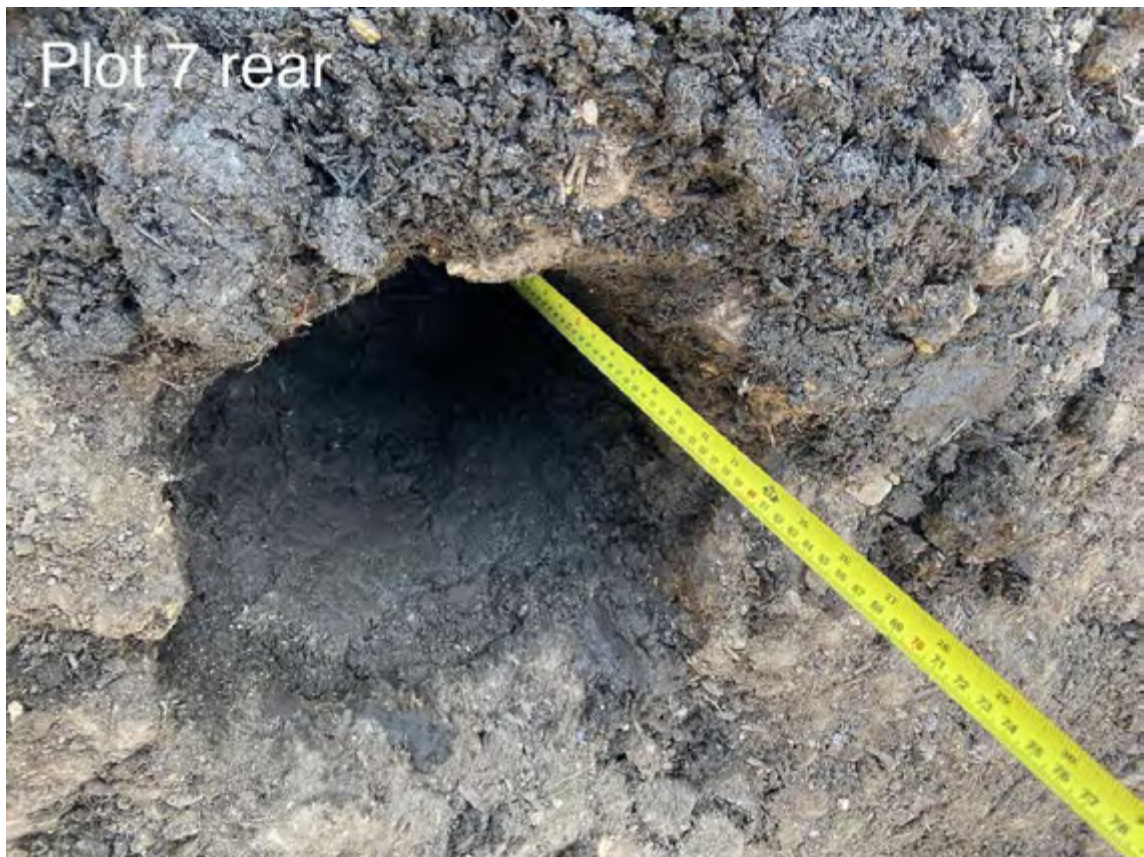
Photograph 17: Verification pit advanced within rear garden of Plot 7.

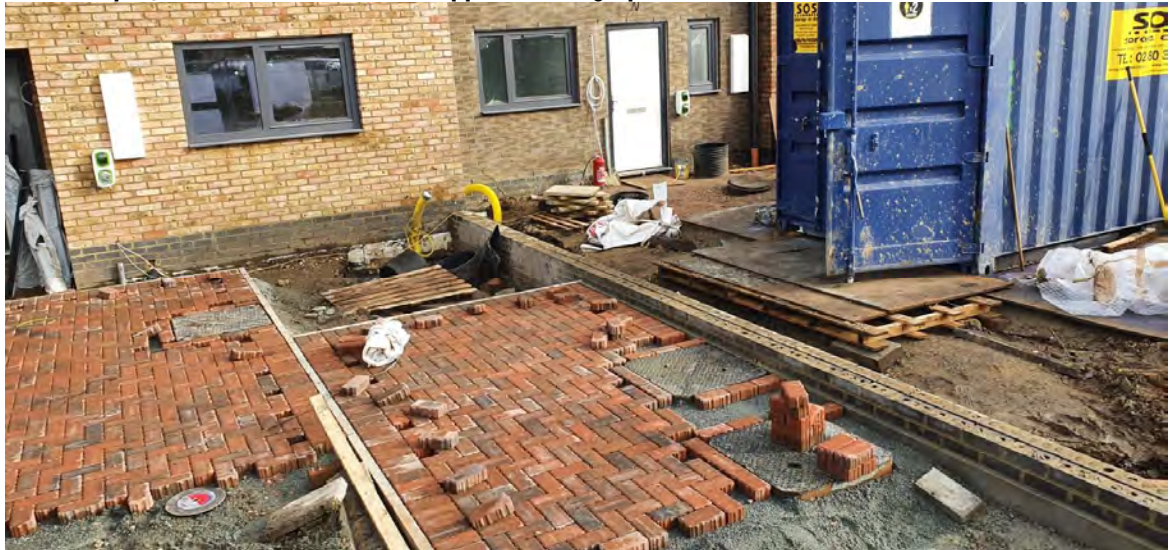
Photograph 18: View of the placement of hardstanding within Plots 1-5.

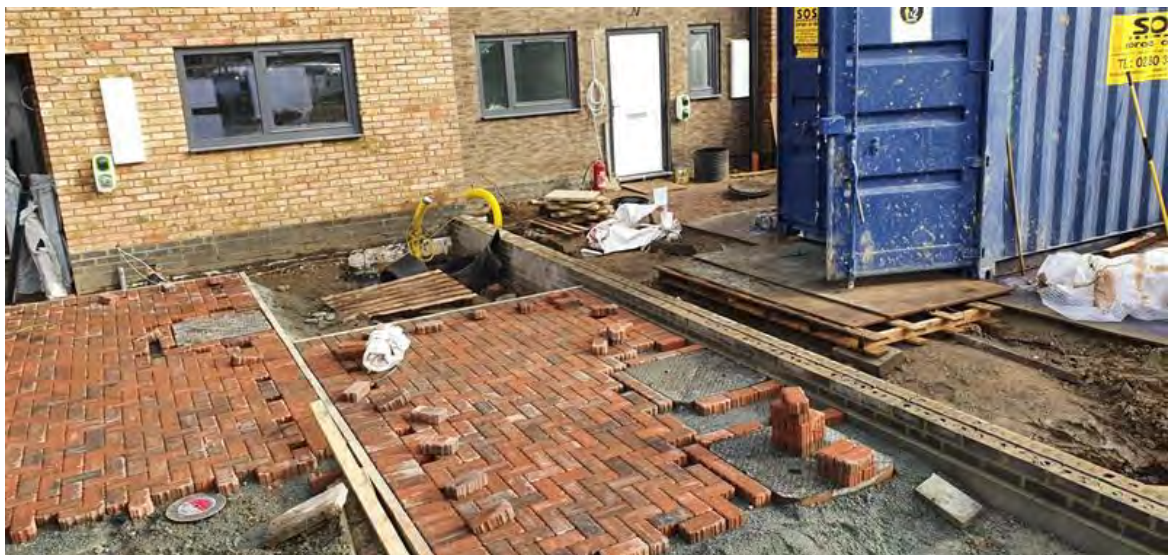
Photograph 19: View of the placement of hardstanding within Plots 1-5.

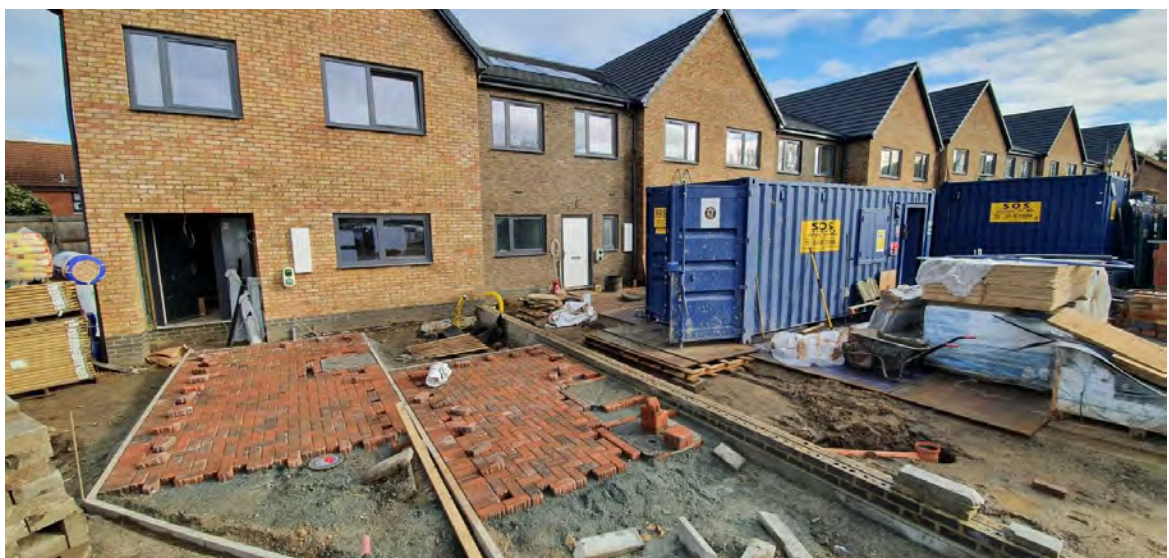
Photograph 20: View of the placement of hardstanding within Plots 1-5.

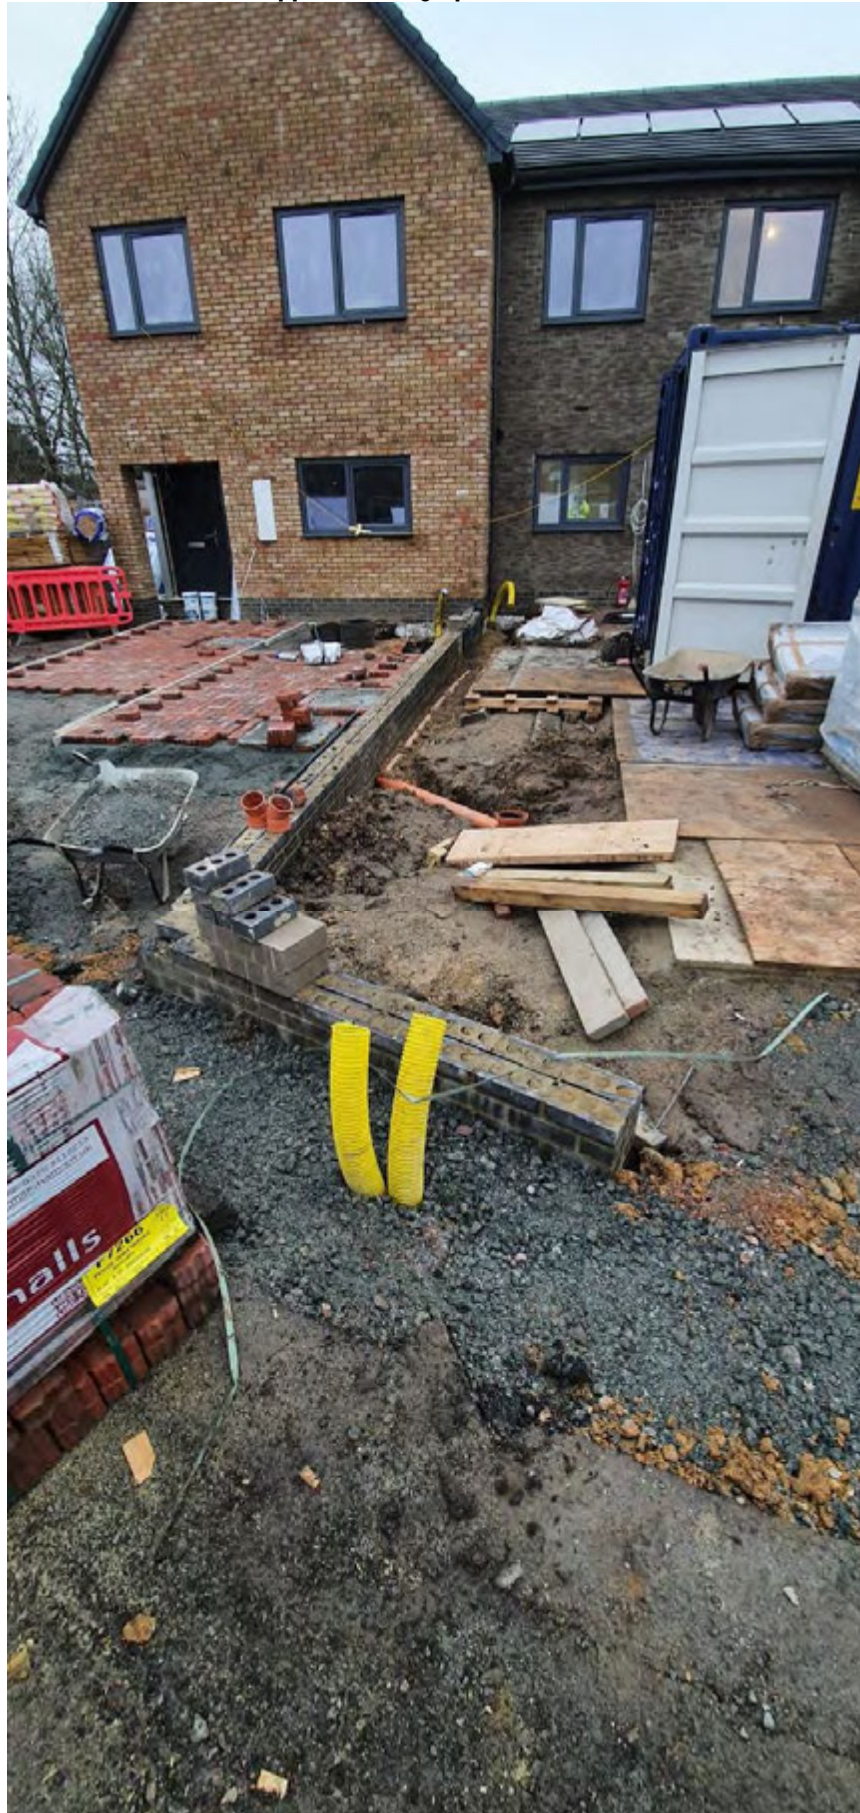
Photograph 21: View of the placement of hardstanding within Plots 1-10.

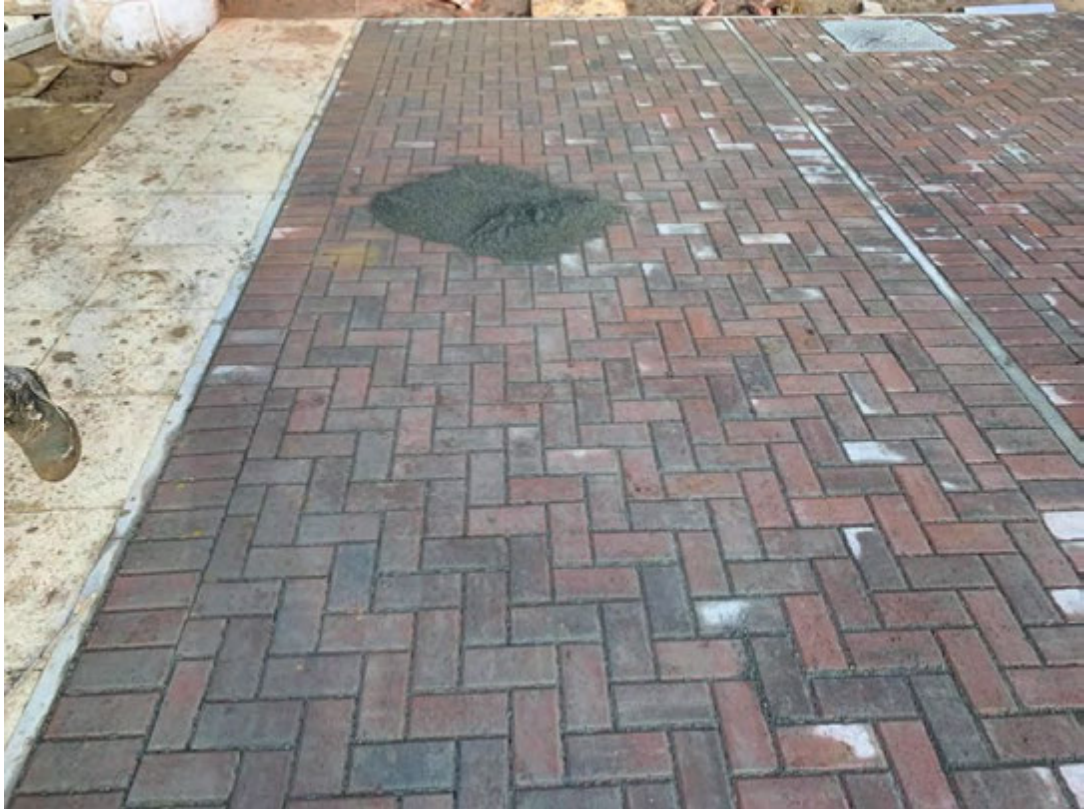
Photograph 22: View of the placement of hardstanding within Plots 1-5.

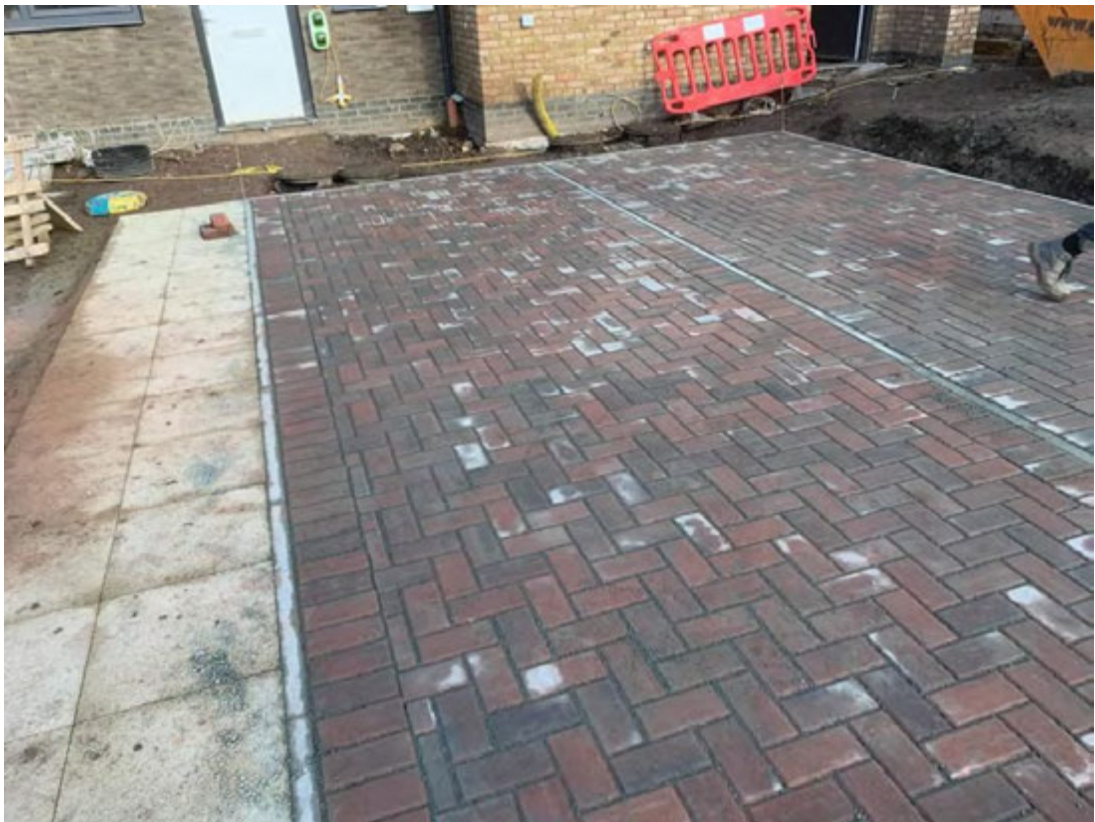
Photograph 23: View of the placement of hardstanding within Plots 1-5.

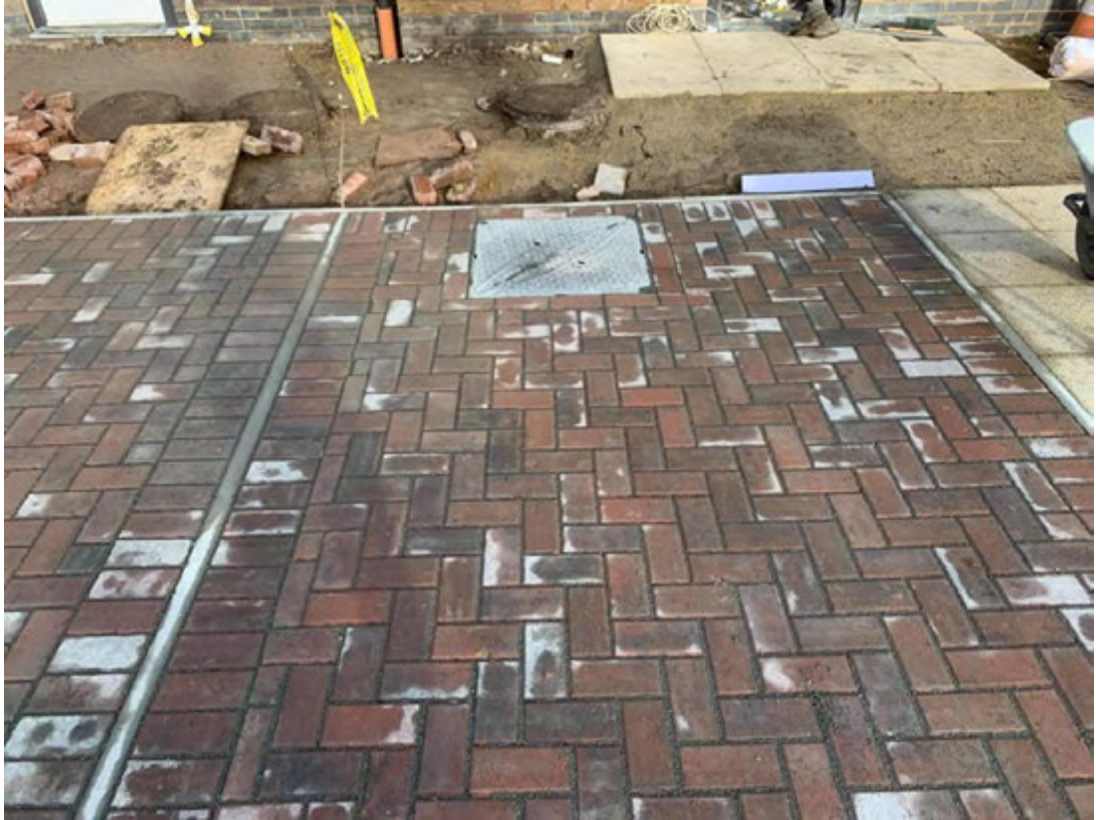
Photograph 24: View of the placement of hardstanding within Plots 1-5.

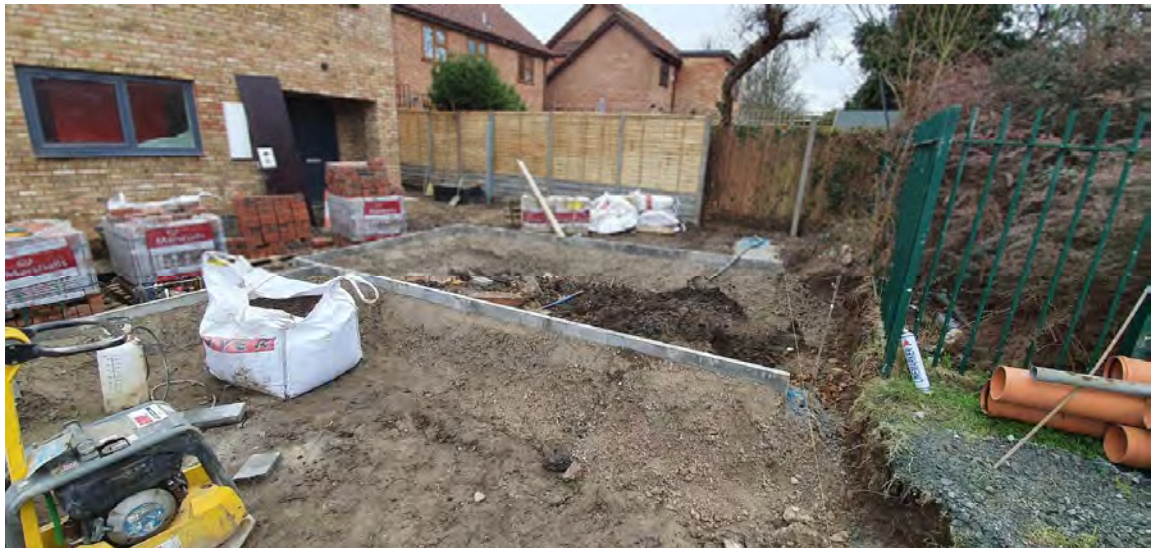
Photograph 25: View of Plots 6-10 prior to the placement of hardstanding.
