# **Willow Tree Depot, Ditchfield Road**

**Verification Report**

| ISSUE RECORD | | | | | |
|---|---|---|---|---|---|
| Report Reference: 2001015.001.01 | | | | | |

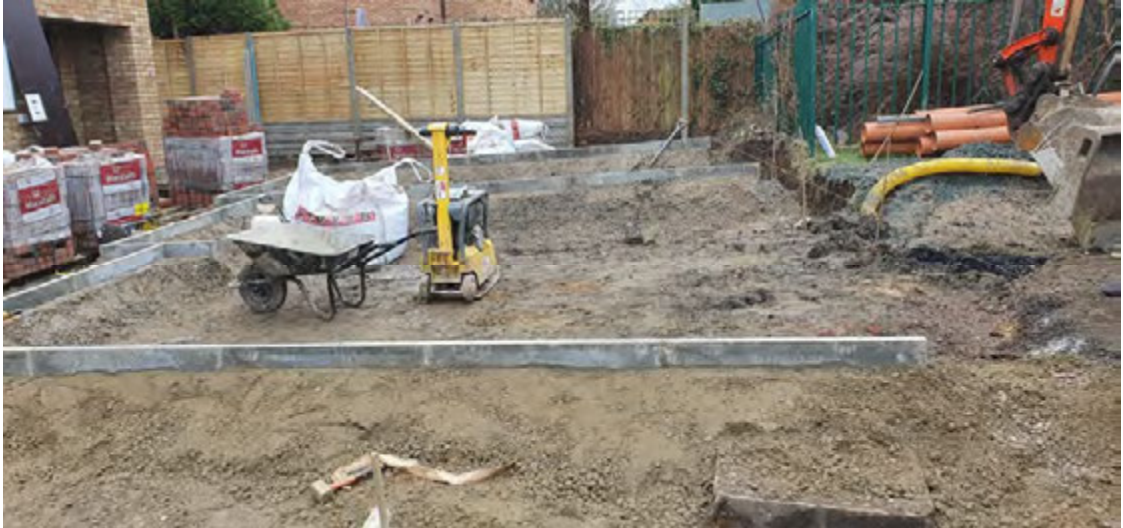
Photograph 26: View of Plots 6-10 prior to the placement of hardstanding.

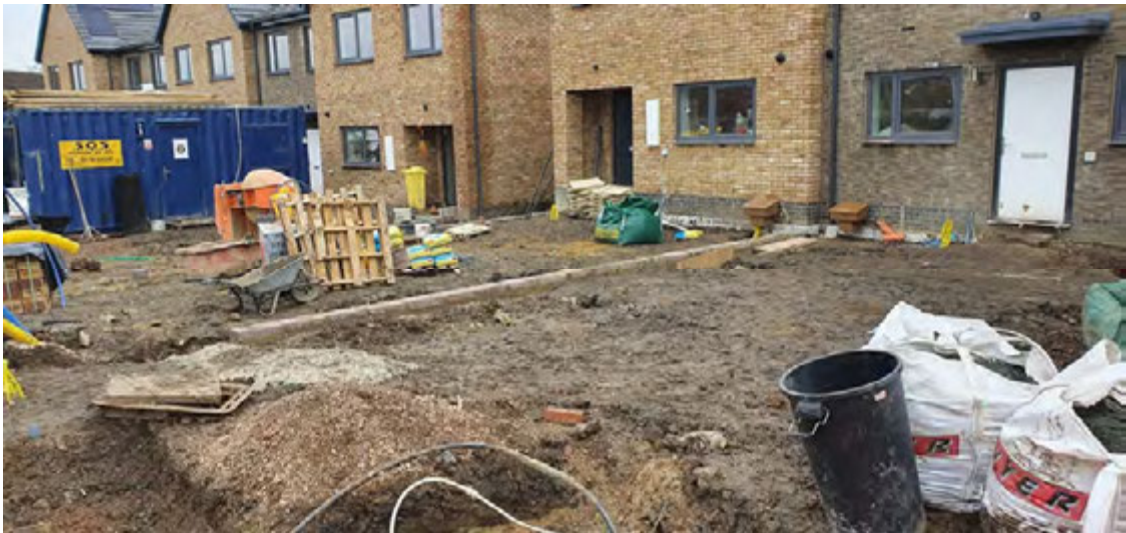
Photograph 27: View of Plots 6-10 prior to the placement of hardstanding.

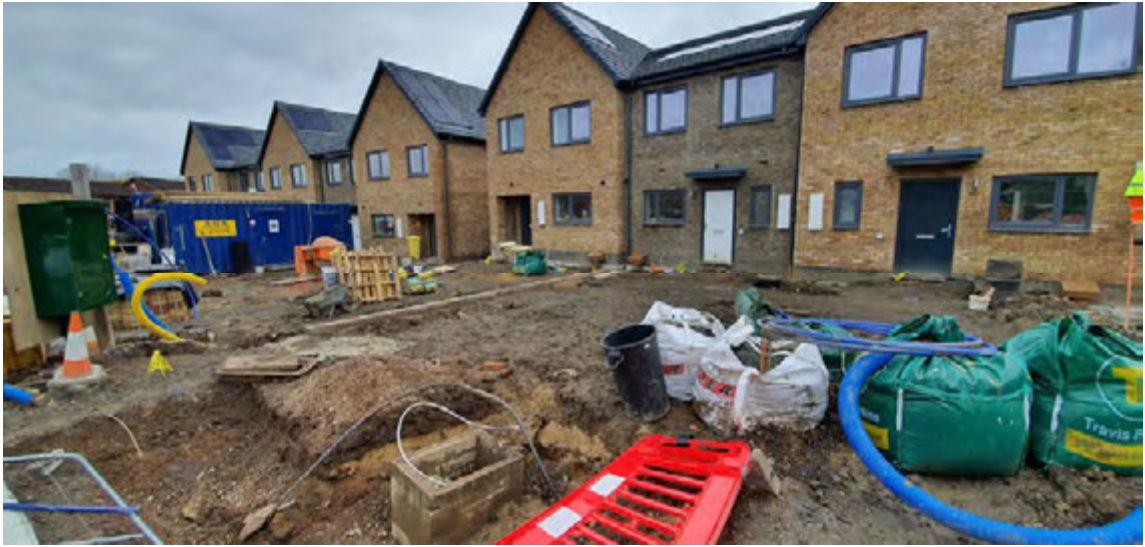
Photograph 28: View of Plots 6-10 prior to the placement of hardstanding.

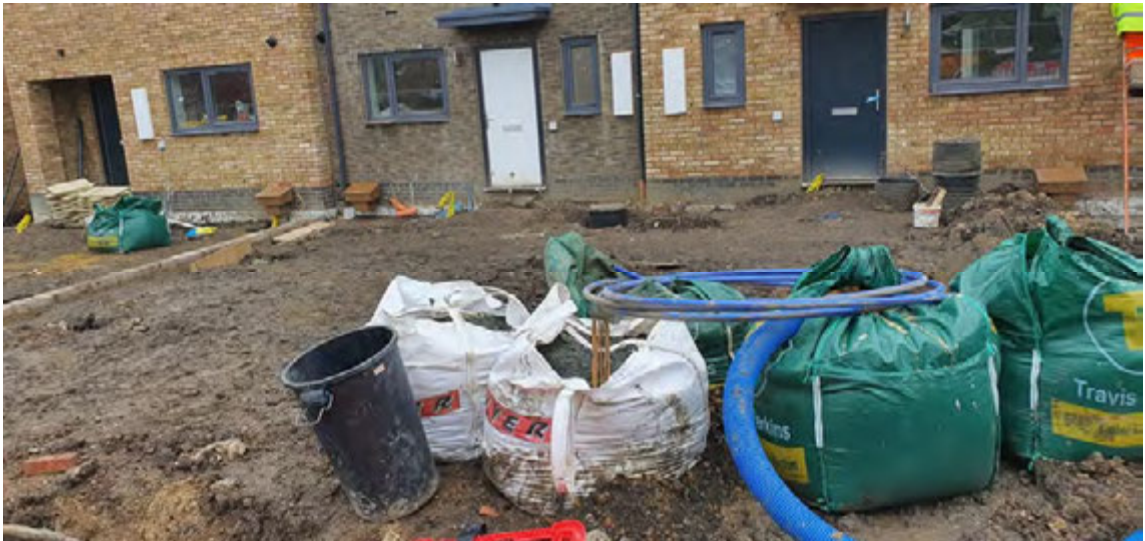
Photograph 29: View of Plots 6-10 prior to the placement of hardstanding.

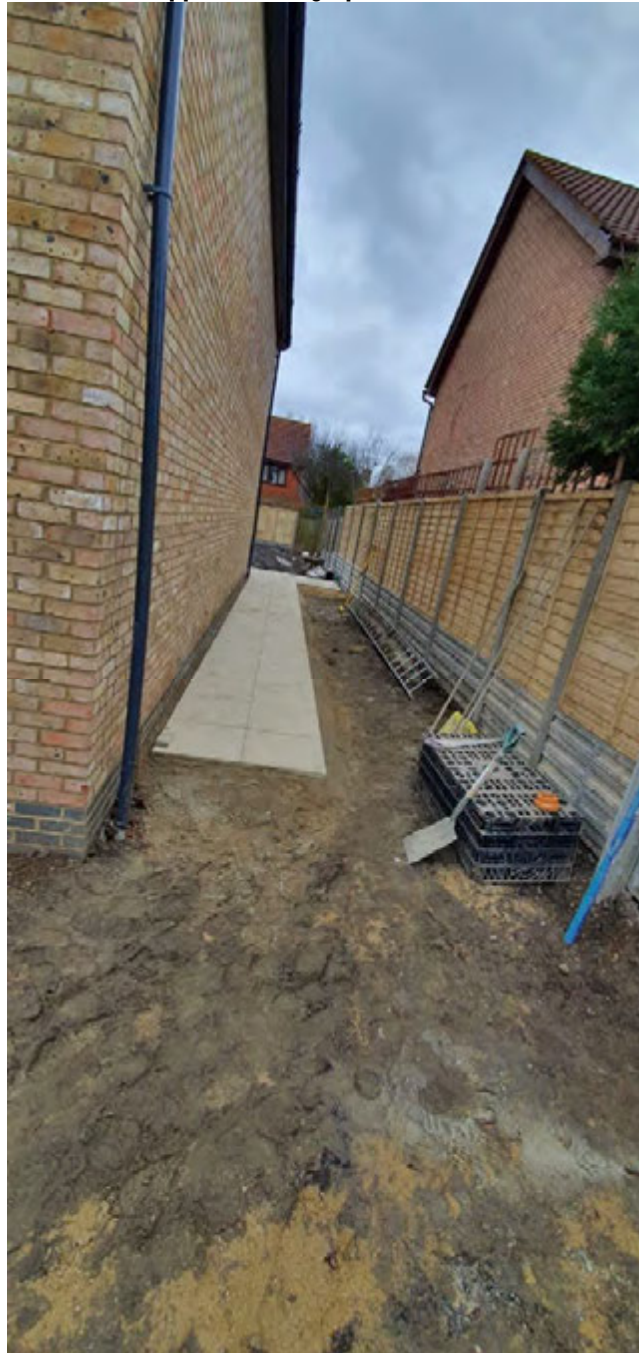
Photograph 30: View of the placement of hardstanding within Plots 6-10.

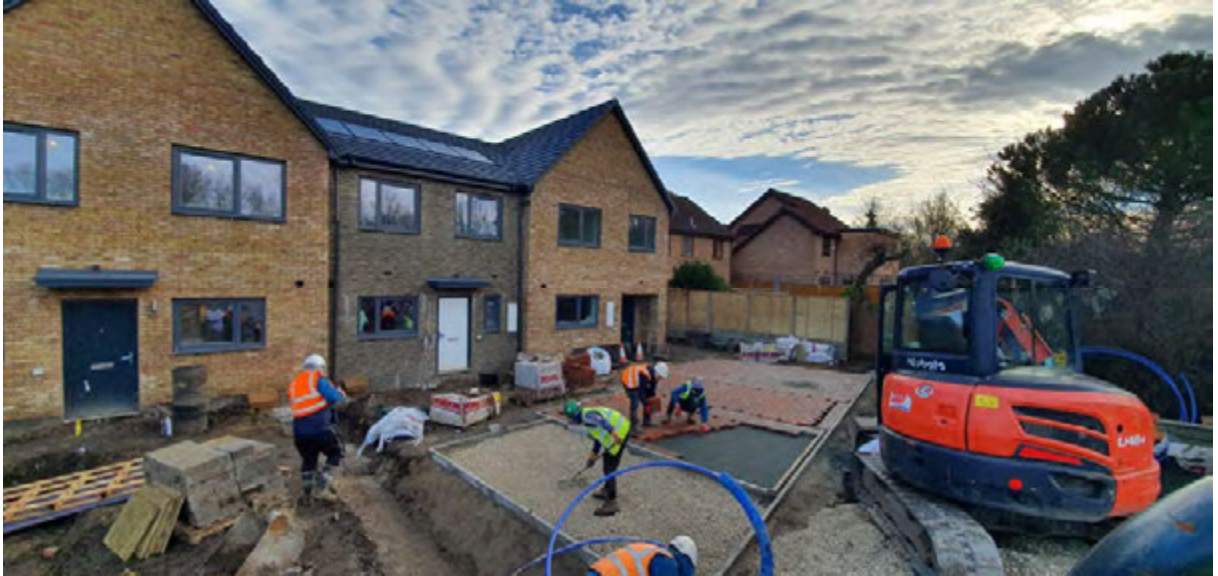
Photograph 31: View of the placement of hardstanding within Plots 6-10.

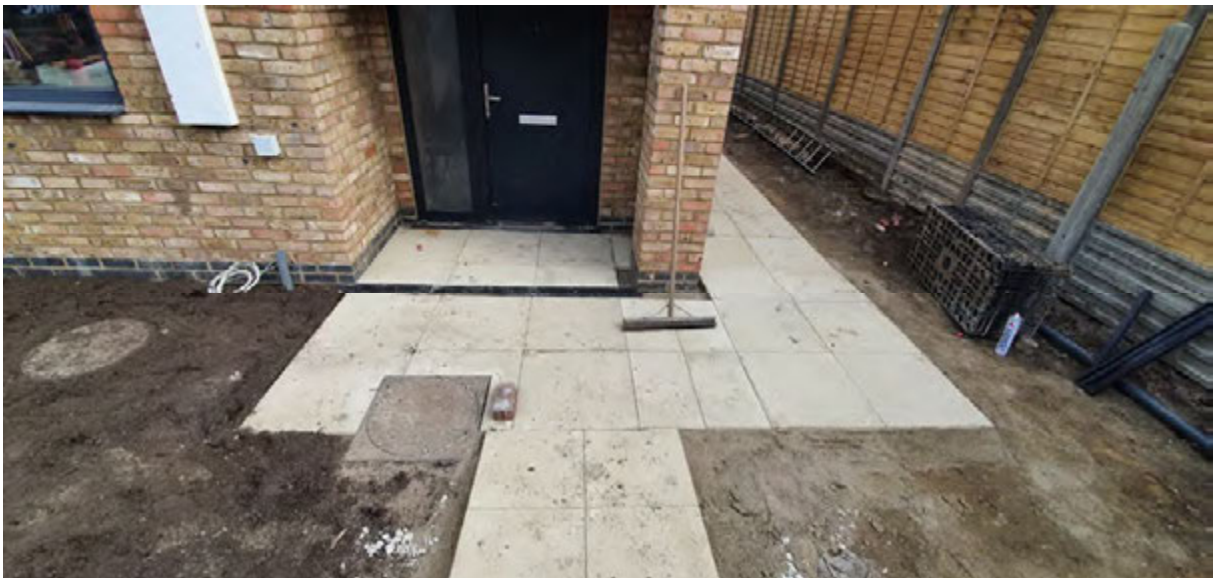
Photograph 32: View of the placement of hardstanding within the front of the properties.

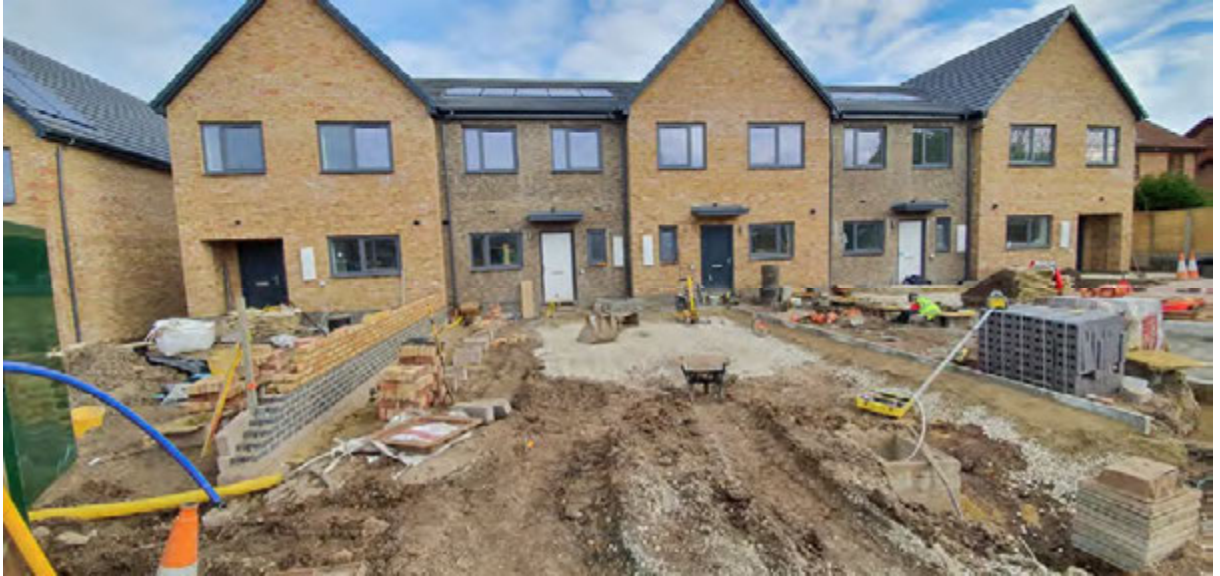
Photograph 33: View of the placement of hardstanding within the front of the properties.

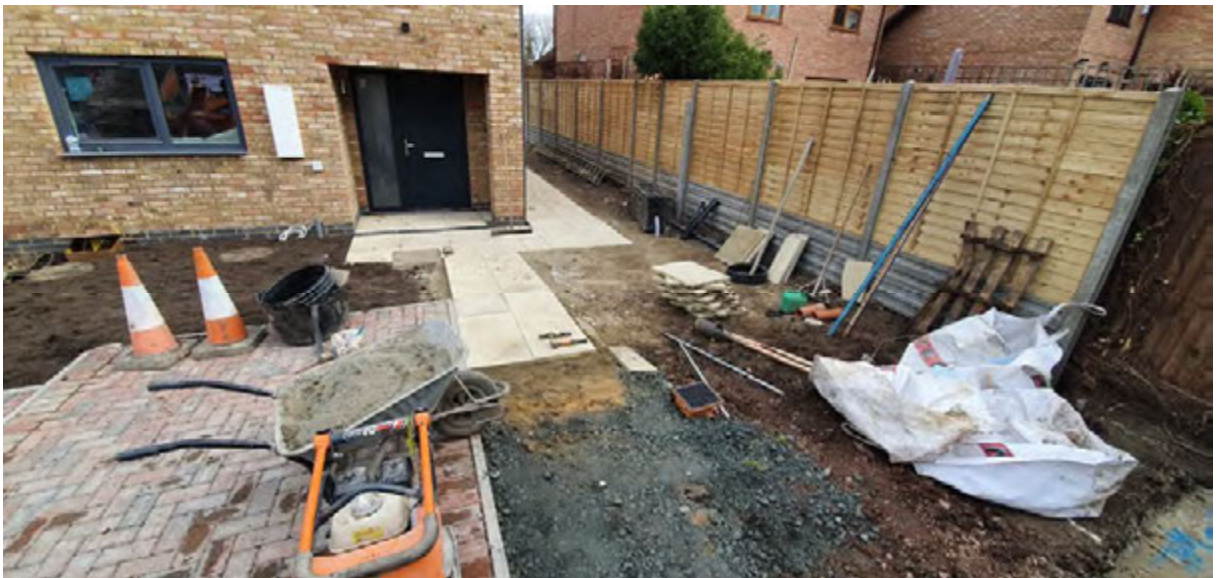
Photograph 34: View of the placement of hardstanding within the front of the properties.

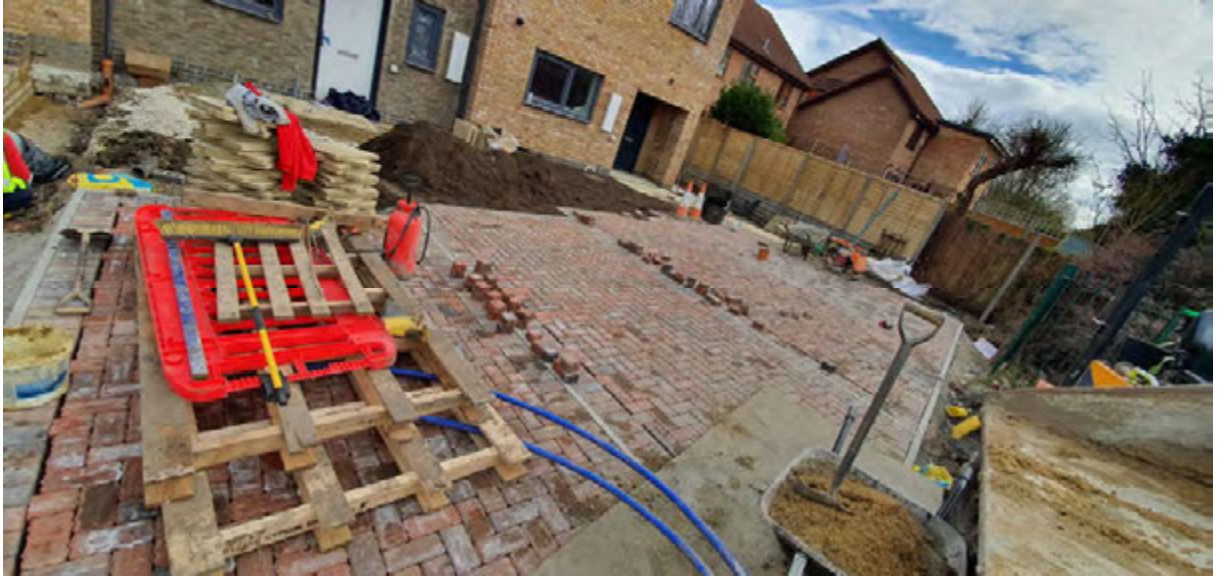
Photograph 35: View of the placement of hardstanding within the front of the properties.

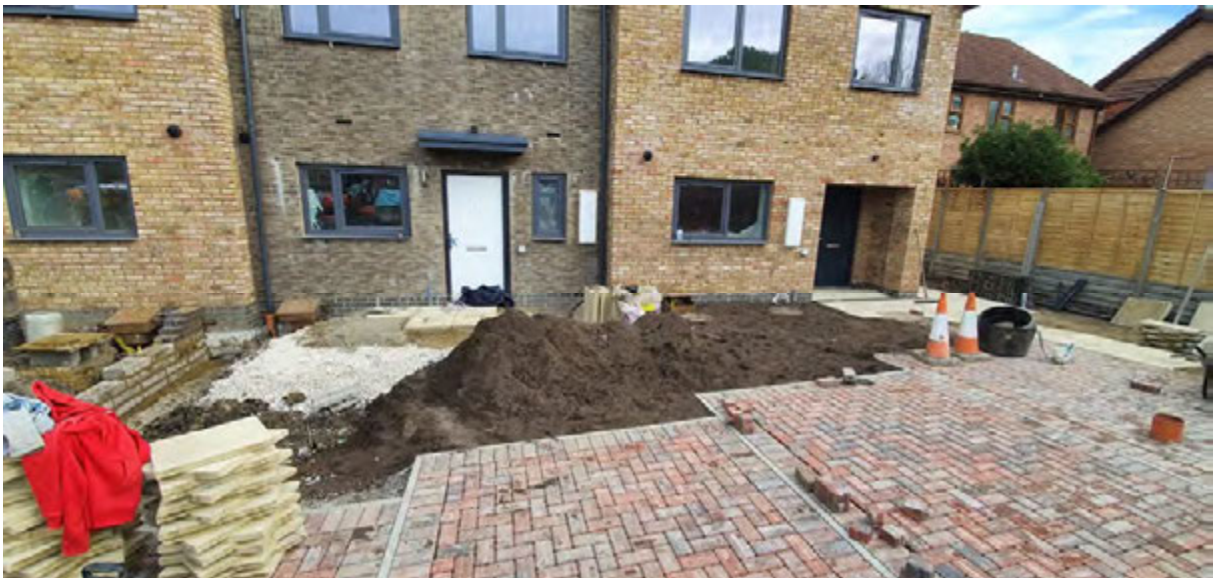
Photograph 36: View of the placement of hardstanding within the front of the properties.

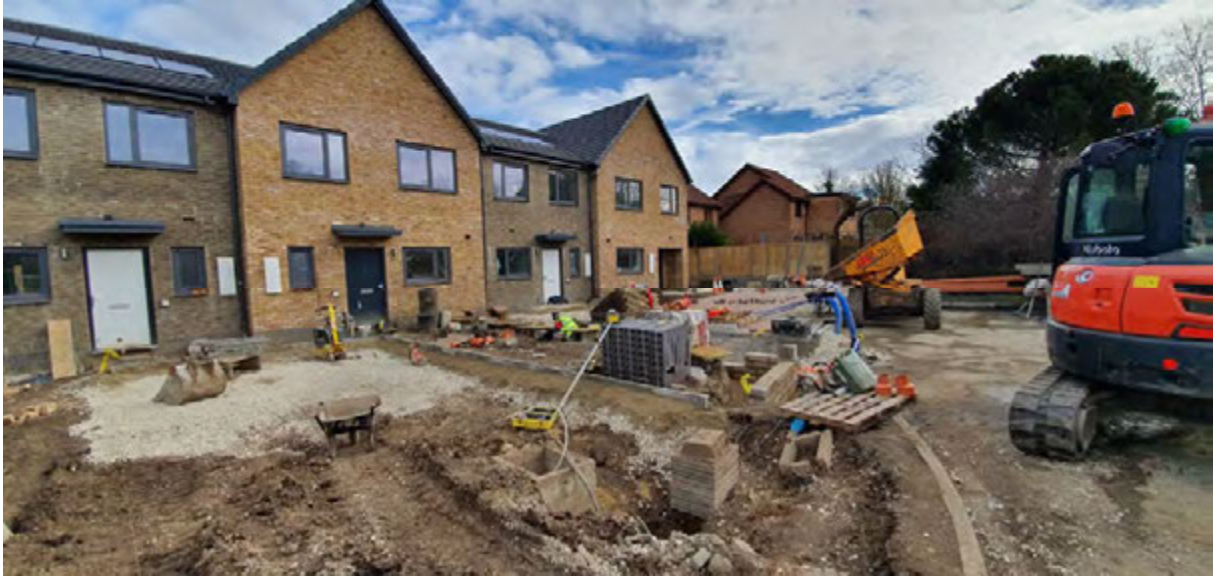
Photograph 37: View of the placement of hardstanding within the front of the properties.

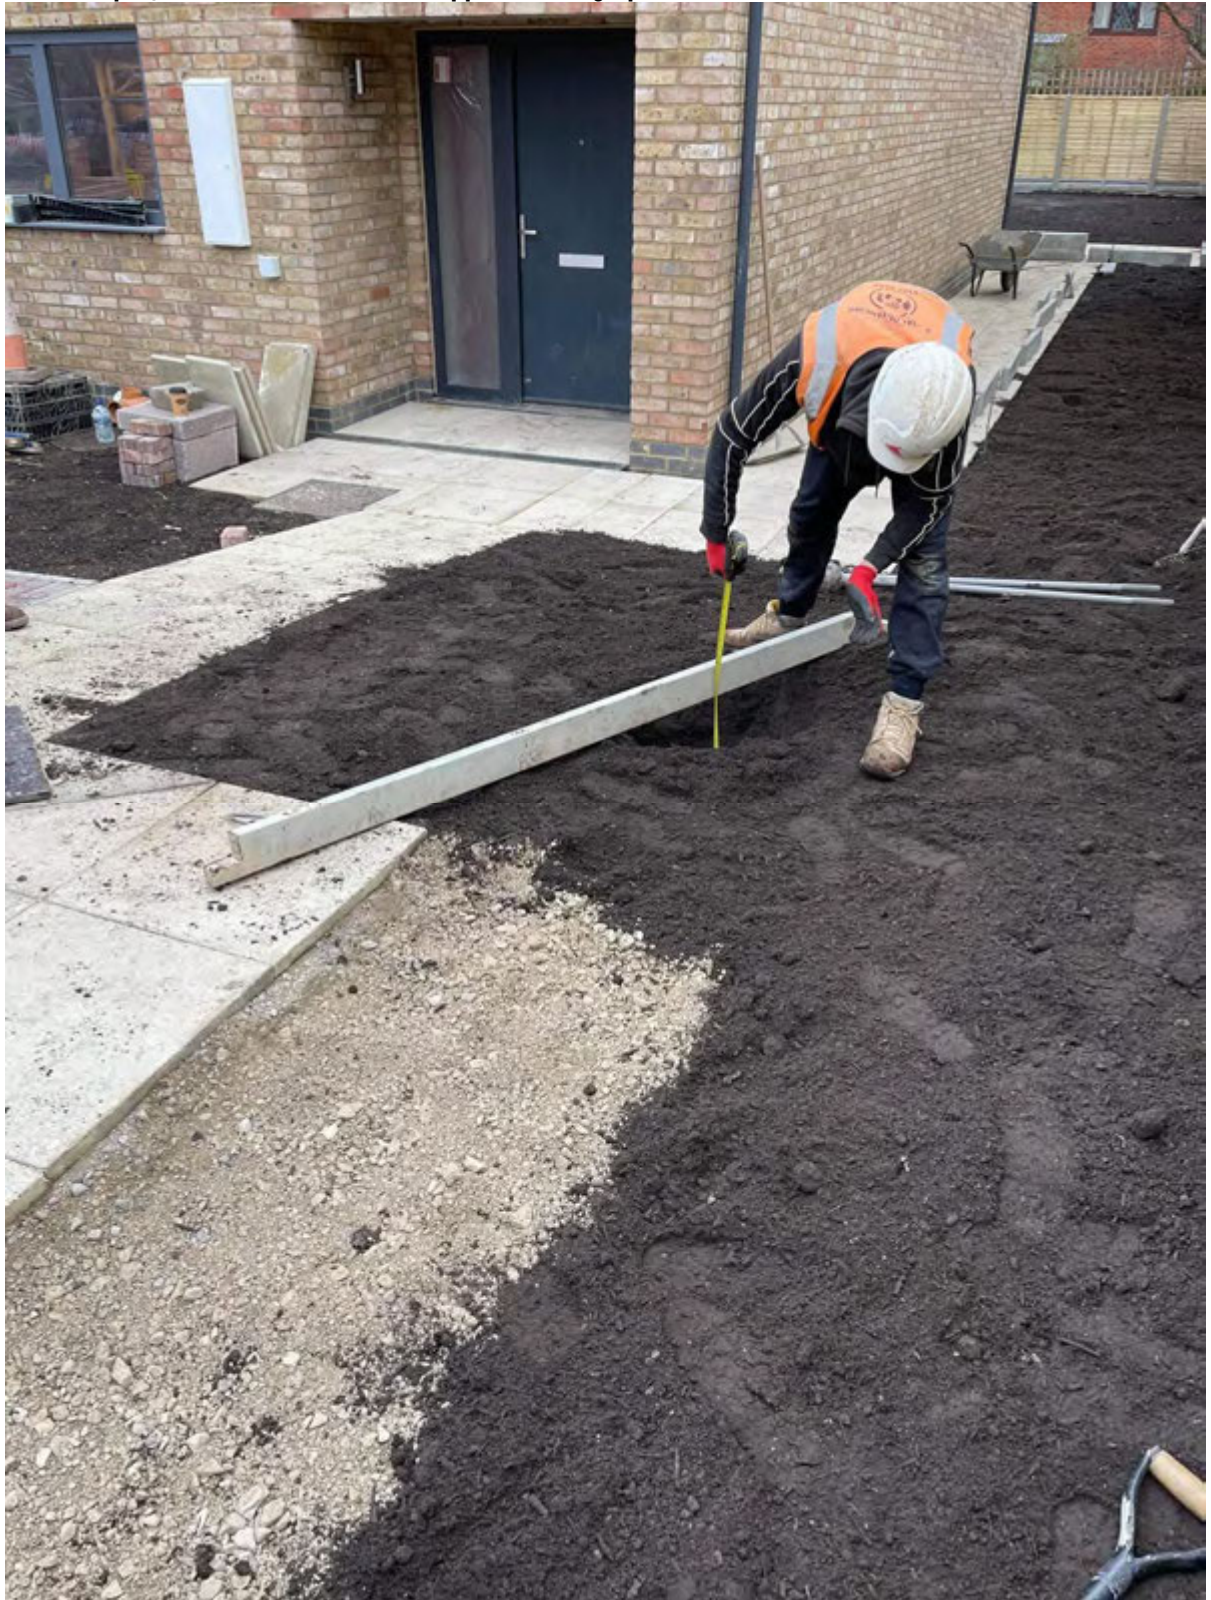
Photograph 38: Placement of soft landscaping to the front of the properties.

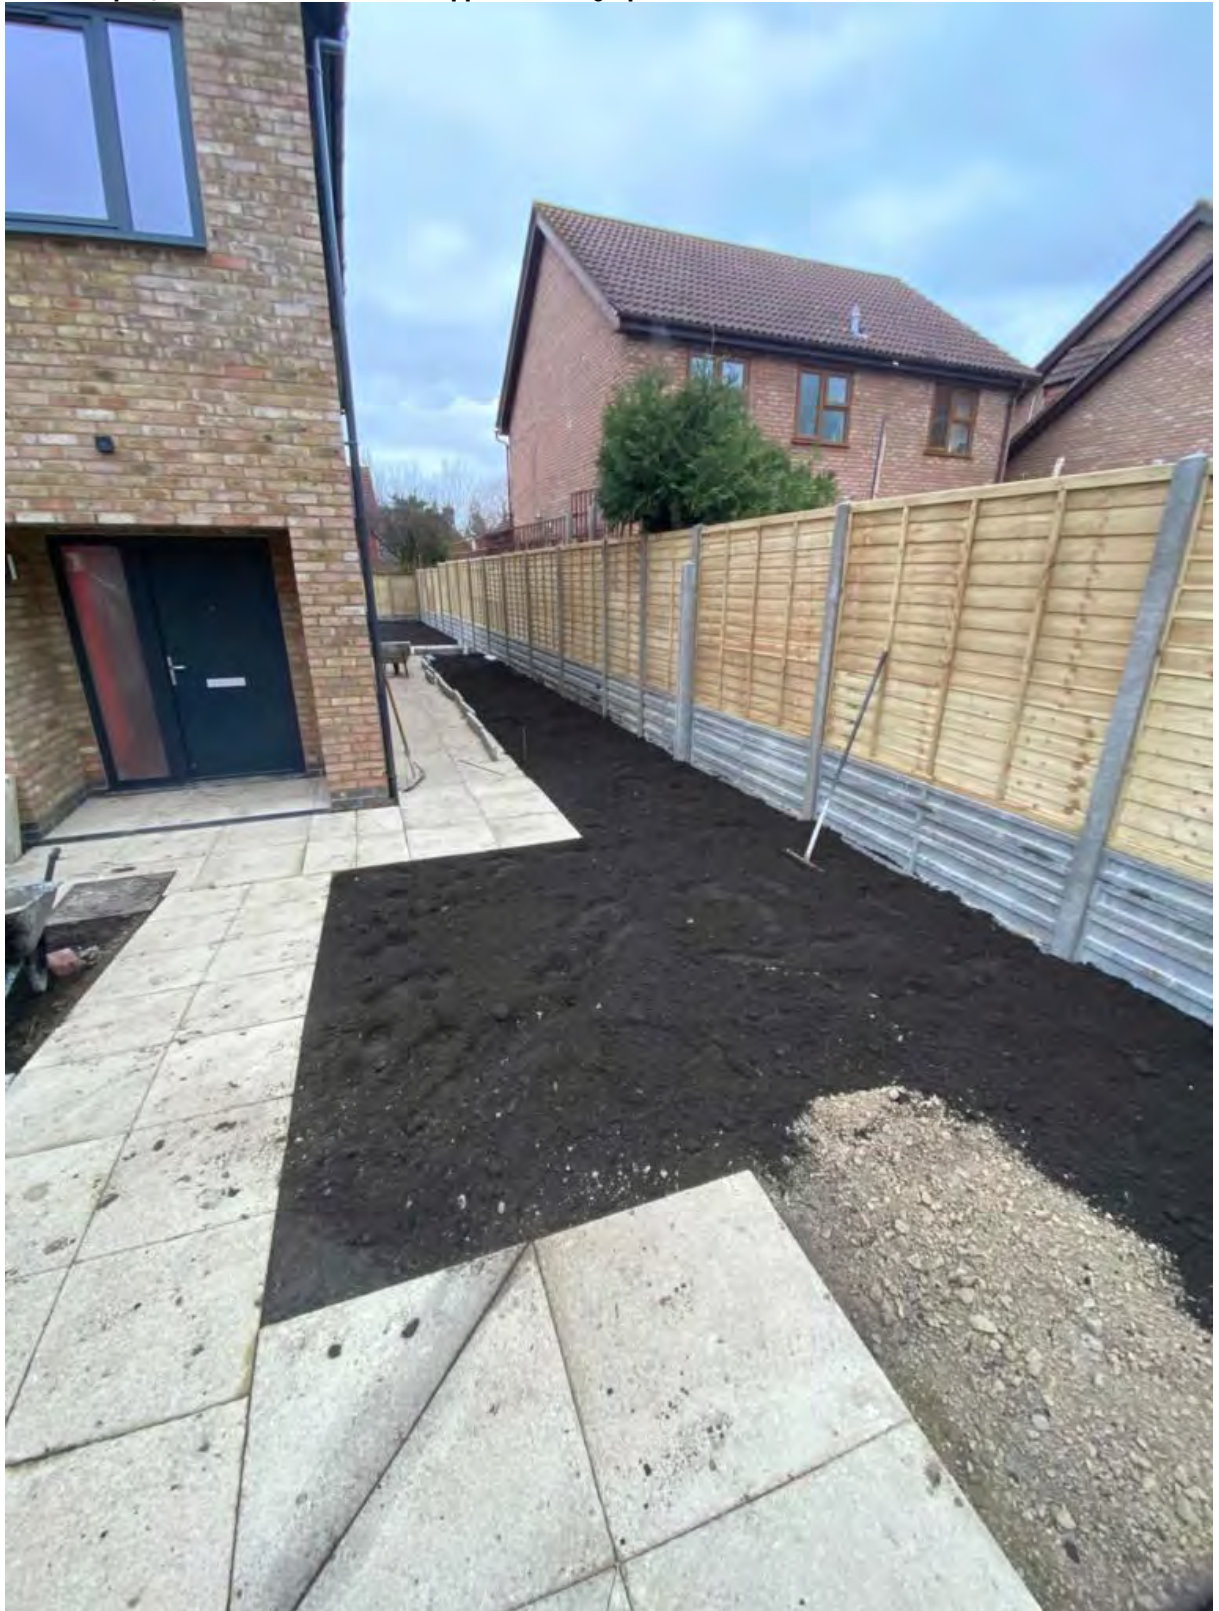
Photograph 39: Placement of soft landscaping to the front of the properties.

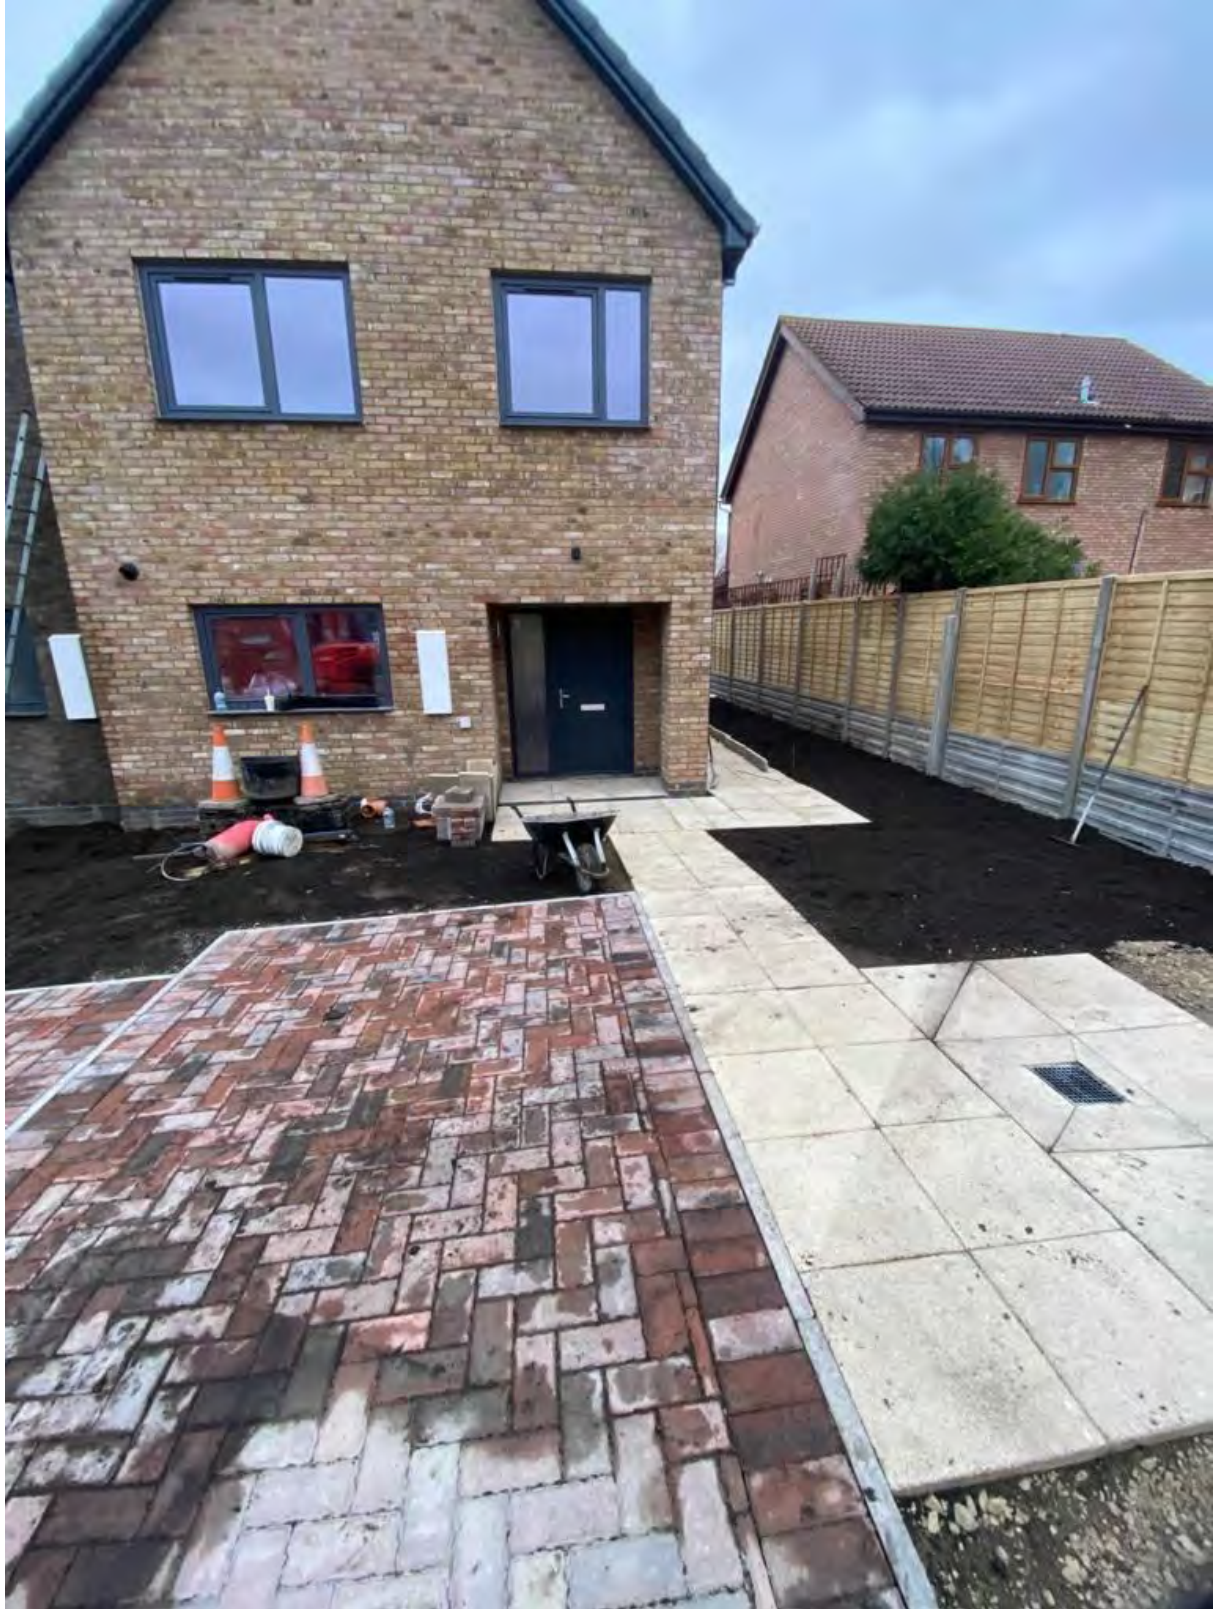
Photograph 40: Placement of soft landscaping to the front of the properties.

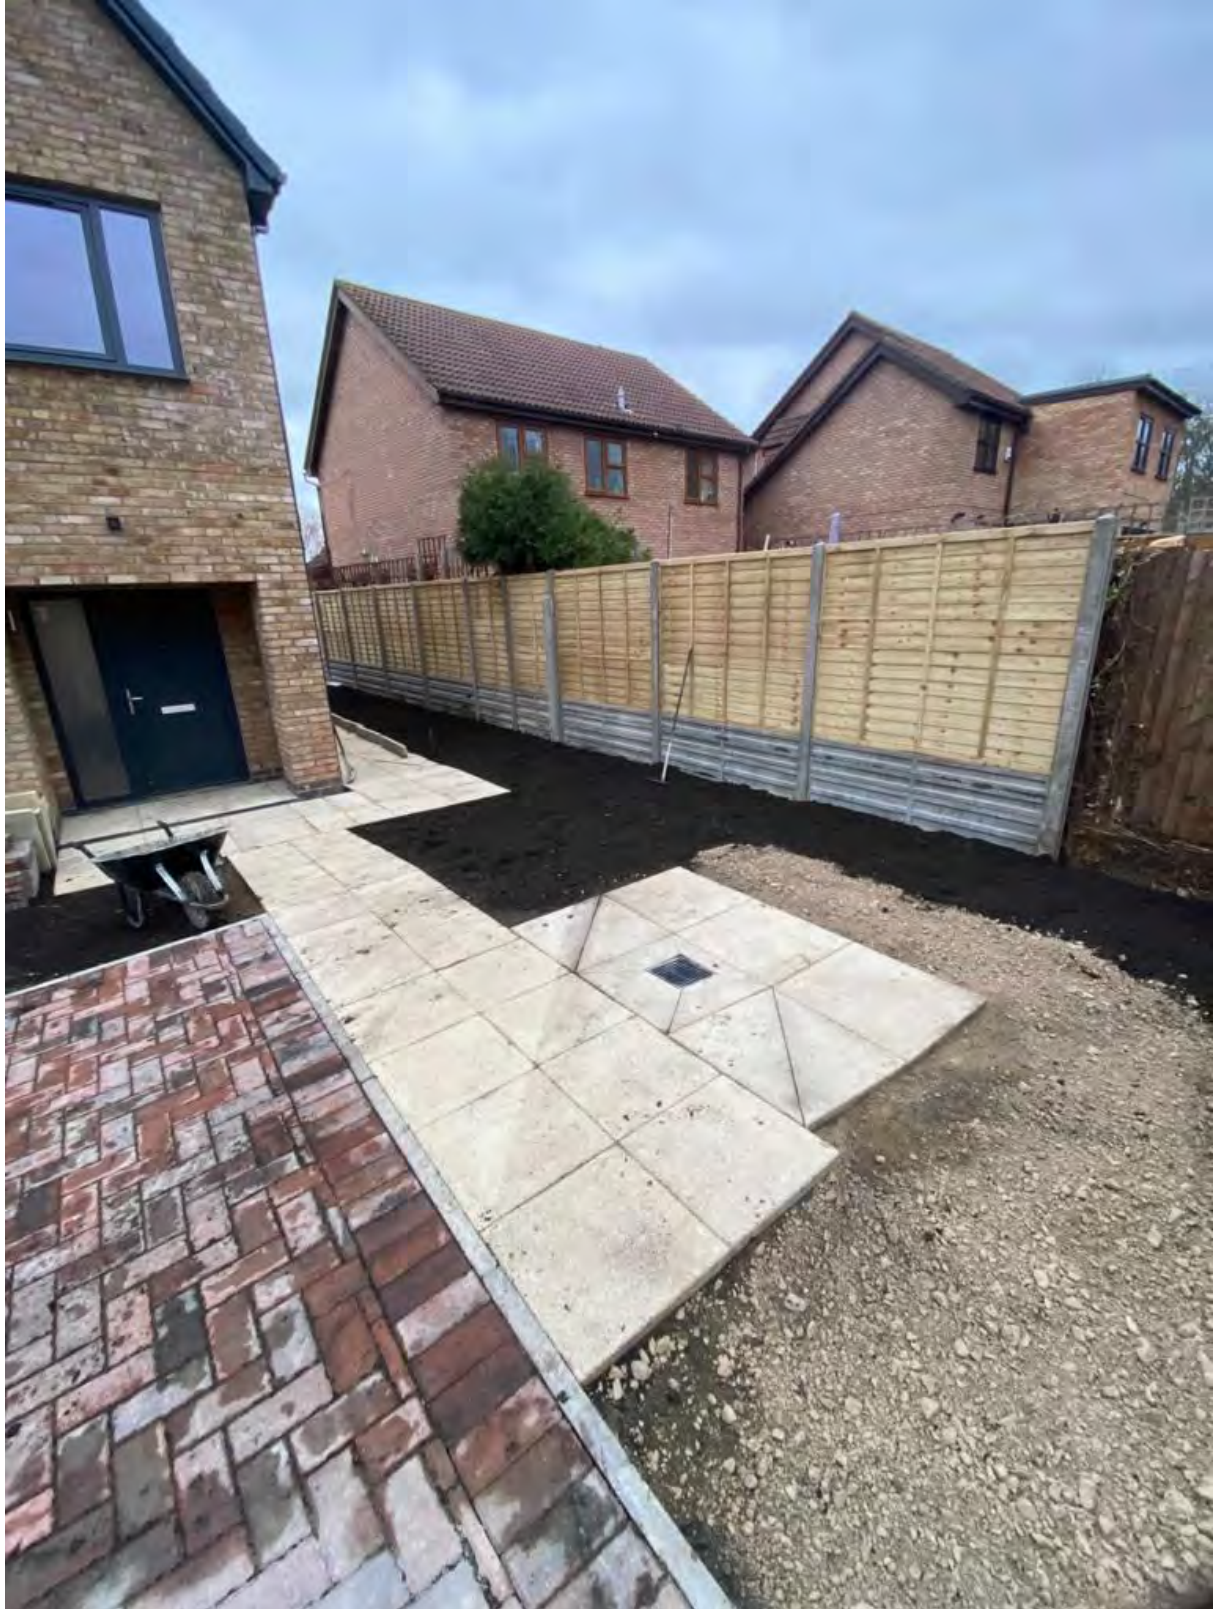
Photograph 41: Placement of soft landscaping to the front of the properties.

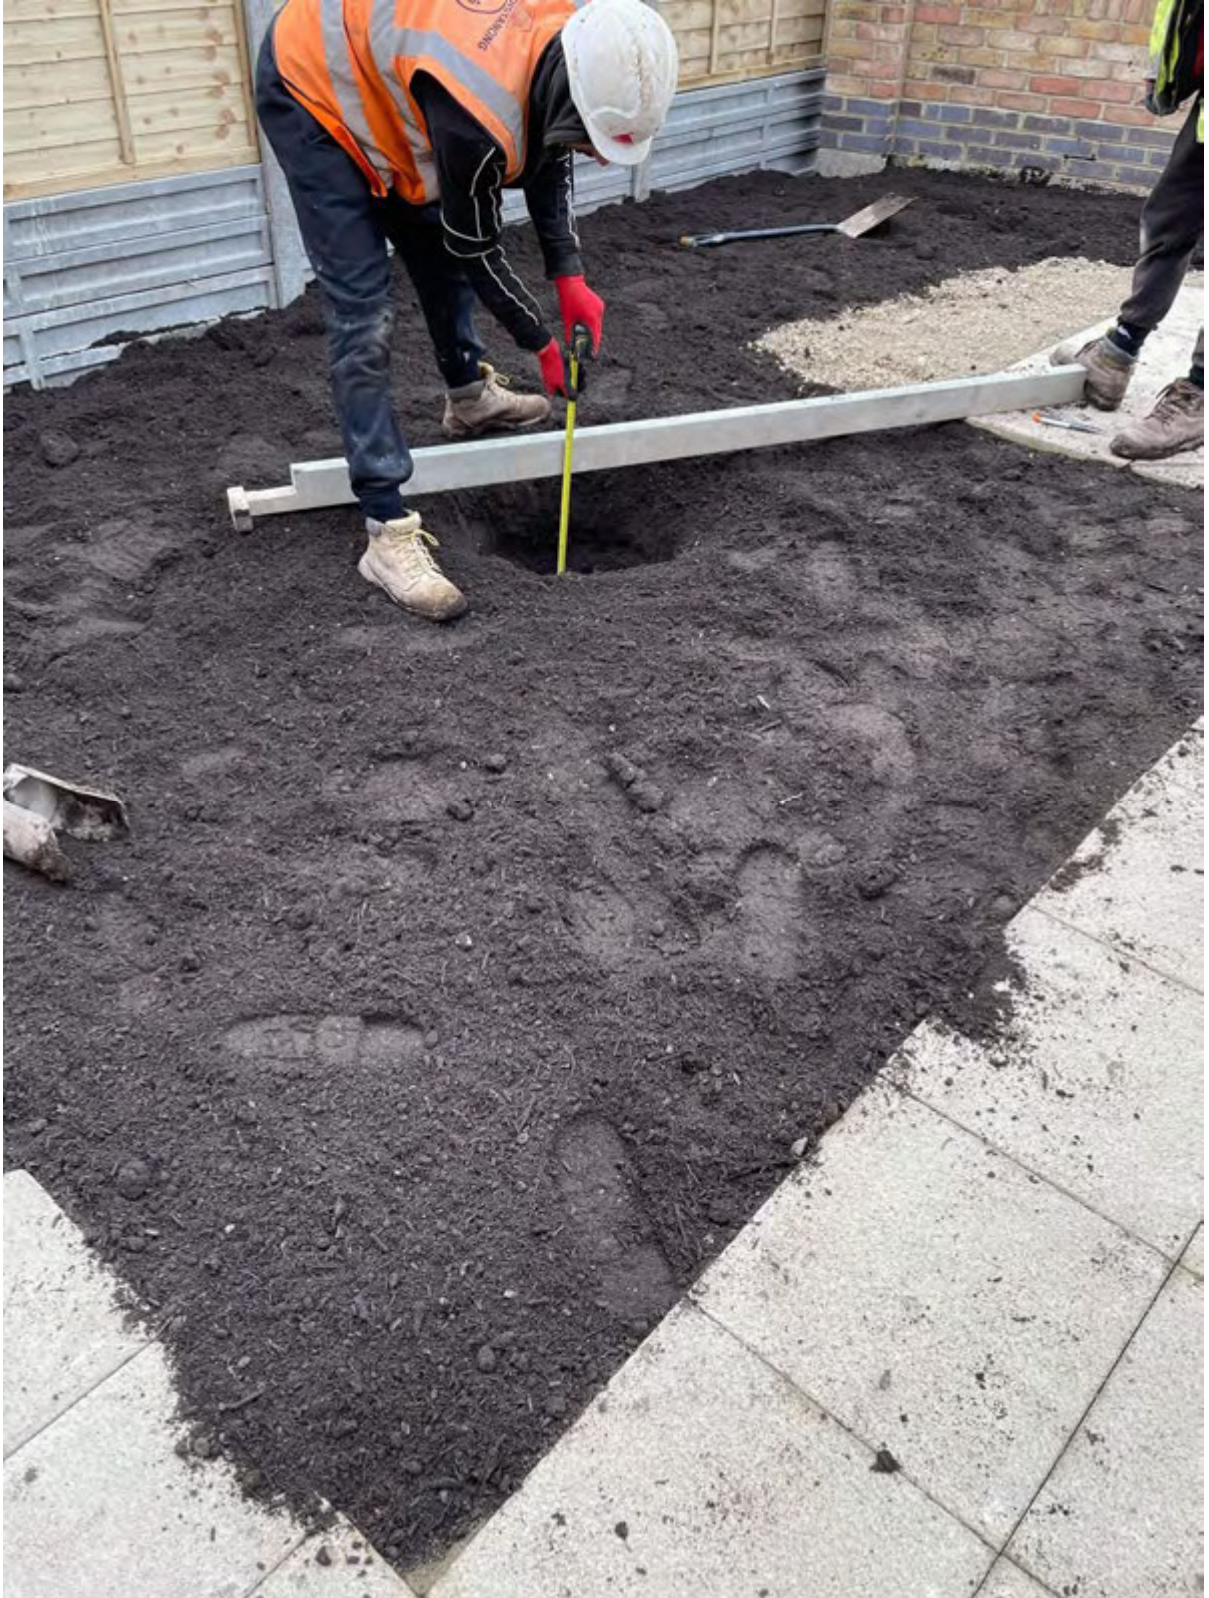
Photograph 42: Placement of soft landscaping to the front of the properties.
