Project: 21_VTA_04_14
Site: 39 Oak Avenue, Ickenham, UB10 8LR.
Client: Amol Varpe

Document Title:	Tree Safety Survey - 3 year time cycle.
Document Author:	Matt Harmsworth
Project Manager:	Matt Harmsworth
Project Title:	39 Oak Avenue, Ickenham, UB10 8LR

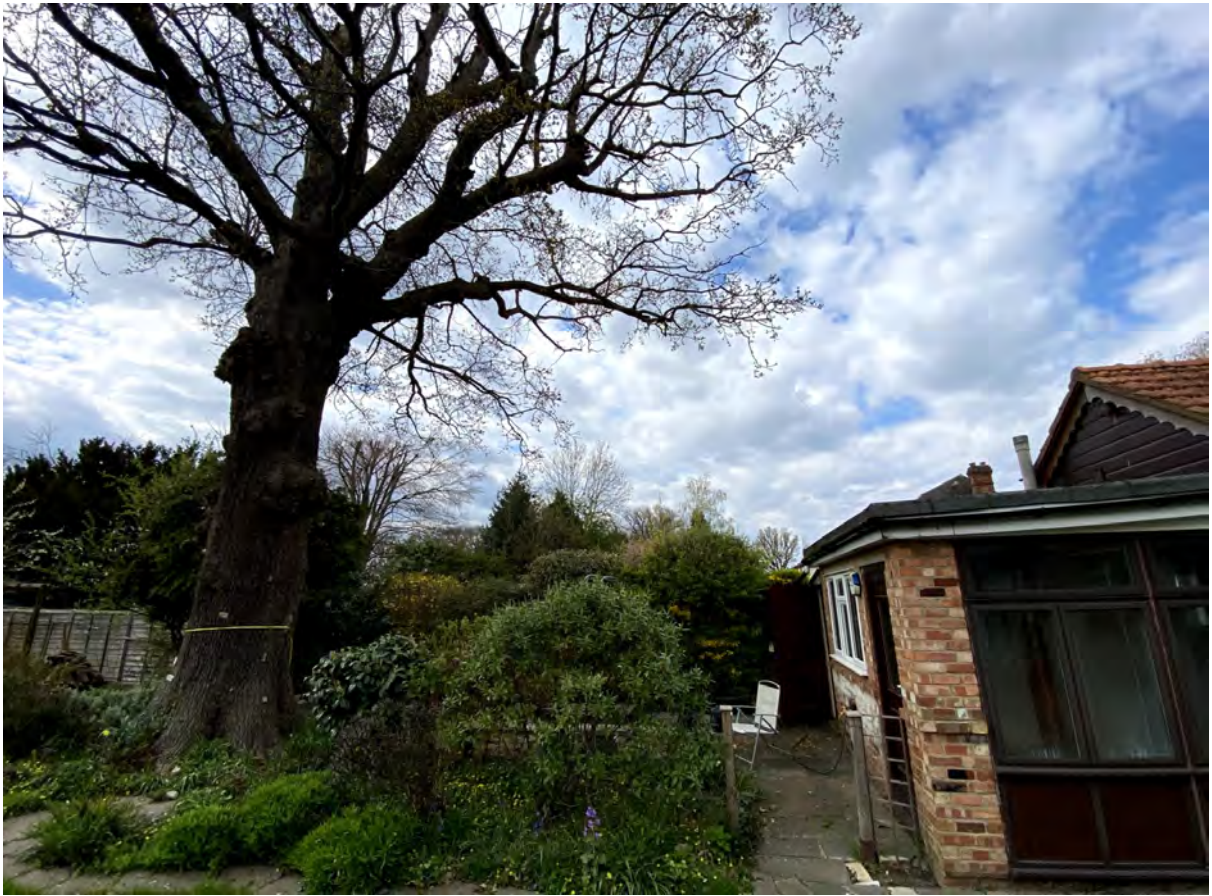
Photographic plate showing the tree in relation to the house.

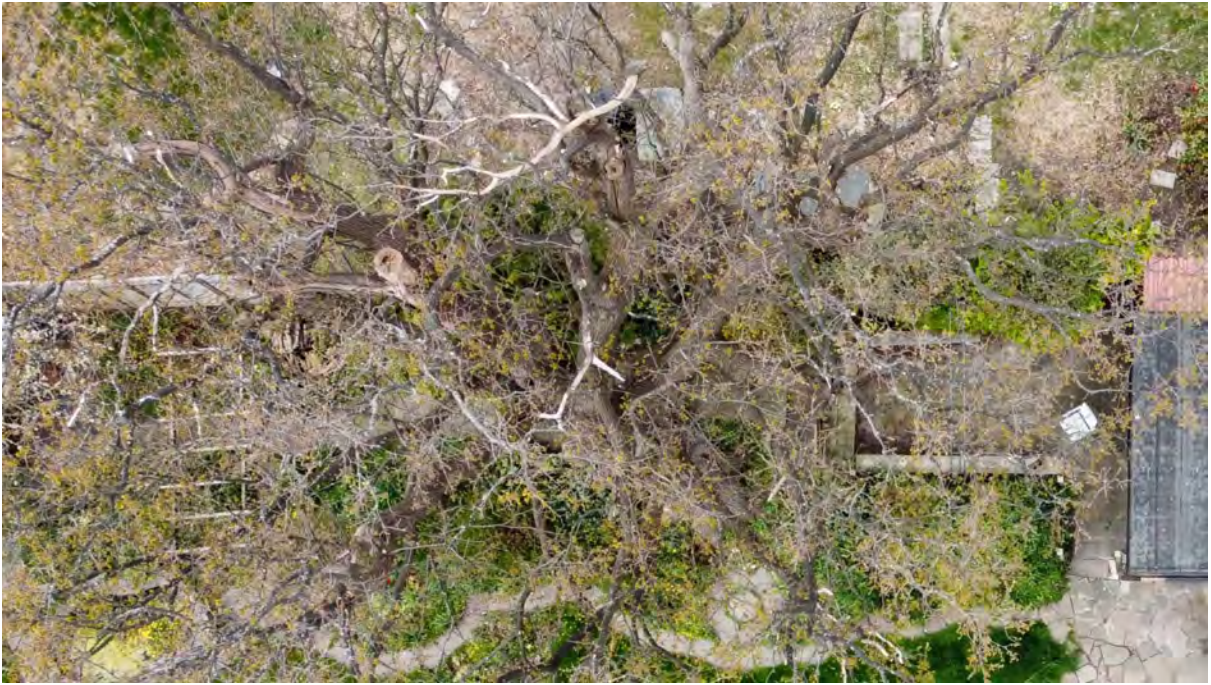
Aerial photographic plate showing the upper crown, note old pruning wounds and delaminating limbs.

3.5 T1 requires removal on safety grounds. The tree shows reasonable vitality given its location and the inevitable pressures of being located in a residential area. The upper crown of the tree has been reduced many times in previous years and drone imagery shows decay in the old pruning wounds.

3.6 Extensive die back was noted in sections of the upper crown together with delamination of bark on upper surfaces.

3.9 Given the trees location, pollarding and retention of a standing stem for habitat would seem inappropriate and therefore we recommend the tree is removed as soon as possible on safety grounds.

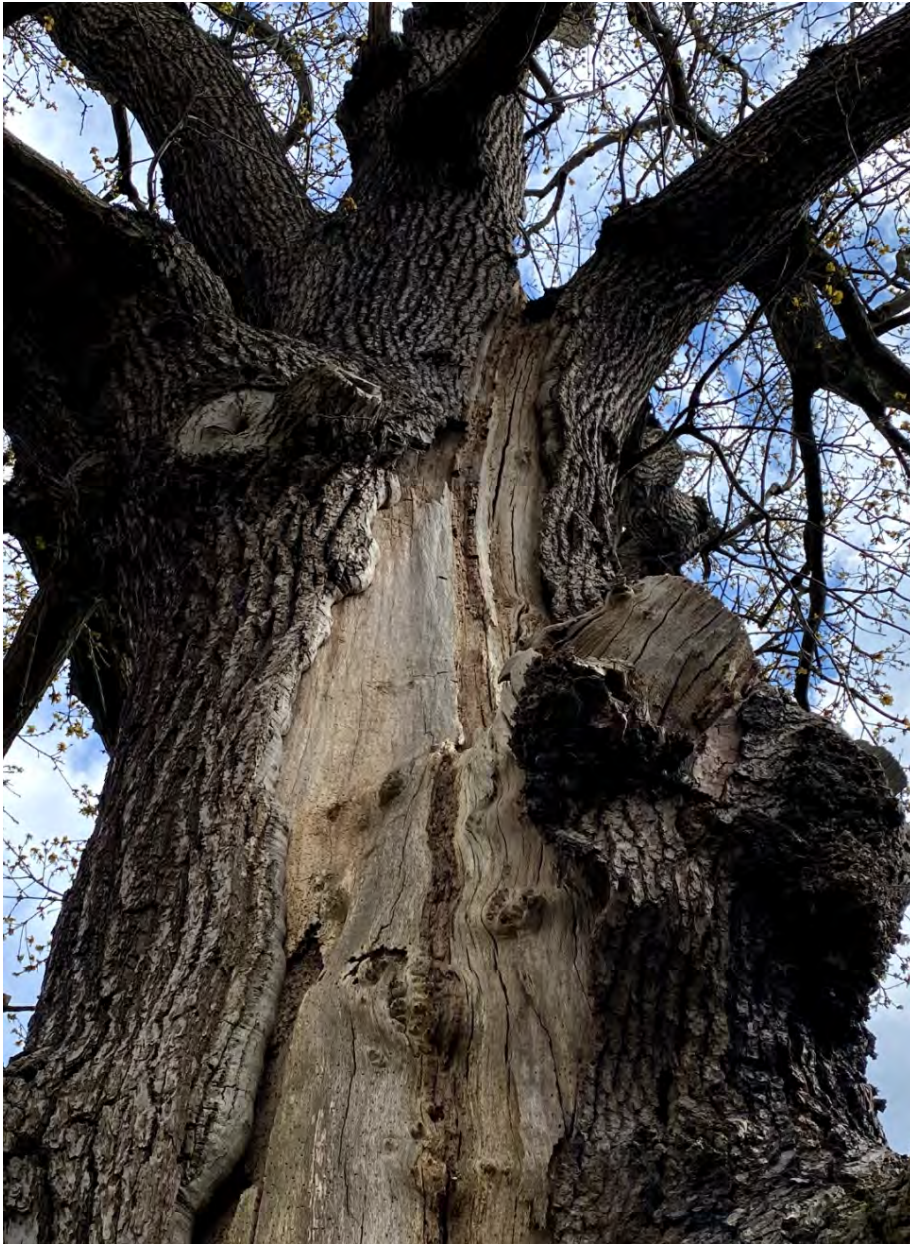
Photographic plate showing the stem wounding, delamination of bark and cracking.

3.7 The tree appears to have been struck by lightning decades ago which has resulted in a linear vertical wound from the upper crown junctions down to 2.5m above ground level. This wound shows delamination, decay and serious cracking.

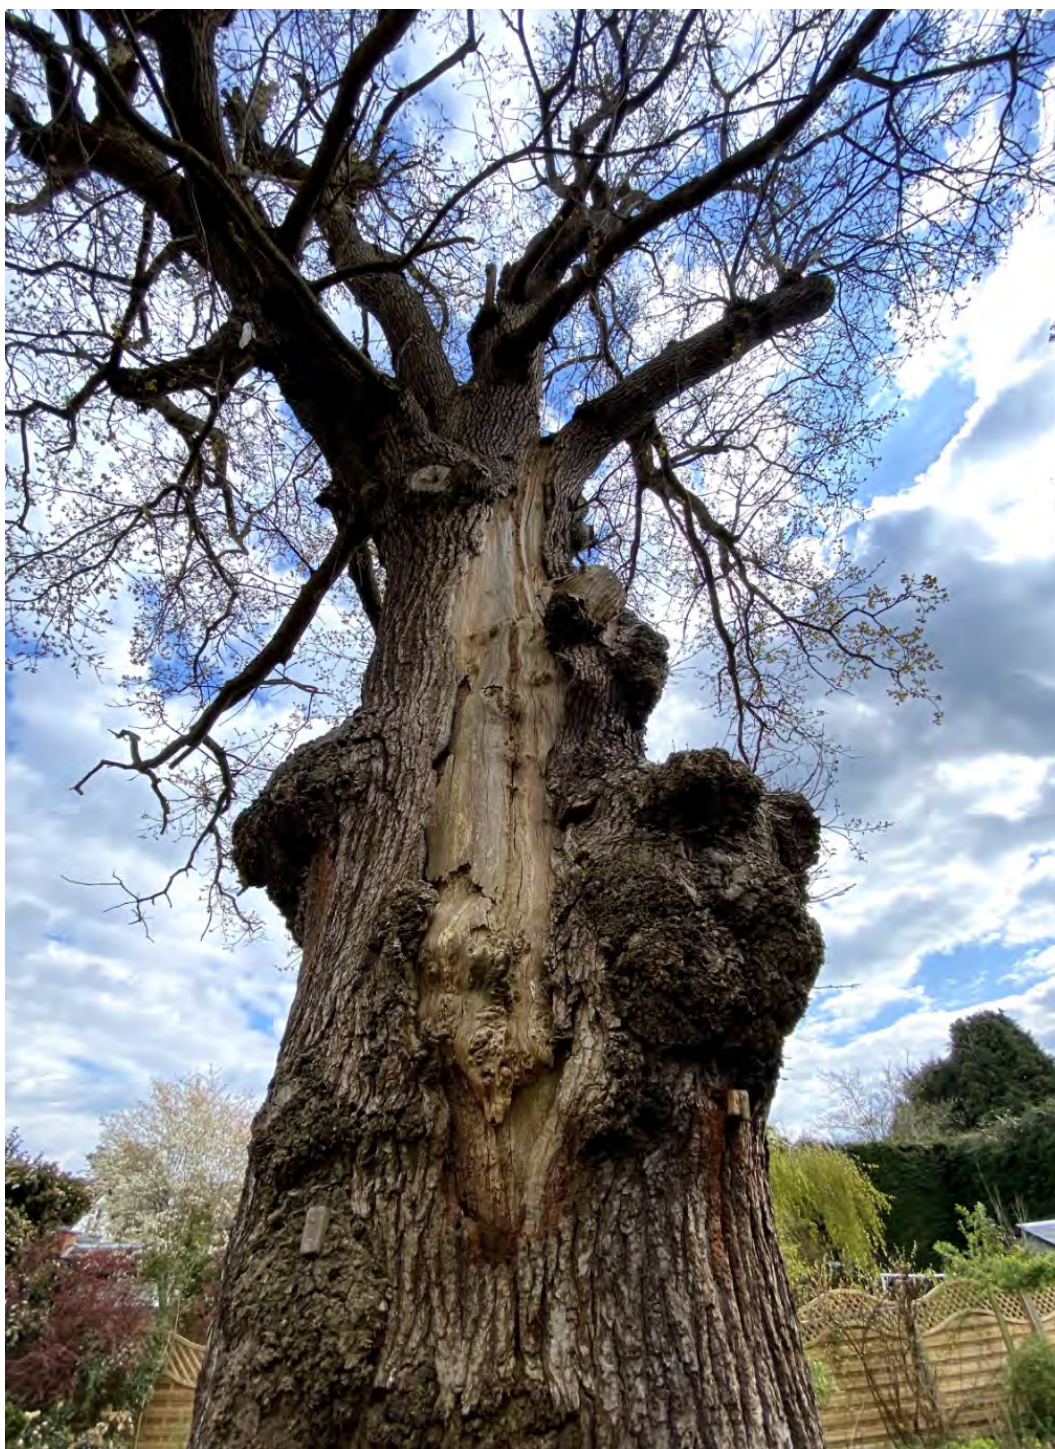
Photographic plate showing the stem wounding, delamination of bark and cracking which extends from the branch unions down to 2-2.5m above ground level.

3.8 A climbing resistograph test was planned but it was deemed unsafe due to the cracking.

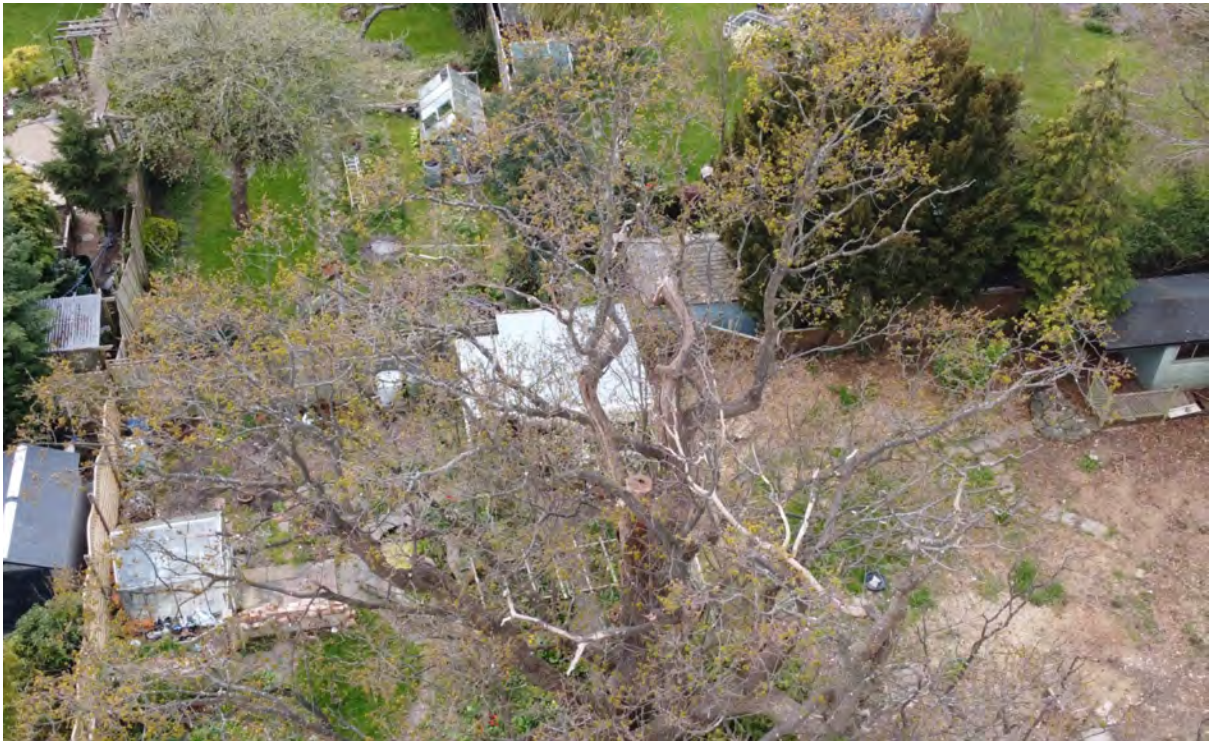
Aerial photographic plate showing the crown of T1.
