21 August 2014

**Re 9 Elmbridge Close Ruislip HA4 7XA.**

**Structural Engineer's General Movement Report.**

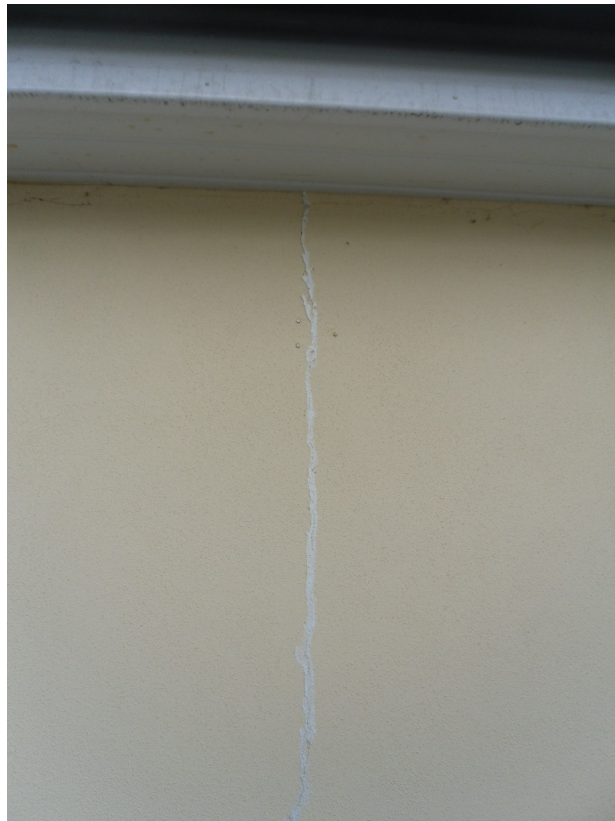
To the left hand side flank wall there is a vertical crack that has been filled with mastic to the junction of the main house and the extension. The crack does not extend to ground level. The crack is reflected internally in hairline form.

The cracking I have described above is generally vertical in form and restricted to the render finish and is therefore likely to be as a result of shrinkage of the render rather than foundation movement through subsidence. Similarly, the crack to the junction of the old and new sections of the building is of constant width over its height and does not extend to ground level. The cracking falls into the category of slight as defined in BRE digest 251. Subsidence cracks to junctions such as this are generally wider at the top and reduce toward ground level due to the rotational mode of failure. It is therefore probable that the crack is due to differential expansion and contraction at the junction of the two types of construction where the structure has effectively formed its own joint.

Cracking to extension/original house junction

GAB Robins established a monitoring location at the crack to the extension/house junction and I have added two more, one above the utility door and one below the kitchen window. Readings were taken at the time of my visit.

Whilst it is probable that the damage to the render is shrinkage related and the crack at the junction due to expansion and contraction, given the location of the mature Oak, there remains the possibility that the damage is subsidence related. I therefore suggest that you consult an Arboriculturist to advise if the Oak tree can be reduced thereby reducing its water demand. I in turn will continue with the monitoring exercise so that any benefit from this work can be catalogued. The monitoring will need to be conducted over a twelve month period with visits at two monthly intervals. In this way the four seasons will be encapsulated within the monitoring period. I will publish the results following each visit. As we agreed, my fees for this will be £100 per visit.

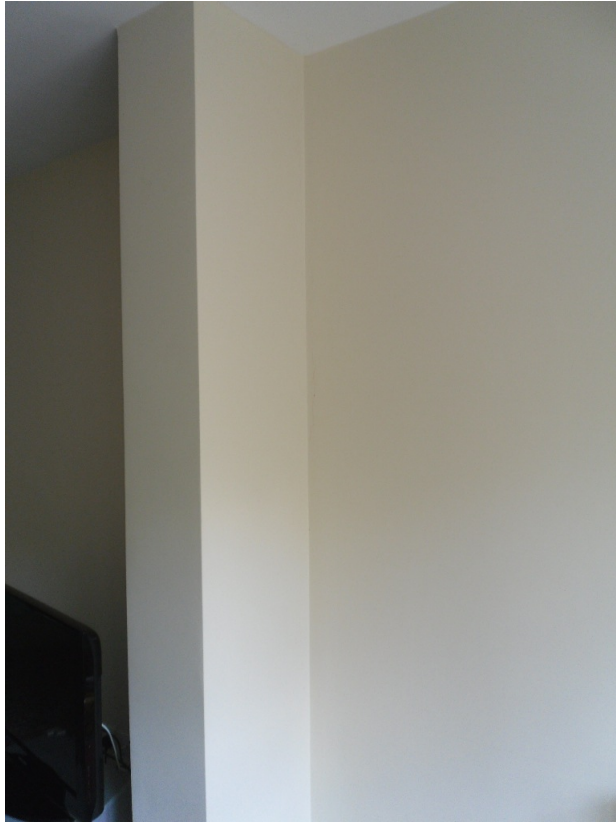
Hairline internal cracking reflecting external crack

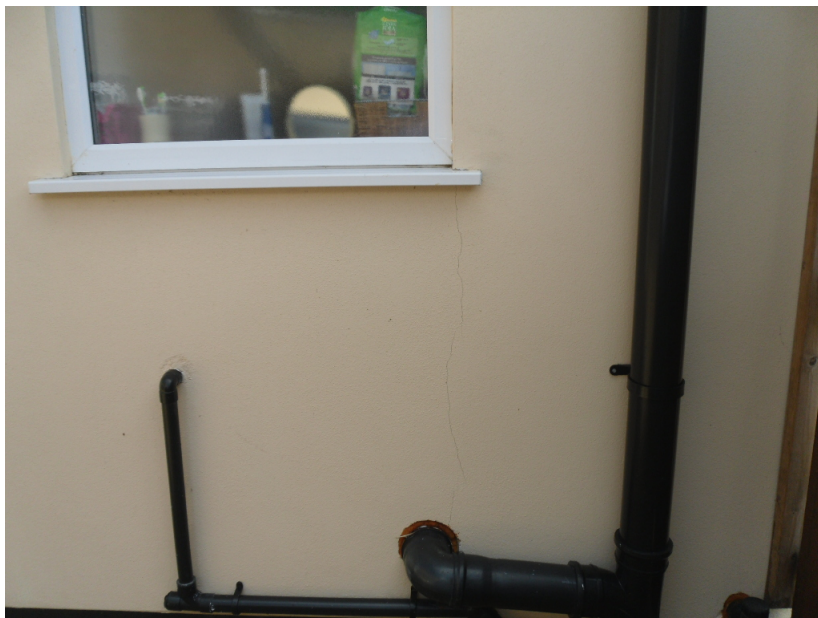
There is a vertical hairline crack below the bathroom window to the right hand side flank wall. Above the side utility room door there is cracking to the front of the opening, the cracking has a maximum width of 0.5mm and emanates from the corner diagonally before progressing vertically to the roofline.

Hairline crack below bathroom window

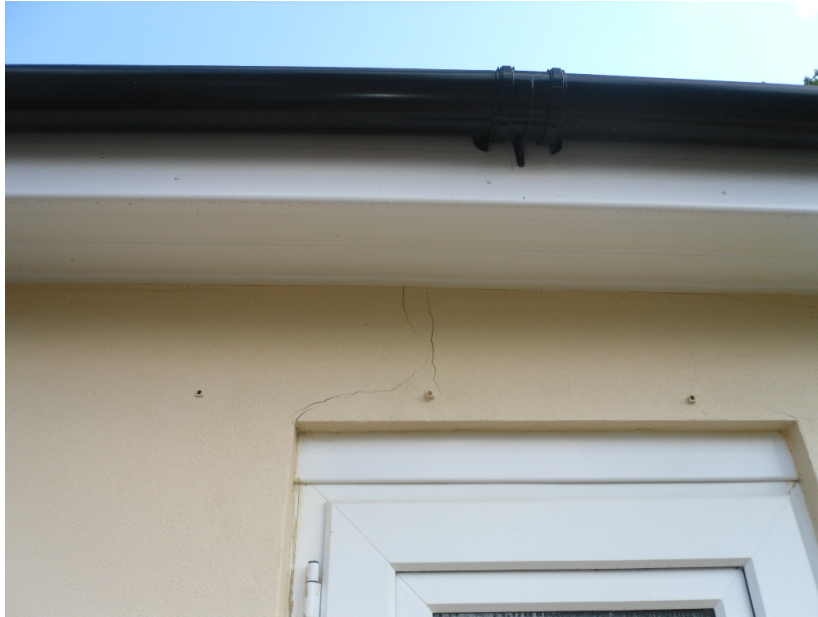
Cracking above utility room door

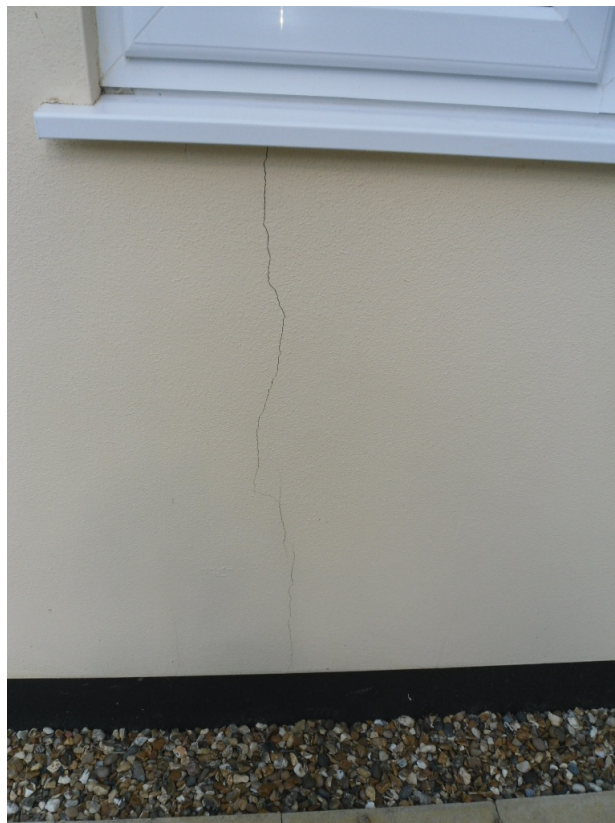
There are three vertical hairline cracks to the render below the rear kitchen window, the cracks do not extend to ground level.

Cracking below kitchen window
