# GEOTECHNICAL

**69 The Green, West Drayton, UB7 7PW**

Client: Subsidence Management Services  
Client Contact: Ian Domigan  
Client Ref: IFS-AVI-SUB-20-0087509  
Policy Holder: Mr & Mrs Thomas and Krisztina Wormald  
Report Date: 26 September 2020  
Our Ref: C56101G24946

## Drainage Investigation Report

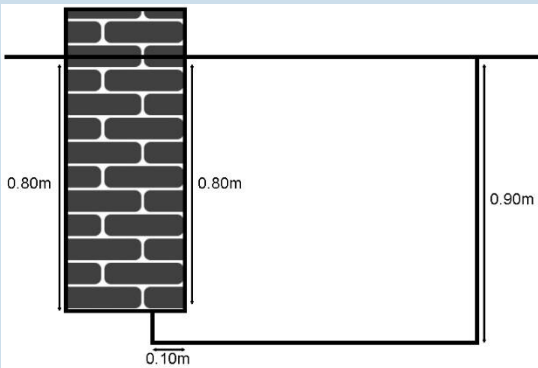
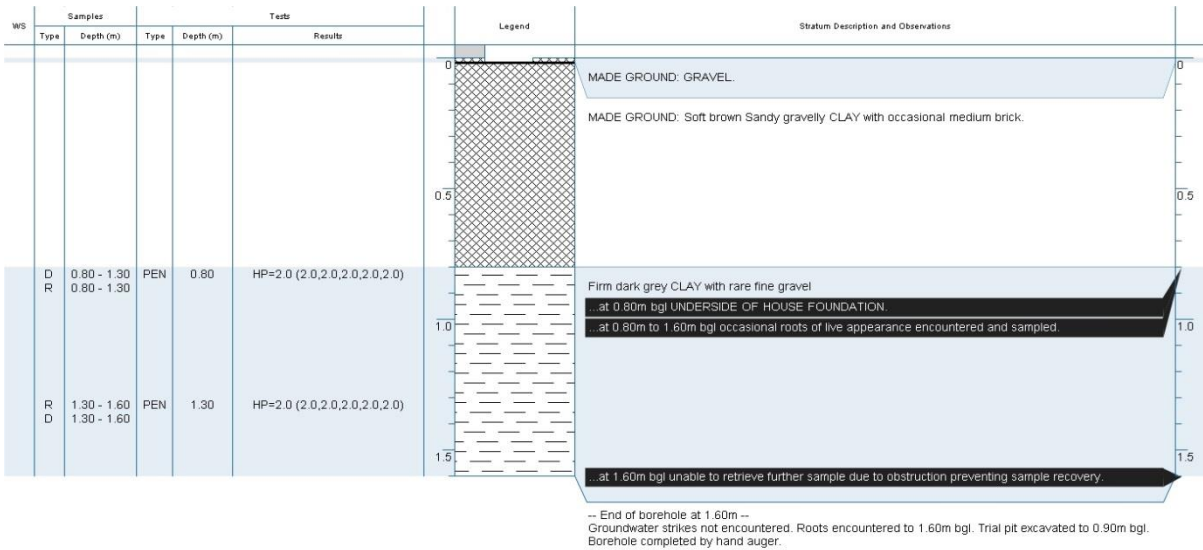
TP/BH1 Foundation Detail and Borehole Log

House foundation comprised of brick wall to 800mm bgl with no projection. Underside of foundation was exposed to 100mm back from the face of the foundation and probed 300mm back from the face of the foundation.

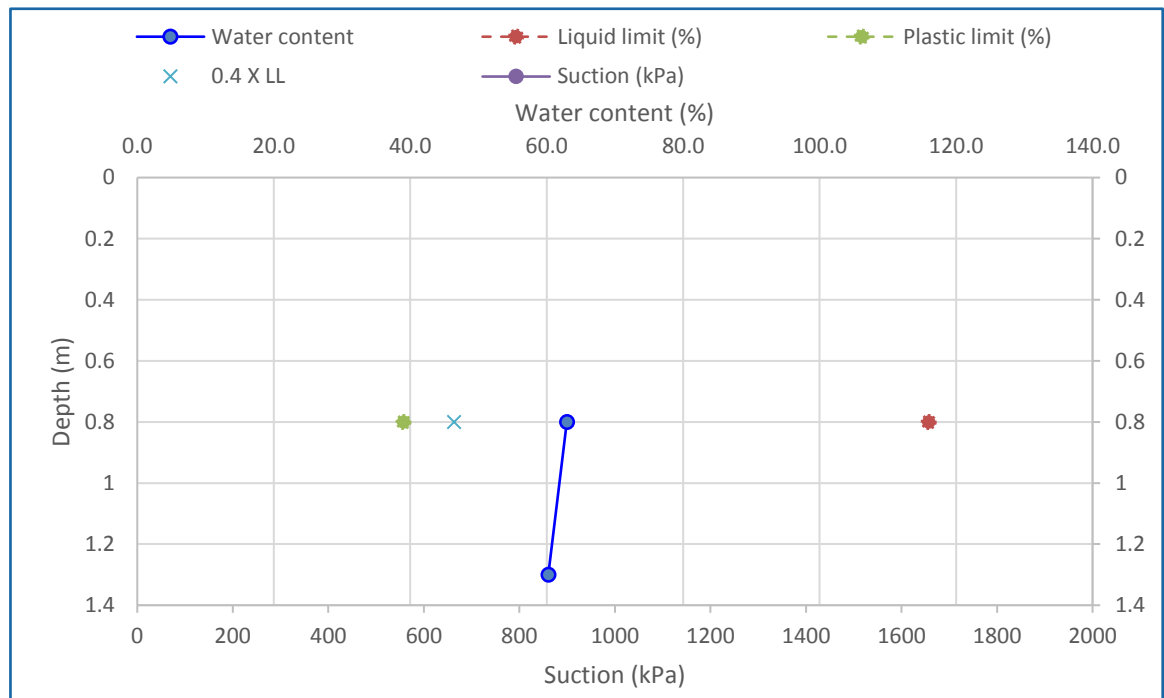
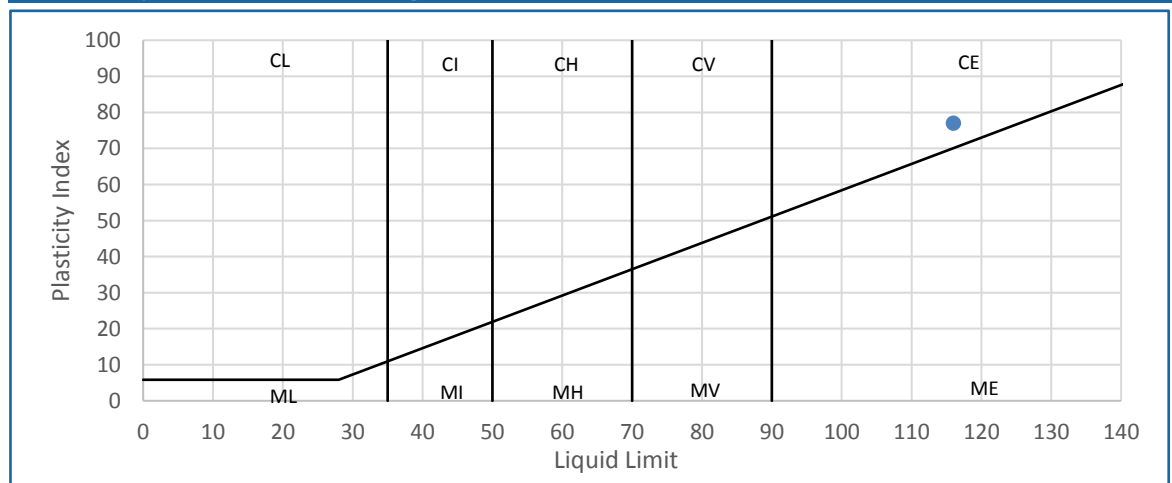
## Samples from BH1

| Lab Ref | Depth (m) | MC (%) | LL (%) | PL (%) | PI (%) | .425 mm(%) | mod. PI (%) | Av. Suc. (kPa) | Description |
|---|---|---|---|---|---|---|---|---|---|
| 1 | 0.8 | 62.9 | 116 | 39 | 77 | 100 | 77 | | Soft dark grey CLAY with rare gravel. Gravel is fine |
| 2 | 1.3 | 60.2 | | | | | | | Soft to firm dark grey CLAY with rare gravel. Gravel is fine and medium. |

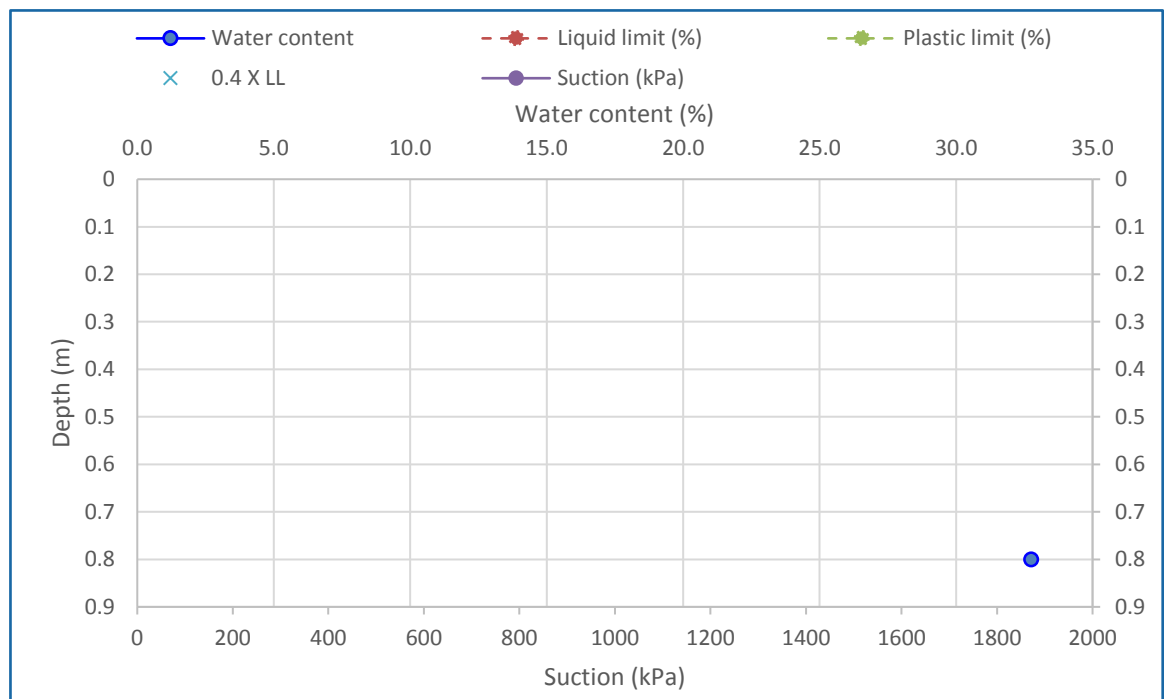
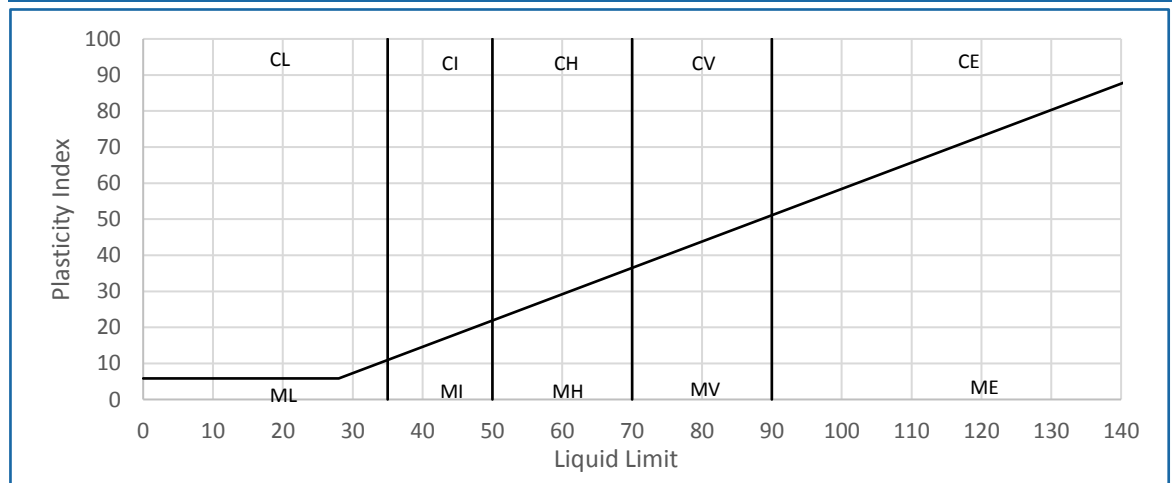
## Samples from BH2

| Lab Ref | Depth (m) | MC (%) | LL (%) | PL (%) | PI (%) | .425 mm(%) | mod. PI (%) | Av. Suc. (kPa) | Description |
|---|---|---|---|---|---|---|---|---|---|
| 3 | 0.8 | 32.7 | | | | | | | Firm grey-brown/dark grey slightly gravelly CLAY with rare sand. Gravel is fine and medium. |

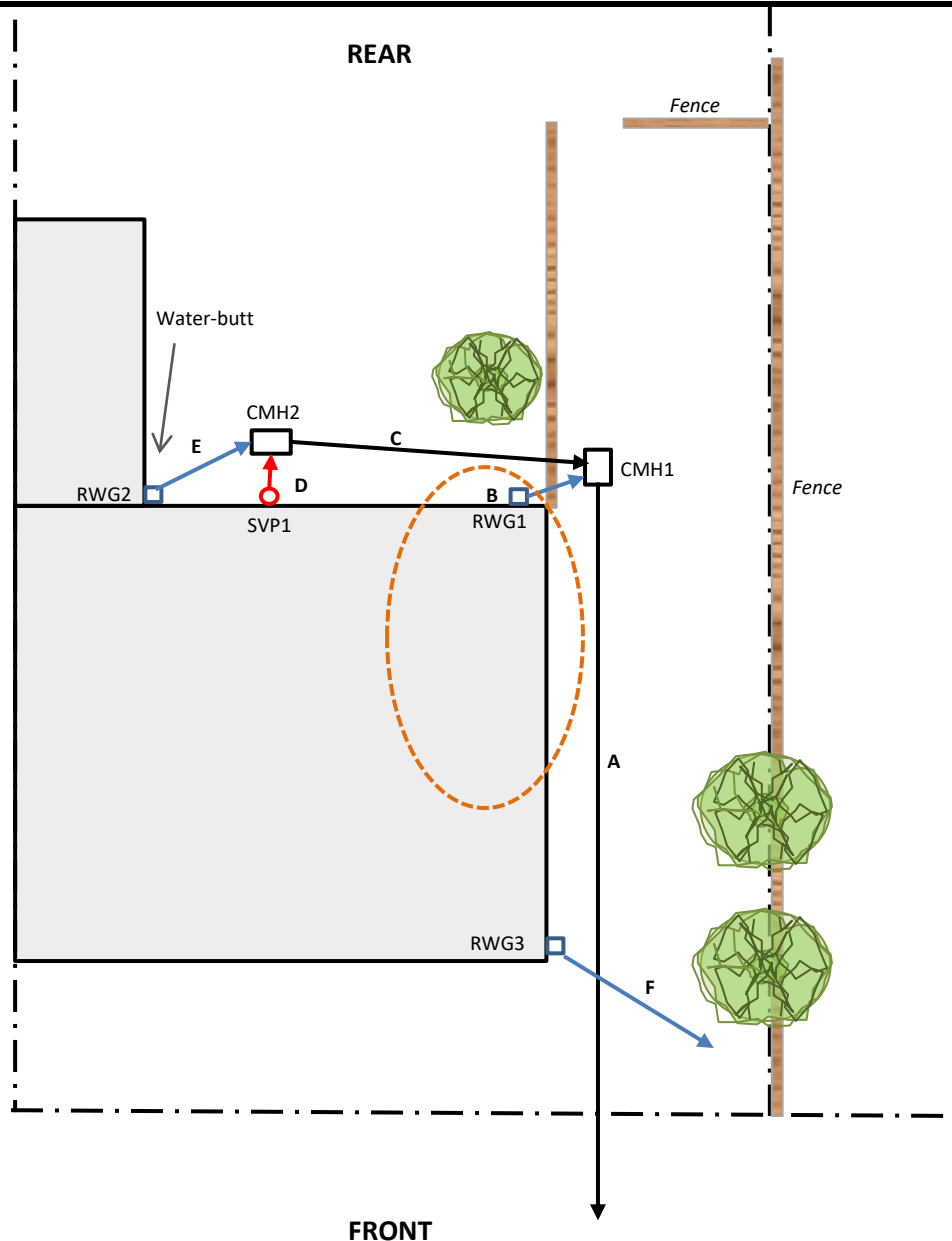
| 0.23 | REM | Remark - Pipe has been cut lengthways | | | | |
| 0.42 | CX | Defective Connection | | | | |
| 1.63 | DES | Settled Deposits (fine) | | | | |
| 1.64 | SA | Survey Abandoned - Unable to push past blockages | | | | |

CCTV Survey Result: Structural damage

- 1) To excavate and replace existing gully including 2m of adjacent pipe work.
- 2) To carry out a further look-see CCTV survey and report findings.
