ARBORICULTURAL ASSESSMENT REPORT

Sweetcroft Residential Care Home, 53 Sweetcroft Lane, Uxbridge,
UB10 9LE

Client Ref: 9677704

PRI Ref: 243431

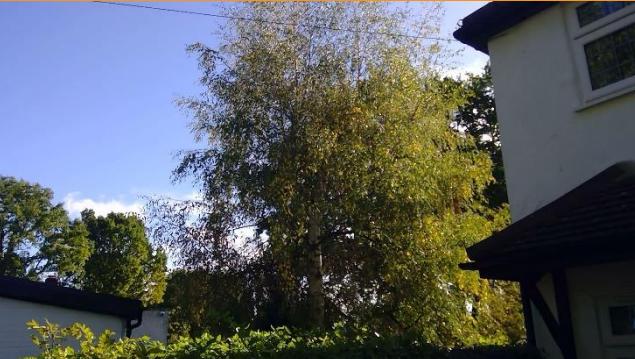
T1 - Birch	H1 - Mixed species hedge

Tree No:	Species	Works Required
H1	Mixed species hedge	Remove section of hedge from front of property (8 stems) and treat stumps with eco plugs to give a minimum clearance of 5 metres from the front of the property
T1	Birch	Fell and treat stump with eco plugs (broadleaved).
T2	Oak	Fell and treat stump with eco plugs (broadleaved).

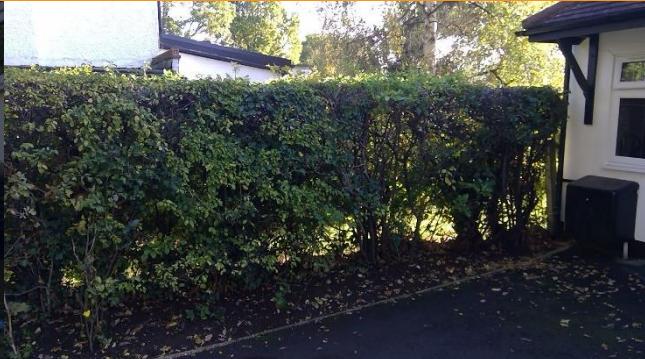
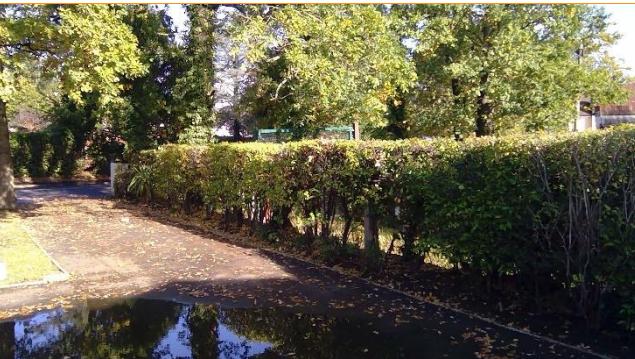
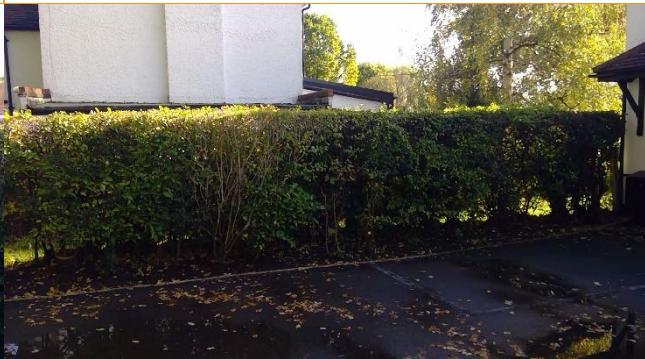
H1 - Mixed species hedge	H1 - Mixed species hedge
